Inspection Photos

Location Name: TEP ROCKY MOUNTAIN LLC, FEDERAL-67S96W/4SENE

Location ID: 334884

Date: 8/9/2023

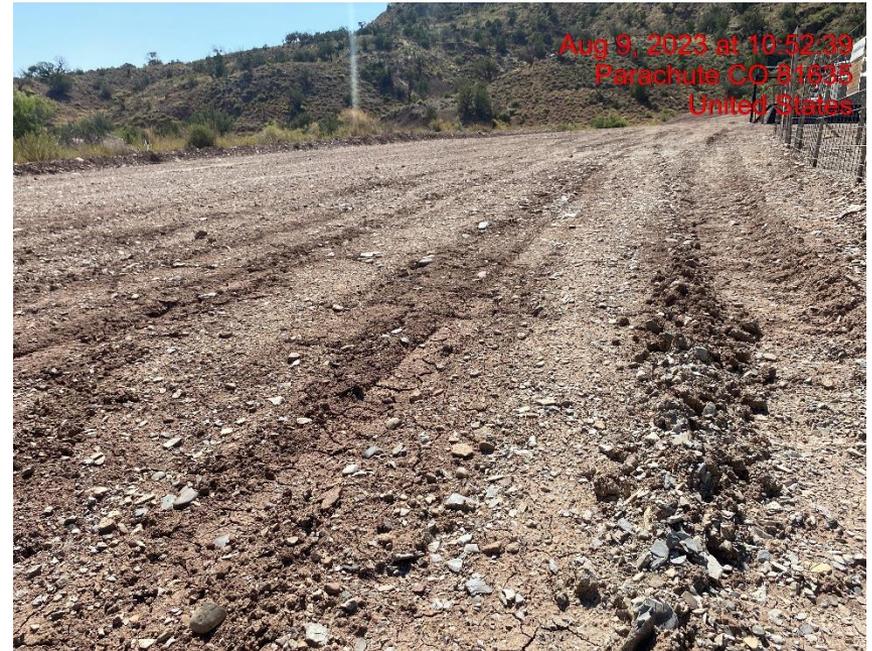
Location Lacks Stabilization – Photo #05713

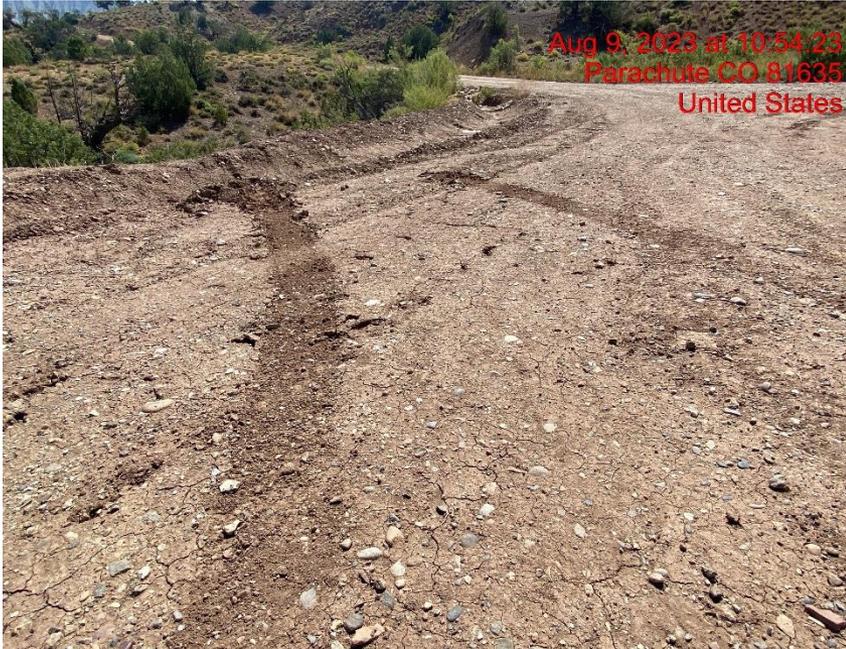
Location Lacks Stabilization – Photo #05717

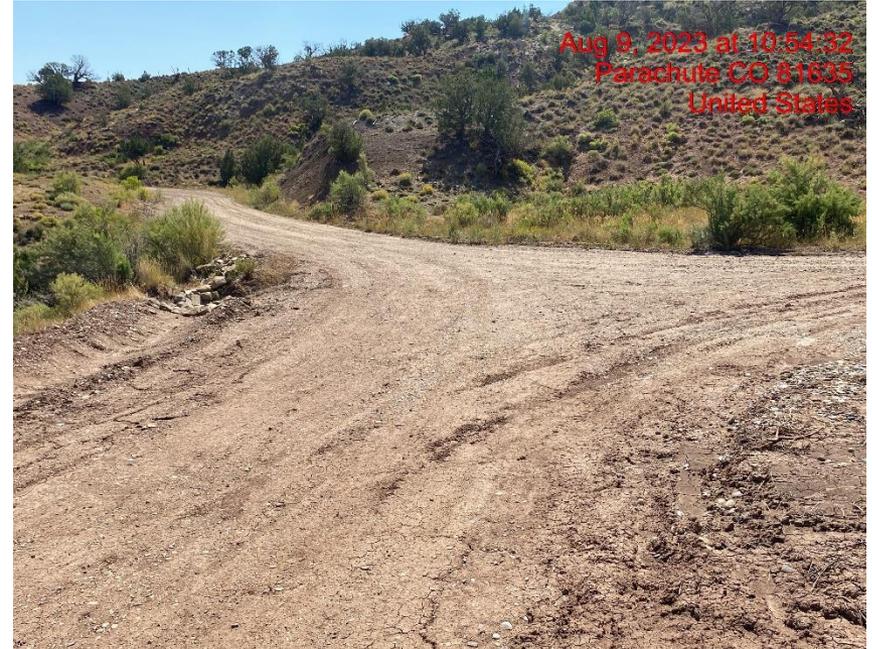
**Insufficient Vehicle Tracking BMPs at Location Entrance/Exit
– Photo #05718**

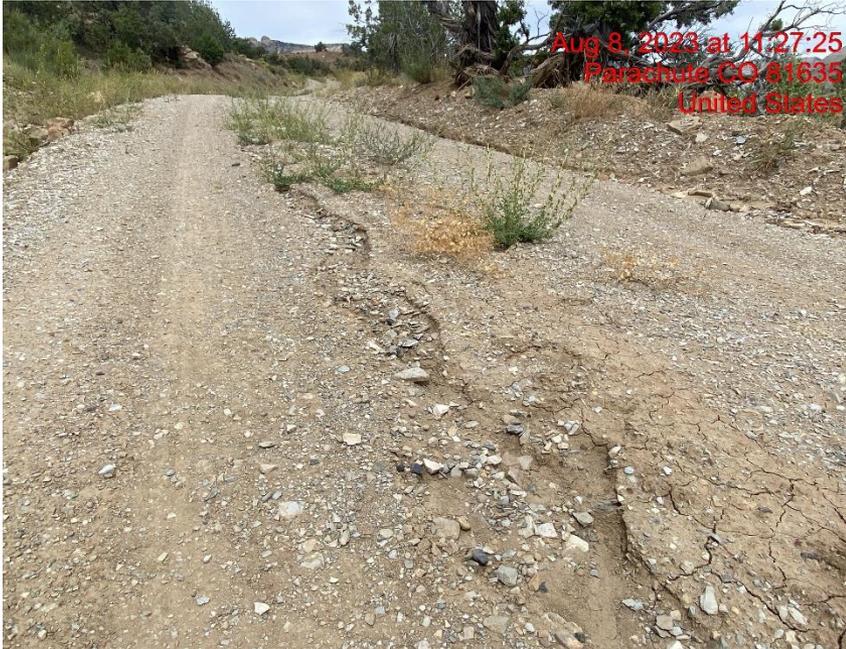
Rill Erosion Cutting Through Lease Road – Photo #05693

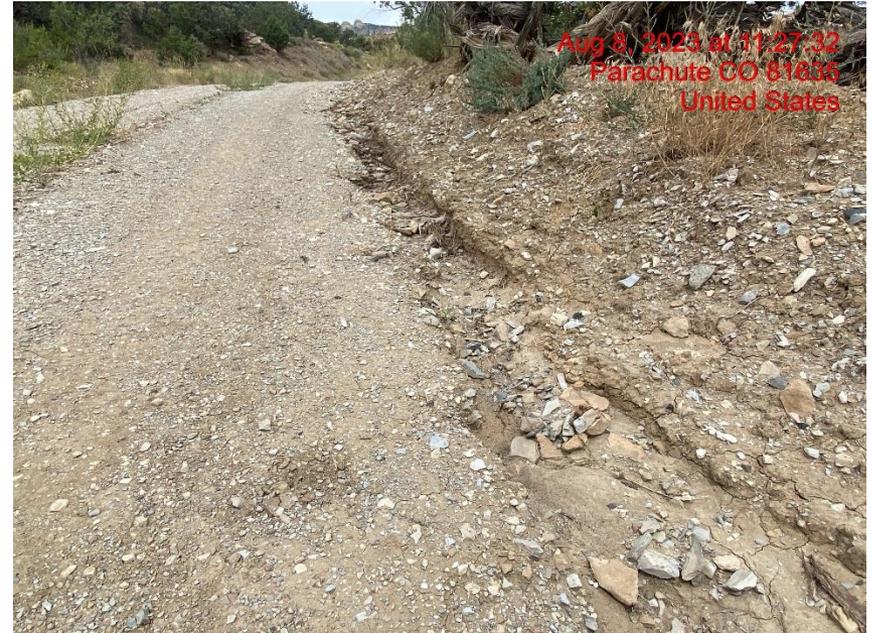
Rill Erosion Cutting Through Lease Road – Photo #05694

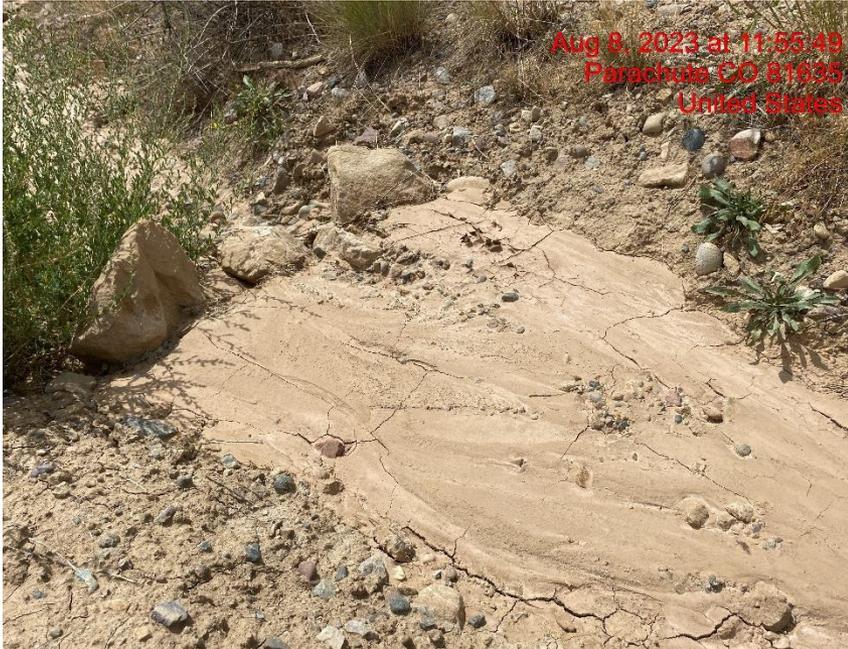
Check Dam Needs Maintenance – Photo #05707

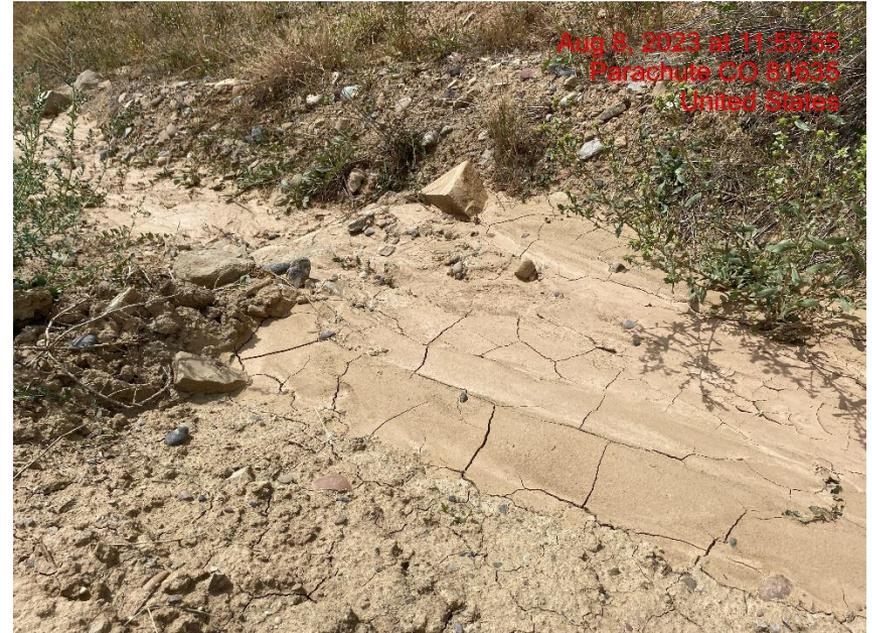
Check Dam Needs Maintenance – Photo #05708
