Inspection Photos

Location Name: TEP ROCKY MOUNTAIN LLC, FEDERAL-67S96W/4NWSE

Location ID: 334795

Date: 8/9/2023

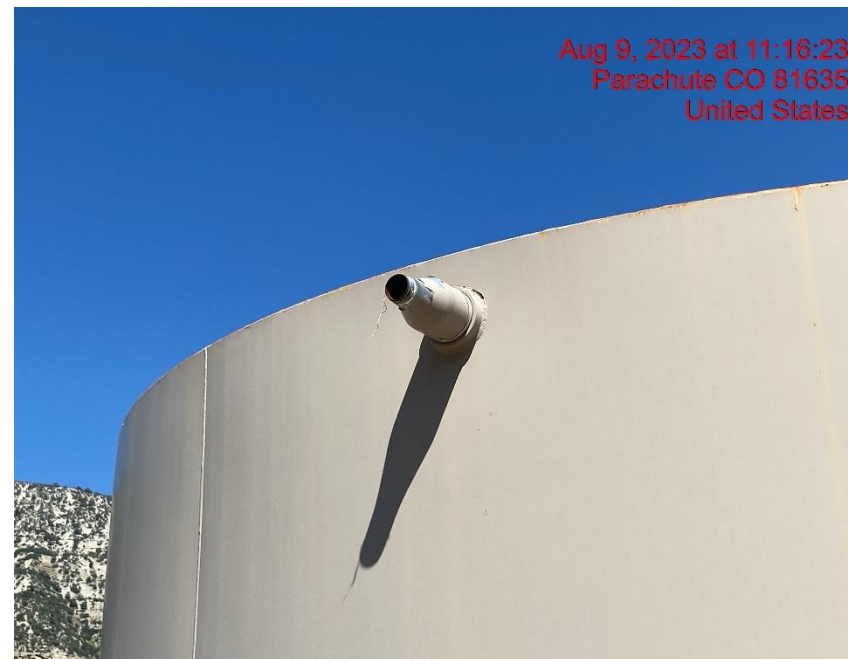
Open-Ended Vent – Photo #05728

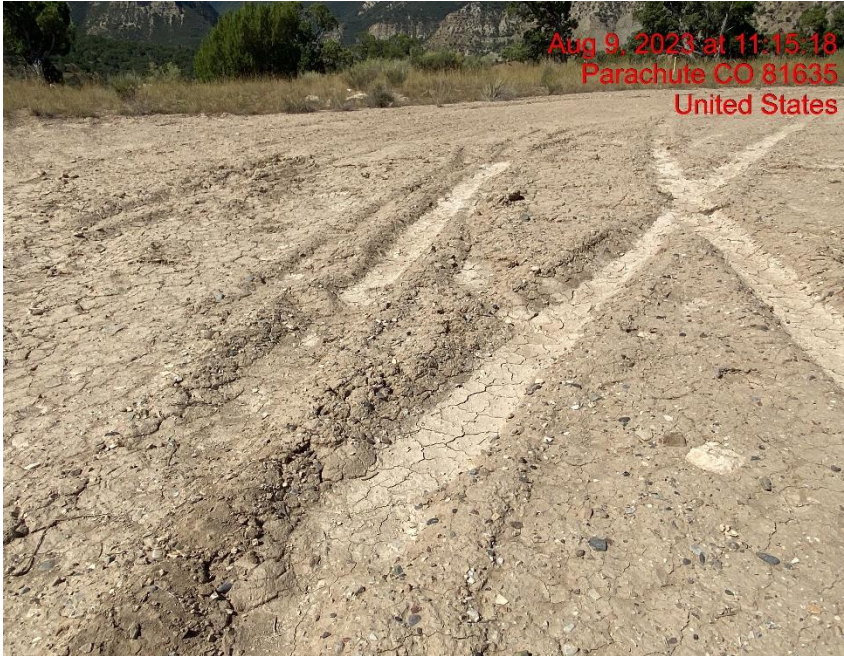
Location Lacks Stabilization – Photo #05727

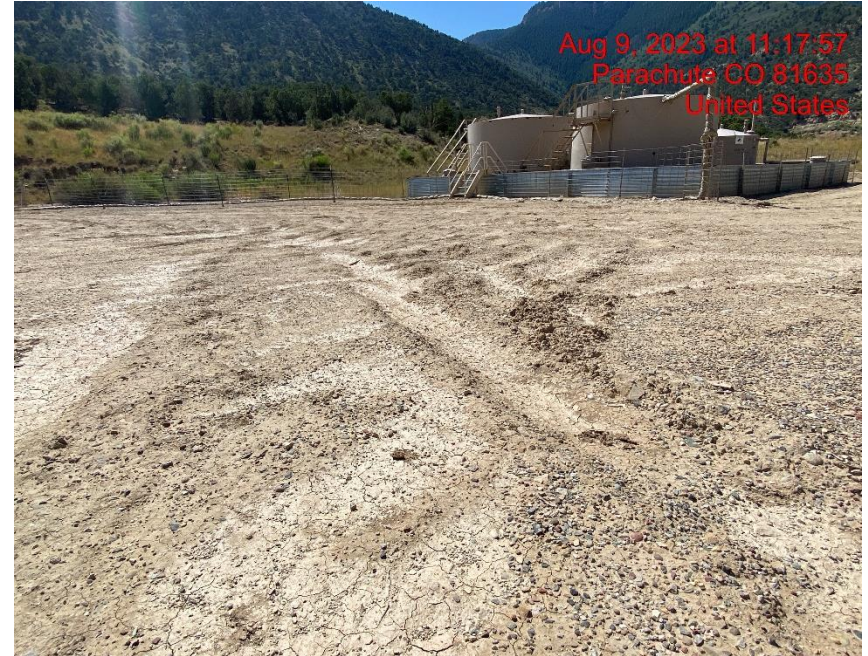
Location Lacks Stabilization – Photo #05730

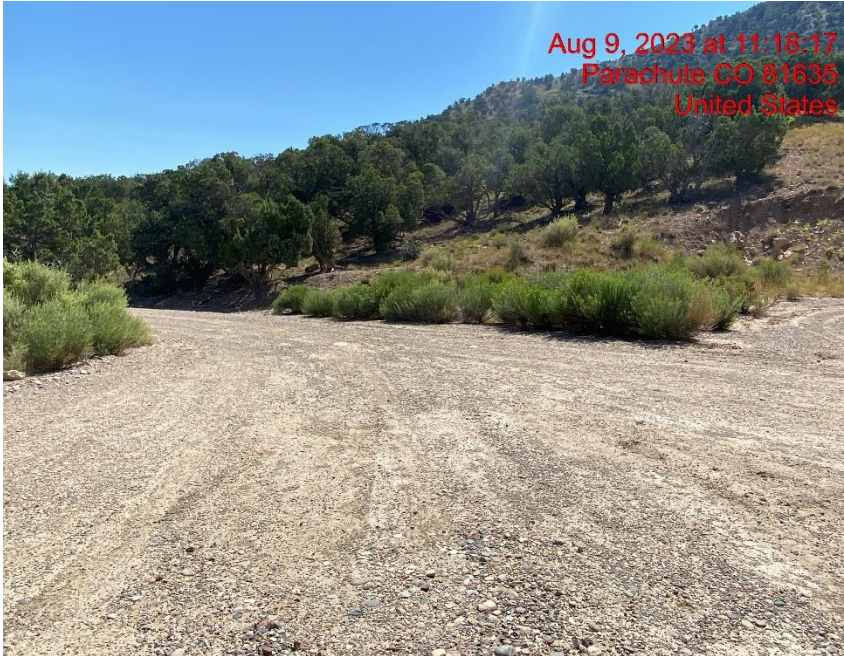
**Insufficient Vehicle Tracking BMPs at Location Entrance/Exit
– Photo #05731**

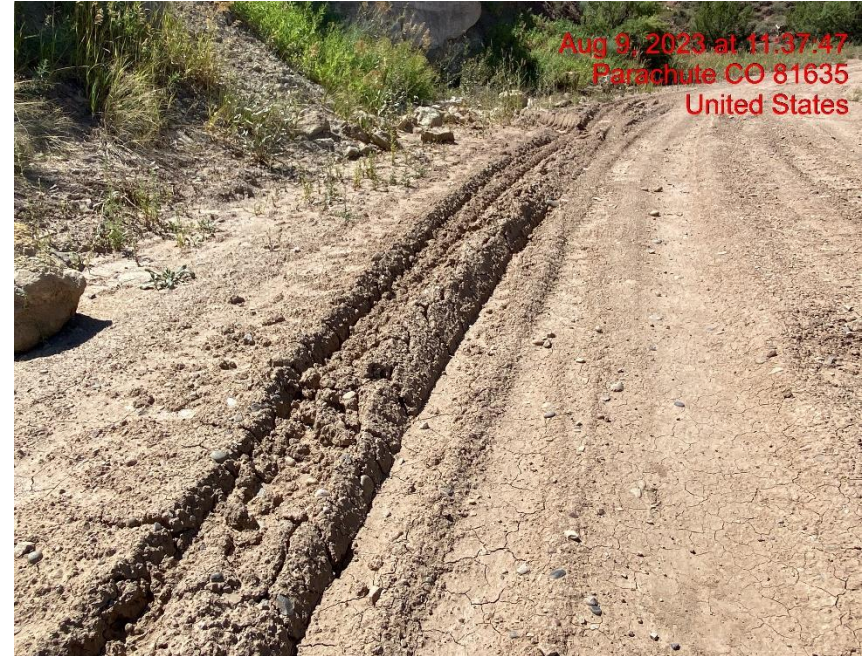
Rill Erosion Cutting Through Lease Road – Photo #05732

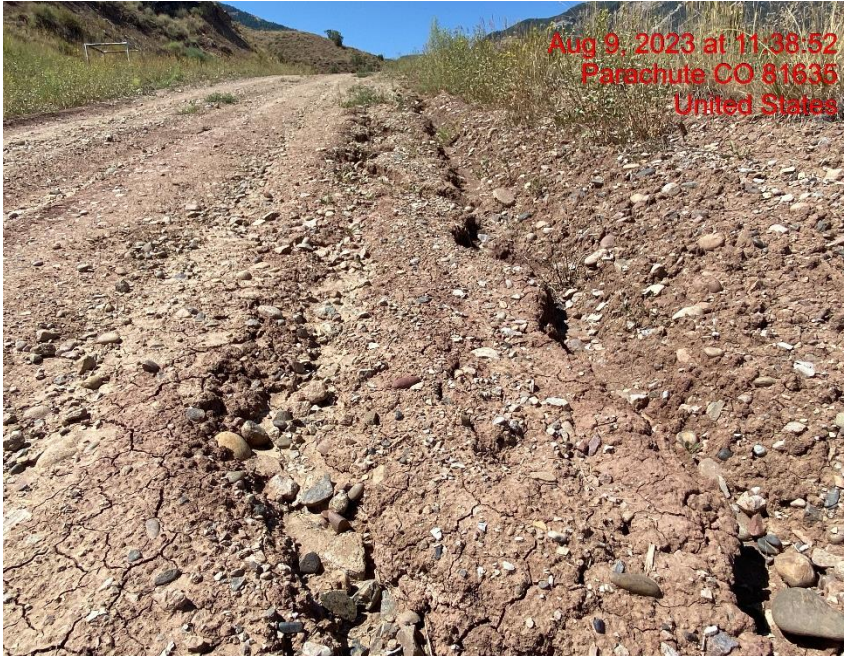
Rill Erosion Cutting Through Lease Road – Photo #05733

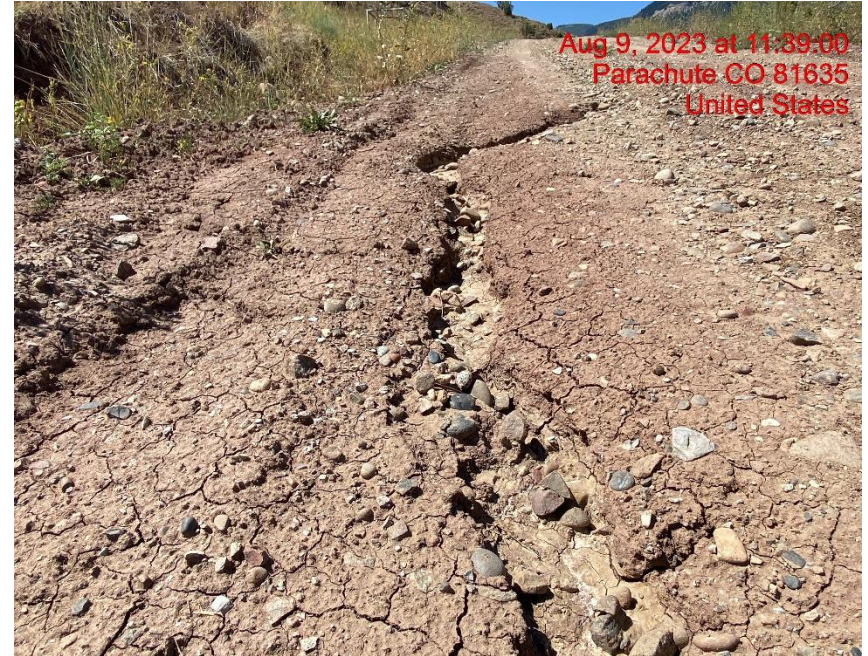
Rill Erosion Cutting Through Lease Road – Photo #05734
