Interim Reclamation and Stormwater Inspection

Operator: WARD & SON* ALFRED - 94300 (IMPETRO
RESOURCES INC -10690)

Location ID: 312310

Inspection Document #: 708200451

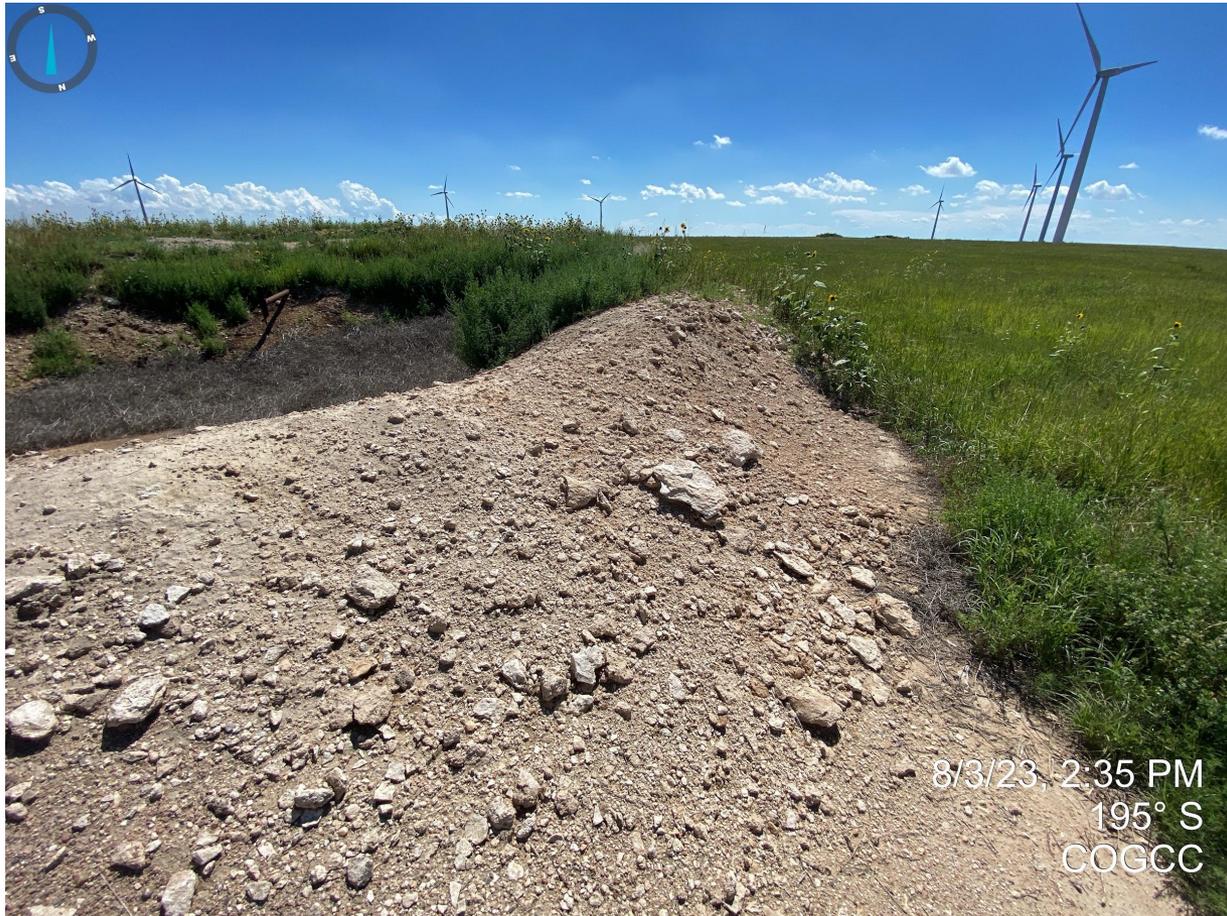
Photo 1. Plt walls/berms appear to be comprised of unconsolidated material and are not properly stabilized.

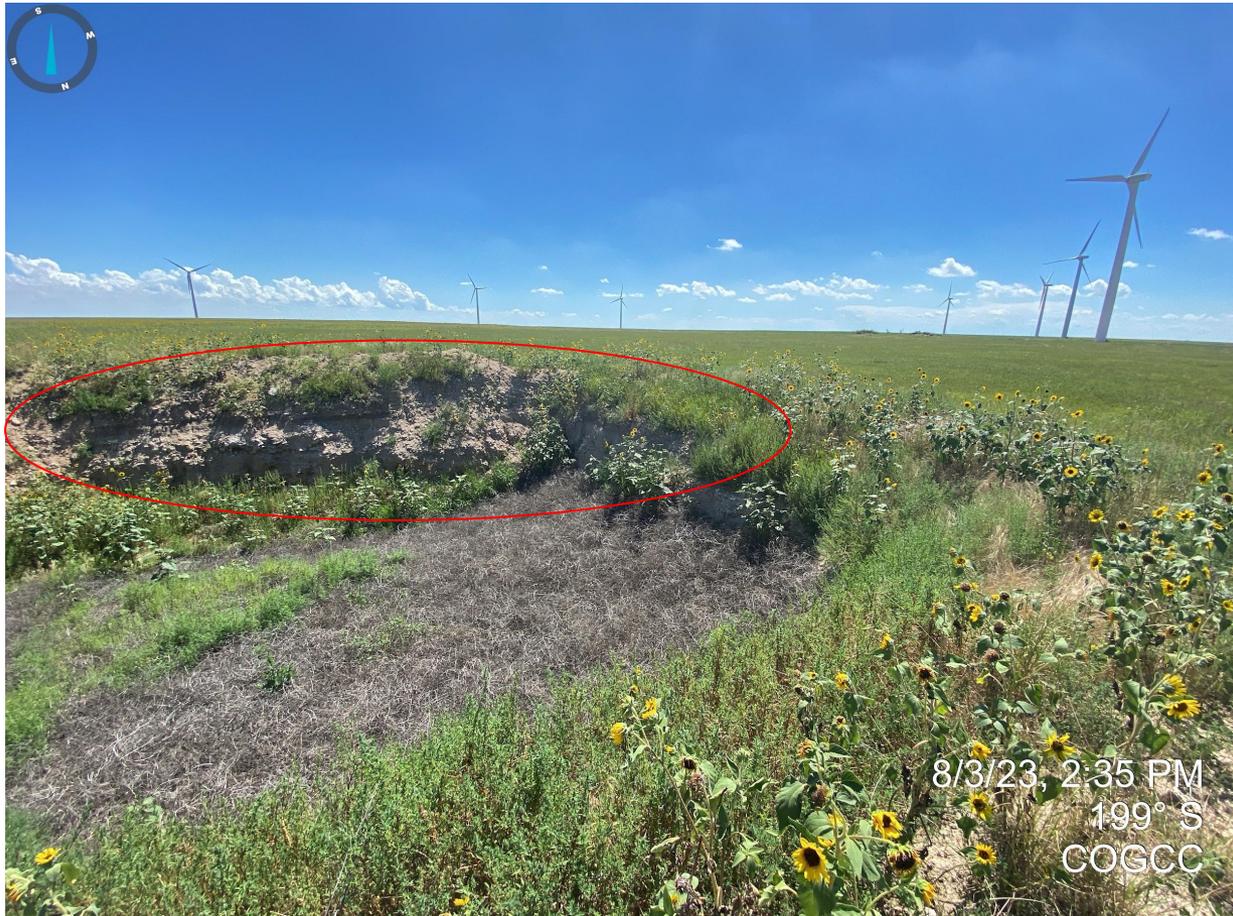
Photo 2. See comments in Photo 1.

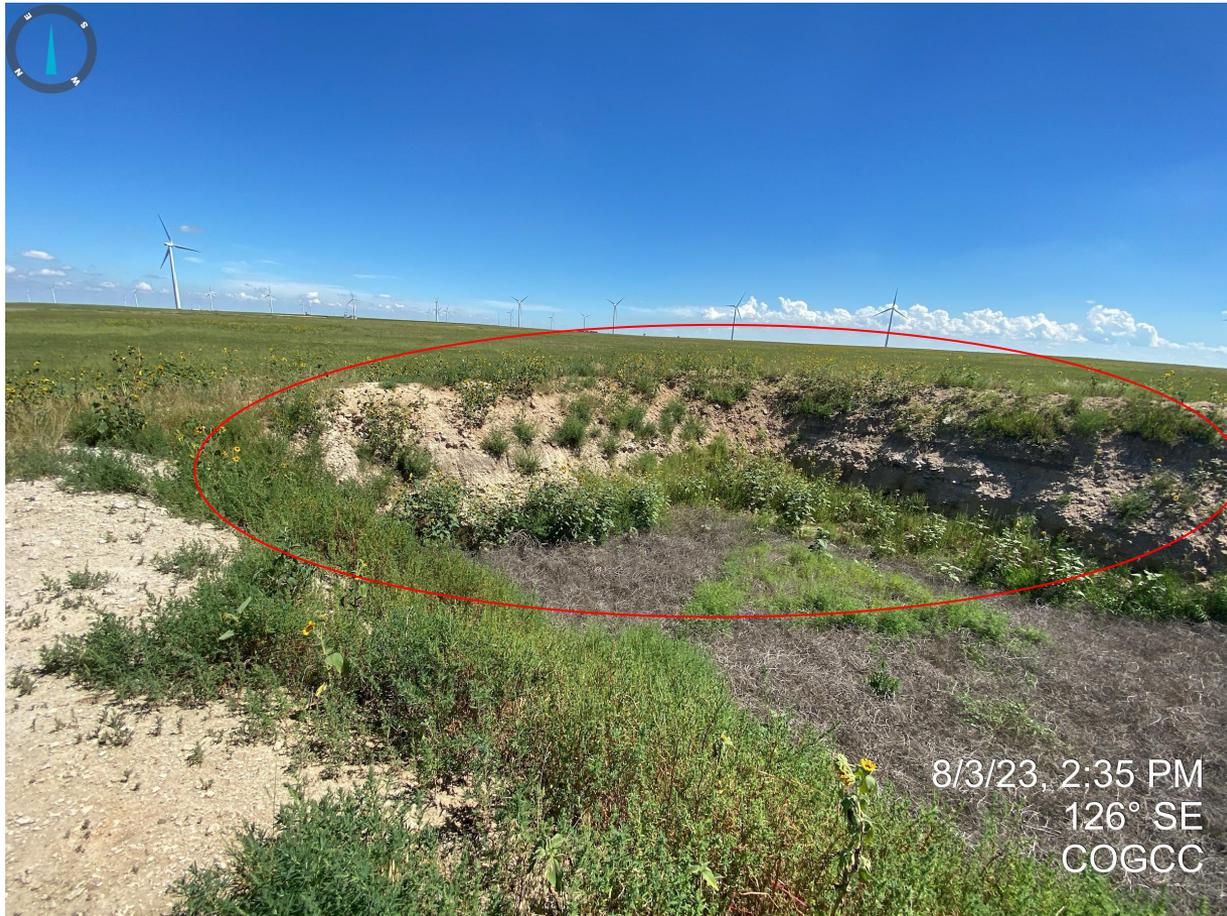
Photo 3. See comments in Photo 1.

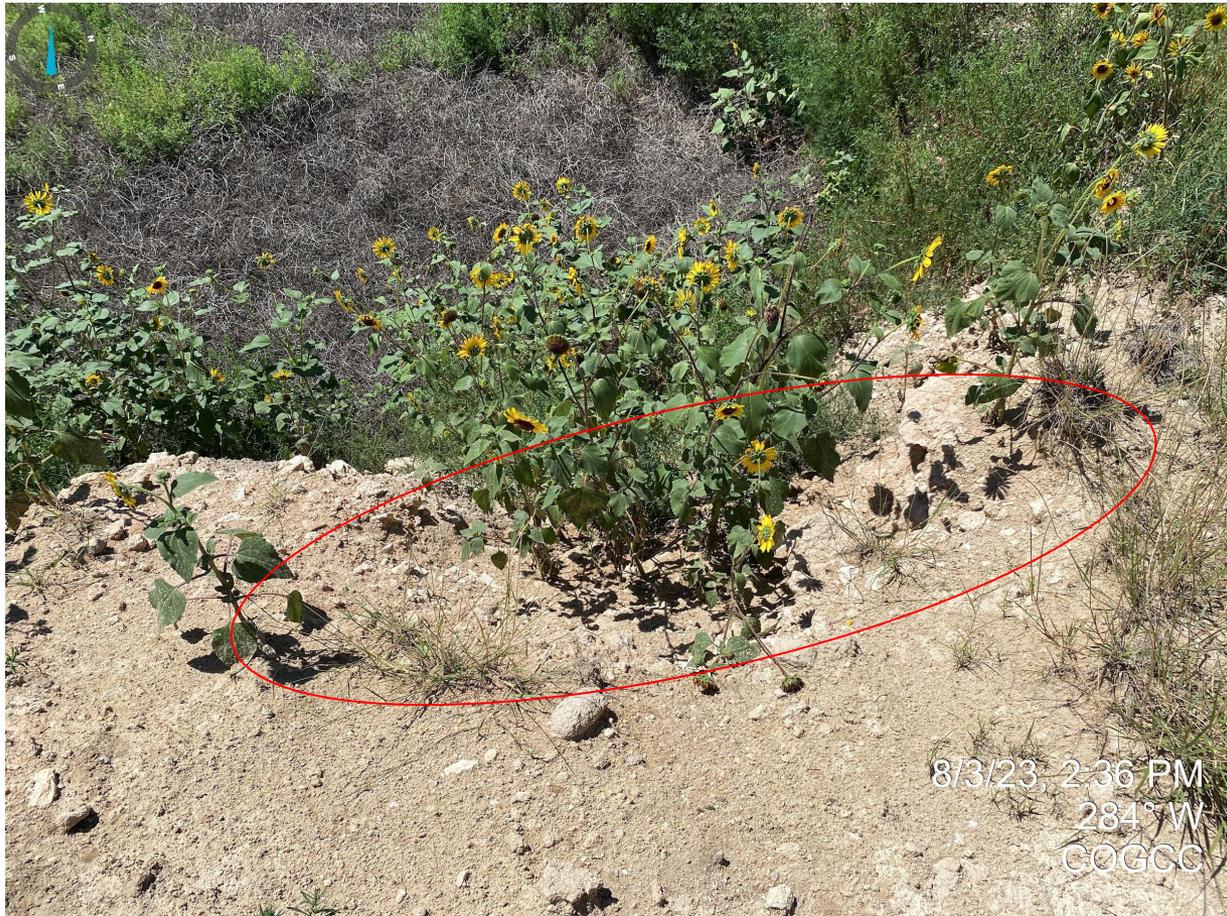
Photo 4. See comments in Photo 1.

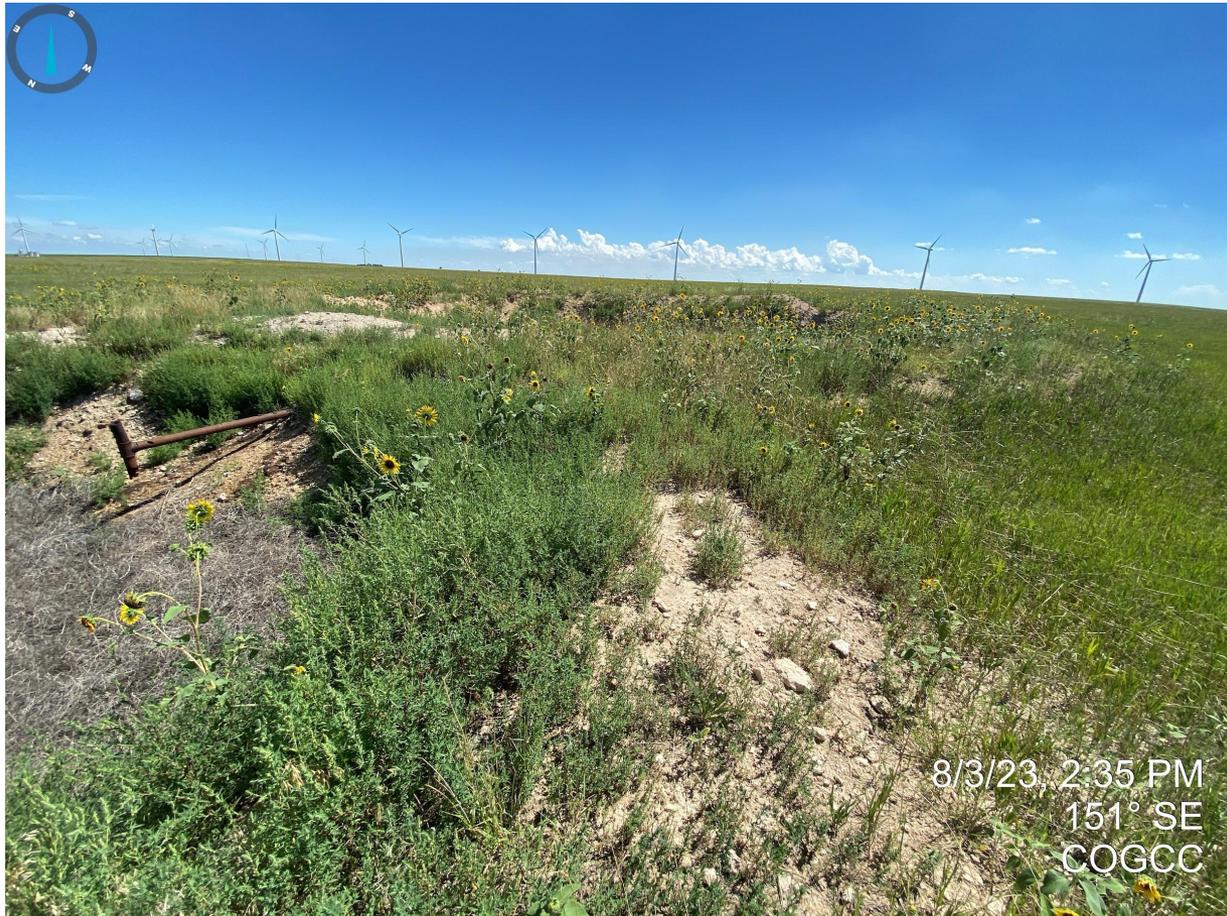
Photo 5. Undesirable vegetation (e.g. kochia and russian thistle) were observed to be growing around the location, including the pits. Management of the undesirable vegetation is required to prevent spread onto adjacent lands.

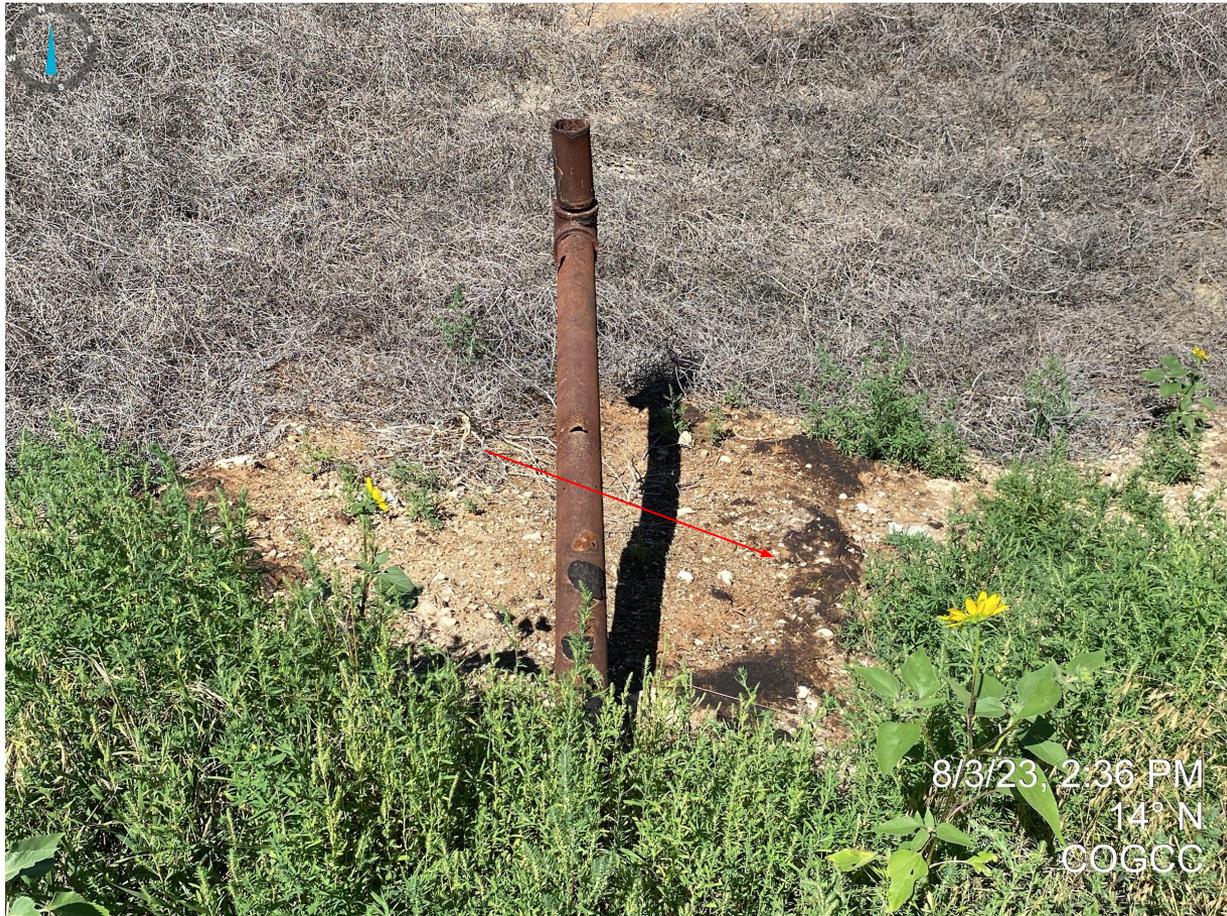
Photo 6. Stained soil observed within the skim pit. Refer to FIRs (Doc #701603755 and #709100070) for additional information.

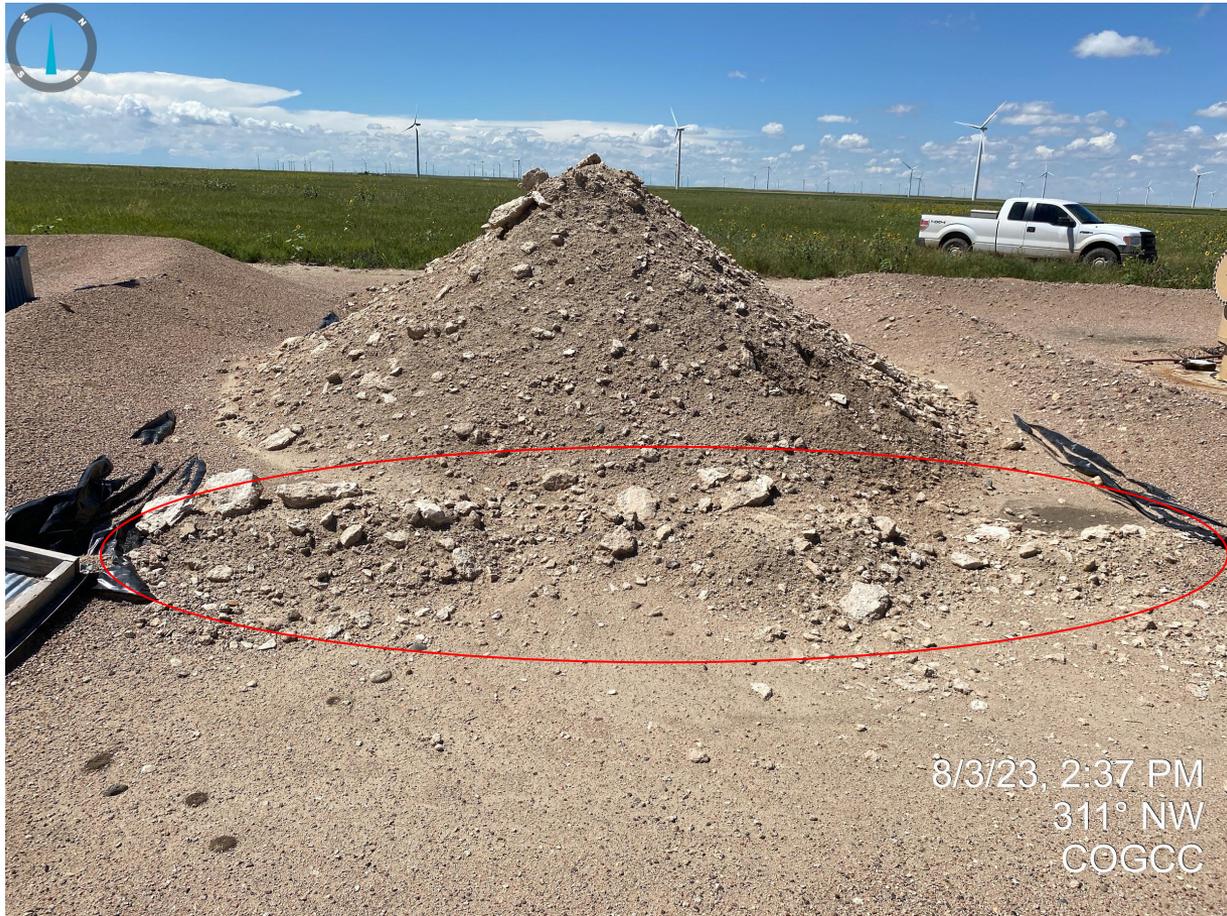
Photo 7. Apparent impacted material does not have adequate secondary containment.

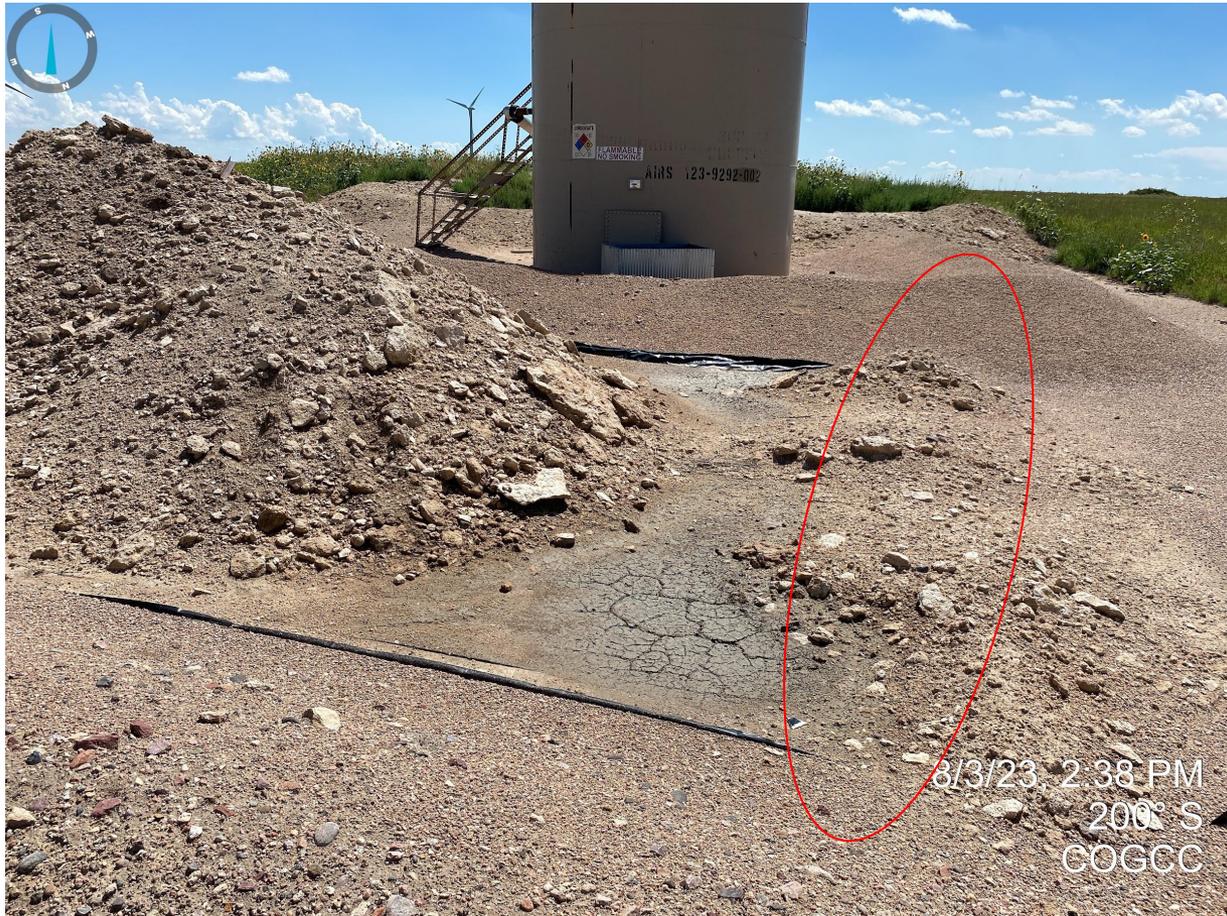
Photo 8. See comments in Photo 7.

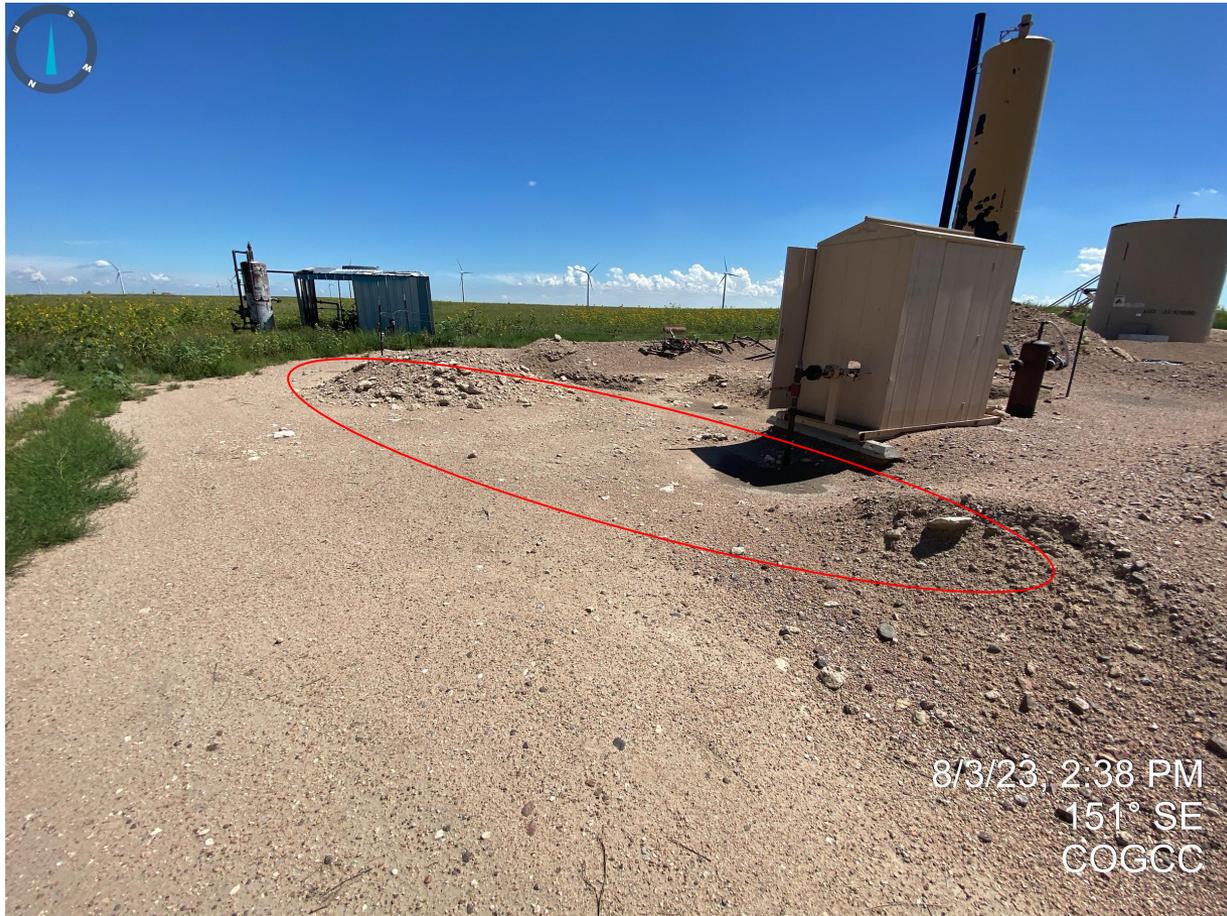
Photo 9. See comments in Photo 7.

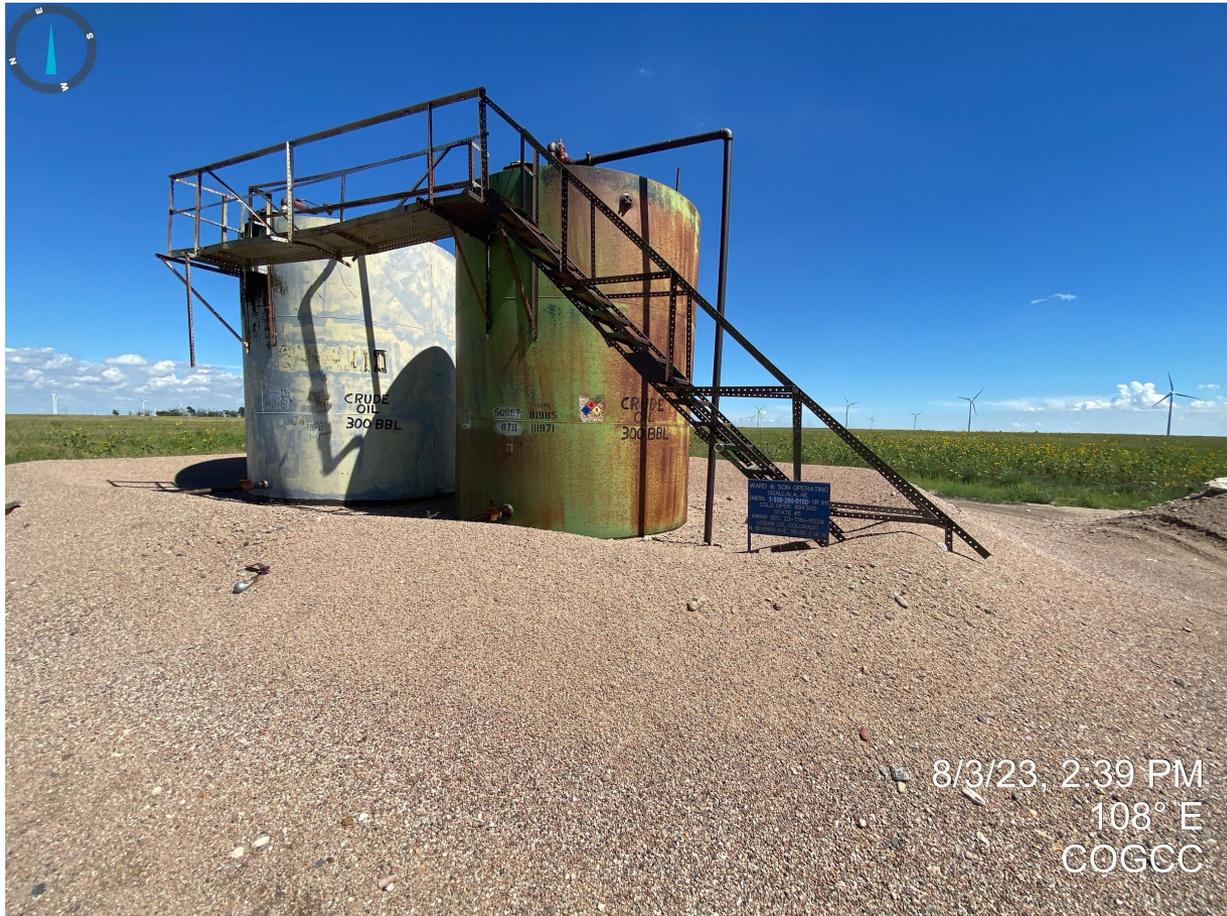
Photo 10. Secondary containment around the tank battery does not appear adequate to contain 150% of the volume of the largest tank.

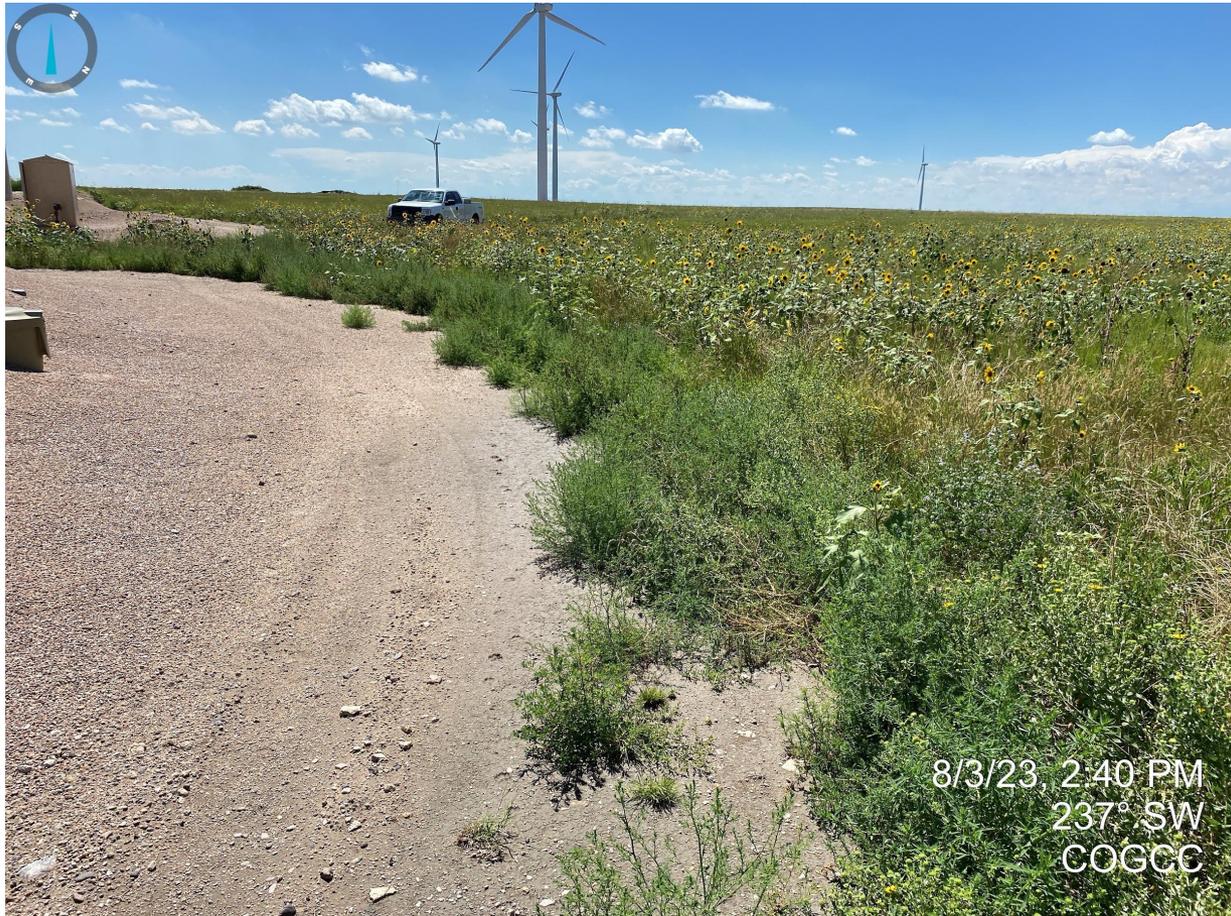
Photo 11. Undesirable vegetation (e.g. kochia and russian thistle) was observed to be growing around the location and access roads. Active management of undesirable vegetation is required to prevent spread onto adjacent lands.

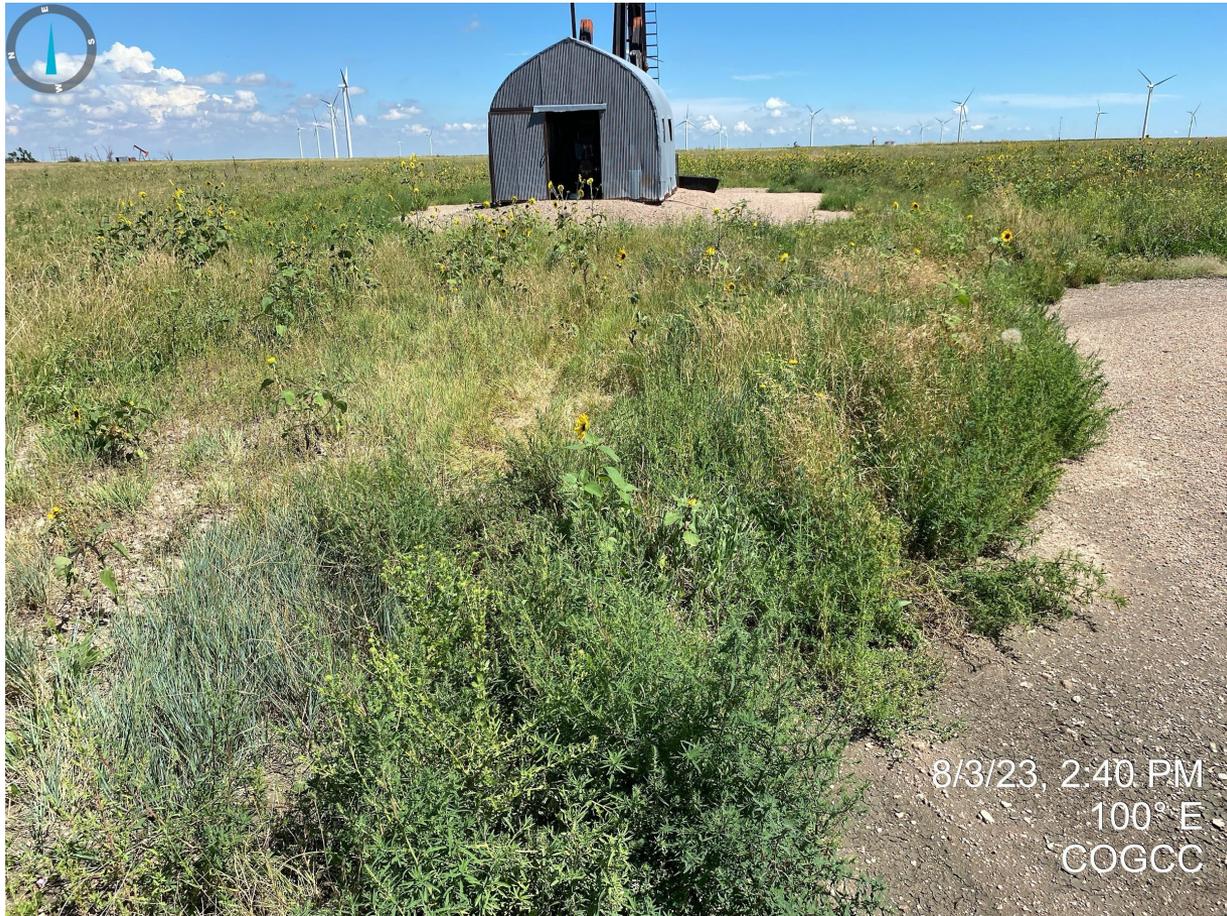
Photo 12. See comments in Photo 11.

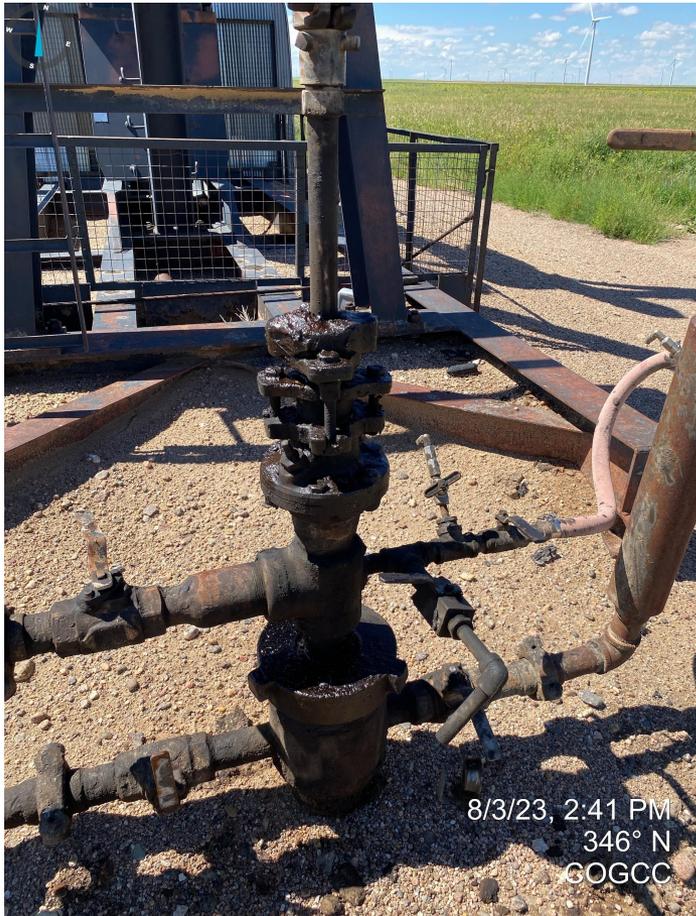
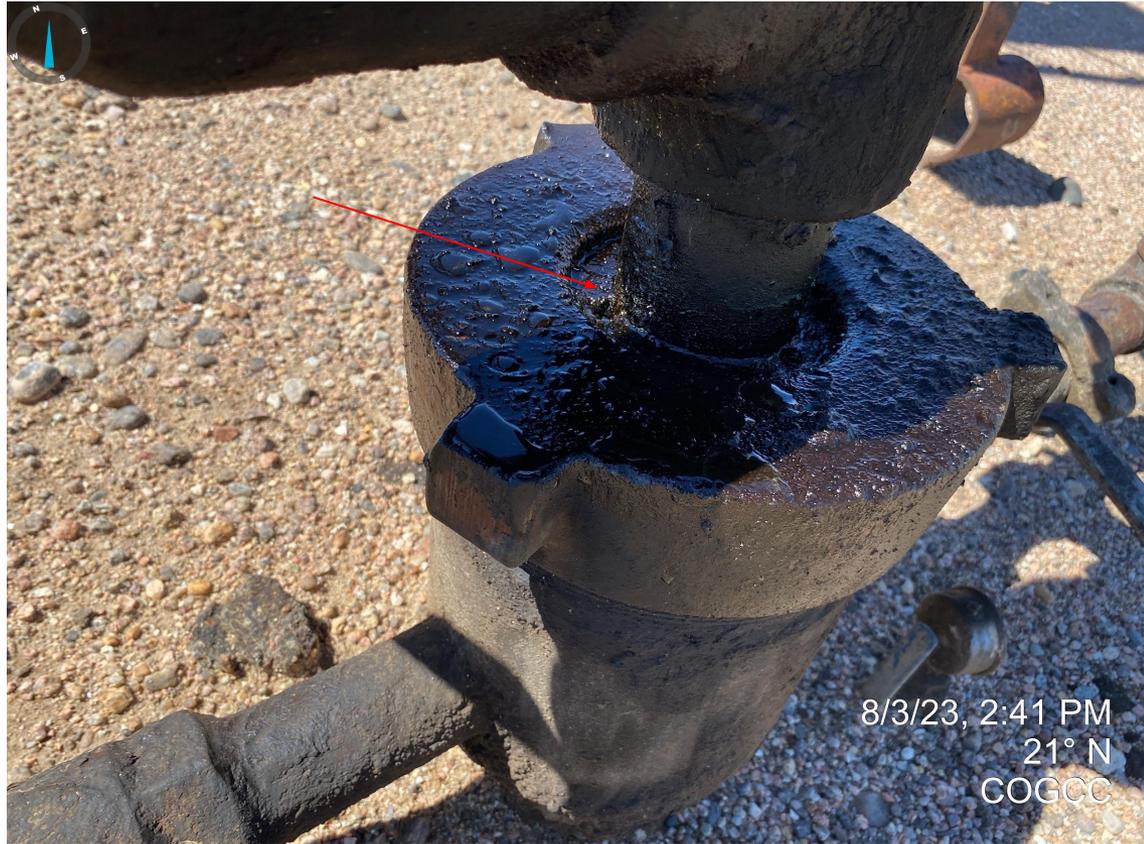
Photos 13 and 14. During this inspection, an auditory and visual leak was observed at the polish rod/stuffing box.
