**Inspection Photos**  
**Location Name: CAERUS PICEANCE LLC P13WB Pad**  
**Location #: 334658**

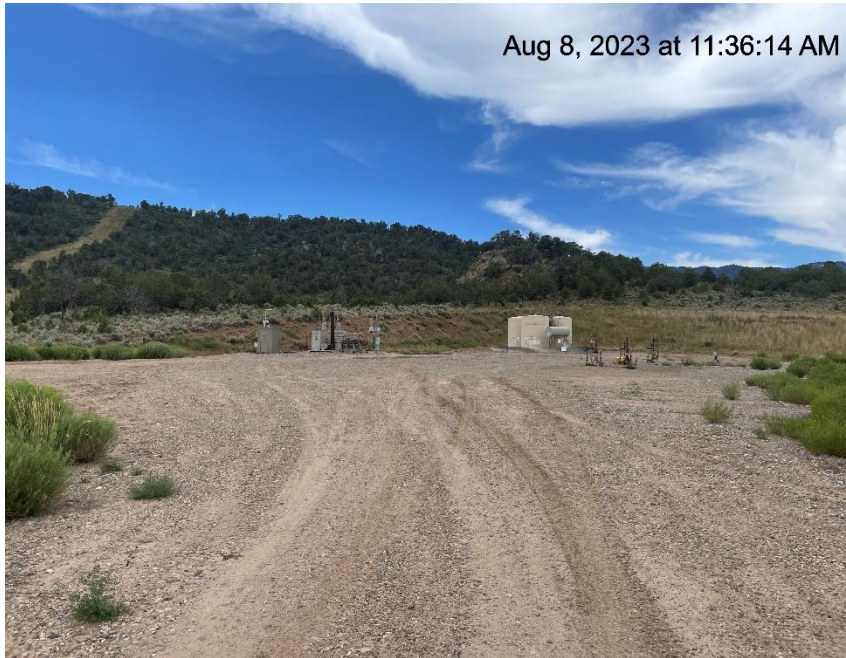
**Photo # 5324 From entrance to location**

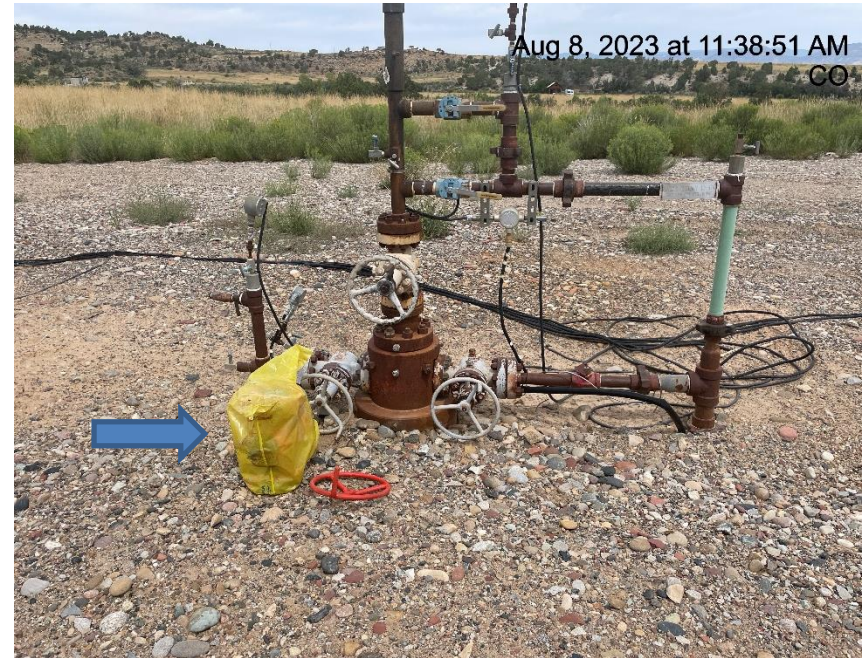
**Photo # 5329 Unused equipment/supplies**

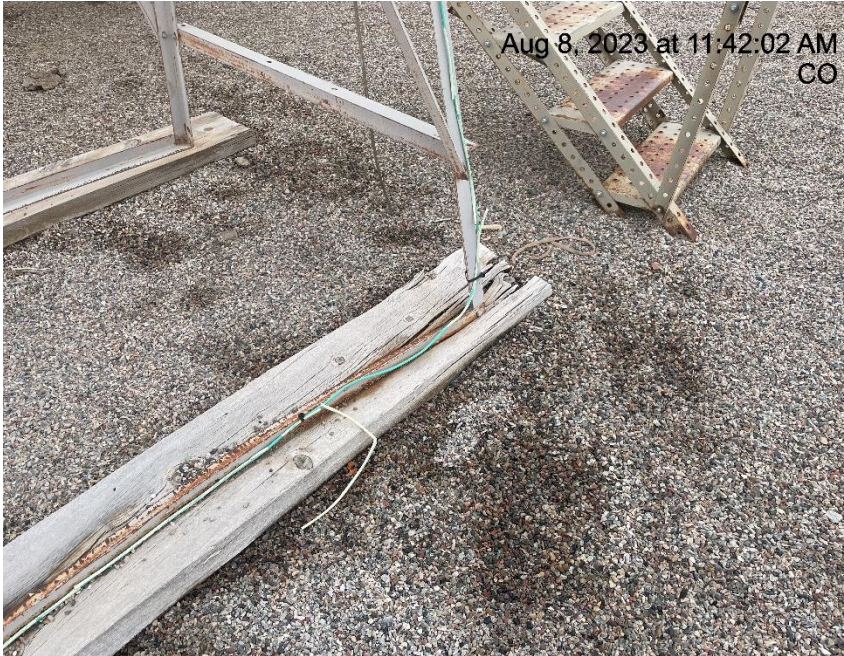
**Photo # 5331 Stained gravel in secondary containment**

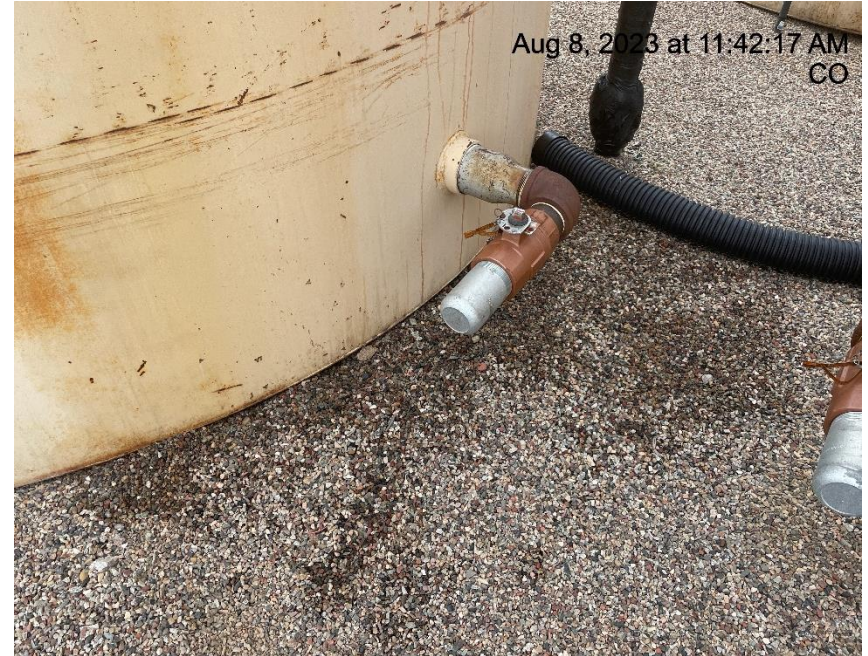
**Photo # 5332 Stained gravel in secondary containment**

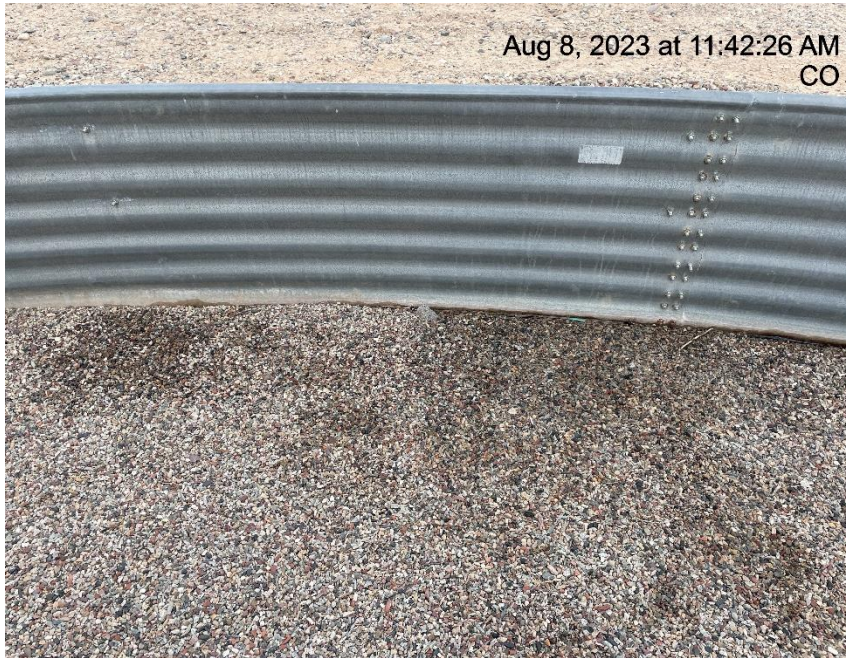
**Photo # 5333 Stained gravel in secondary containment**

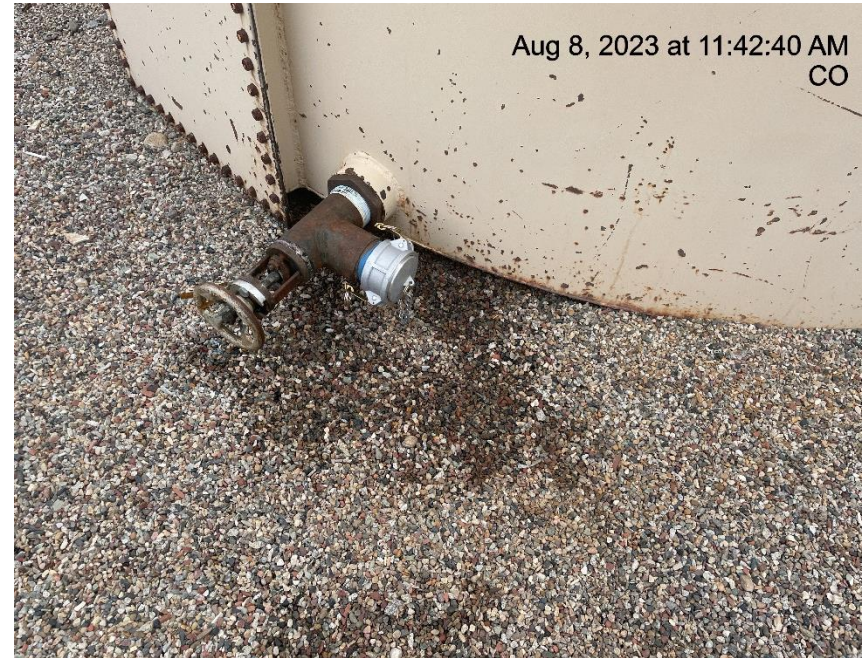
**Photo # 5334 Stained gravel in secondary containment**

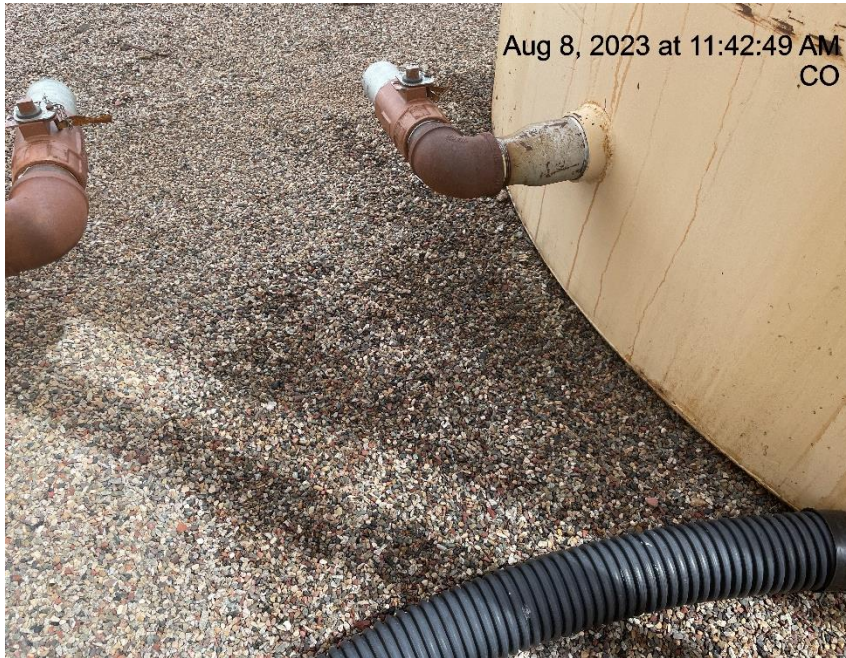
**Photo # 5335 Stained gravel in secondary containment**

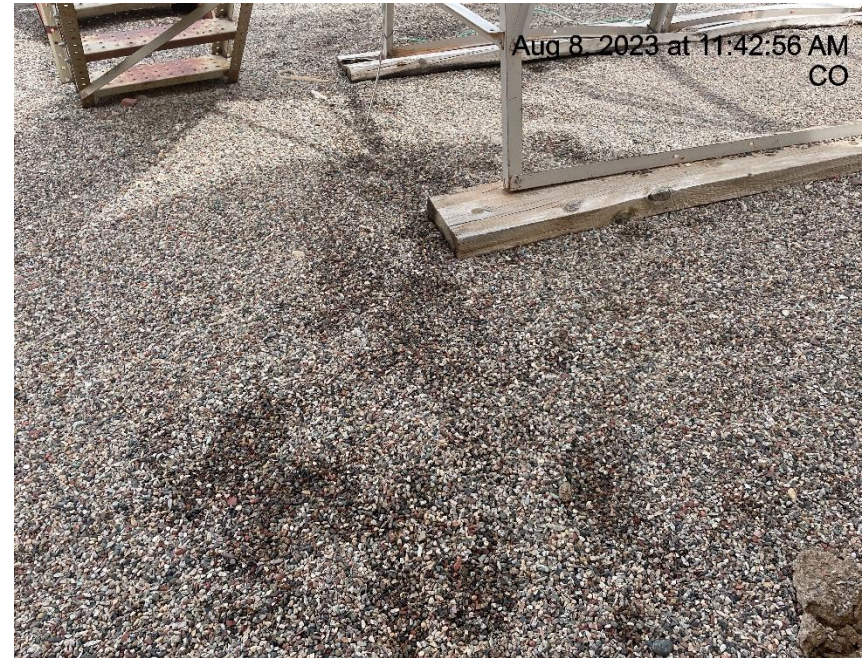
**Photo # 5336 Stained gravel in secondary containment**

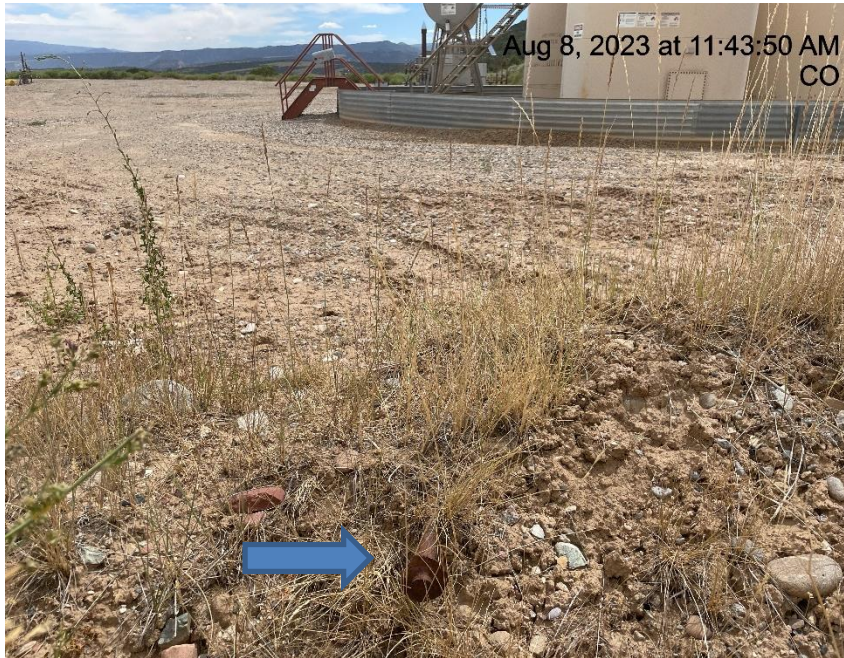
**Photo # 5338 Debris**
