Inspection Photos

Location Name: TEP ROCKY MOUNTAIN LLC, FEDERAL-67S96W/3NWSW

Location ID: 334788

Date: 8/9/2023

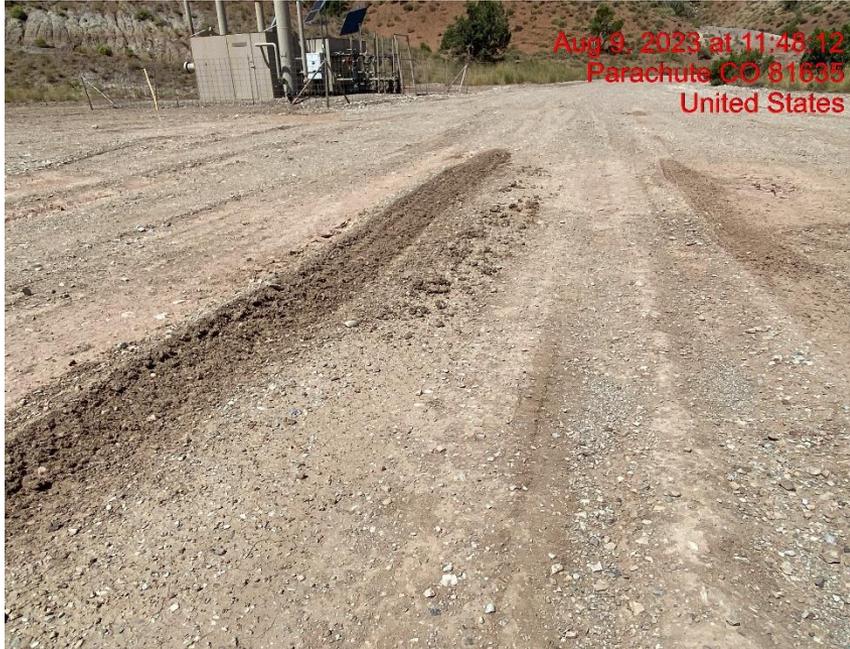
Aug 9, 2023 at 11:48:12
Parachute, CO 81635
United States

Location Lacks Stabilization – Photo #05743

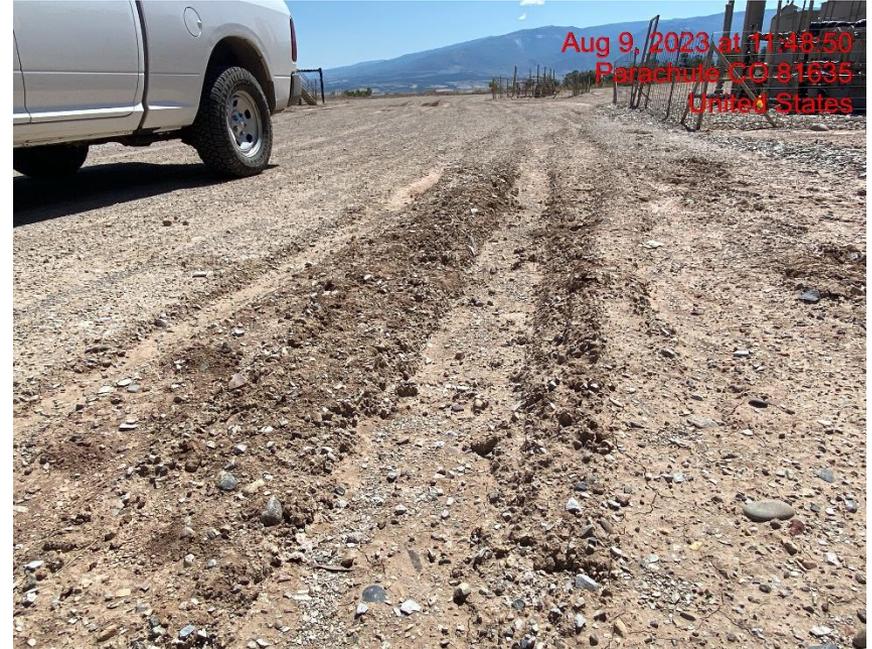
Aug 9, 2023 at 11:48:50
Parachute, CO 81635
United States

Location Lacks Stabilization – Photo #05744

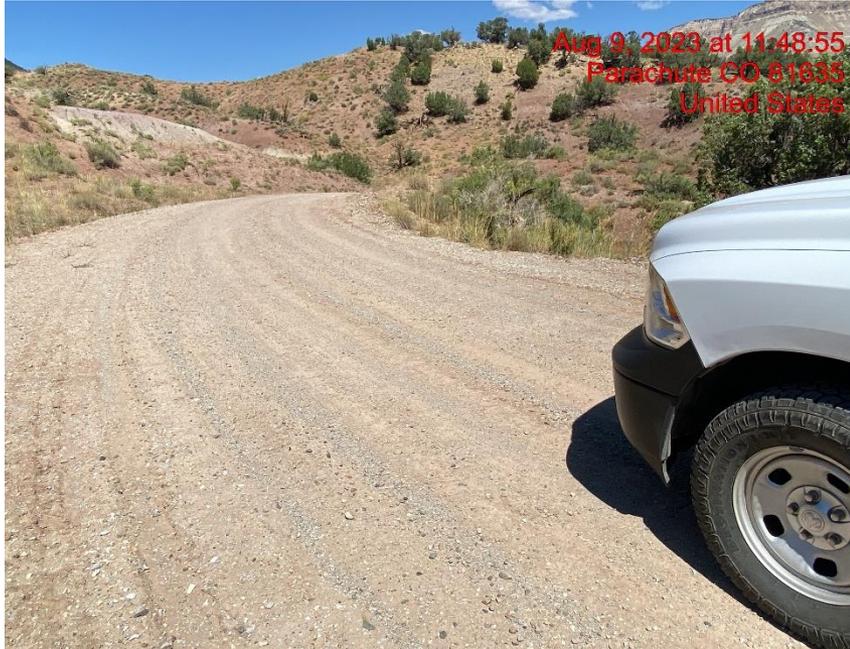
**Insufficient Vehicle Tracking BMPs at Location Entrance/Exit
– Photo #05745**

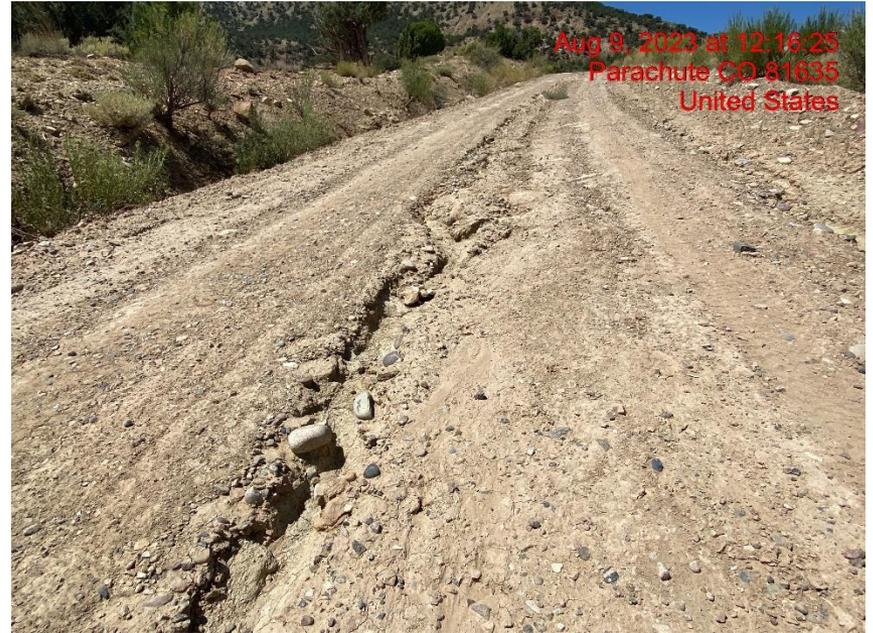
Rill Erosion Cutting Through Lease Road – Photo #05756

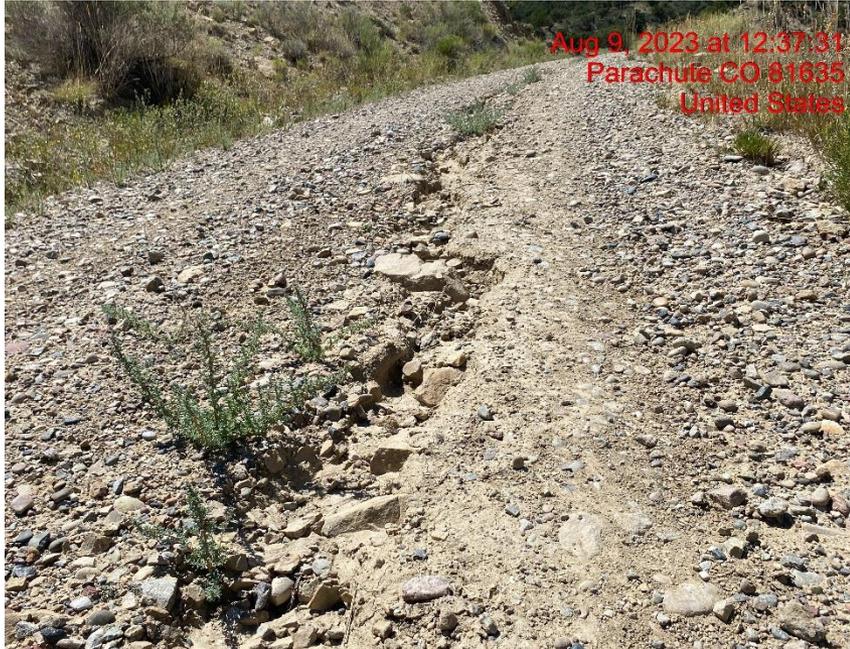
Rill Erosion Cutting Through Lease Road – Photo #05769

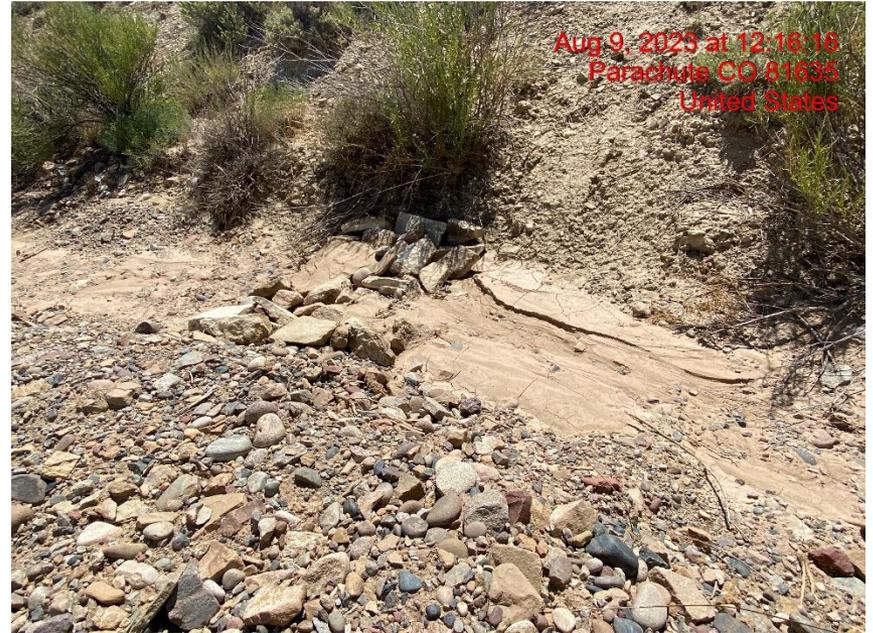
Check Dam Needs Maintenance – Photo #05755
