## Inspection Photos

Location Name: TEP ROCKY MOUNTAIN LLC, FEDERAL-67S96W/3NESW

Location ID: 334812

Date: 8/9/2023

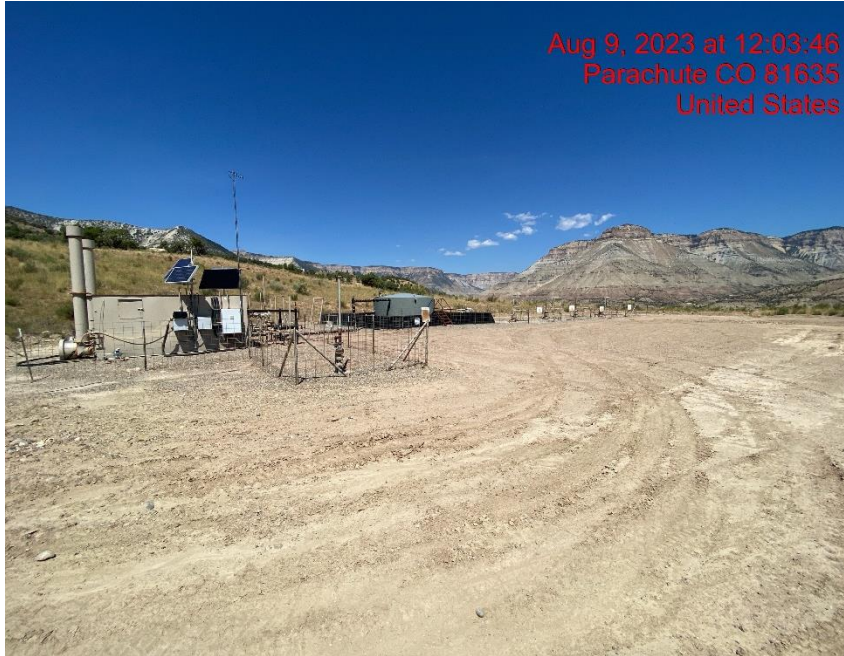
South Entrance to Location – Photo #05747

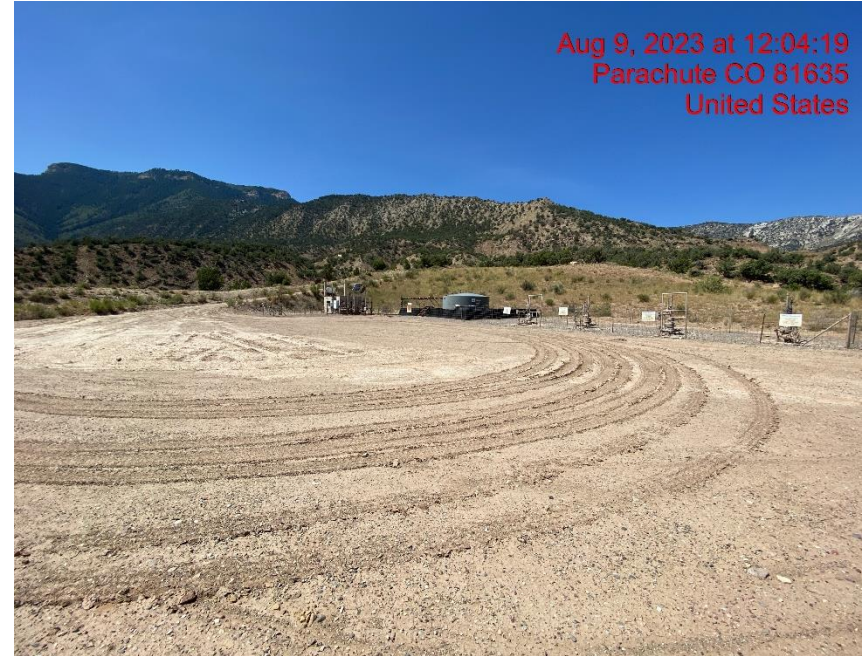
North End of Location – Photo #05748

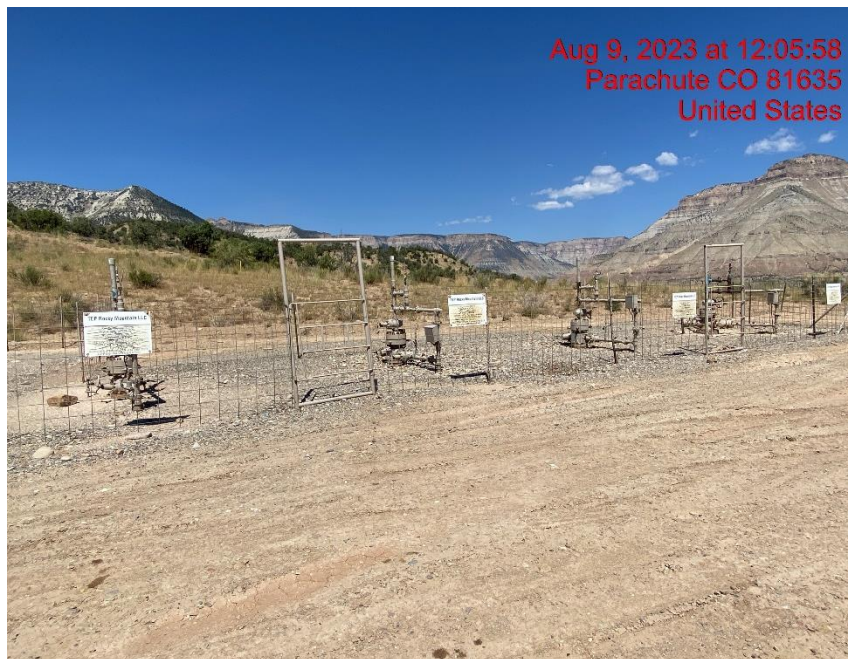
Wellheads – Photo #05753

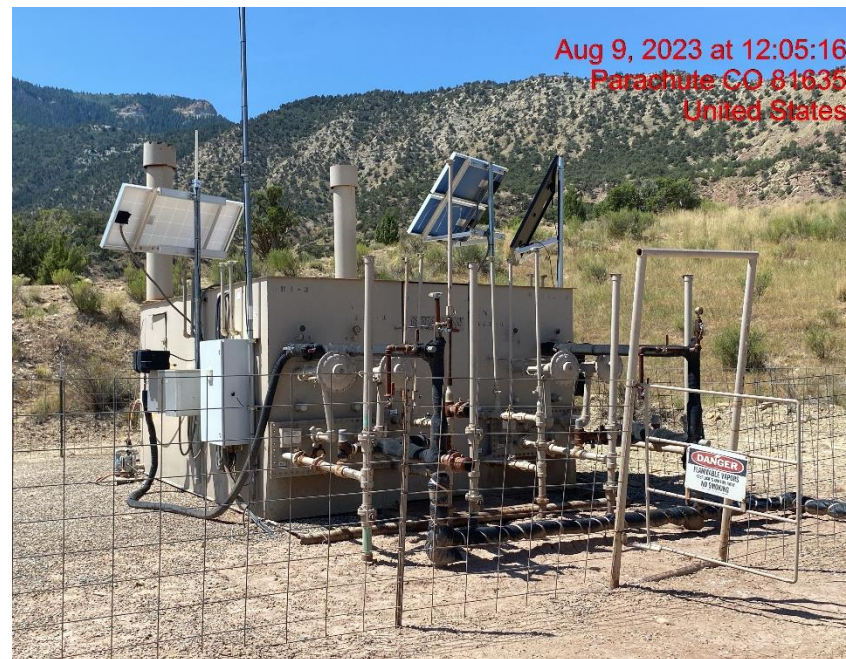
Separators – Photo #05751

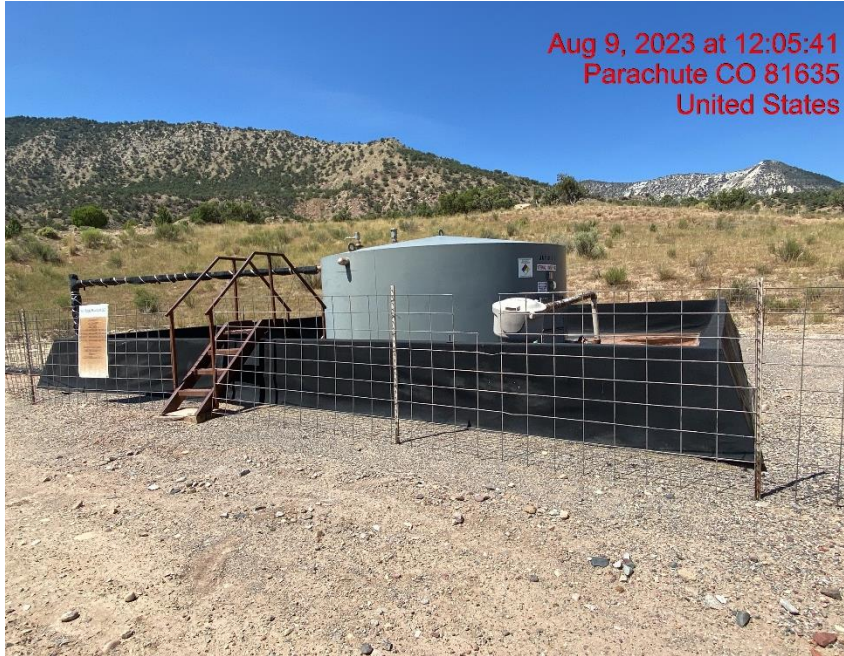
**Tank Battery – Photo #05752**

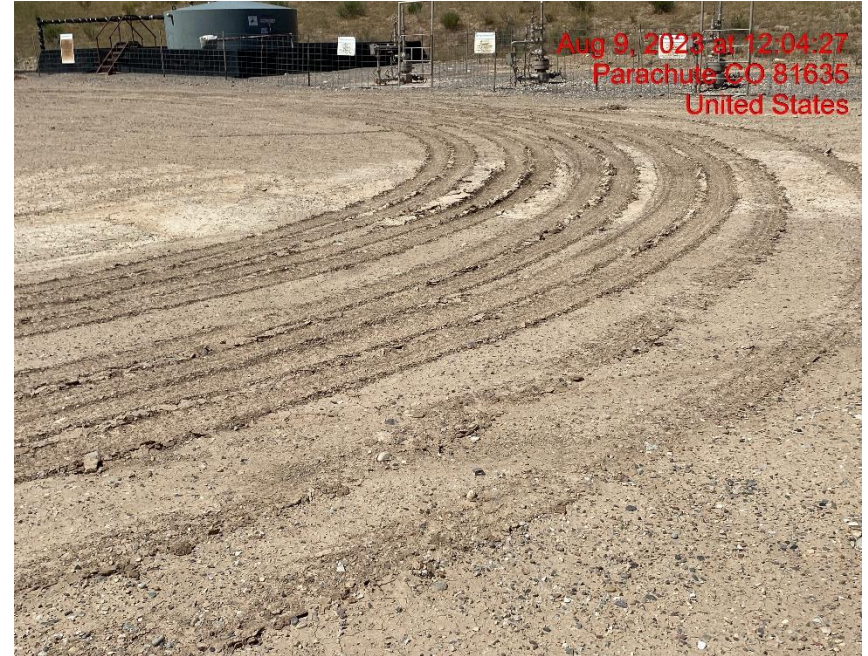
**Location Lacks Stabilization – Photo #05749**

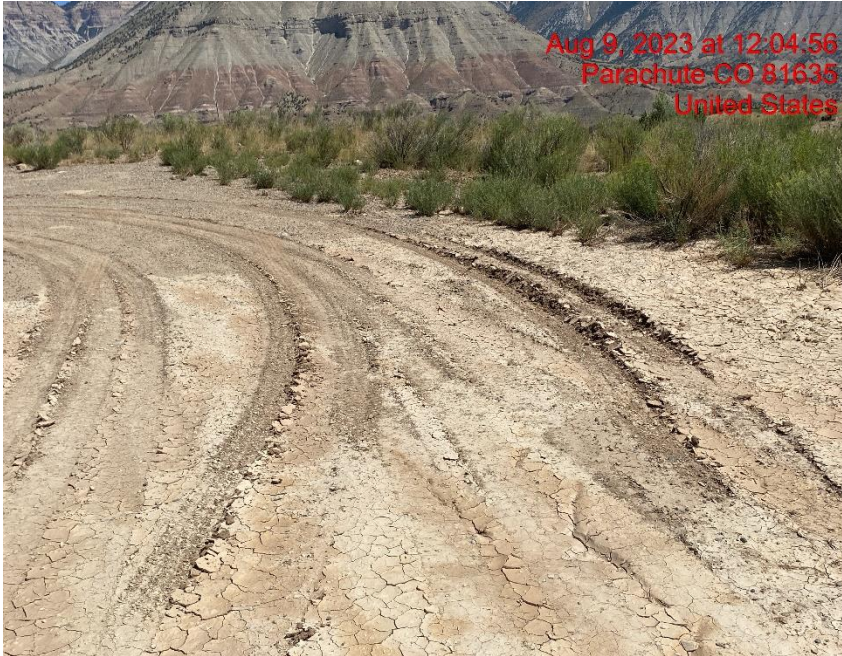
**Location Lacks Stabilization – Photo #05750**

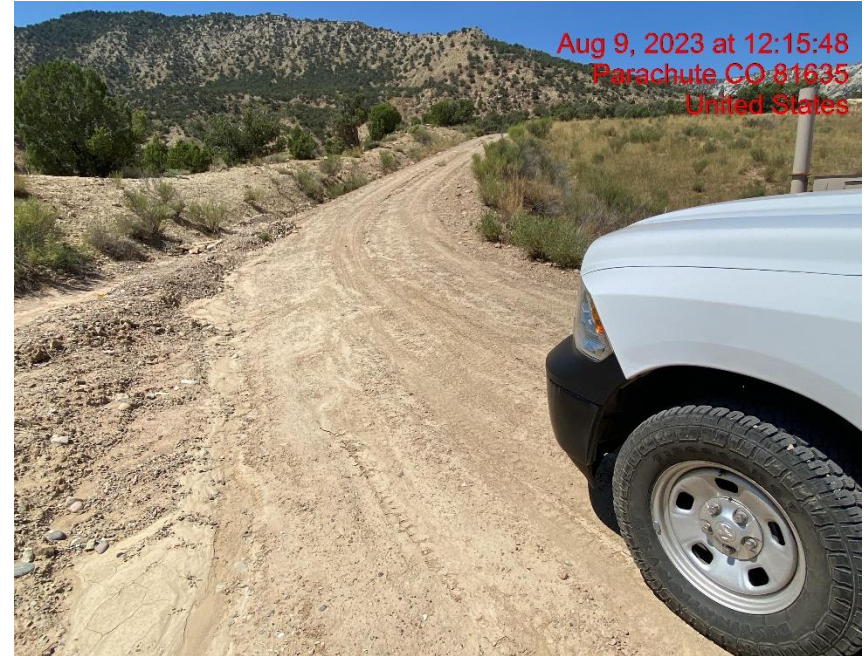
**Insufficient Vehicle Tracking BMPs at Location Entrance/Exit  
– Photo #05754**

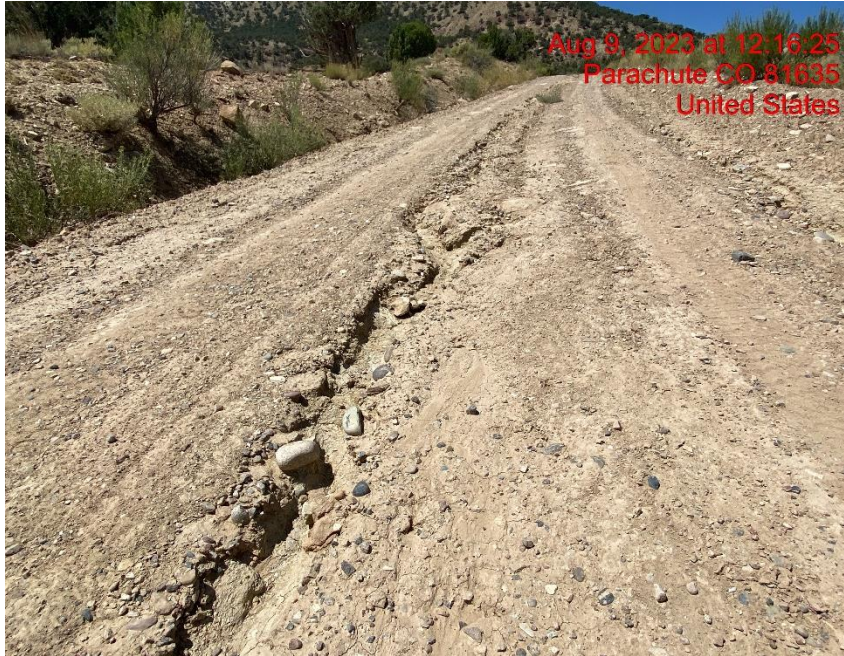
**Rill Erosion Cutting Through Lease Road – Photo #05756**

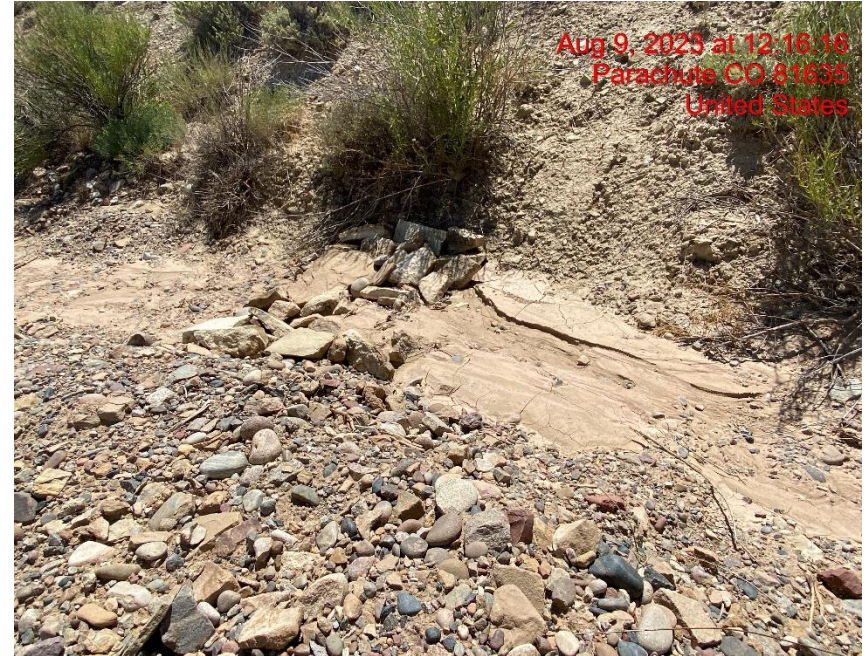
**Check Dam Needs Maintenance – Photo #05755**
