Inspection Photos

Location Name: TEP ROCKY MOUNTAIN LLC, FEDERAL-67S96W/3SESW

Location ID: 334817

Date: 8/9/2023

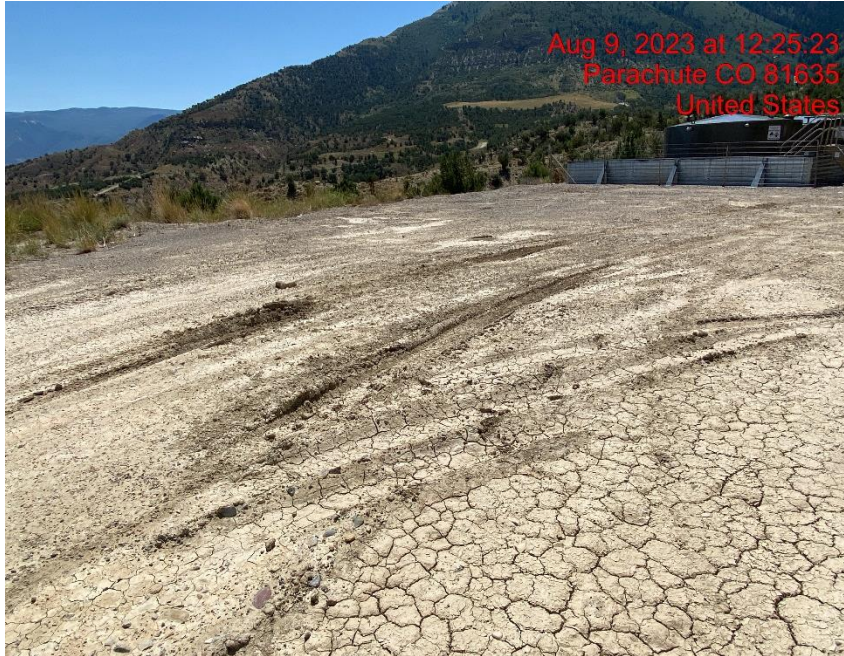
Location Lacks Stabilization – Photo #05765

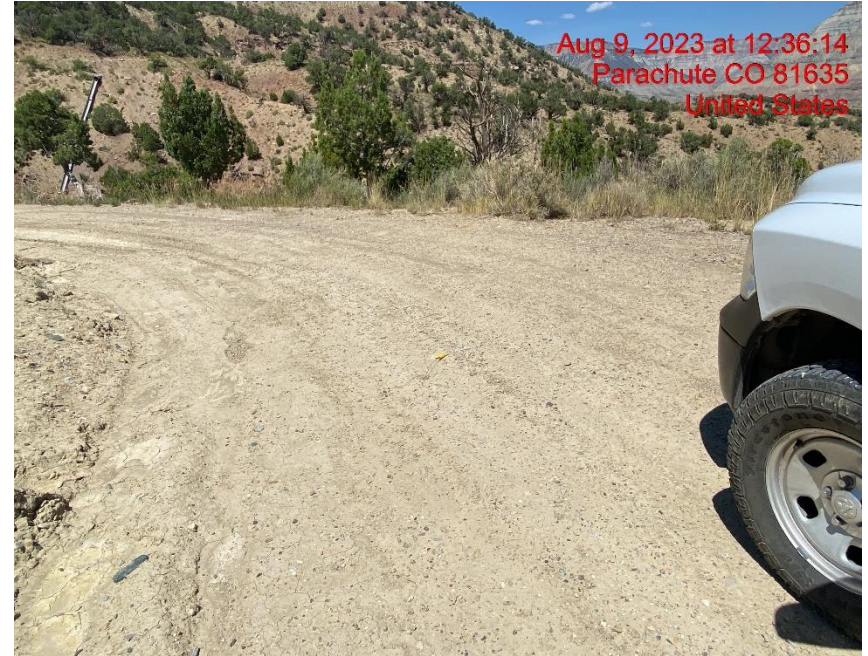
Insufficient Vehicle Tracking BMPs at Location Entrance/Exit – Photo #05766

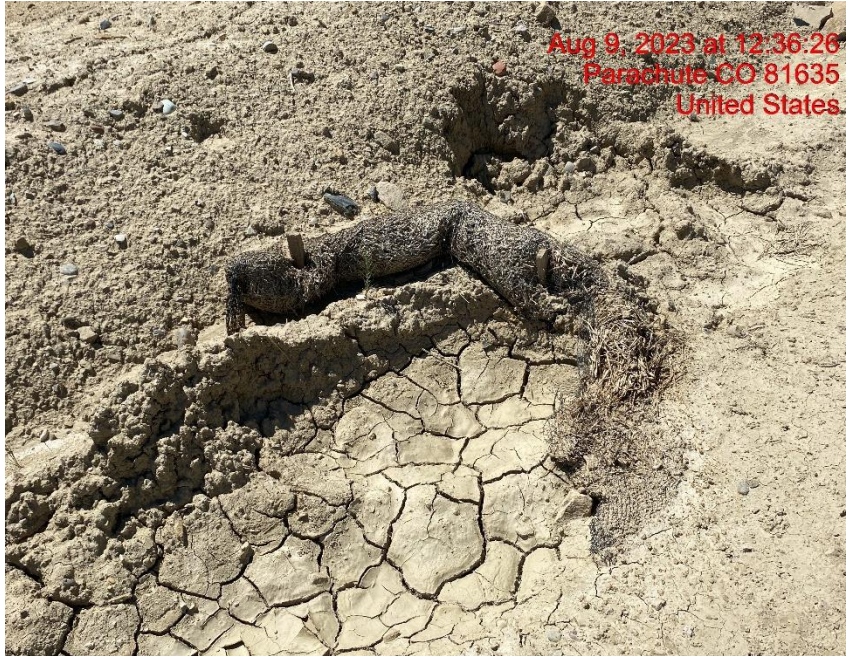
BMP Needs Maintenance – Photo #05767

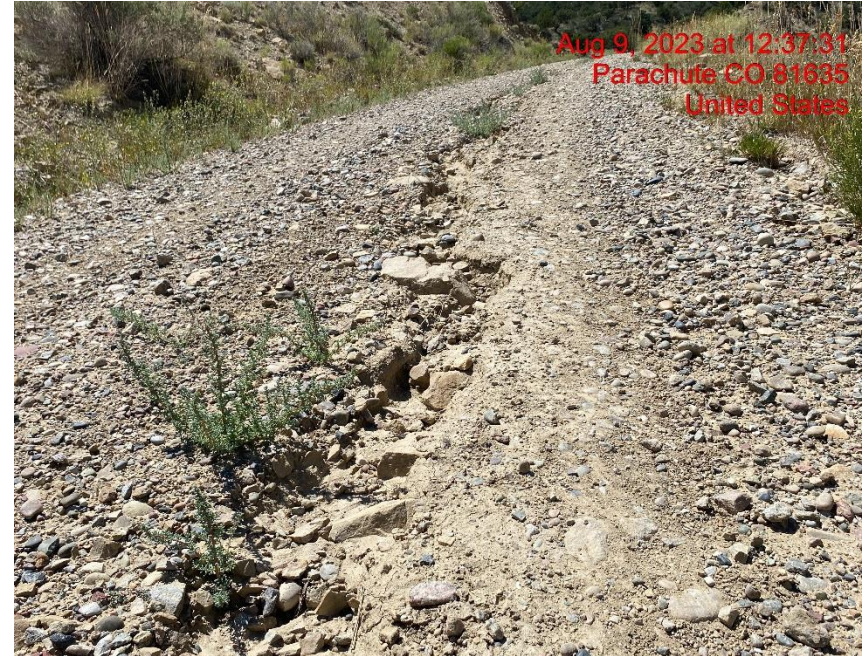
Rill Erosion Cutting Through Lease Road – Photo #05769

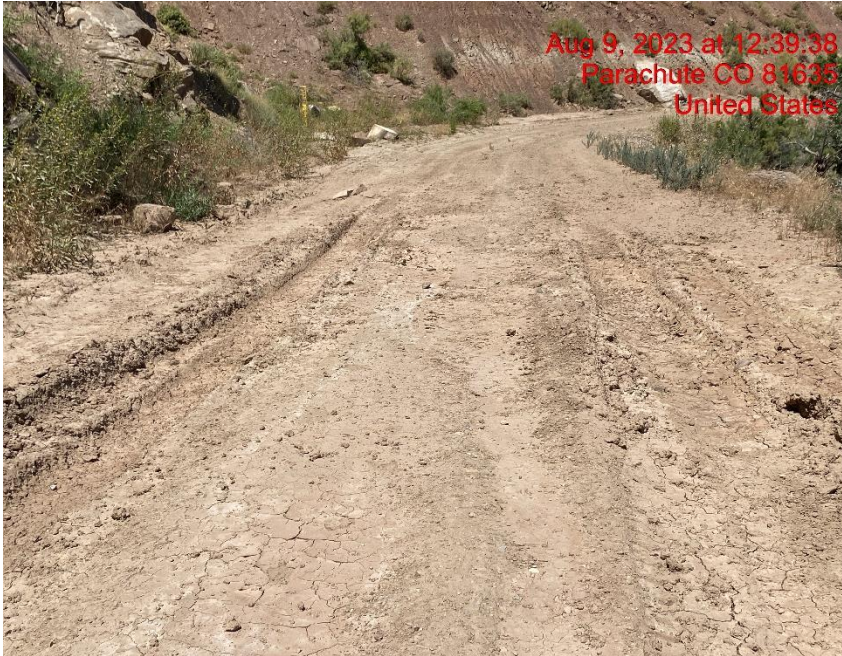
Lease Road Lacks Stabilization – Photo #05770
