Inspection Photos
Location Name: CAERUS PICEANCE LLC H18E Pad
Location ID: 323940

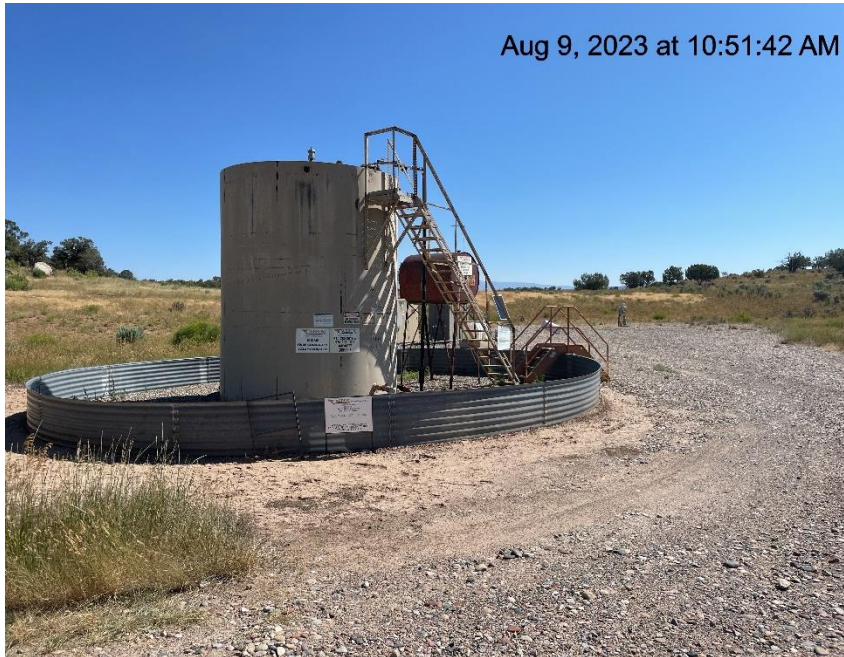
Photo # 5510 From entrance to location

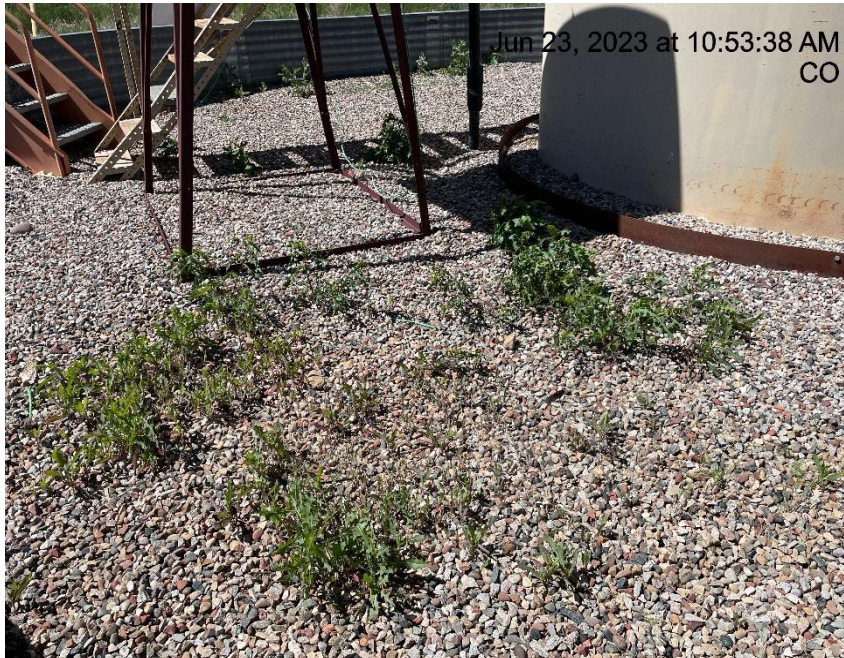
Photo # 1661 From Inspection 708900841 conducted on 06/23/2023 Weeds/undesirable plant species in secondary containment

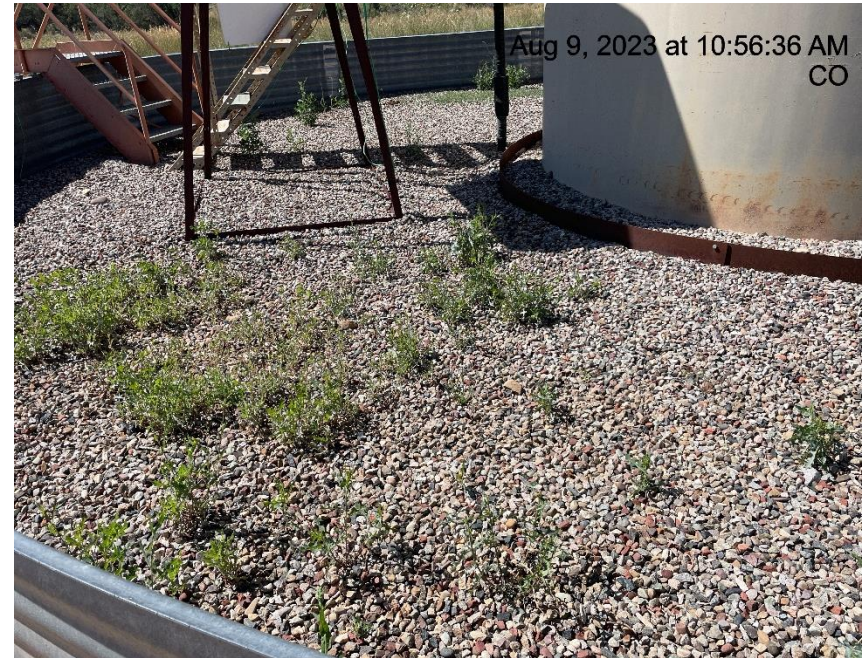
Photo # 5516 Weeds/undesirable plant species in secondary containment

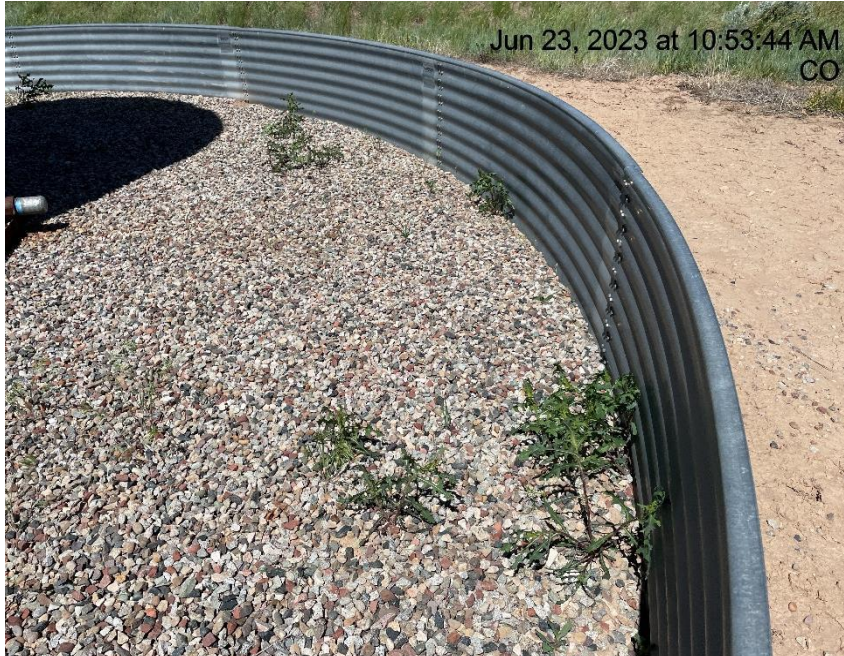
Photo # 1662 From Inspection 708900841 conducted on 06/23/2023 Weeds/undesirable plant species in secondary containment

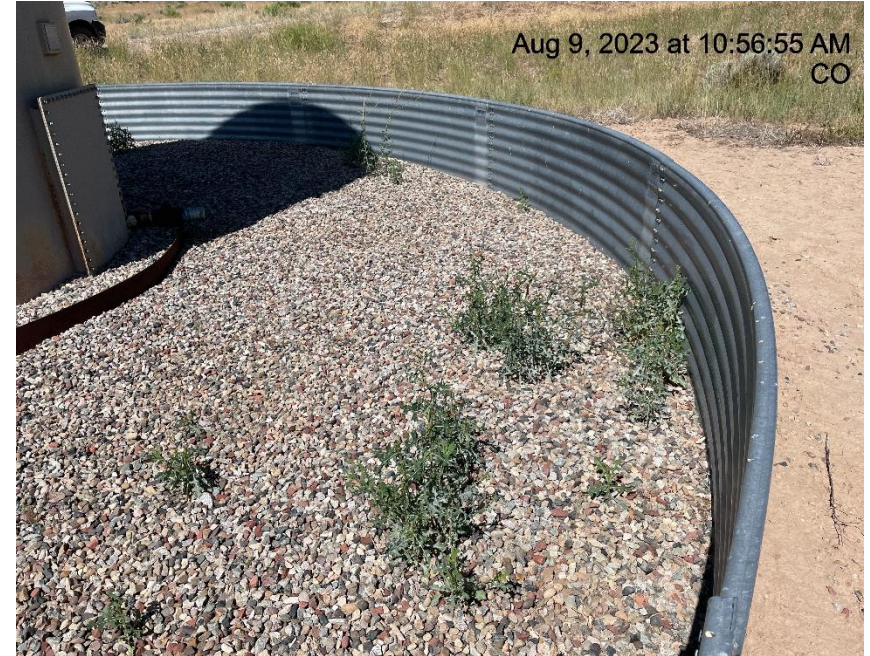
Photo # 5517 Weeds/undesirable plant species in secondary containment

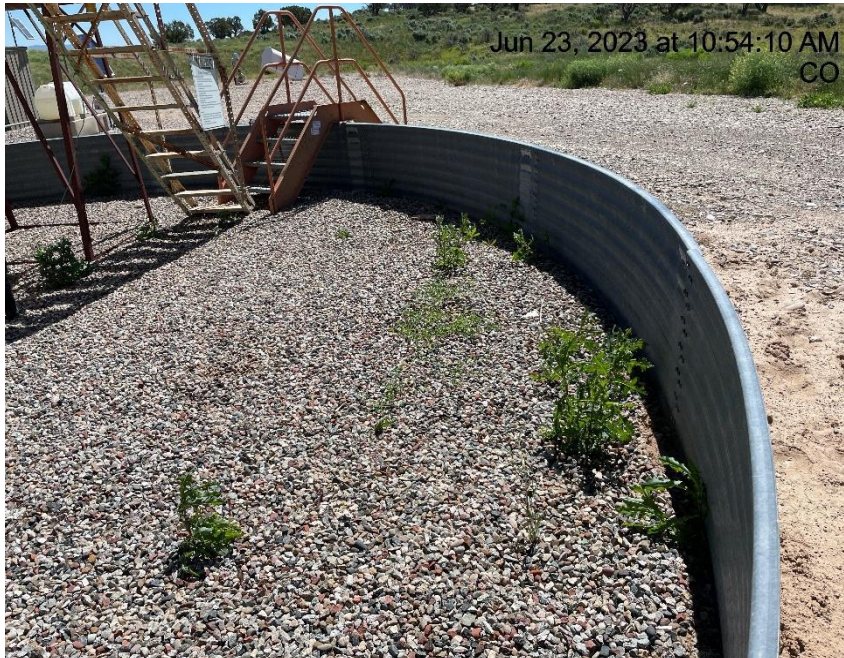
Photo # 1664 From Inspection 708900841 conducted on 06/23/2023 Weeds/undesirable plant species in secondary containment

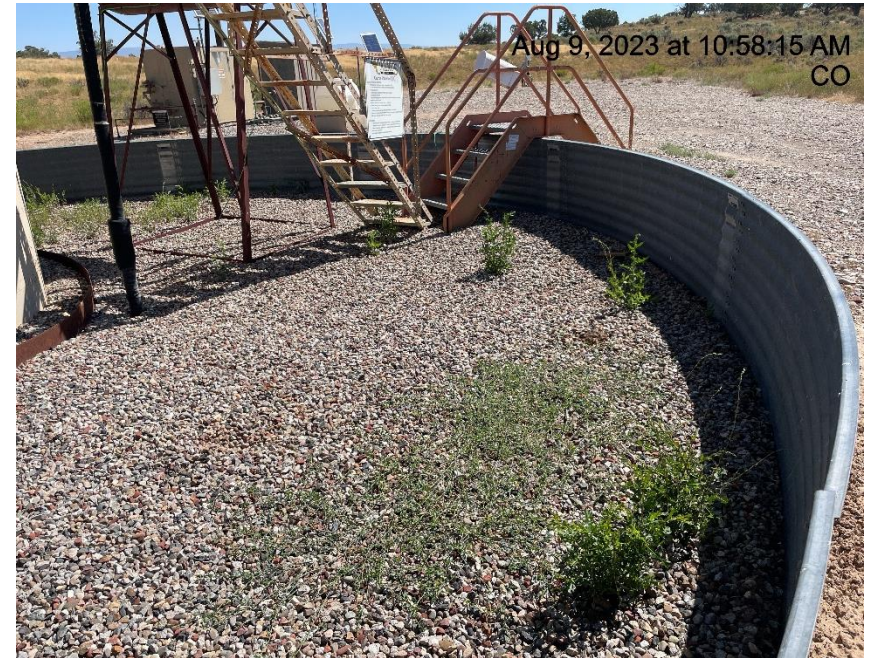
Photo # 5520 Weeds/undesirable plant species in secondary containment

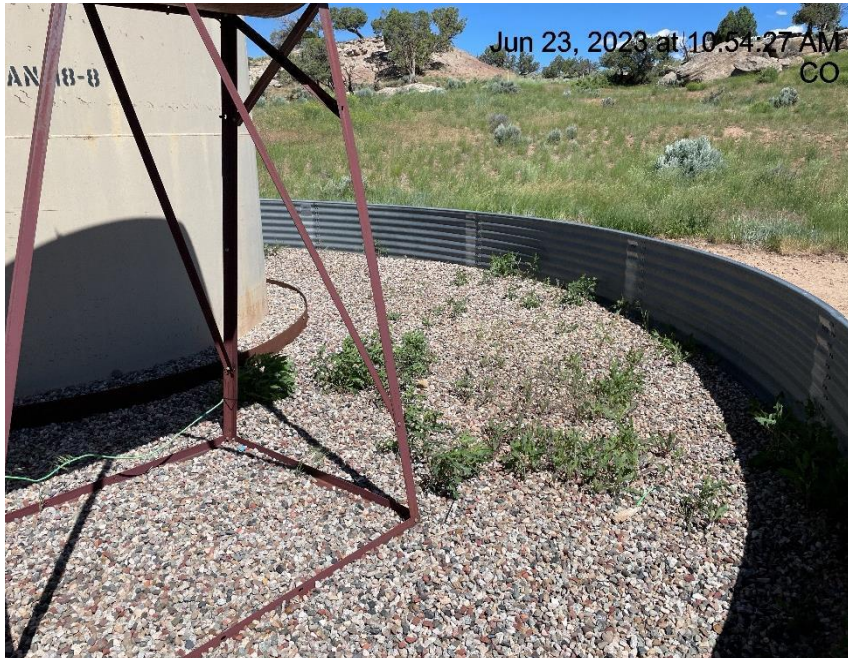
Photo # 1665 From Inspection 708900841 conducted on 06/23/2023 Weeds/undesirable plant species in secondary containment

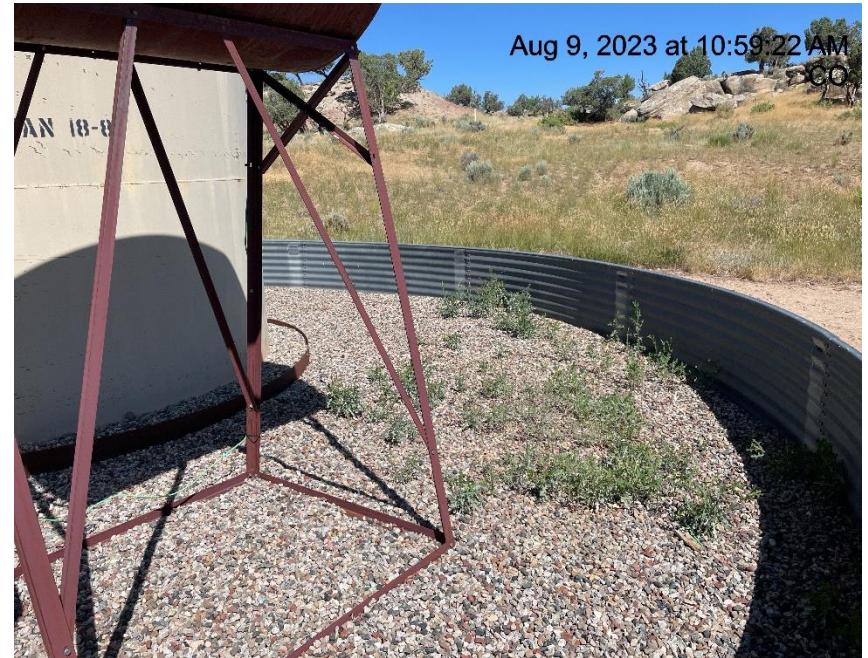
Photo # 5523 Weeds/undesirable plant species in secondary containment

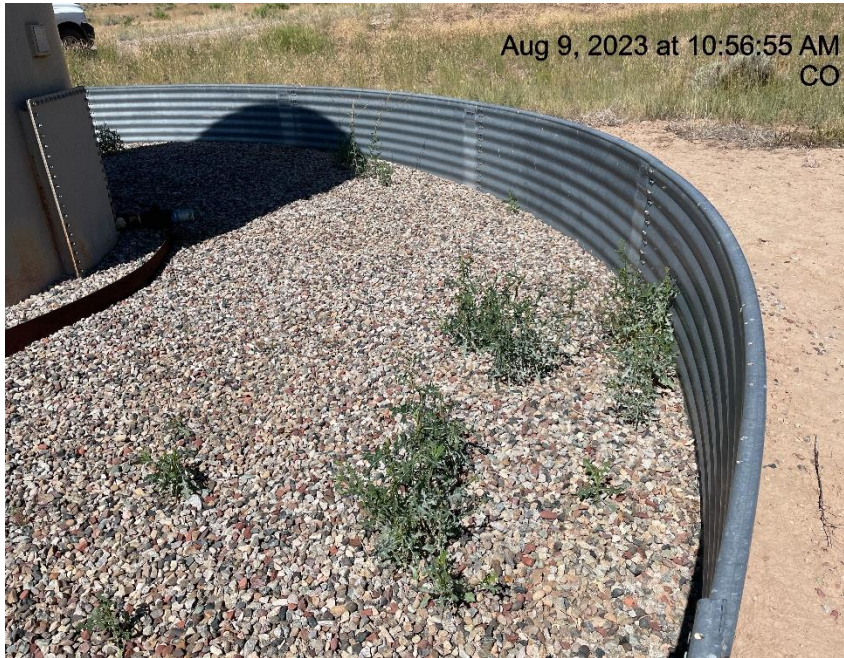
Photo # 5517 Weeds/undesirable plant species in secondary containment

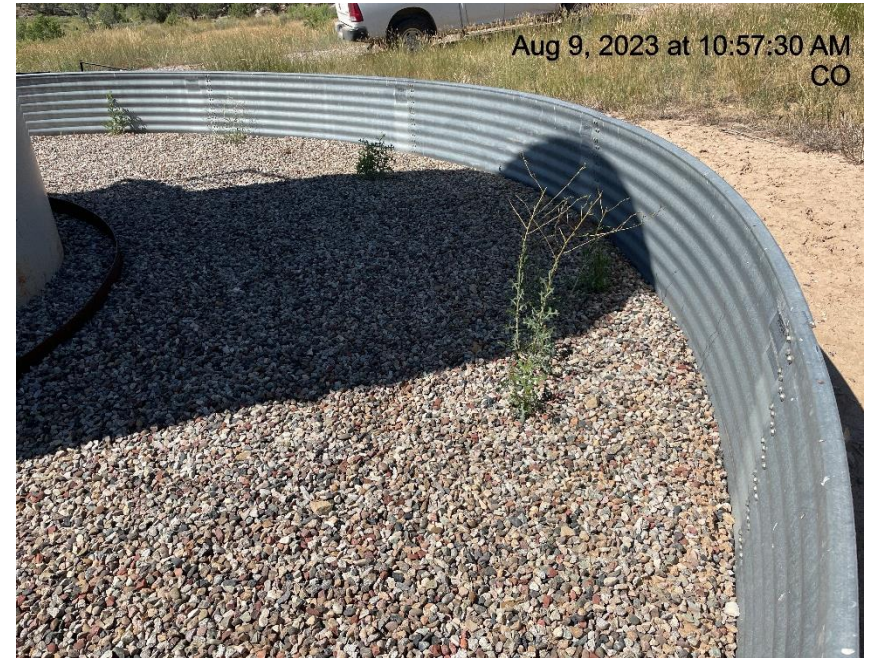
Photo # 5518 Weeds/undesirable plant species in secondary containment
