# Inspection Photos

API: 061-06742

Operator: NEWELL ENERGY LTD

Inspection Date: 8/9/2023

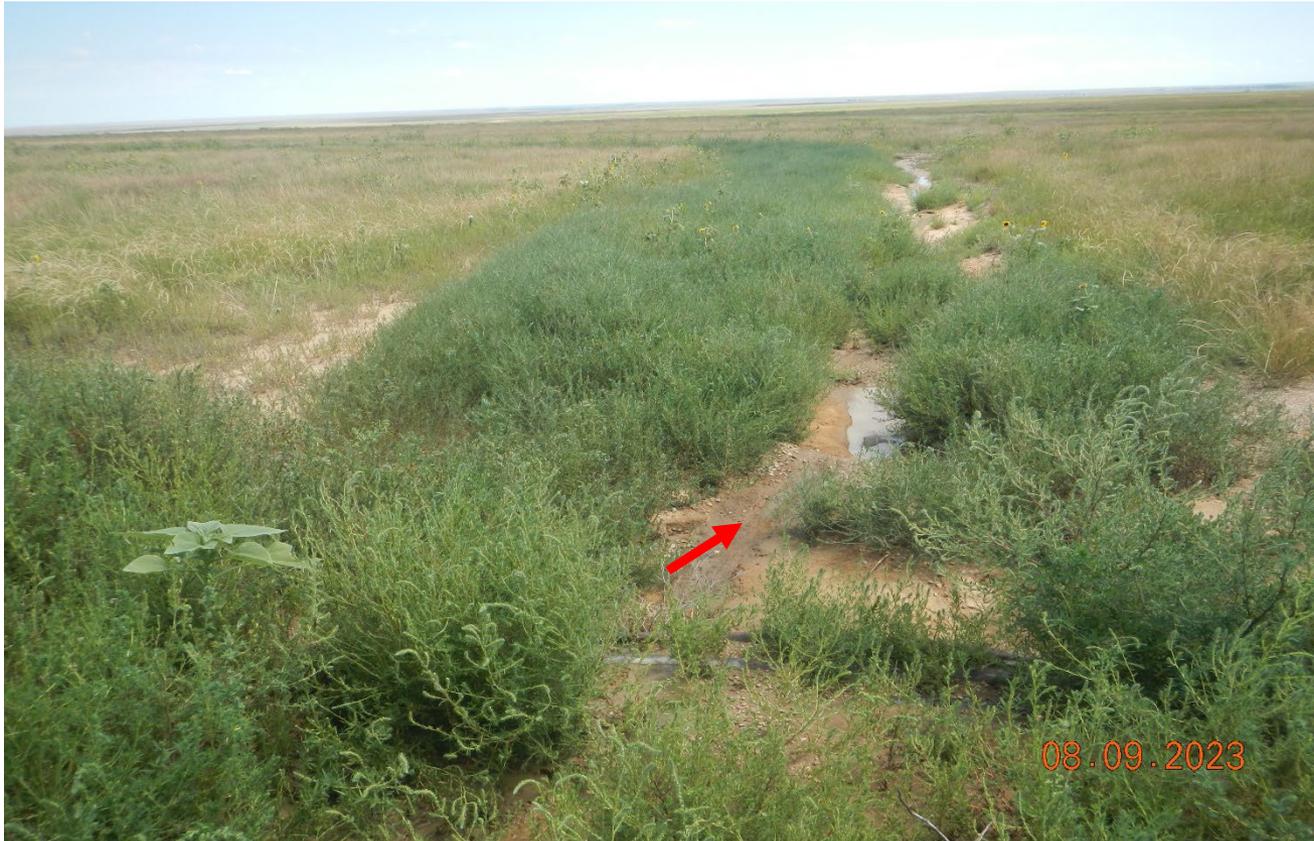
**Photo 1.** Facing east at the access road. The cattleguard has filled in with sediment and there is erosion along the road shown at red arrow. There is also undesirable weeds (Russian thistle - dark green) growing along the road that needs to be controlled.

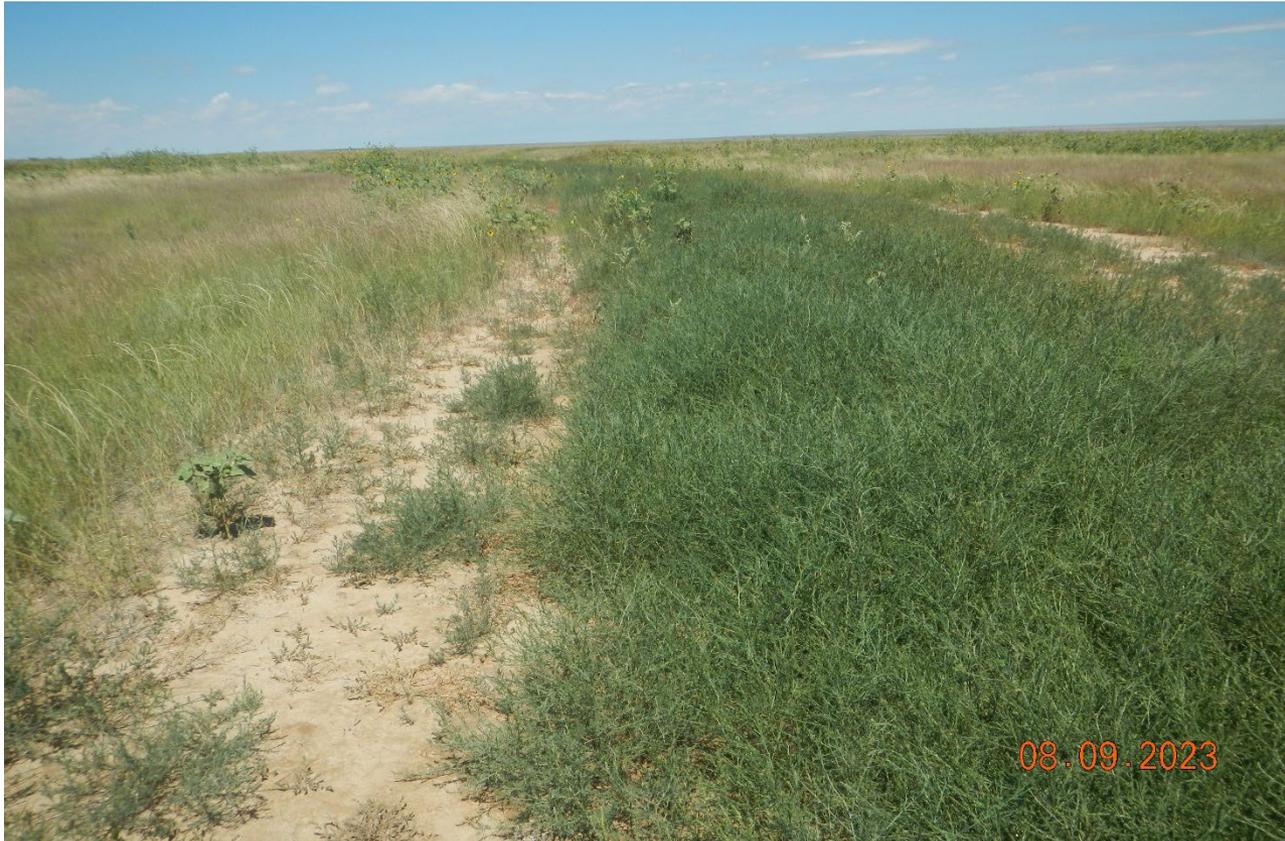
**Photo 2.** Facing northeast along the access road. The road was reclaimed however, there are undesirable weeds (Russian thistle - dark green) growing along the road that needs to be controlled.

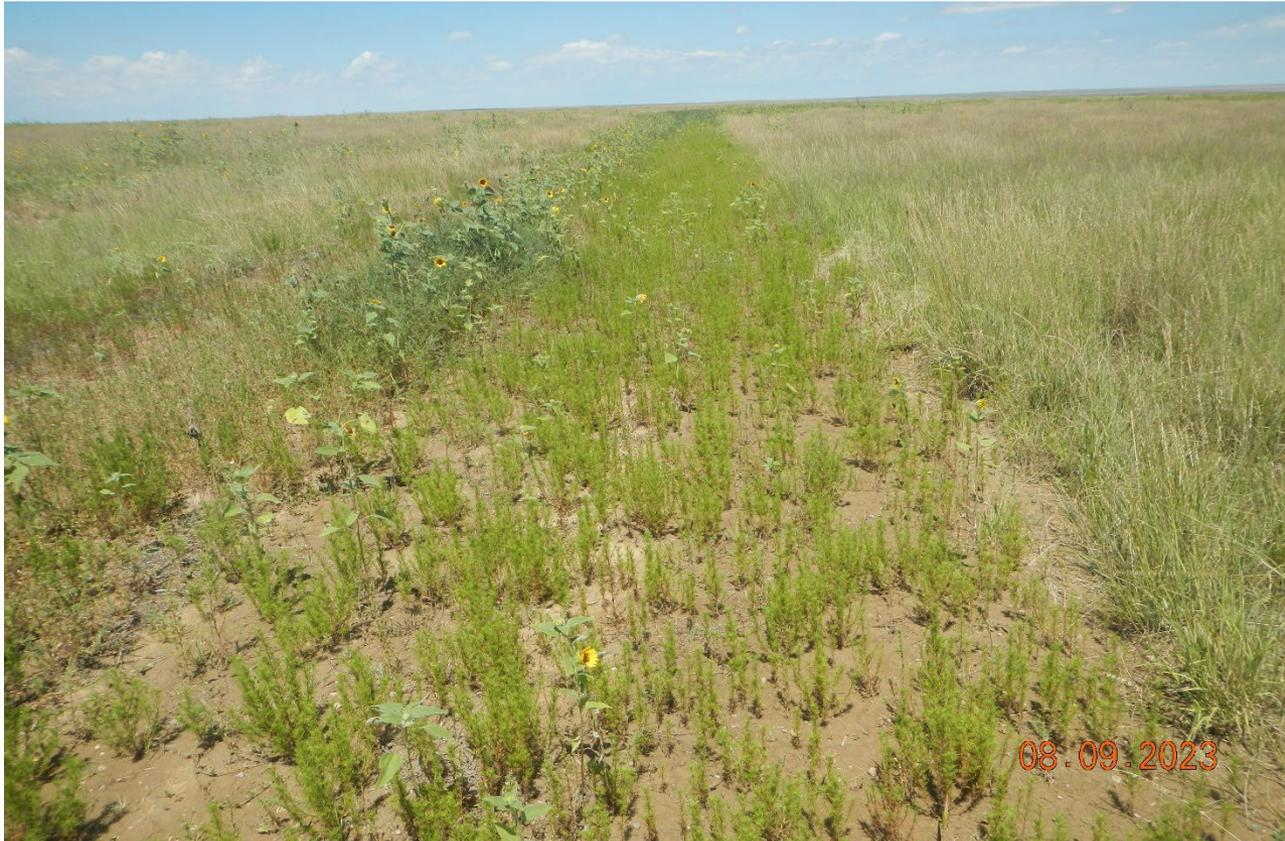
**Photo 3.** Facing northeast along the access road. The road was reclaimed however, there are undesirable weeds (Kochia) growing along the road that needs to be controlled.

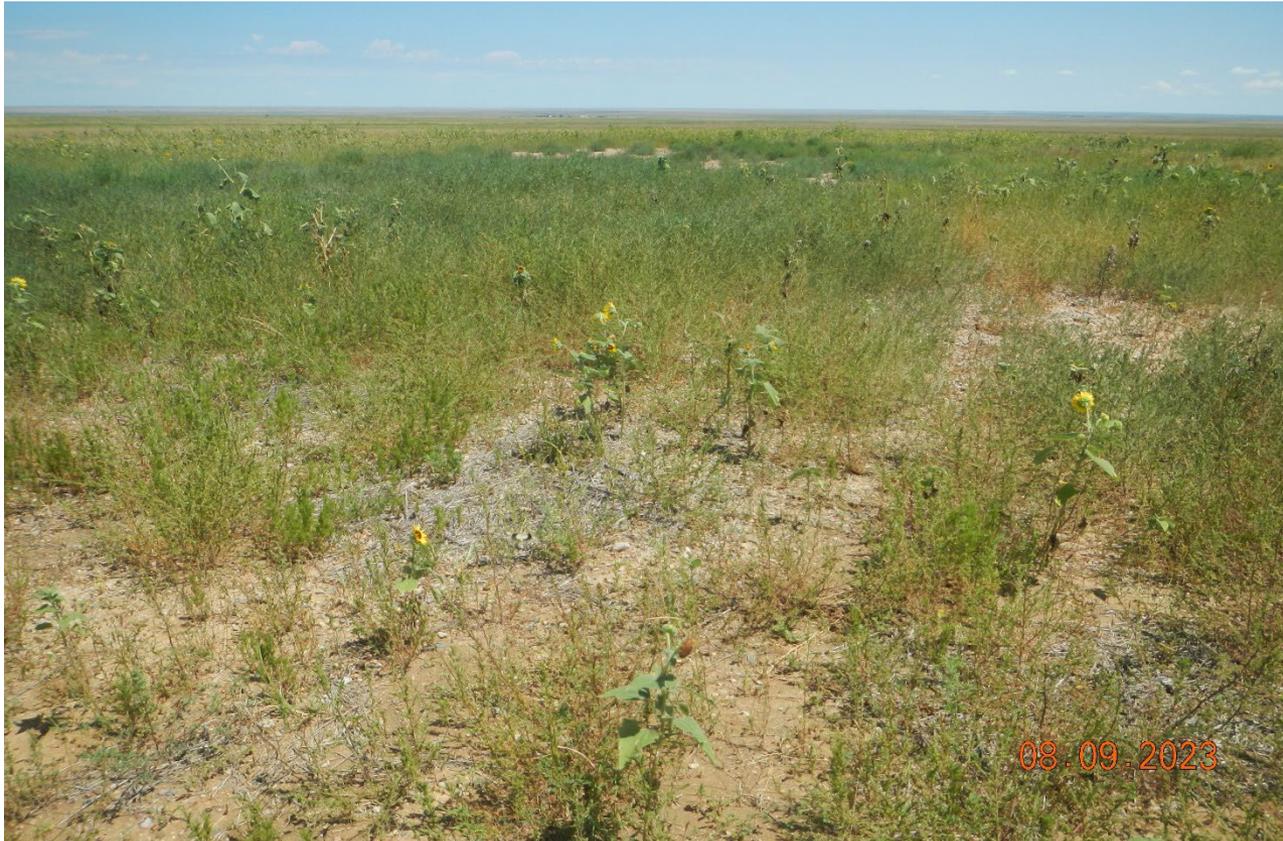
**Photo 4.** Facing northeast toward the location. The well has been plugged and abandoned and all equipment is removed. Reclamation was performed however desirable vegetation is not establishing and there are undesirable weed.

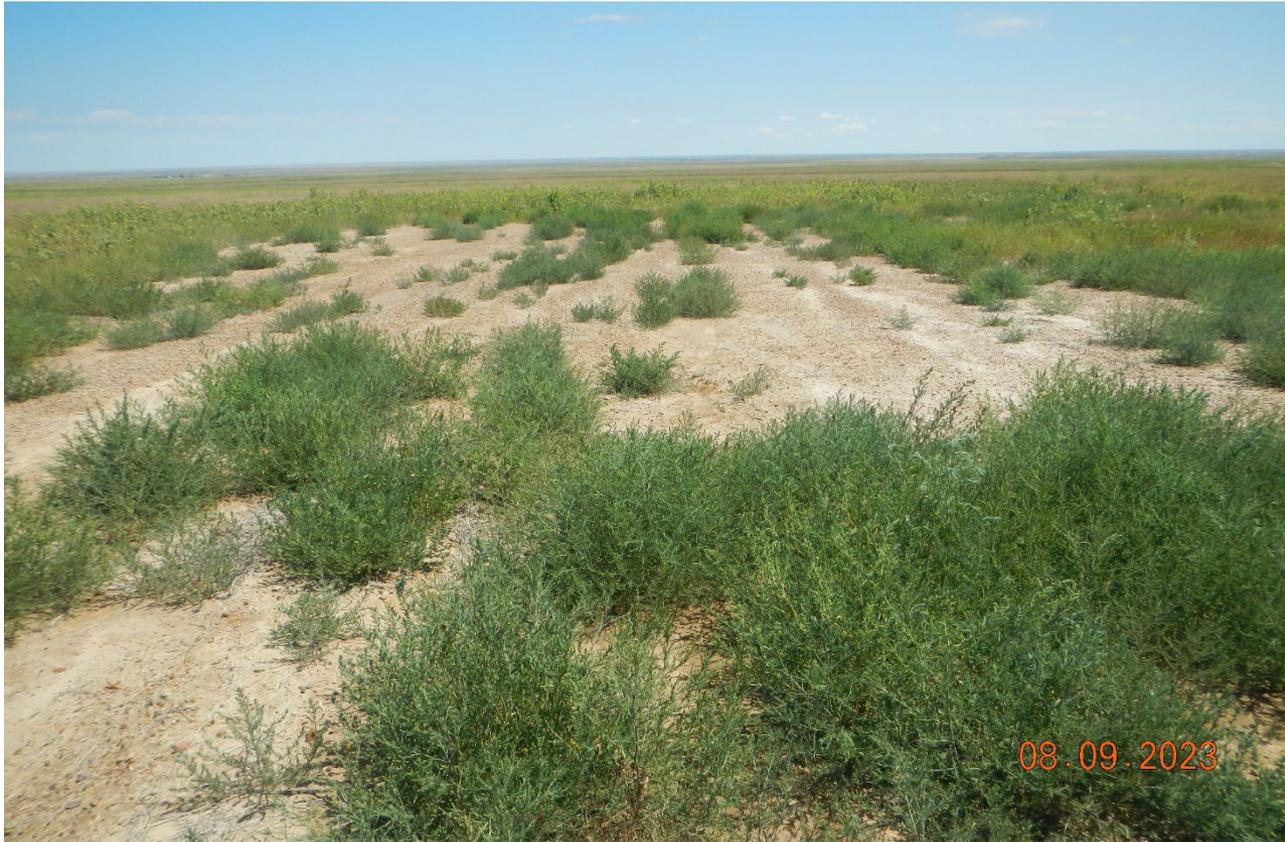
**Photo 5.** Facing east at the location. This area where the former tank battery was located is bare of vegetation and may have impacted soils.

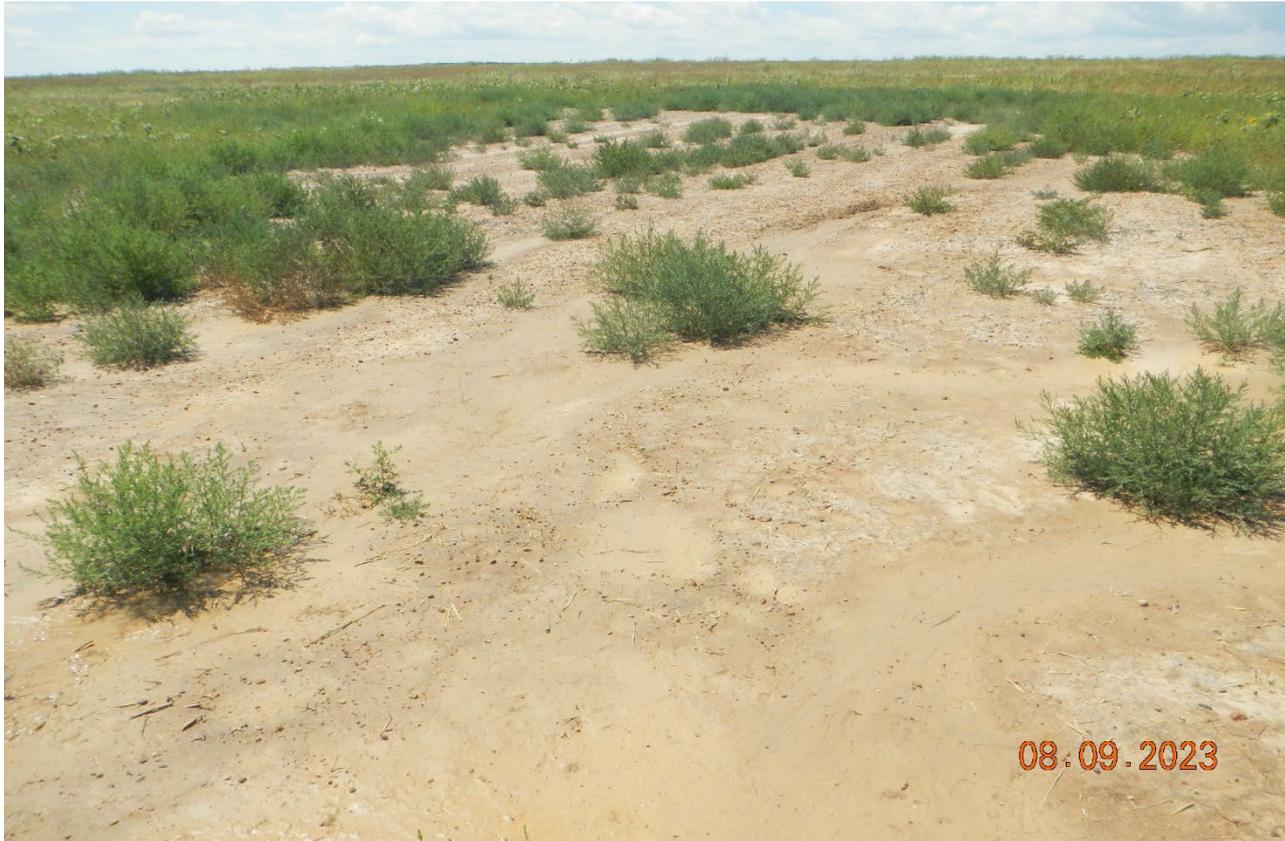
**Photo 6.** This area where the former tank battery was located is bare of vegetation and may have impacted soils.

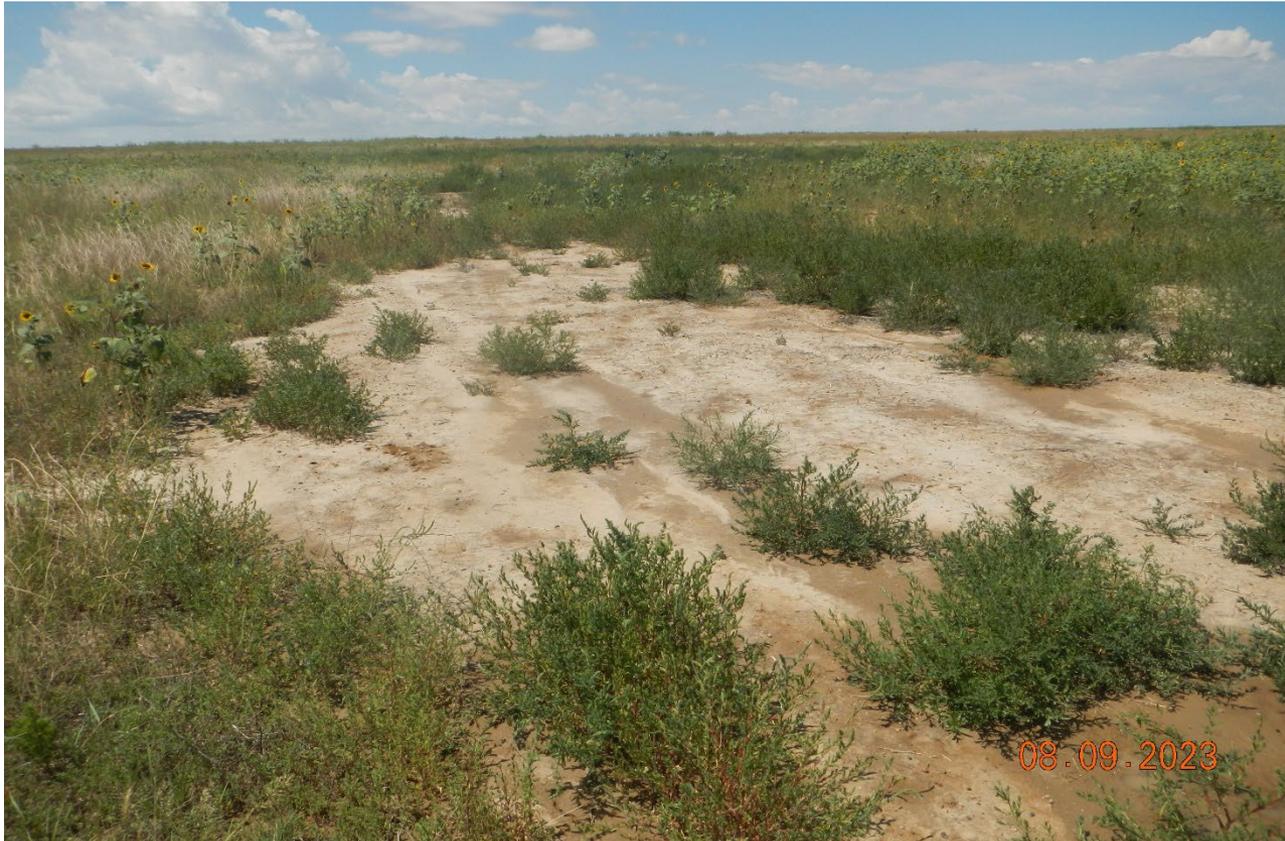
**Photo 7.** East of the location facing west. There appears to be impacted soils downhill east of the location.

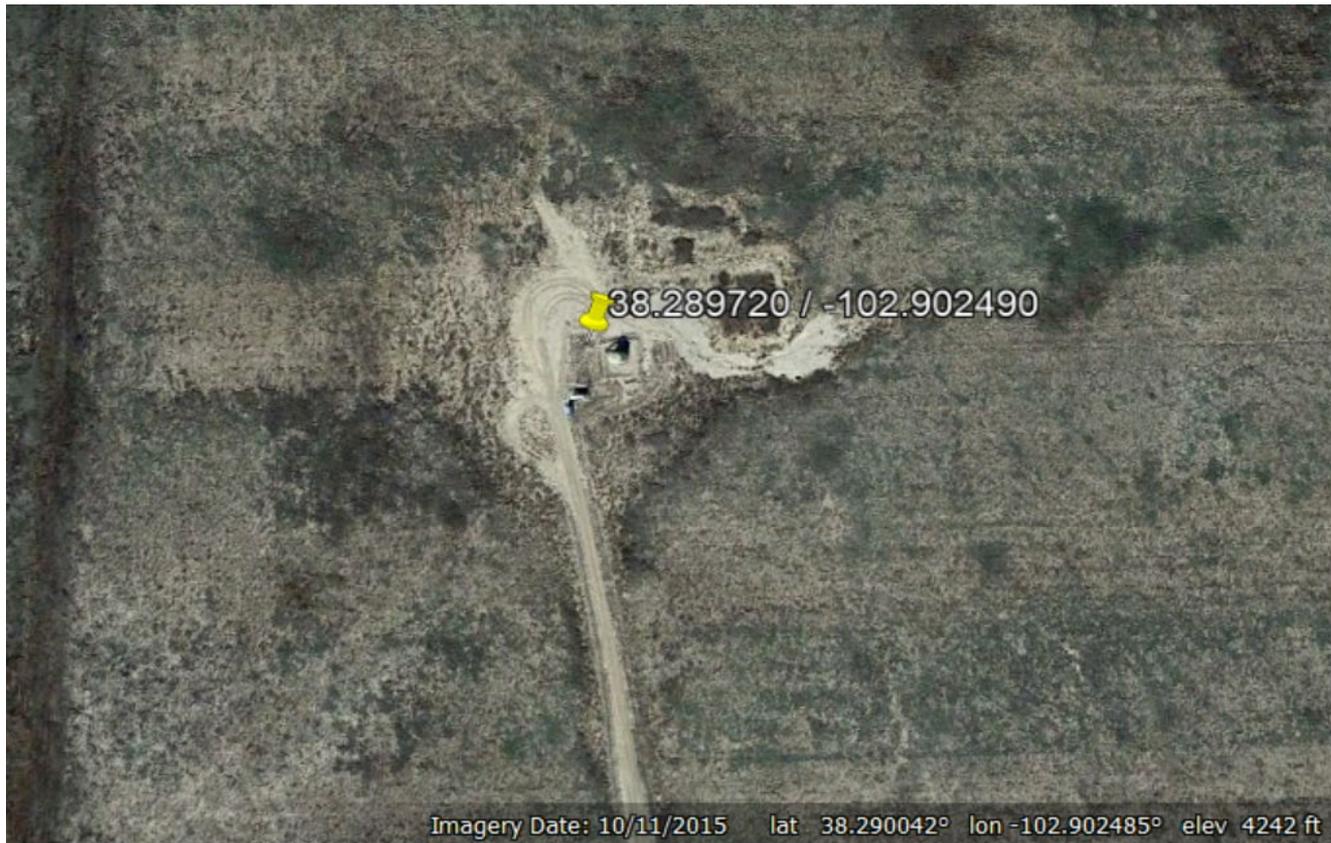
**Photo 8.** 2015 aerial photos shows signs of impacted soil east of the tank battery.

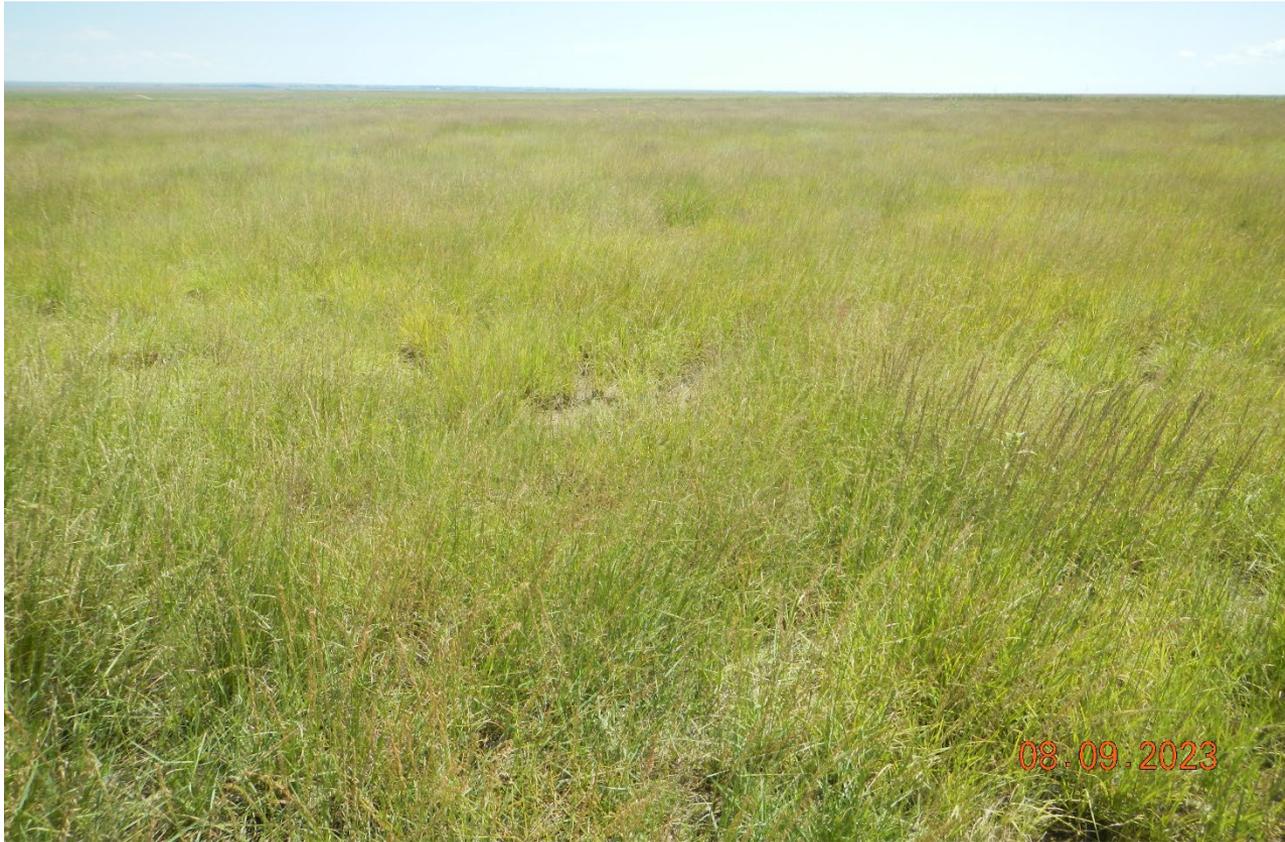
**Photo 9.** Facing south toward the surrounding undisturbed CRP grassland which shows uniform vegetation cover with little to no undesirable weeds.
