Inspection Photos

API: 061-05138

Operator: WESTERN OPERATING COMPANY

Inspection Date: 8/9/2023

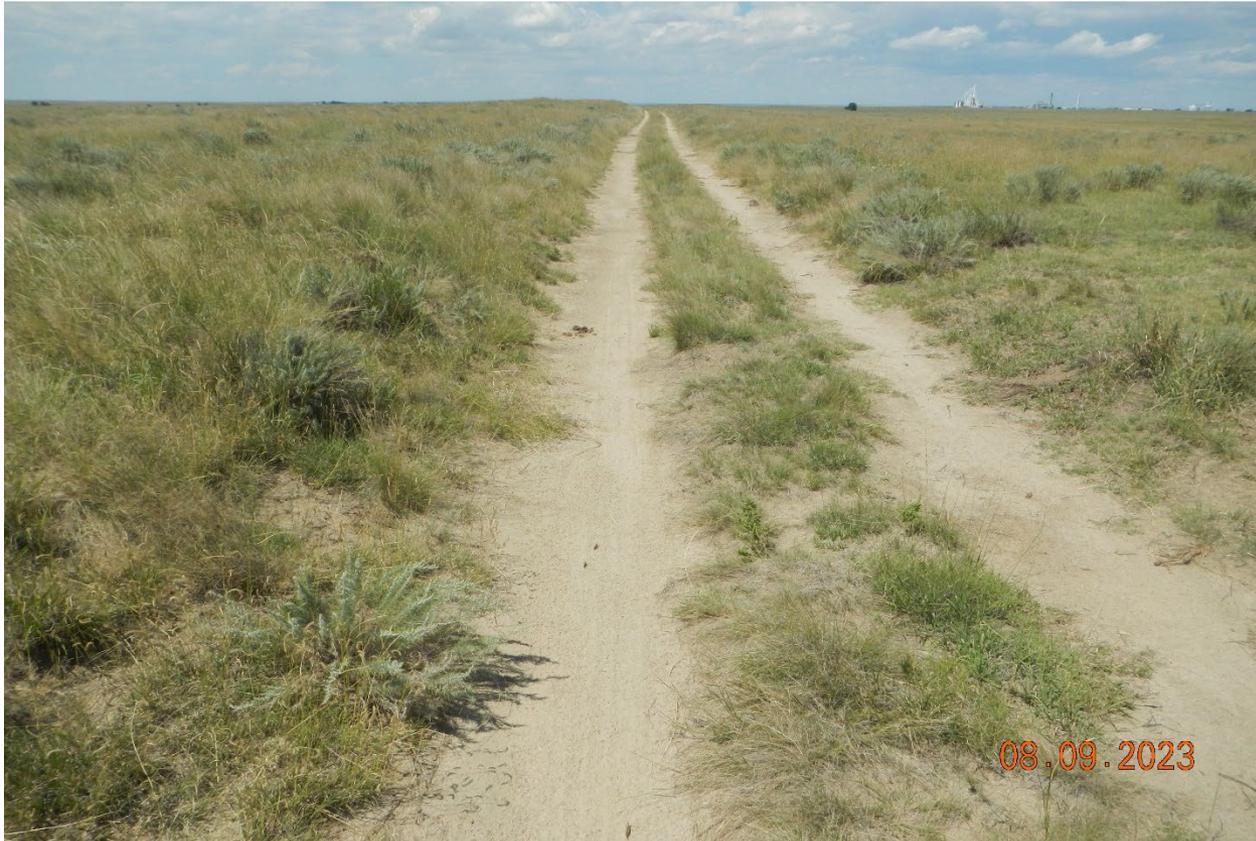
Photo 1. Facing north along the access road. This portion of the road has not been recontoured and reclaimed. Previous corrective action not completed.

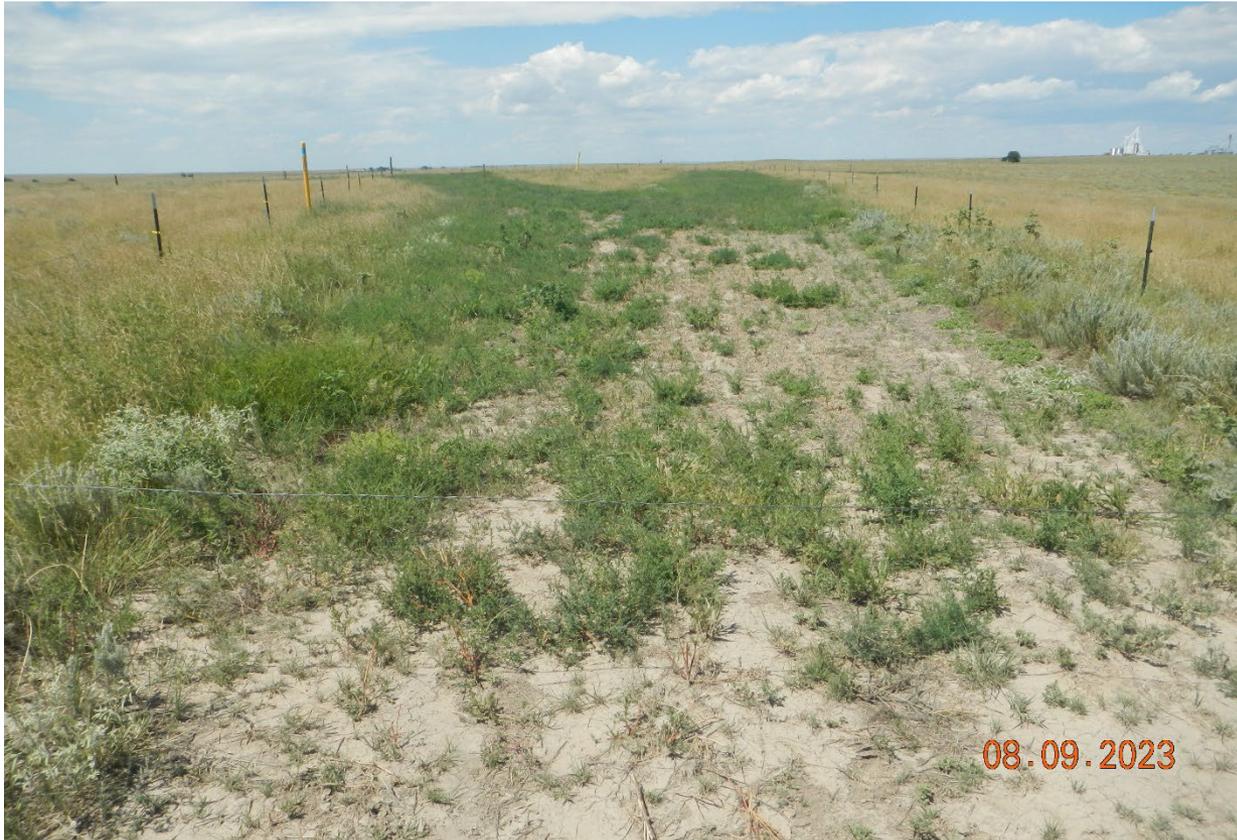
Photo 2. Facing northwest toward the two access road to the former tank battery and wellsite. There is desirable vegetation germinating but dark green vegetation is undesirable weeds that will need to be controlled (e.g. mowed).

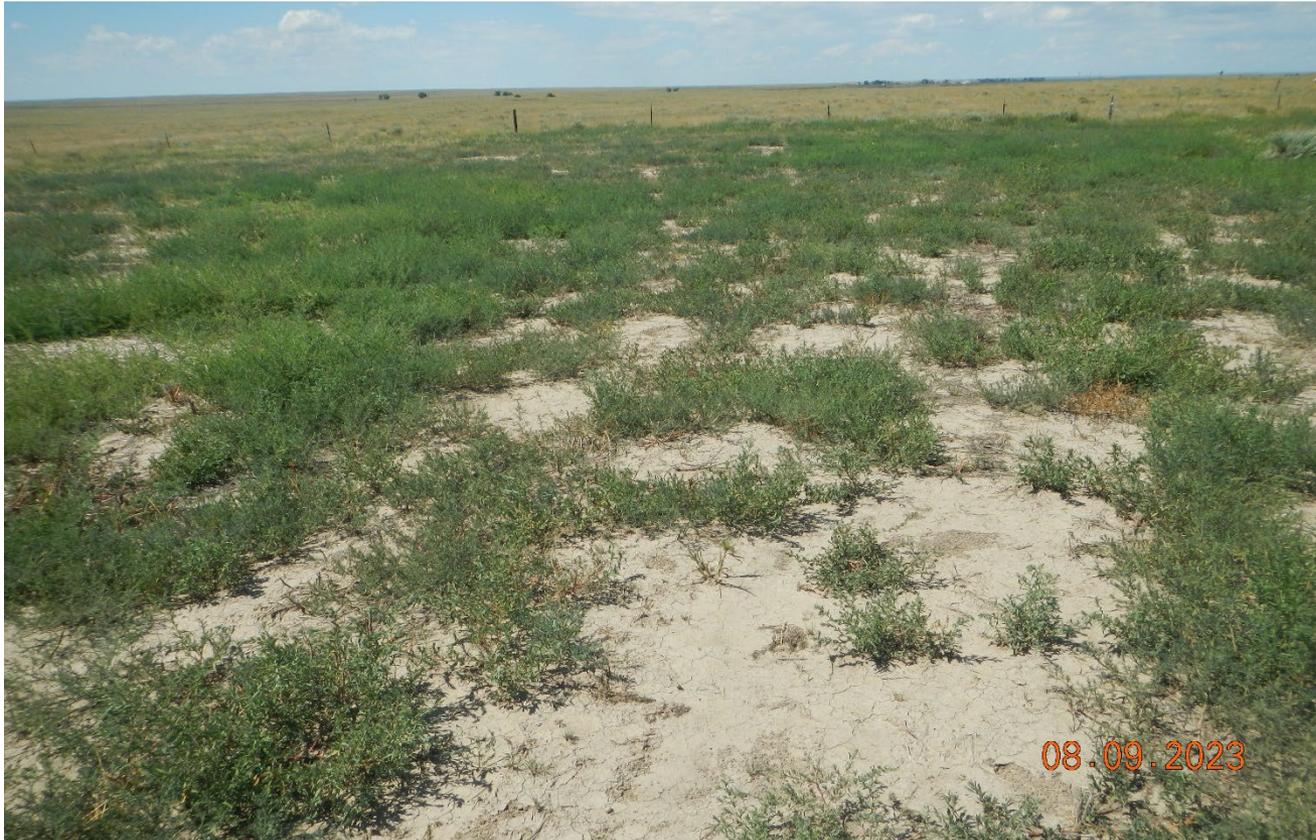
Photo 3. Facing northwest toward the former tank battery site located 300' southwest of the well site. The dark green vegetation is undesirable weeds that will need to be controlled (e.g. mowed).

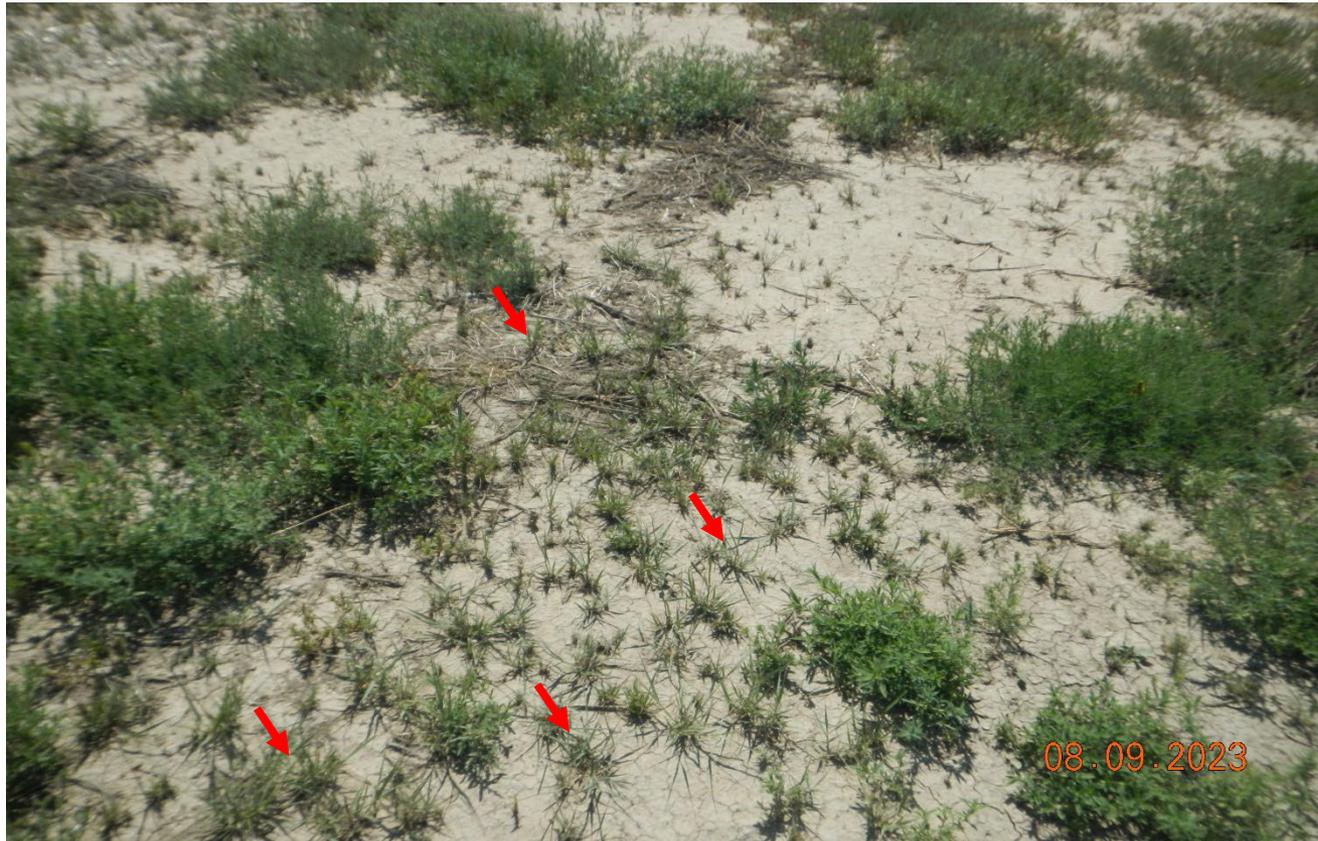
Photo 4. View of groundcover shows some desirable vegetation beginning to establish.

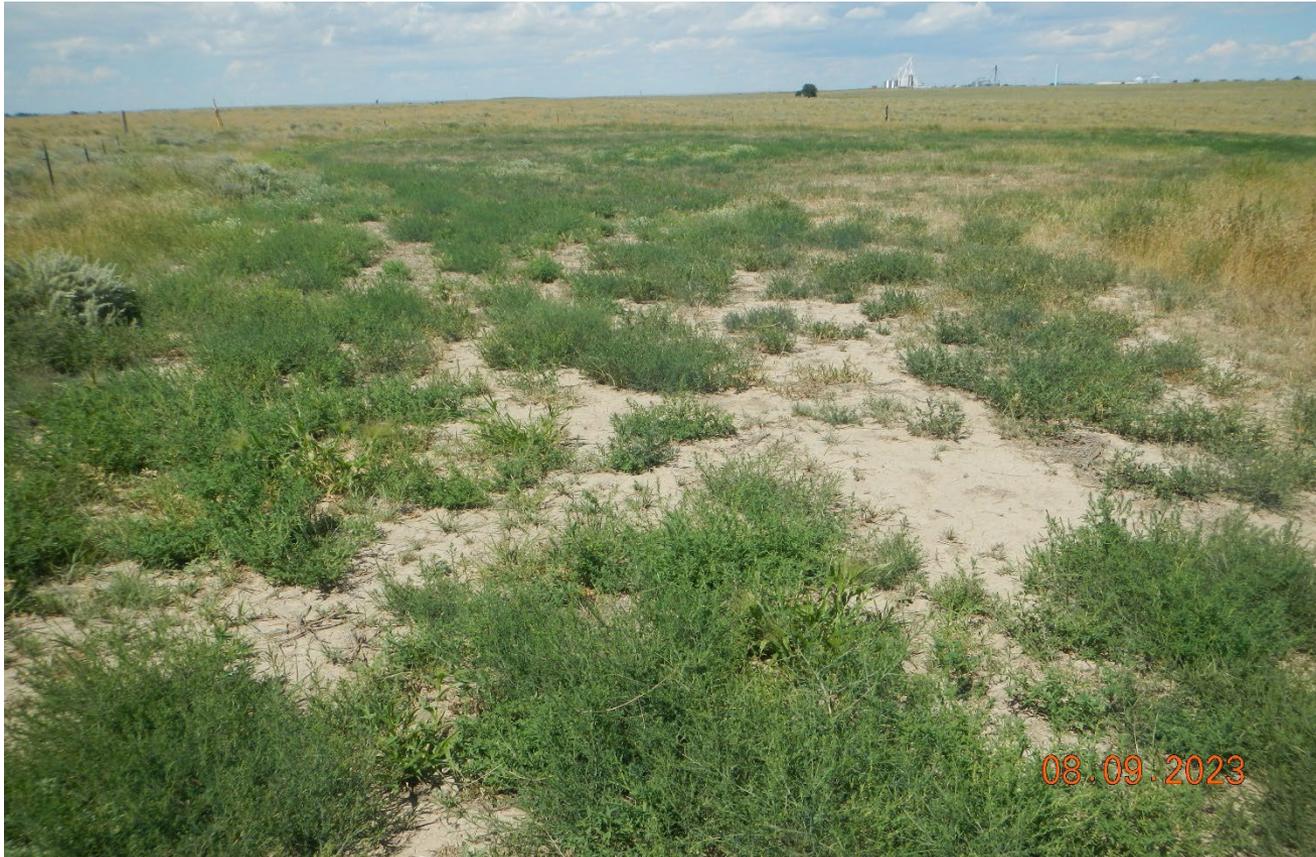
Photo 5. Facing northeast toward the former wellsite. The dark green vegetation is undesirable weeds that will need to be controlled (e.g. mowed).

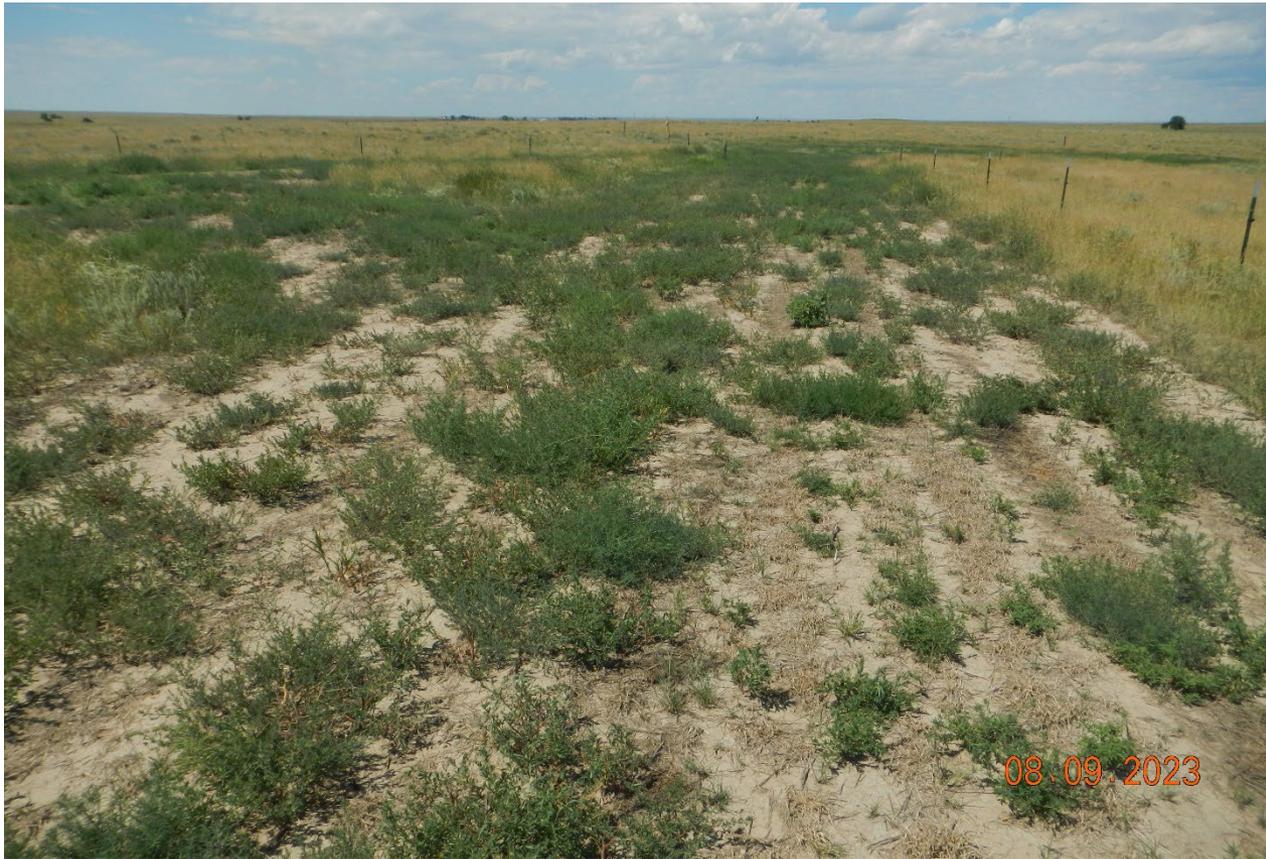
Photo 6. Facing north along the reclaimed access road.
