# Inspection Photos

API: 061-06488

Operator: CHEMCO INC

Inspection Date: 8/9/2023

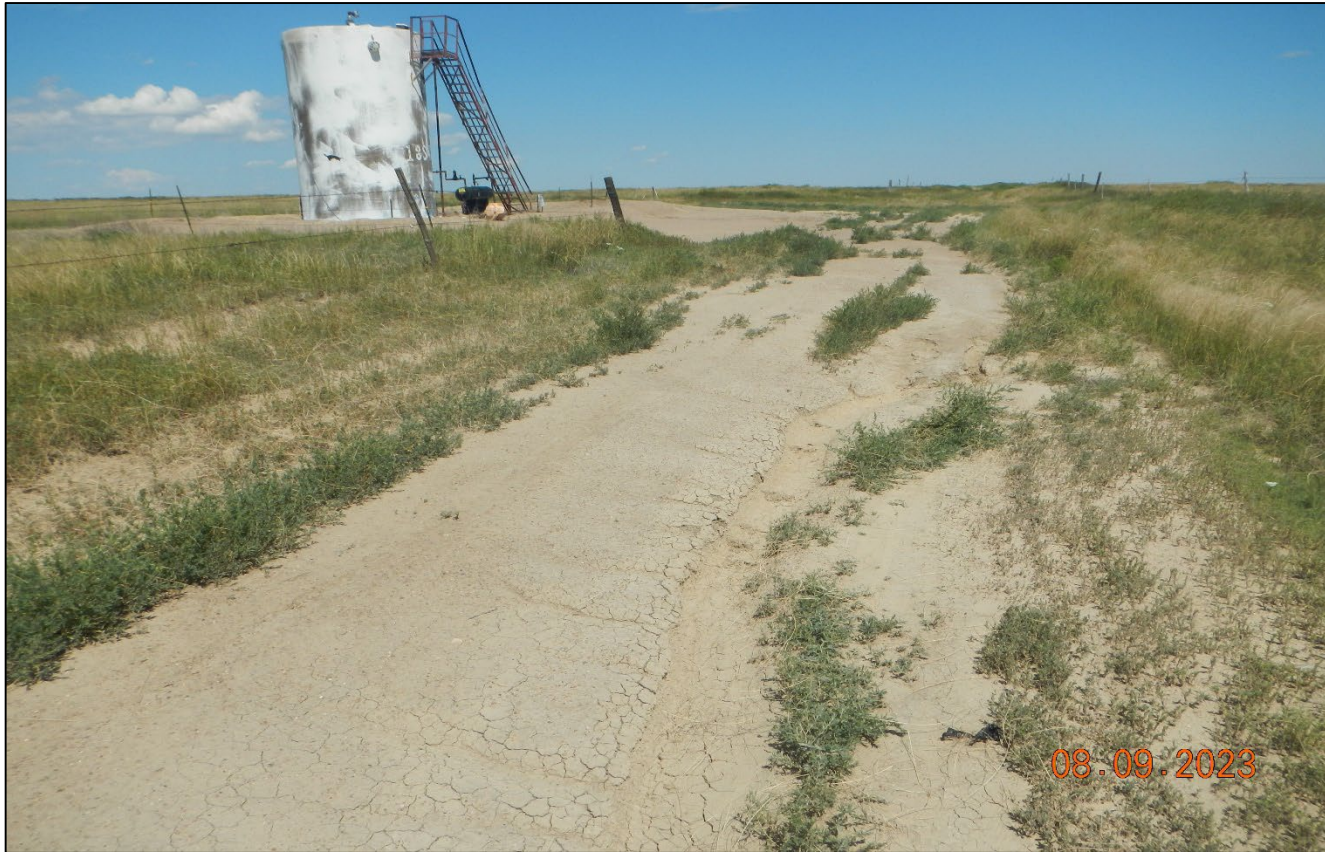
**Photo 1.** Facing east near the tank battery. There is erosion along the access road in this area that needs to be repaired.

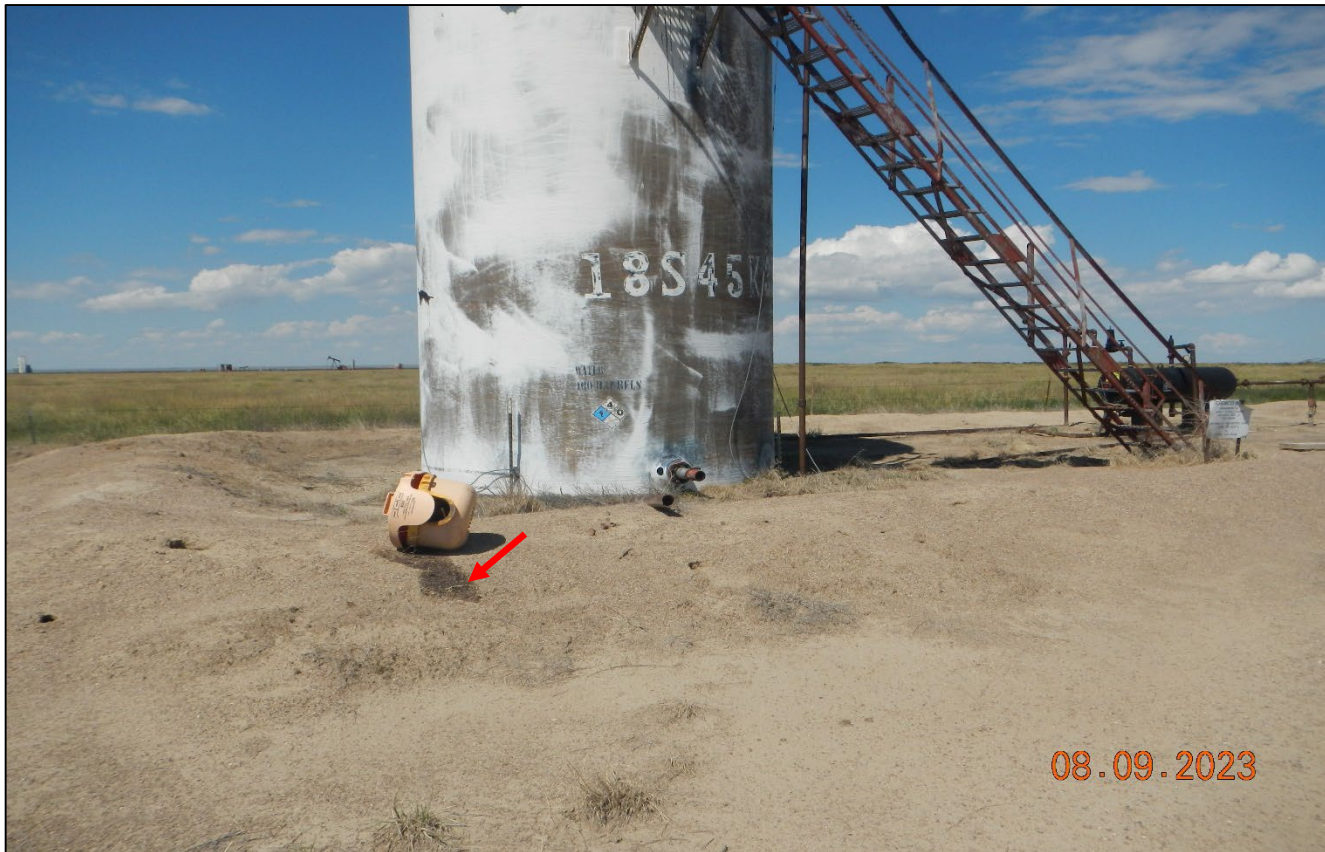
**Photo 2.** Facing northeast toward the tank battery. There is oil stained soil at red arrow that needs to be cleaned up. Berm does not appear to be adequate for containment.

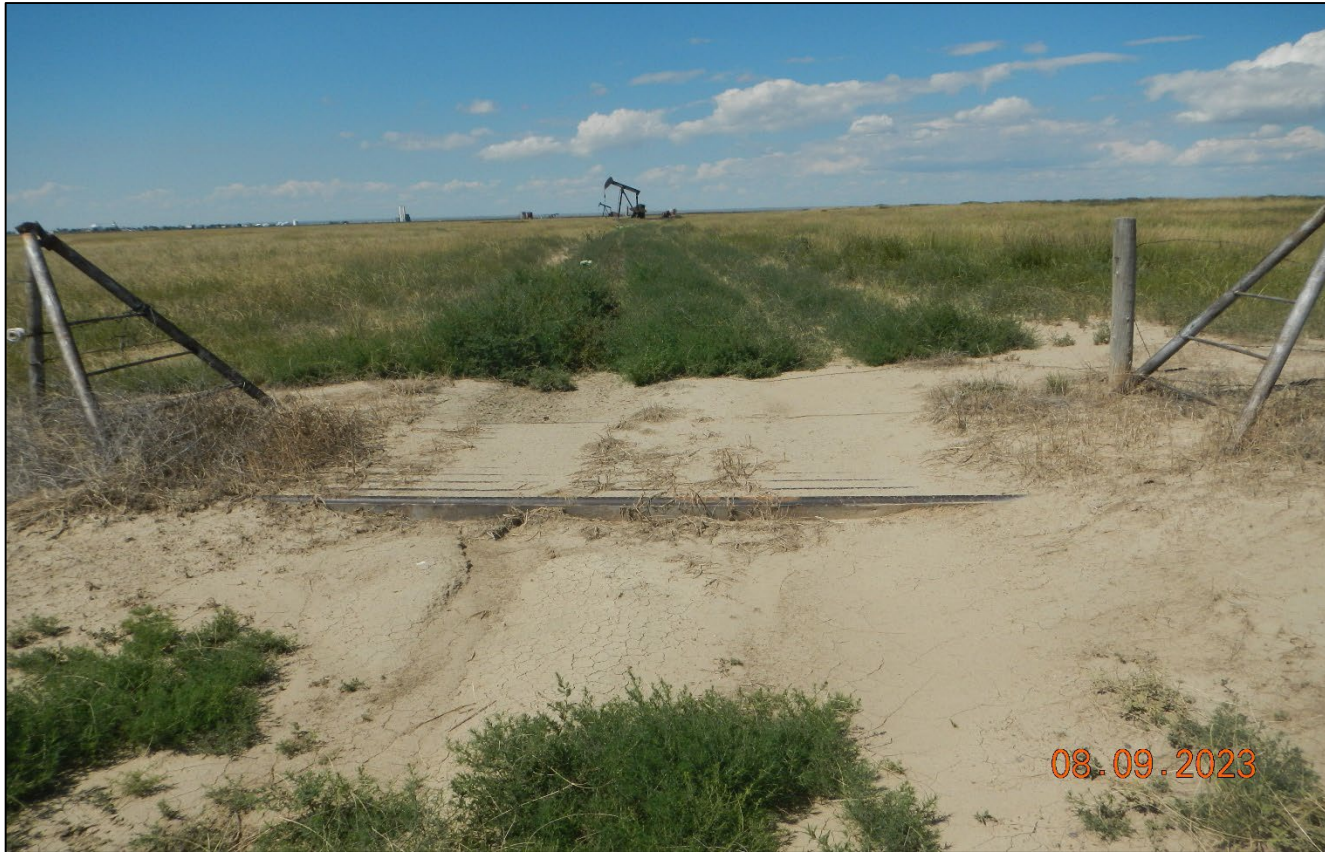
**Photo 3.** Facing north along the access road. The cattle guard is filled in with sediment and needs maintenance.

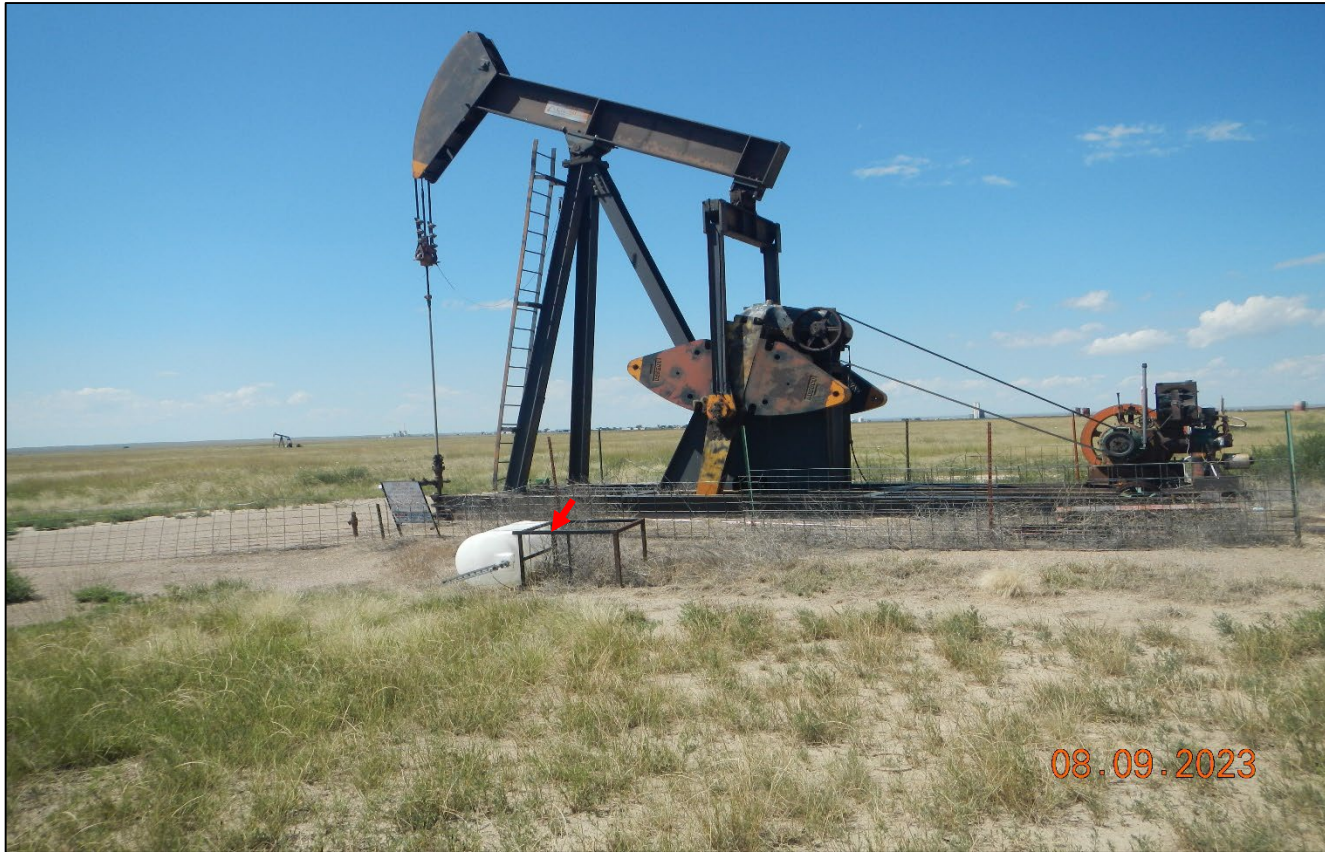
**Photo 4.** Facing toward the pumpjack. The chemical container has fallen over and does not have secondary containment.

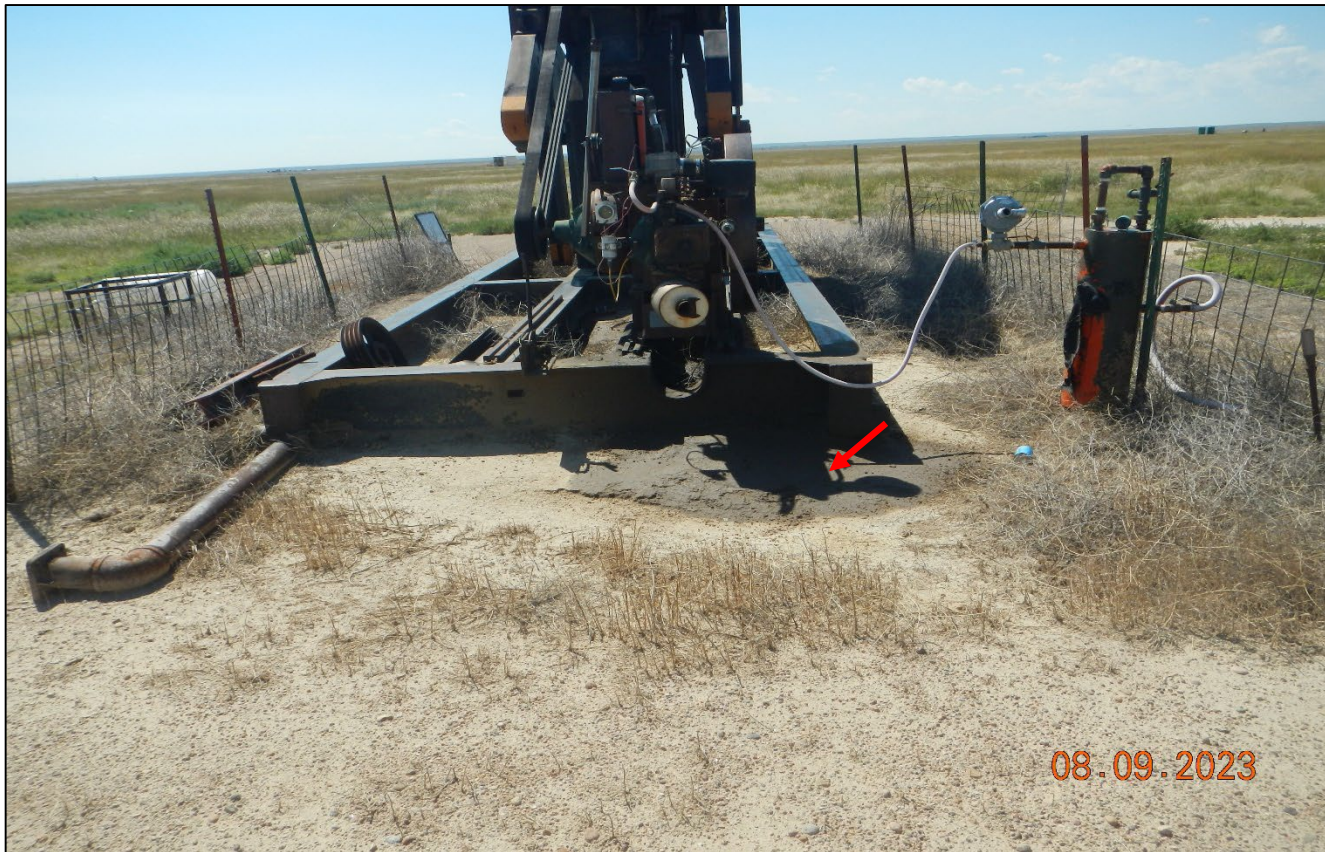
**Photo 5.** There is oil stained soils shown at red arrow that need to be cleaned up..

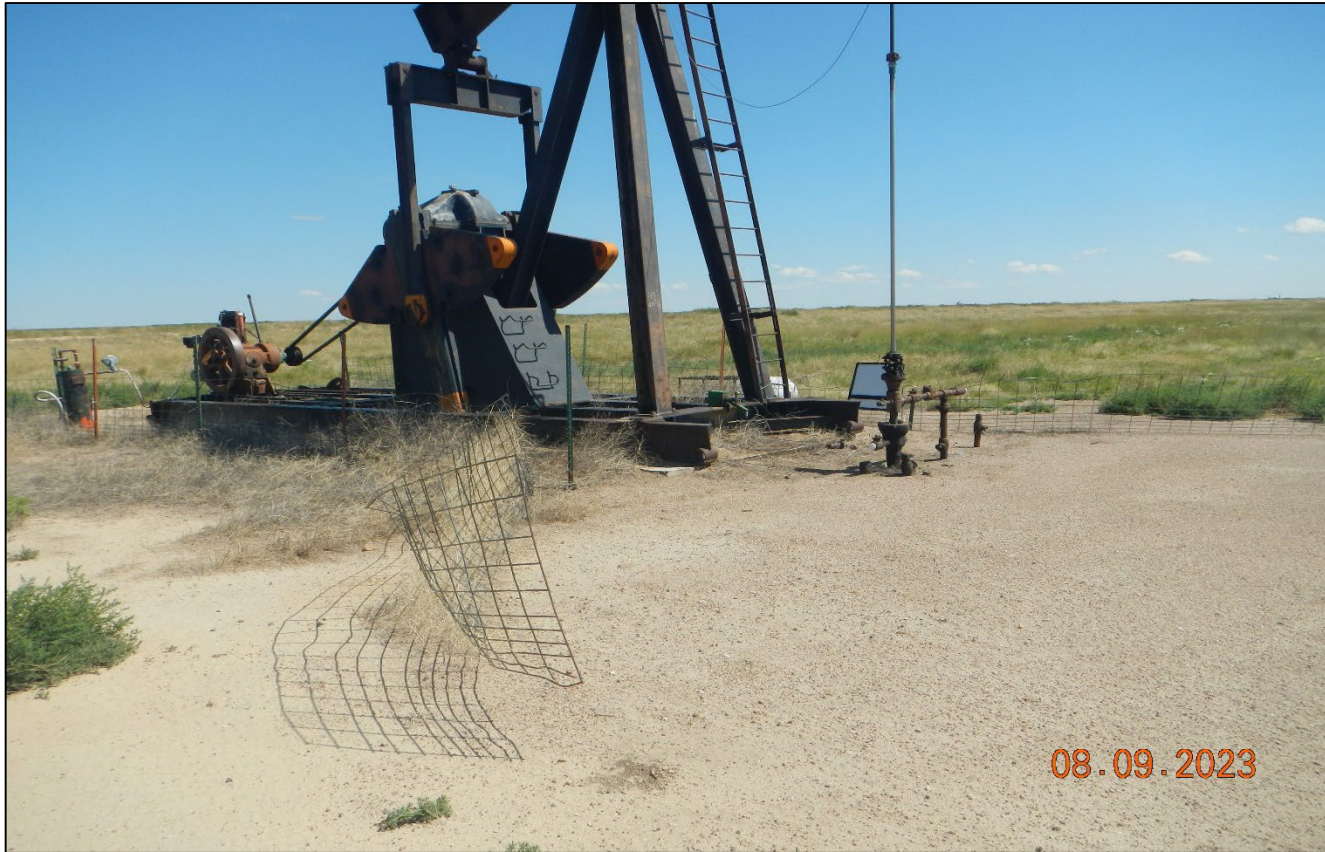
**Photo 6.** The fence around the tank battery is not maintained..
