Final Reclamation Inspection

Operator: PDC ENERGY INC - 69175

Location ID: 319113

Inspection Photos
Location Name: Davis Farms 33-28
Location ID: 319113

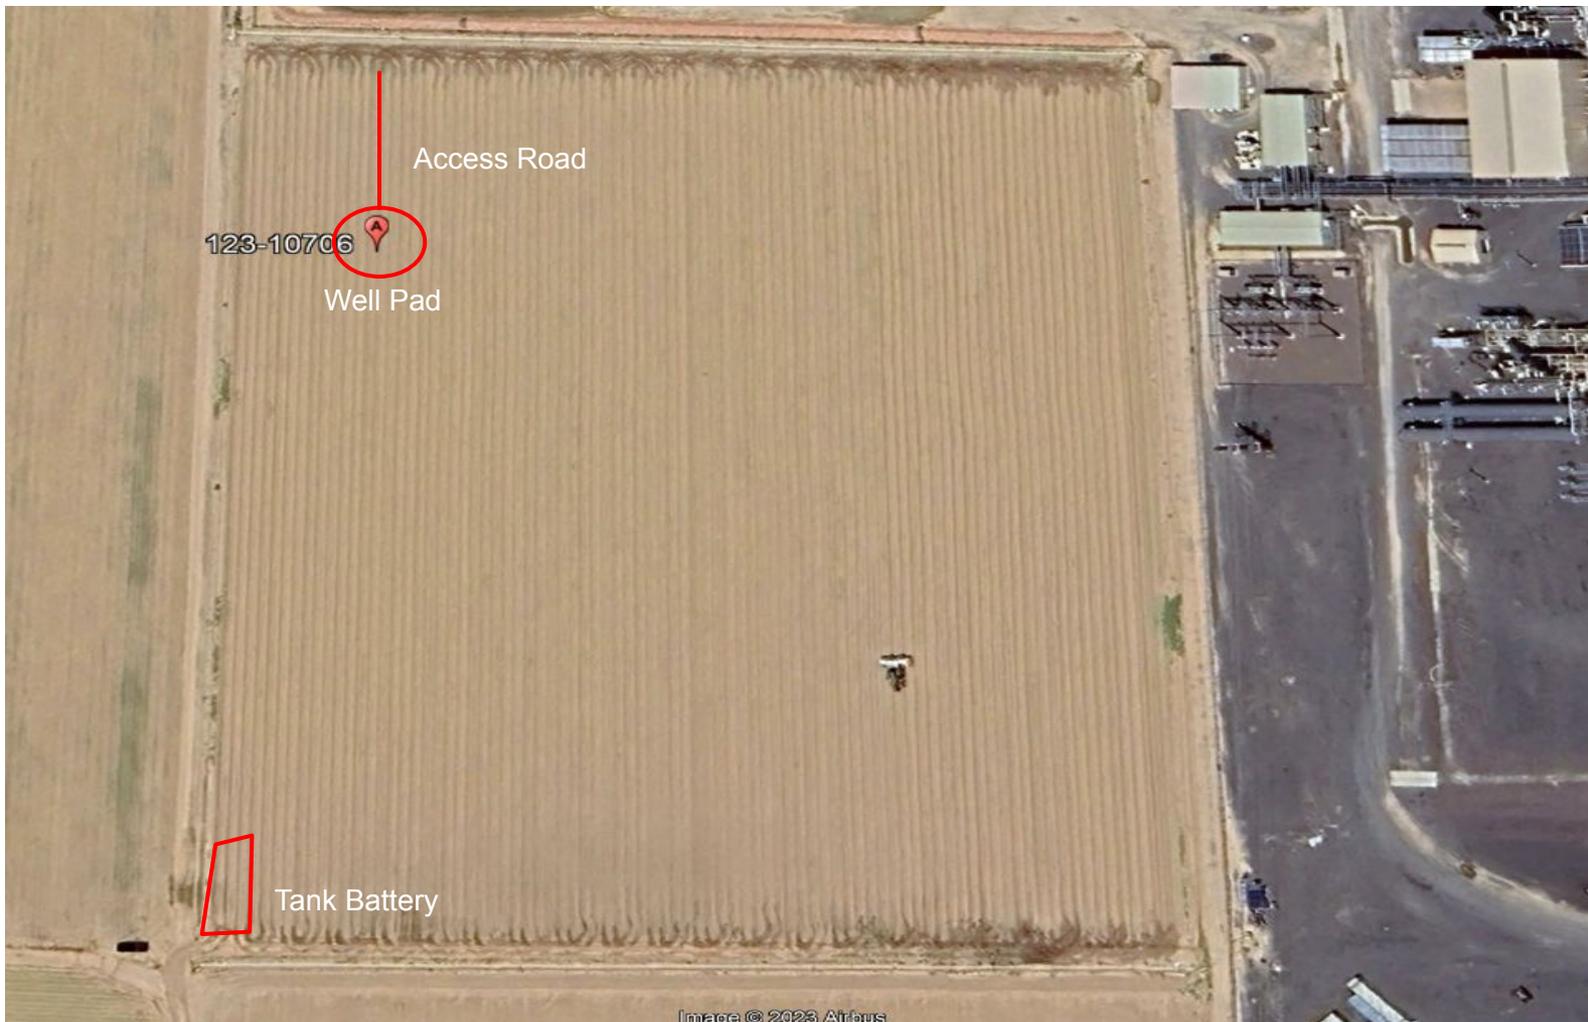
Photo 1. 2023 aerial imagery of the well pad, access road and associated tank battery (north is up).

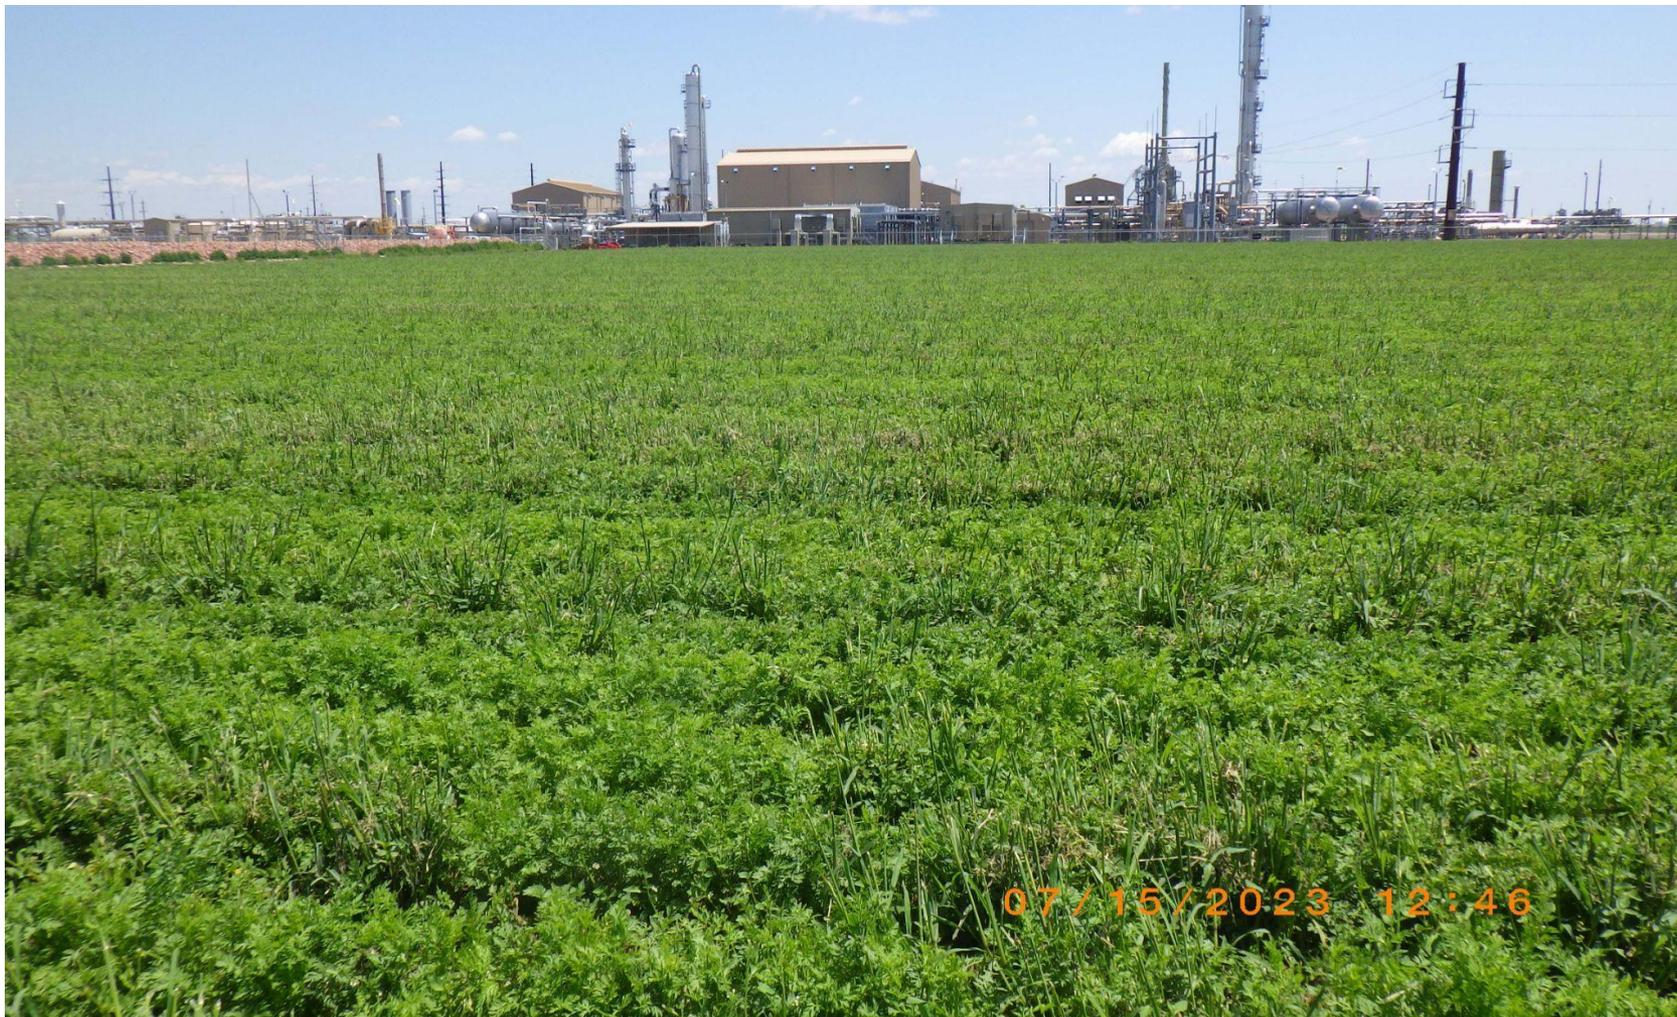
Photo 2. Overview photo of the well pad taken from the western edge facing east.

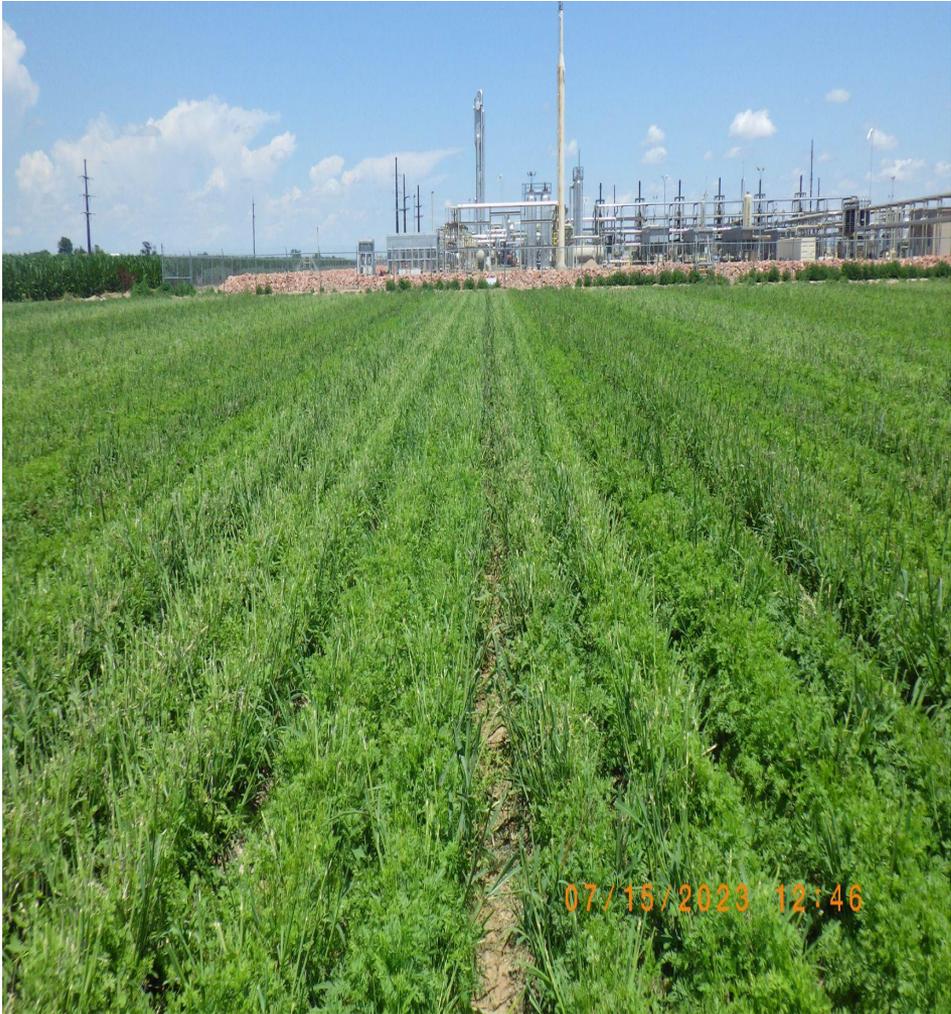
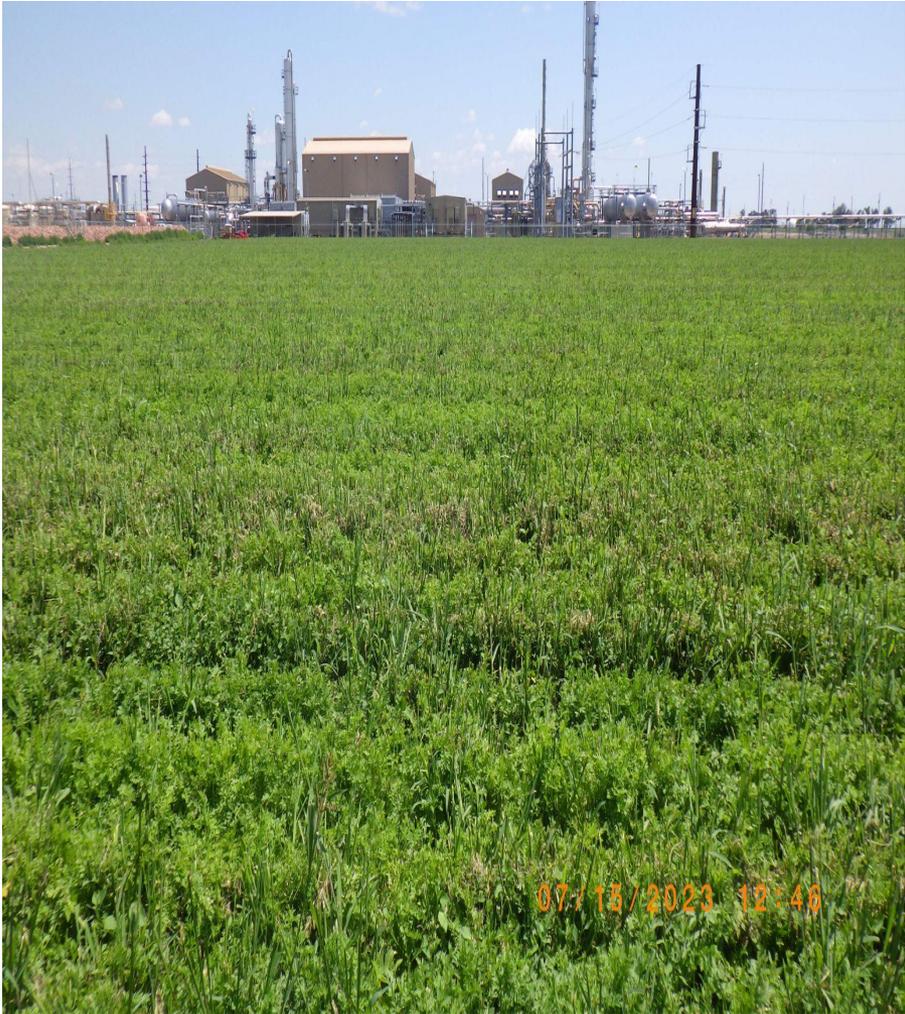
Photo 3. Cardinal photos taken from the middle of the well pad. Left photo facing north, right photo facing east.

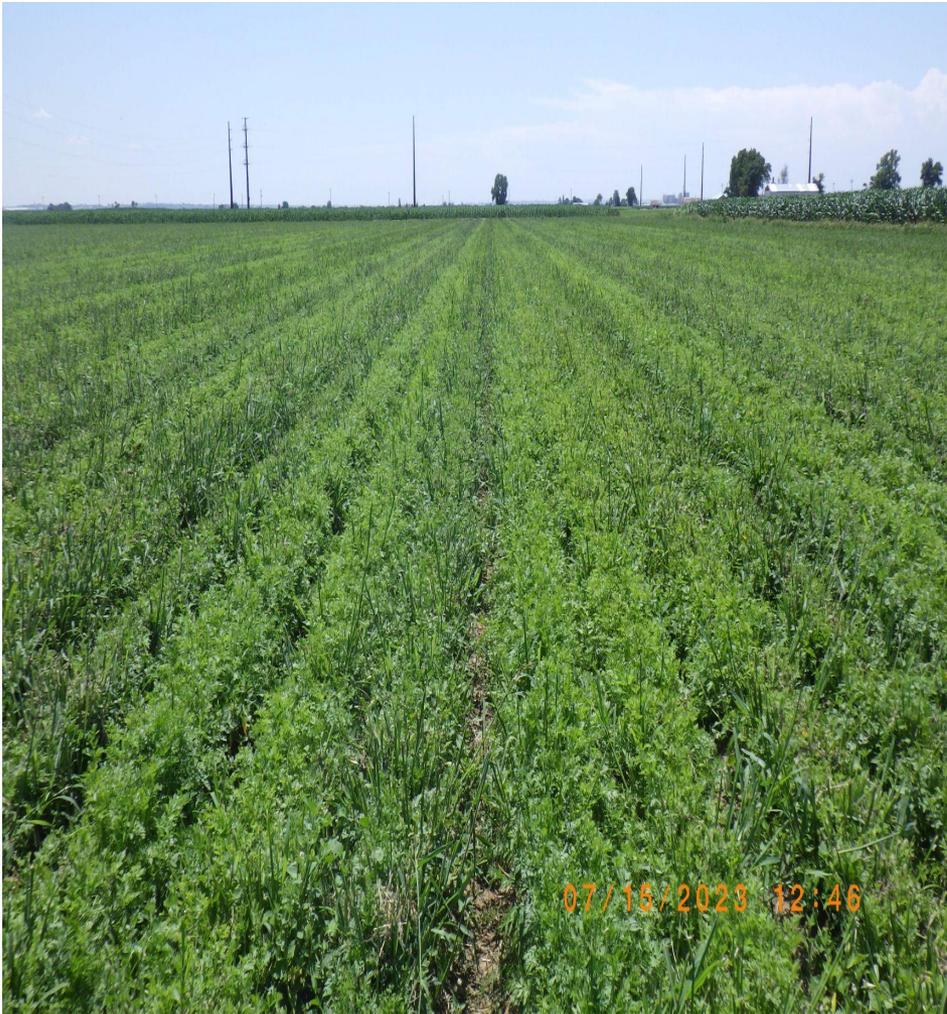
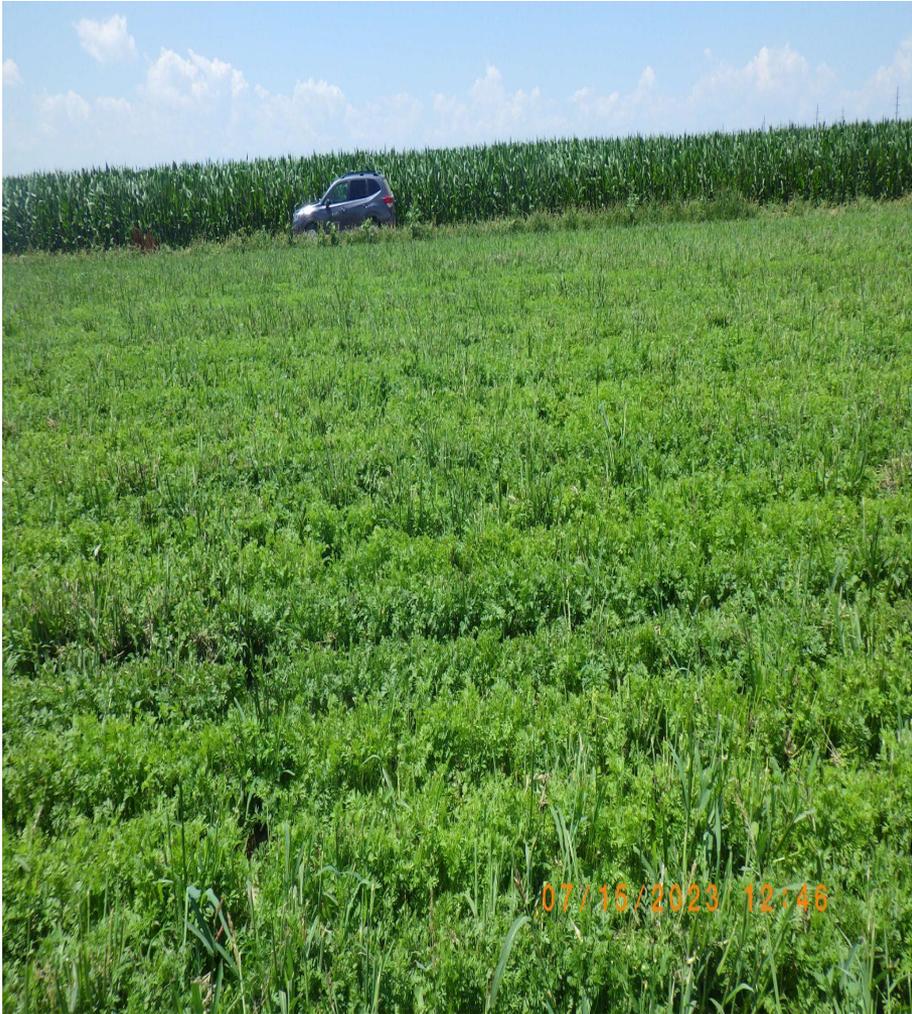
Photo 4. Cardinal photos taken from the middle of the well pad. Left photo facing south, right photo facing west. Note: well pad appears consistent with adjacent reference area (see photo #5).

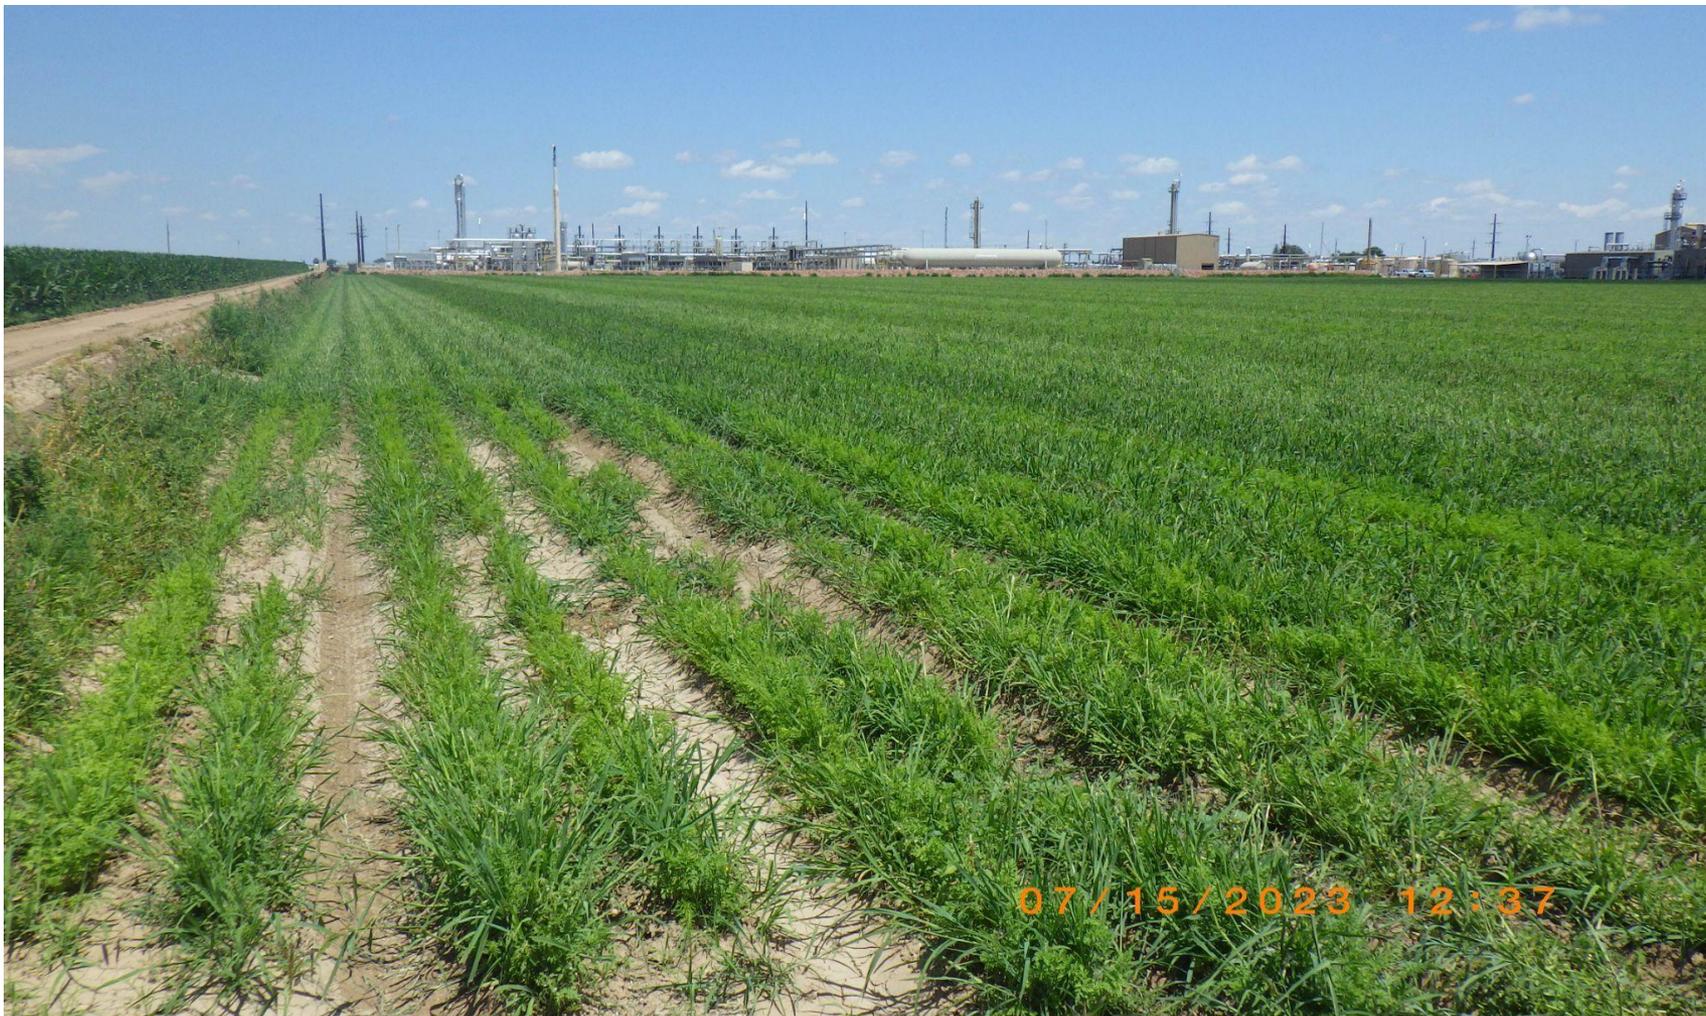
Photo 5. Overview photo of the tank battery taken at ground level from the southern edge facing north. Photo shows that the western edge of the tank battery shows stunted crop growth and bare ground which does not appear consistent with adjacent crop reference area.
