Inspection Photos
Location Name: Thomas East #1
Location ID: 443574

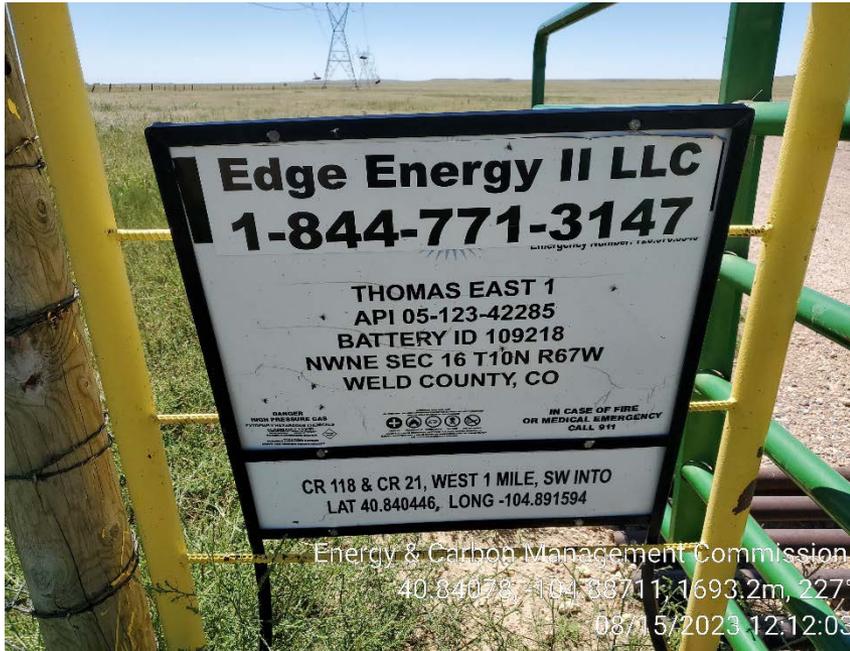
Lease road entrance

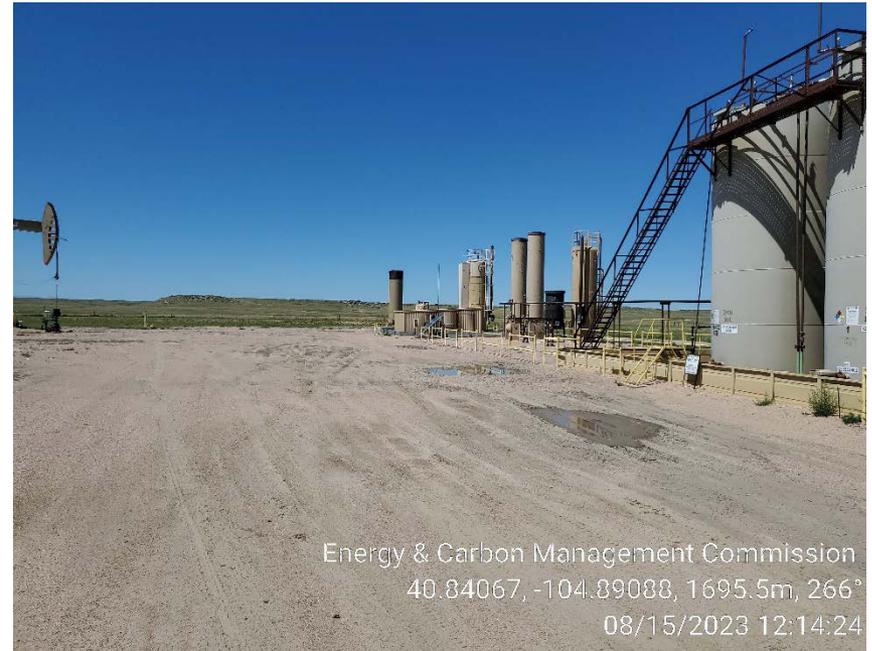
Production facility

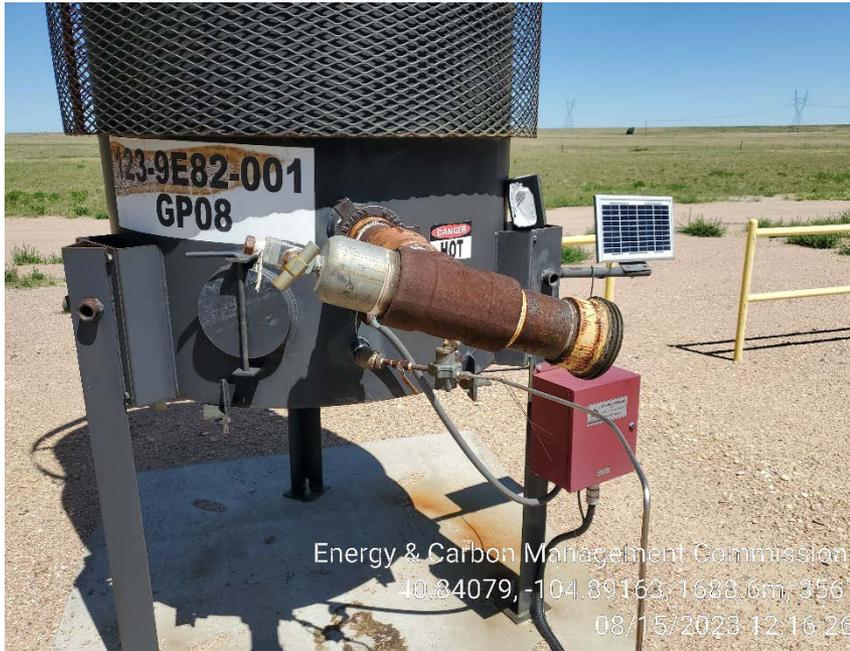
Disconnected ECD with pilot on

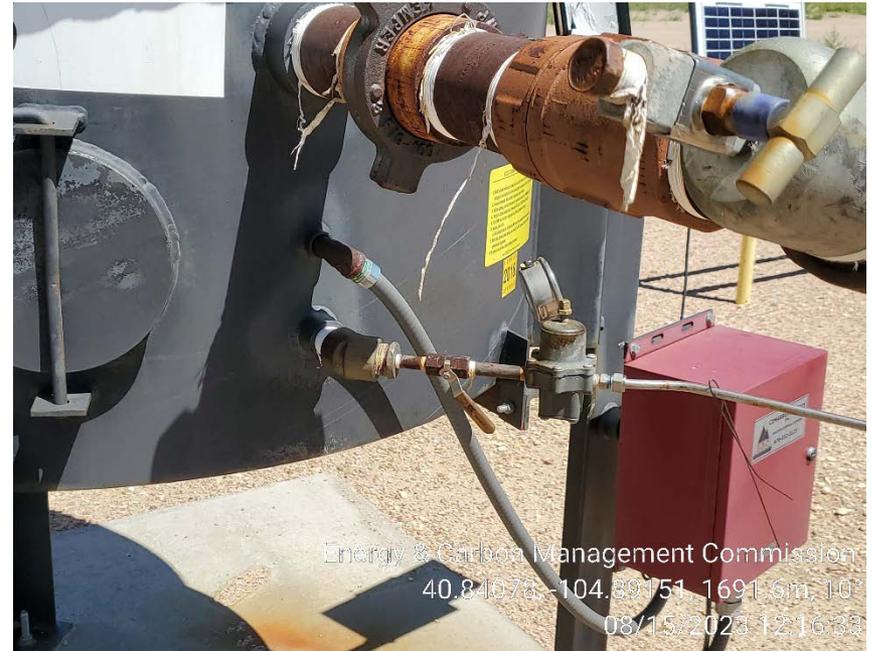
Pilot gas valve

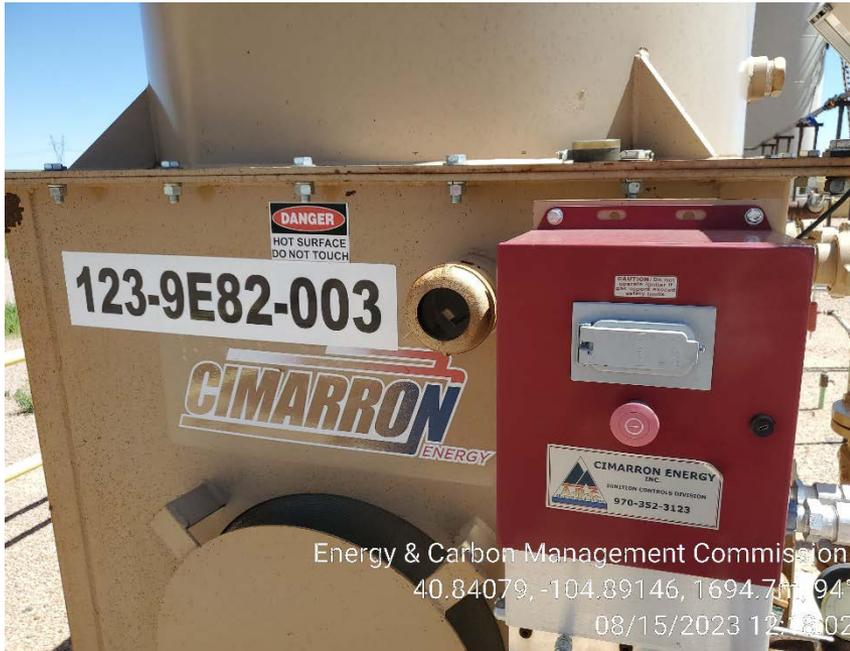
Tank connected inlet shut in ECD

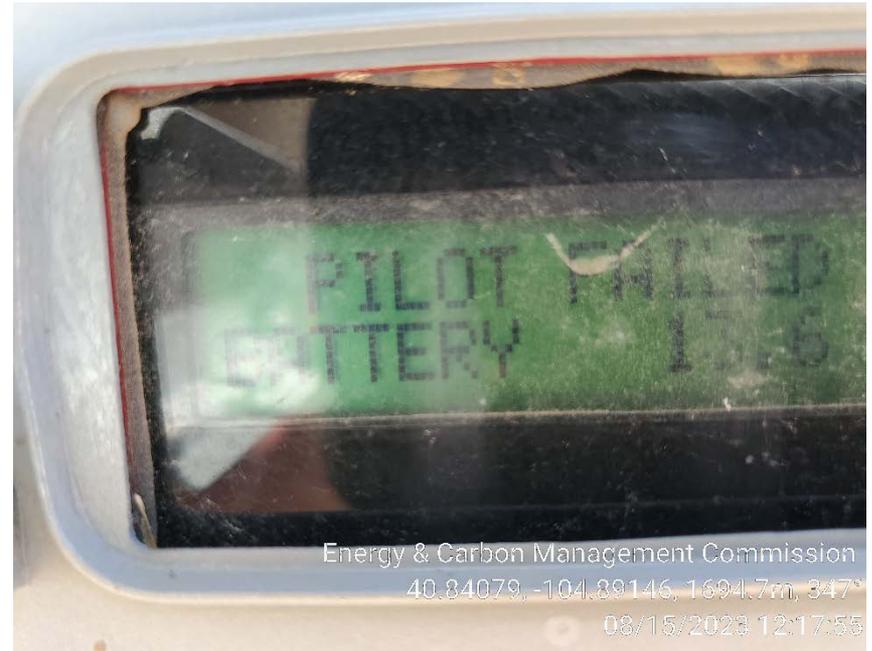
Pilot display

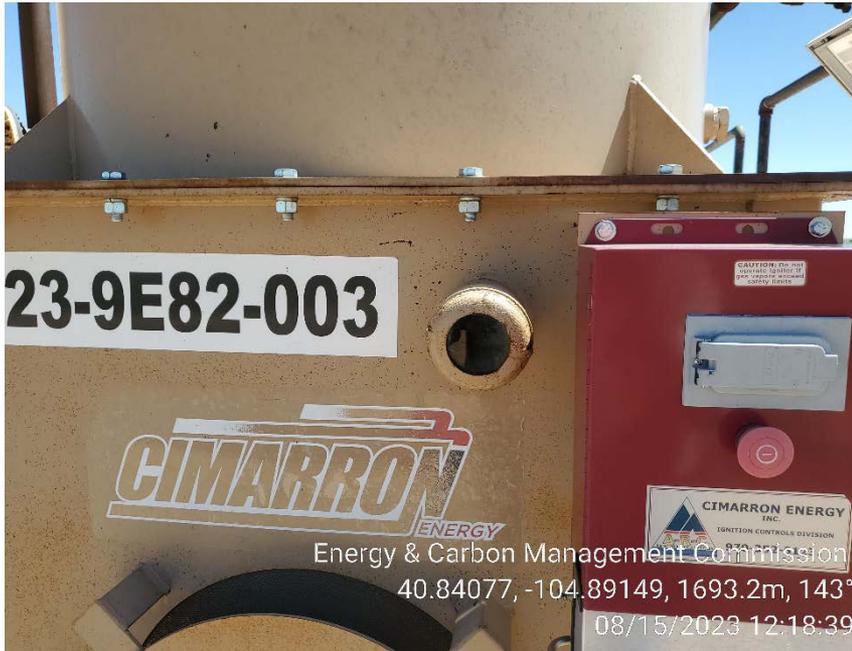
Tank connected inlet open ECD

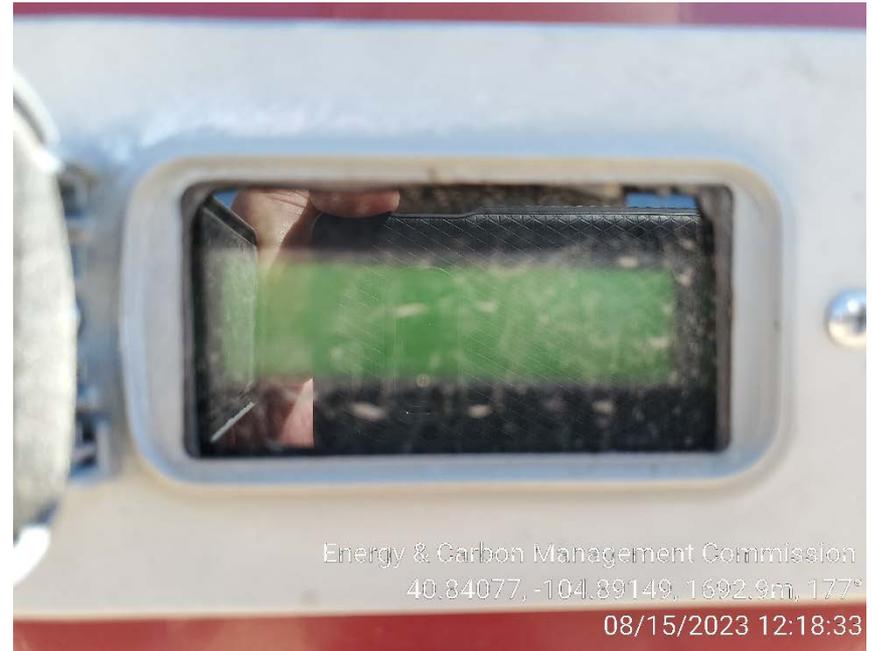
Pilot display

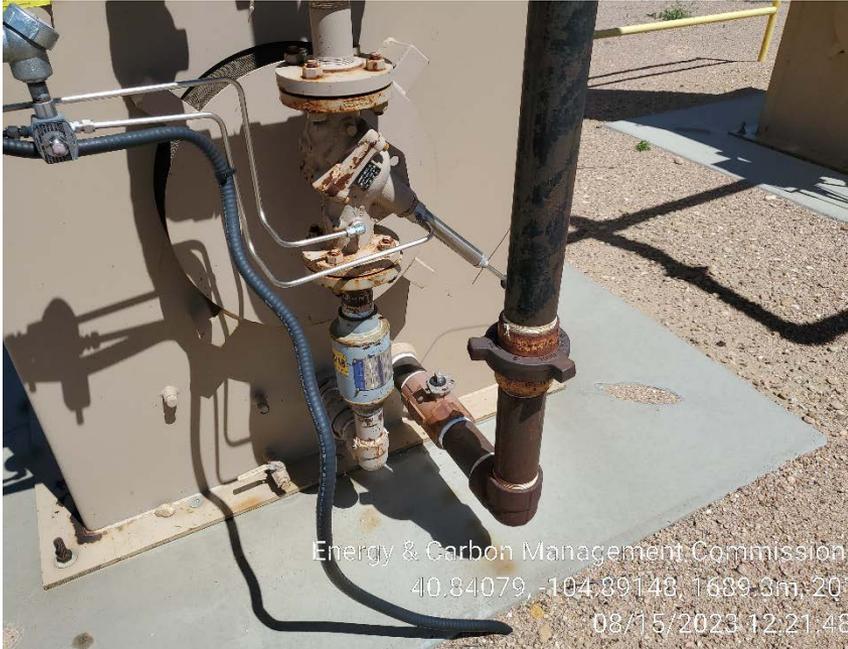
Tank connected ECD inlet valve position

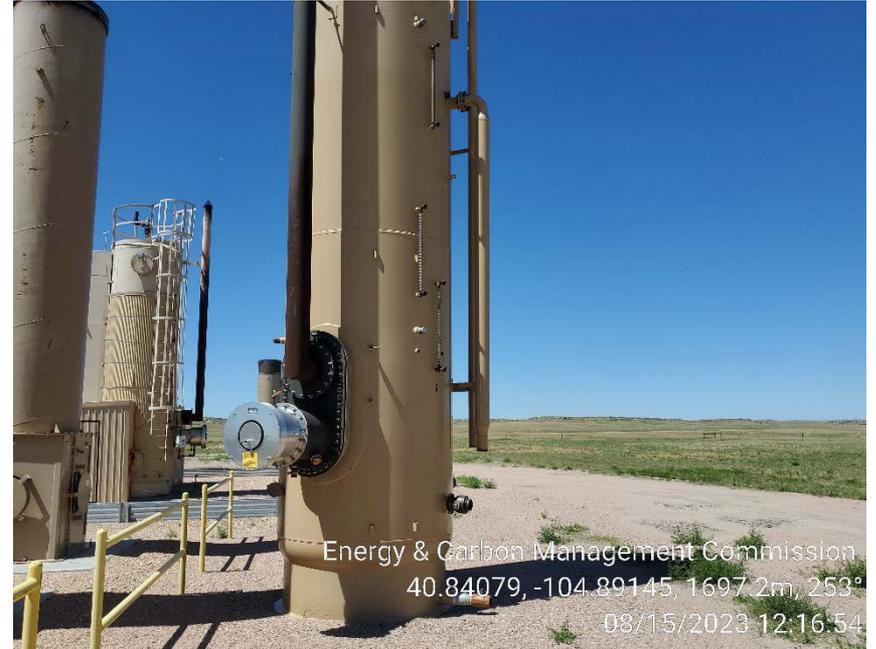
Unused equipment

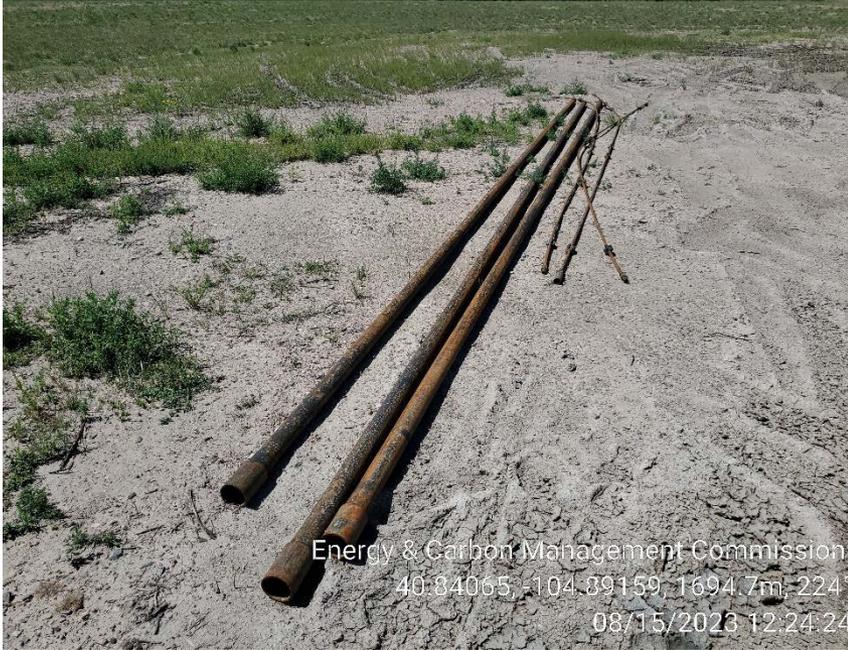
Unused equipment

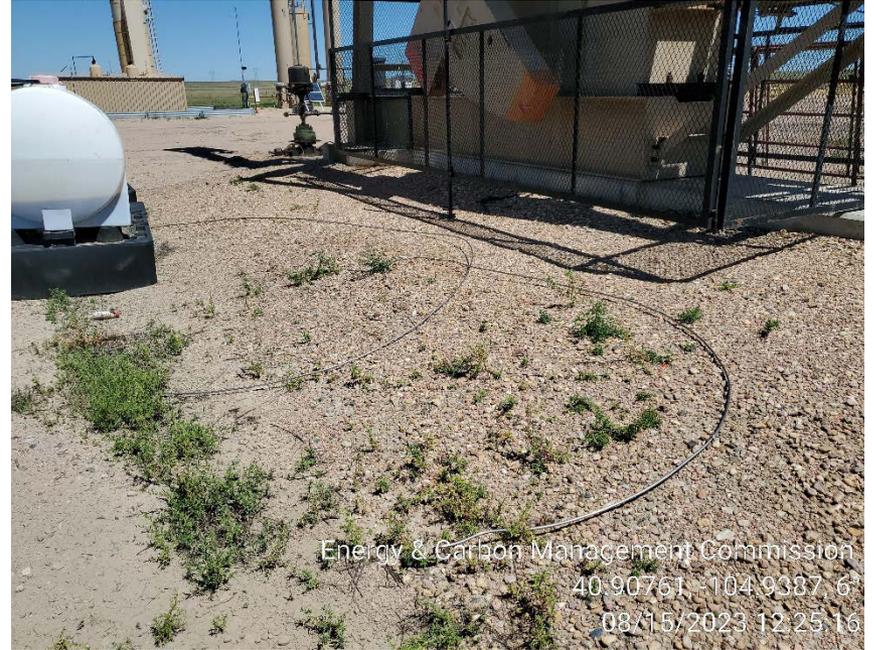
Unused equipment

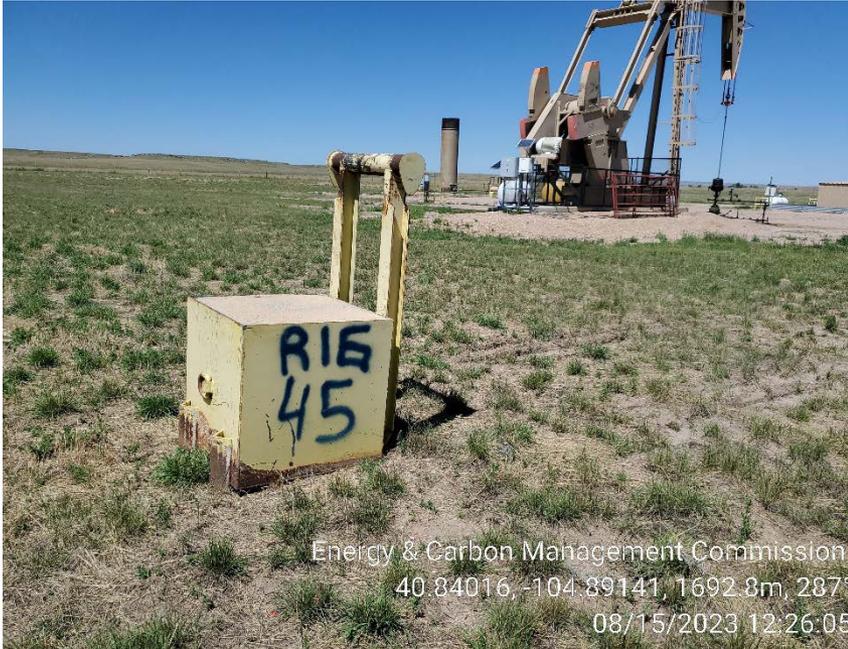
Unused equipment

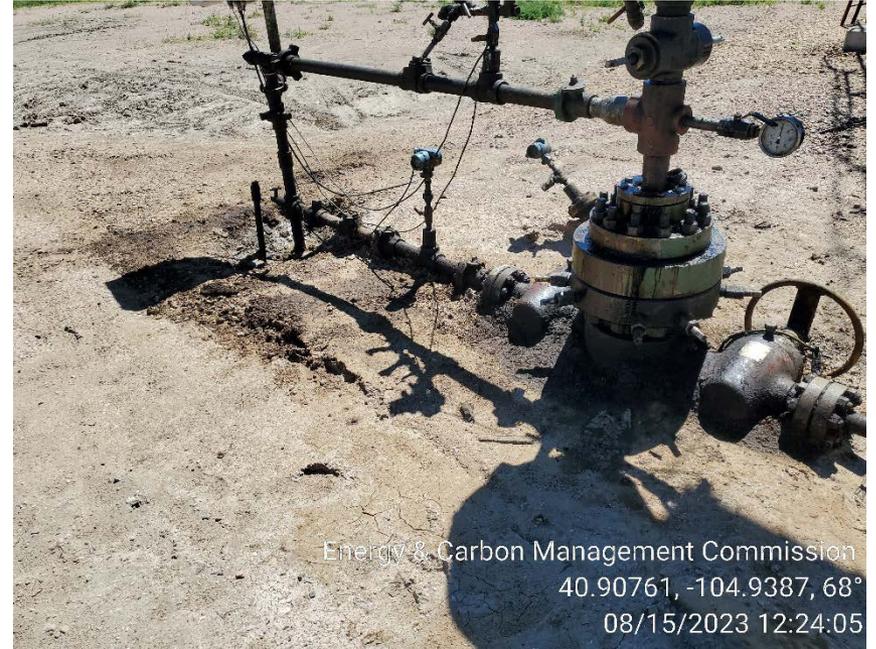
Stained soil

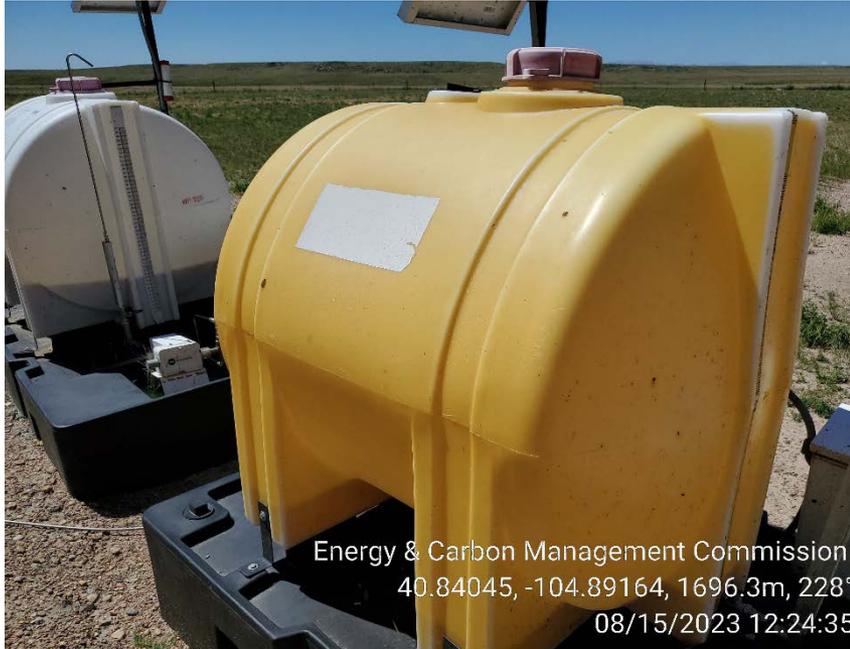
Chemical system placards

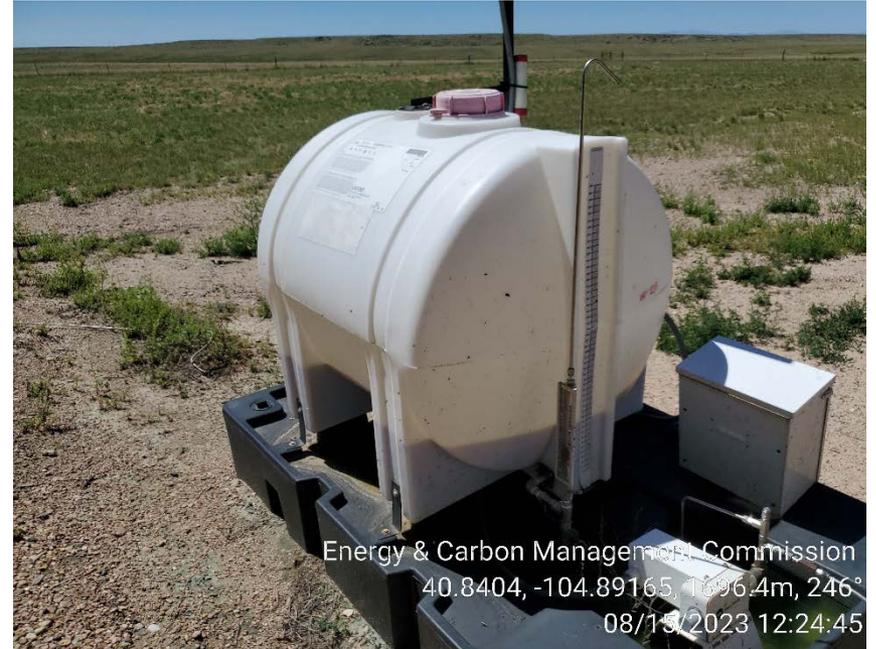
Chemical system placards

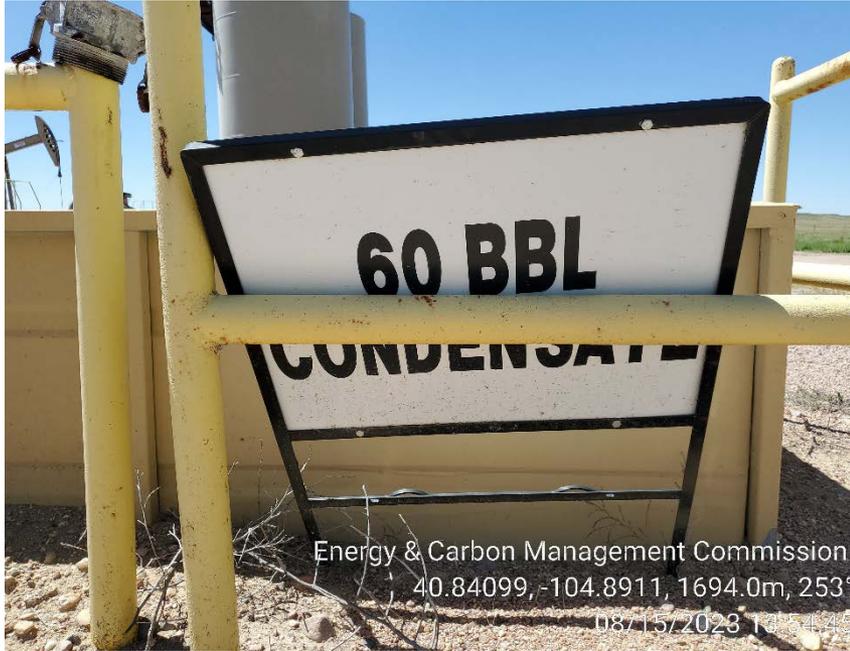
Condensate placards

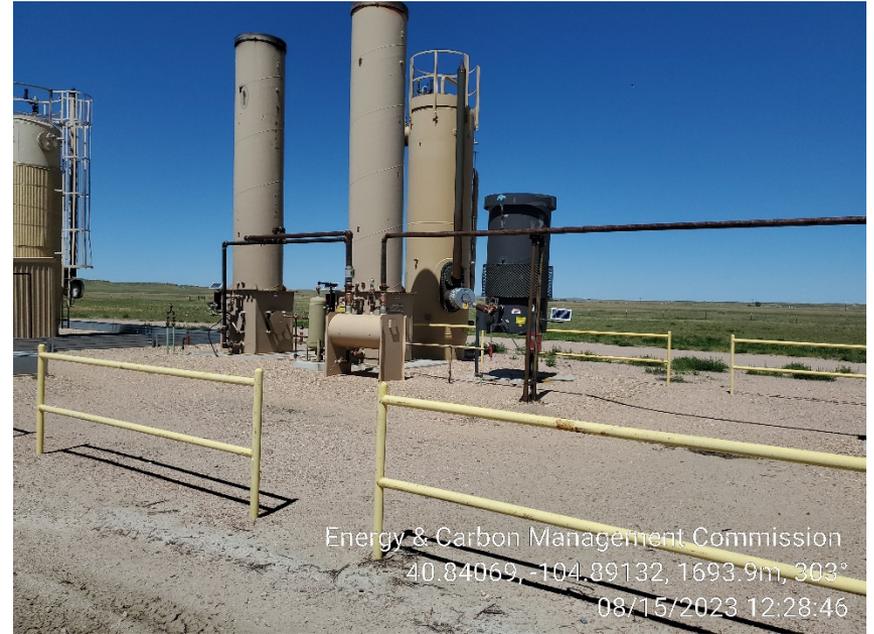
ECD positions
