**Inspection Photos**  
**Location Name: Champlin 246 Amoco A #1**  
**API # 05-123-10084**

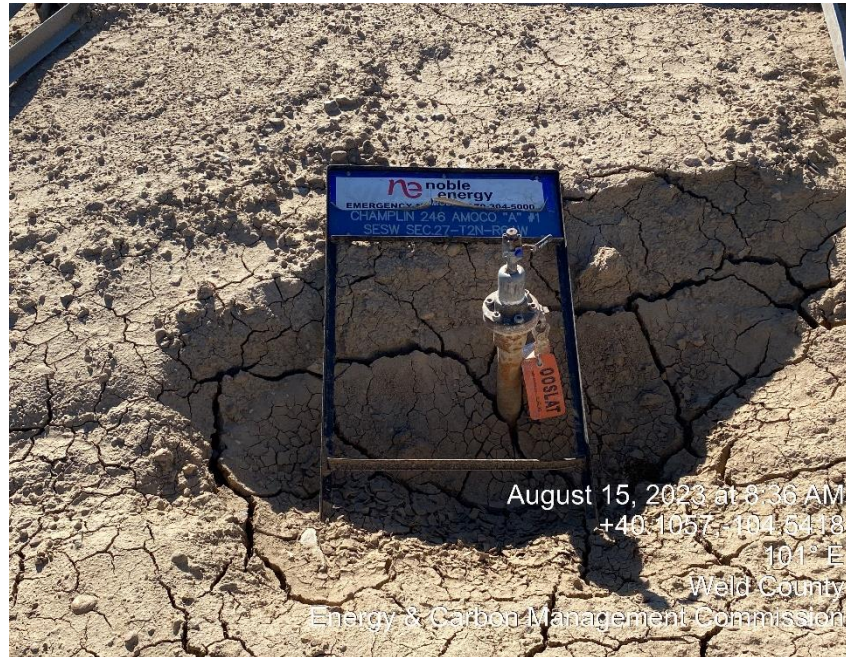
**Appears to be the flow line**
