Inspection Photos
Location Name: CAERUS PICEANCE LLC H26NW Pad
Location #: 335314

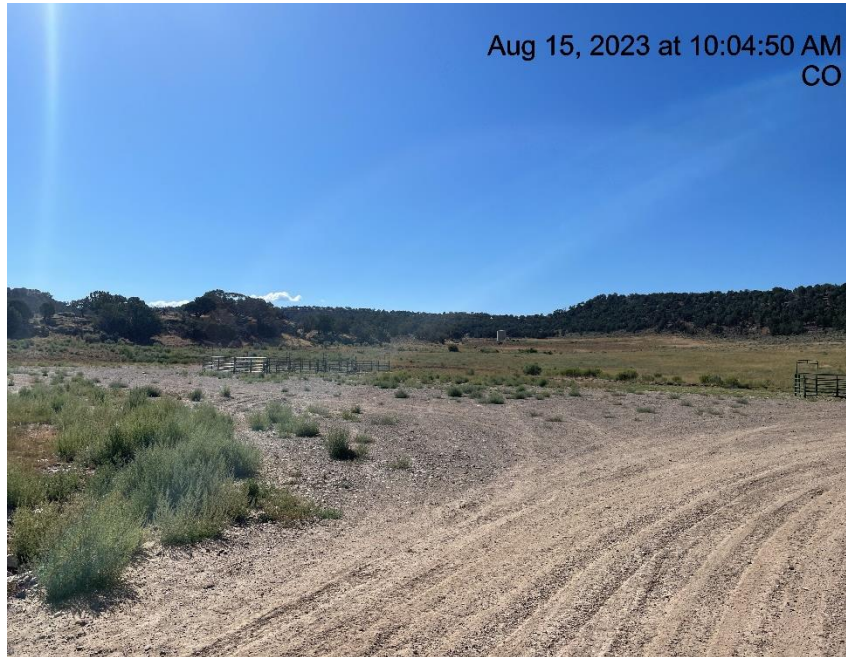
Photo # 5801 From entrance to location

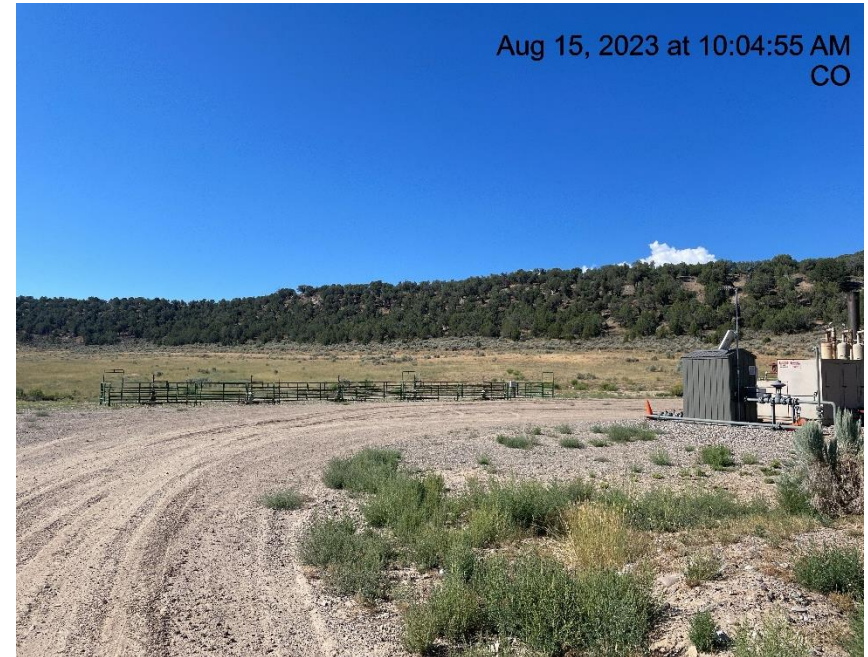
Photo # 5802 From entrance to location

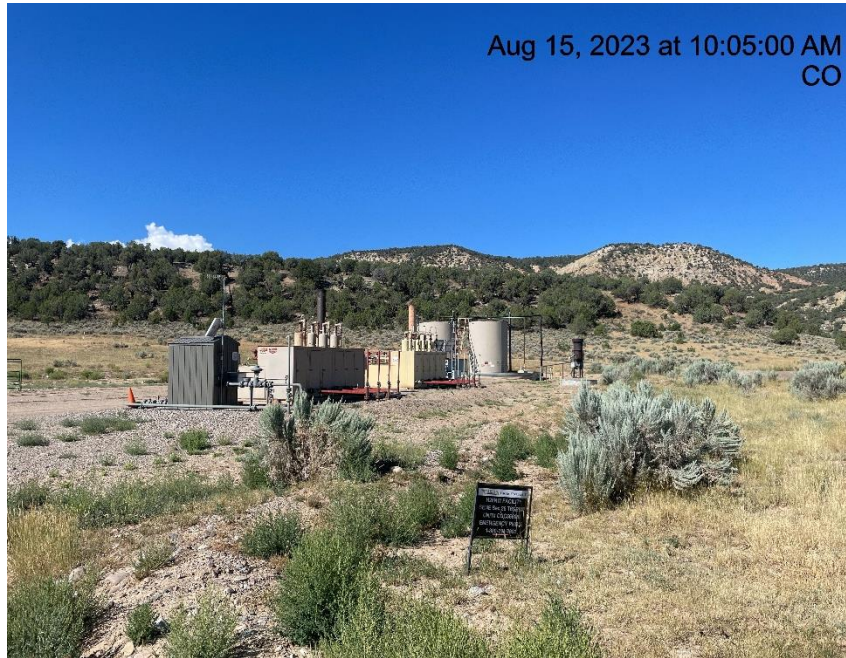
Photo # 5803 From entrance to location

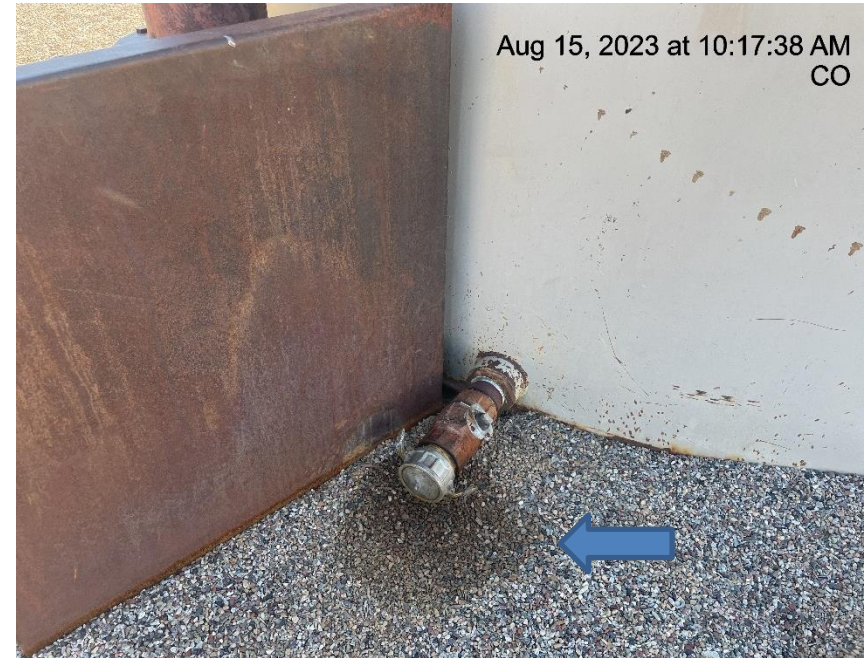
Photo # 5813 Stained gravel in secondary containment

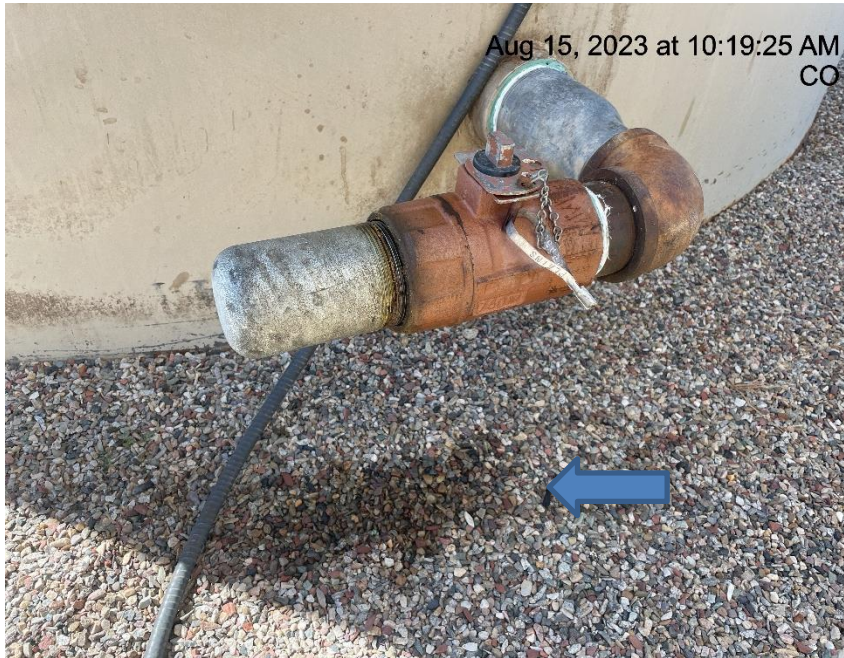
Photo # 5818 Stained gravel in secondary containment

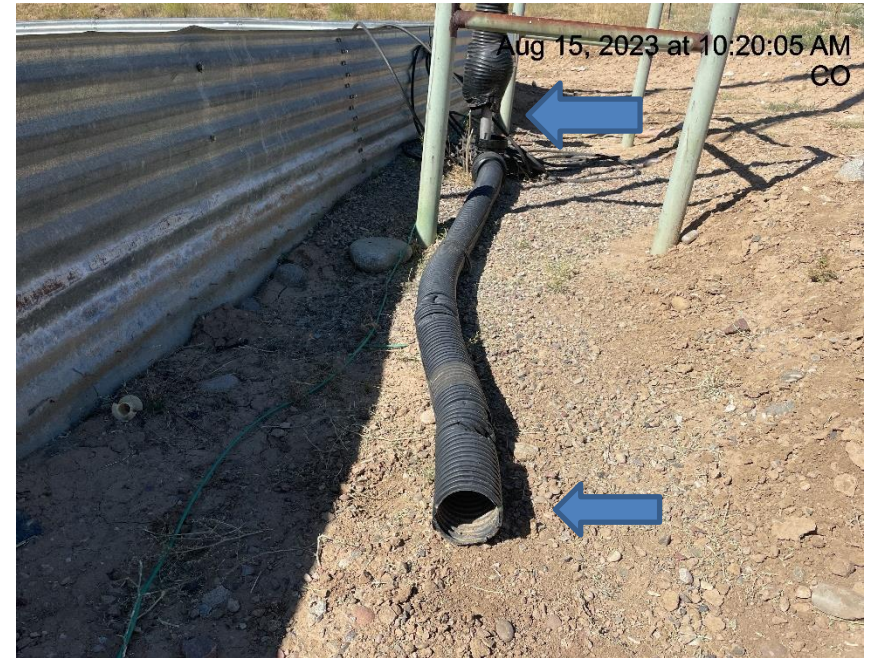
Photo # 5819 Flowline heating insulation open ended
