Storm Water Management and Erosion control
Location Name: CAERUS PICEANCE LLC N36NW Pad
Location #: 334944

**Location Overview: Location is within High
Priority/Density/Black Bear Habitat areas.**

Section/Township/Range: 36 6S93W

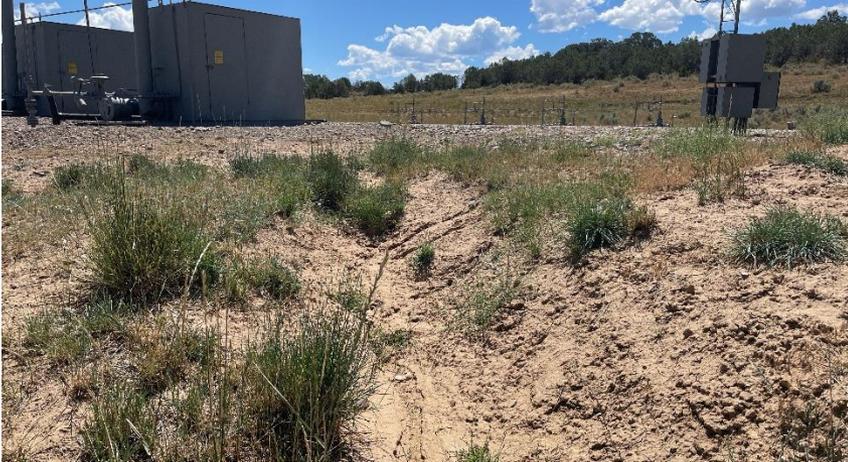
North West corner of location.

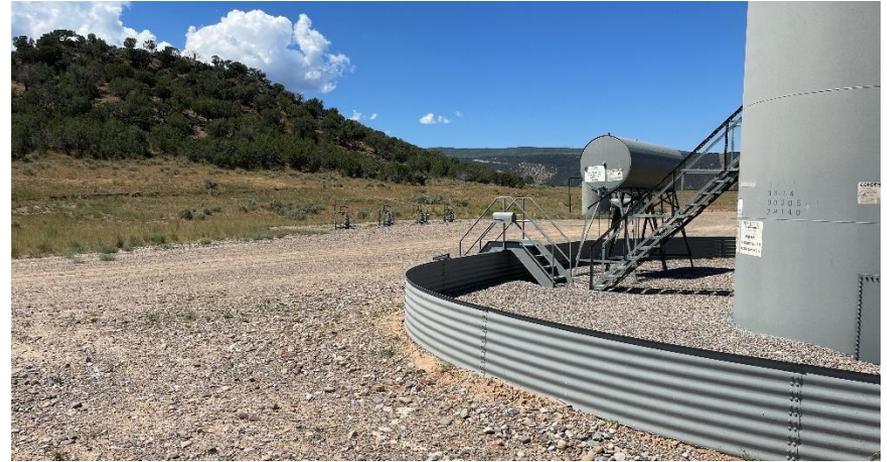
North East corner of location.

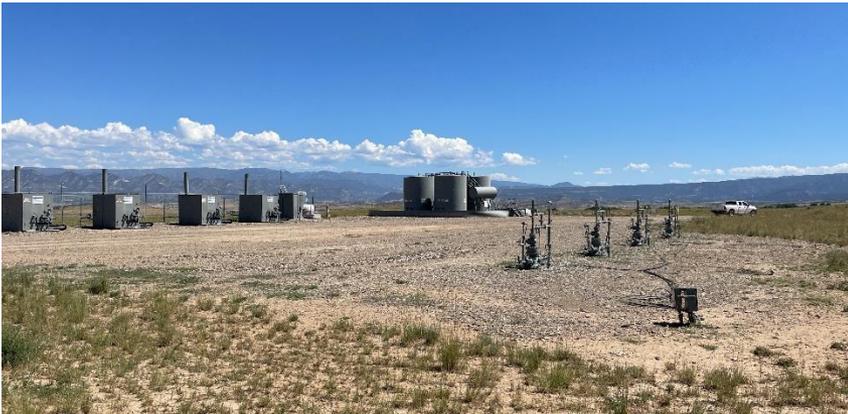
South West corner of location.

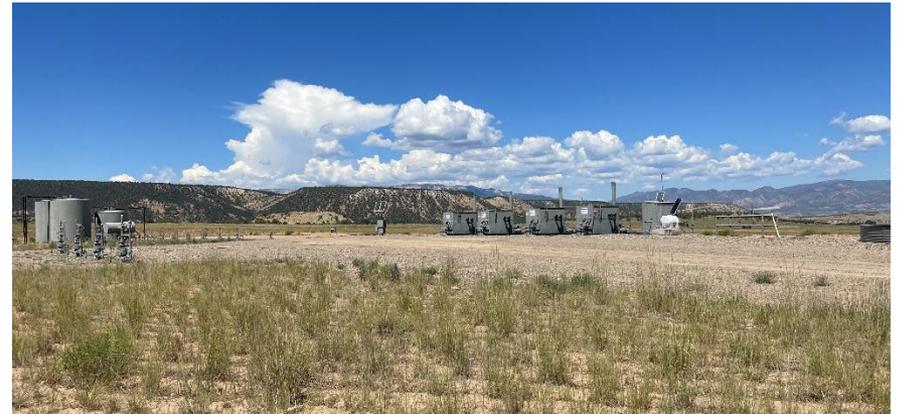
South East corner of location.

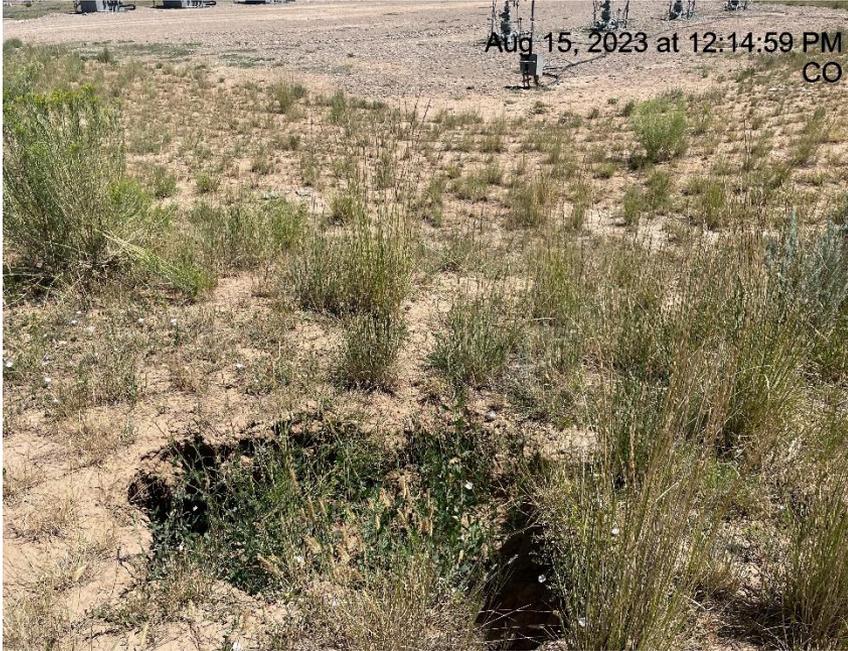
Photo # 5950 Tunnel erosion/sink hole (SW corner of location)

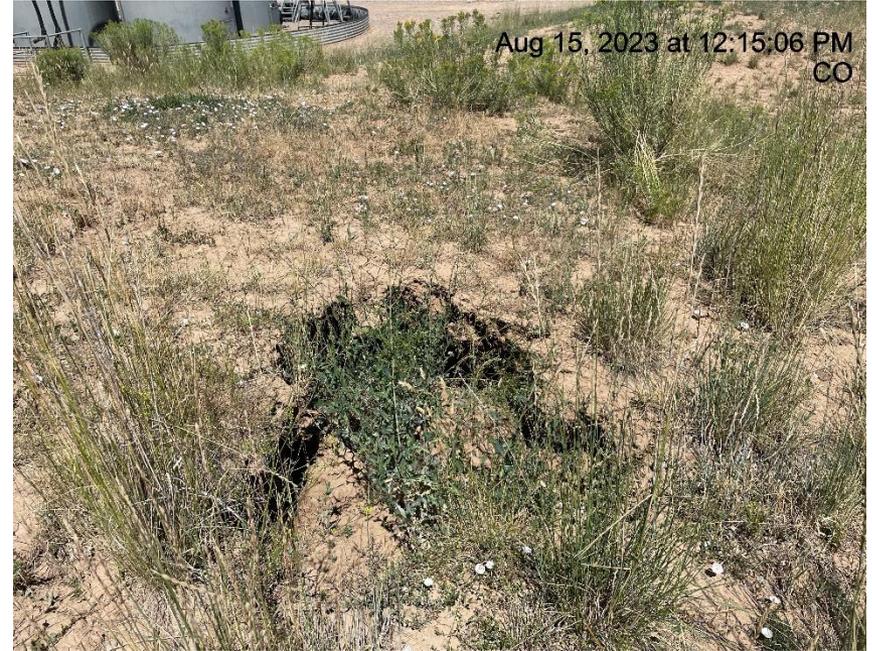
Photo # 5951 Tunnel erosion/sink hole (SW corner of location)

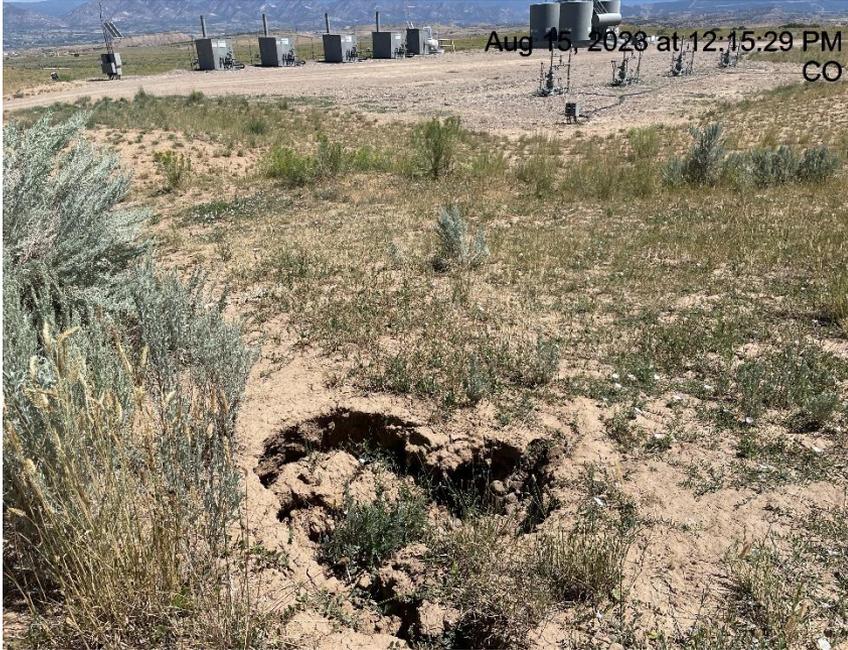
Photo # 5952 Tunnel erosion/sink hole (SW corner of location)

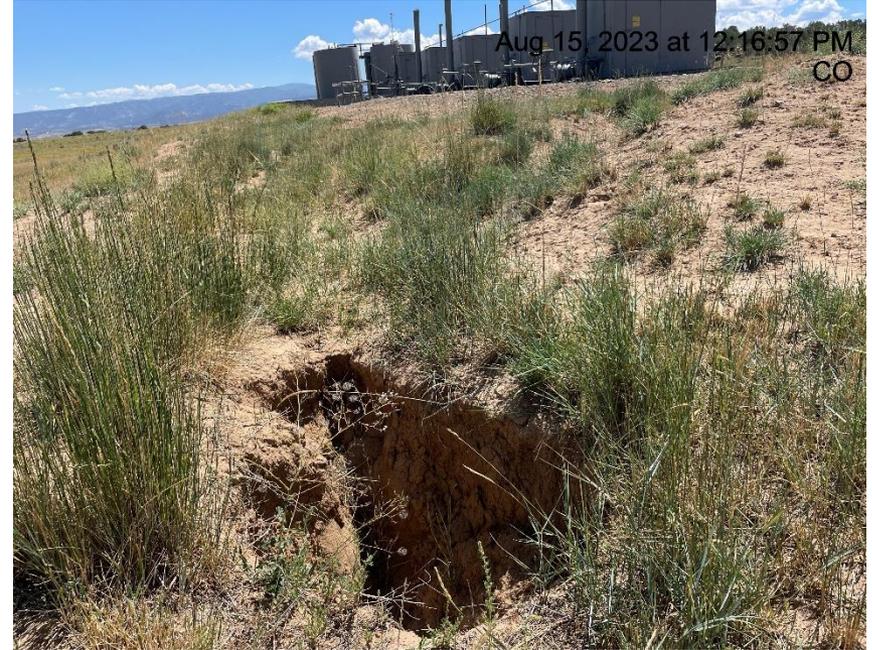
Photo # 5953 Tunnel erosion/sink hole/insufficient runoff controls/BMP's (NW corner of location in ditch)

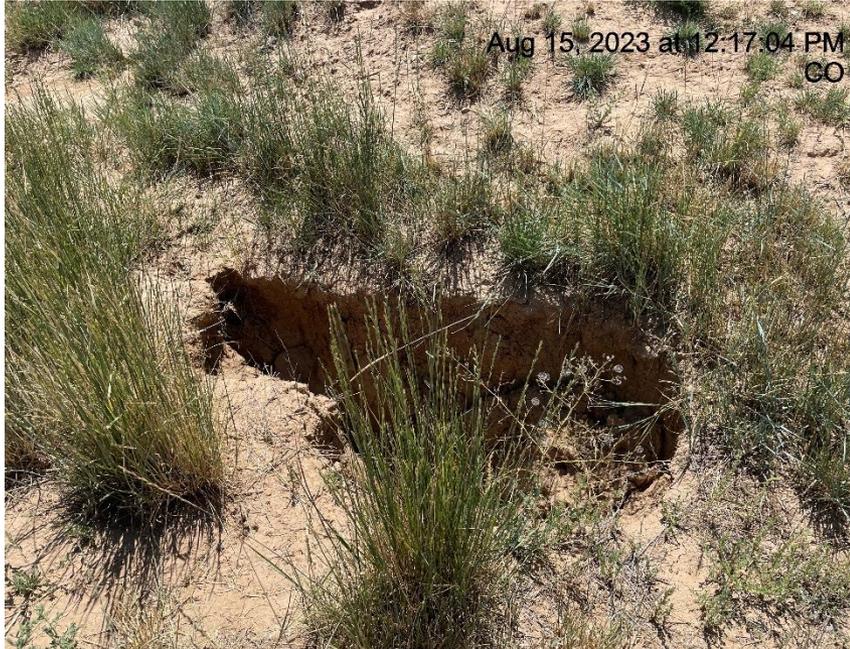
Photo # 5954 Tunnel erosion/sink hole/insufficient runoff controls/BMP's (NW corner of location near ditch)

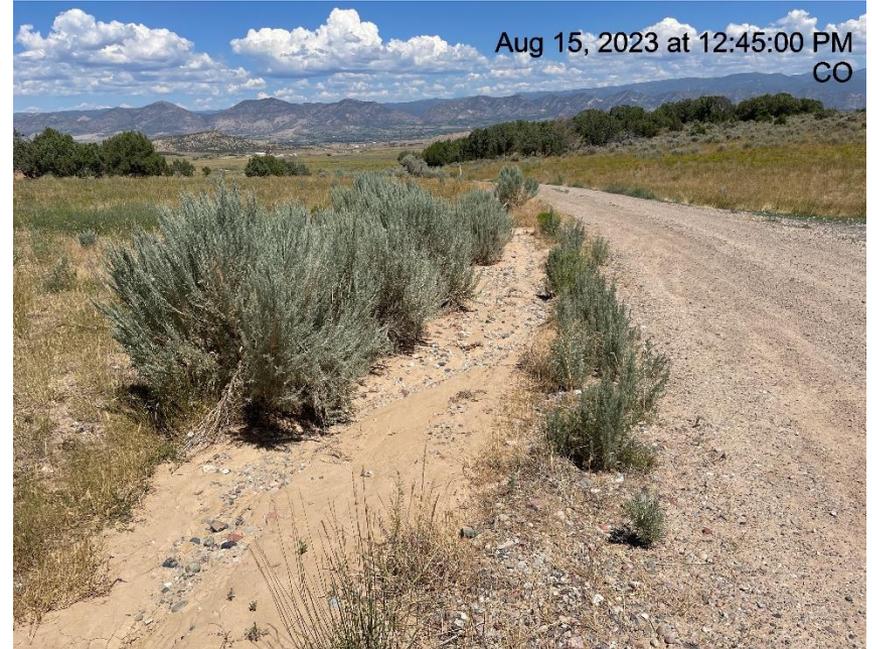
Photo # 5990 Ditch needs maintenance (west side of road just after you turn onto spur road, near aluminum shed & grain bins)

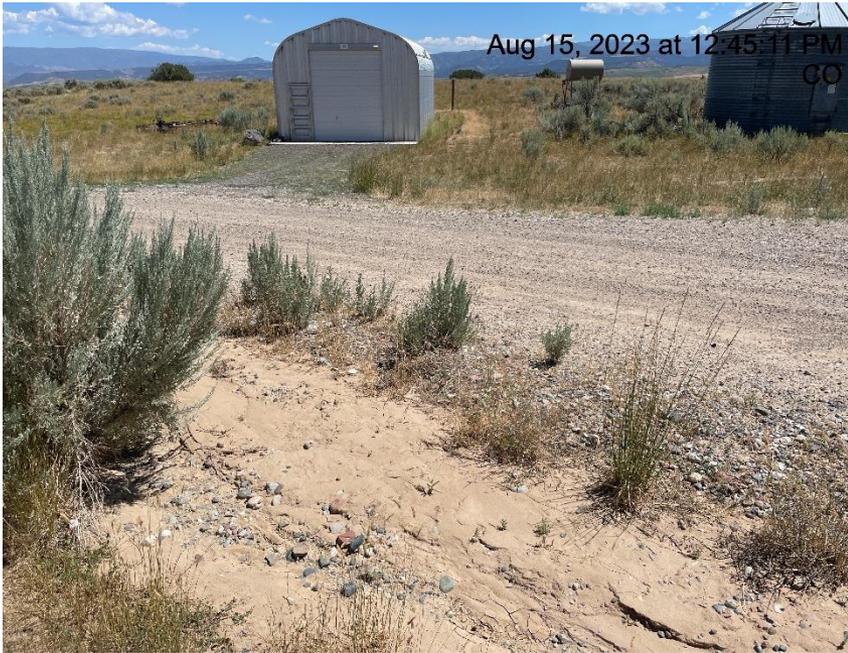
Photo # 5991 Ditch needs maintenance (west side of road just after you turn onto spur road, near aluminum shed & grain bins)

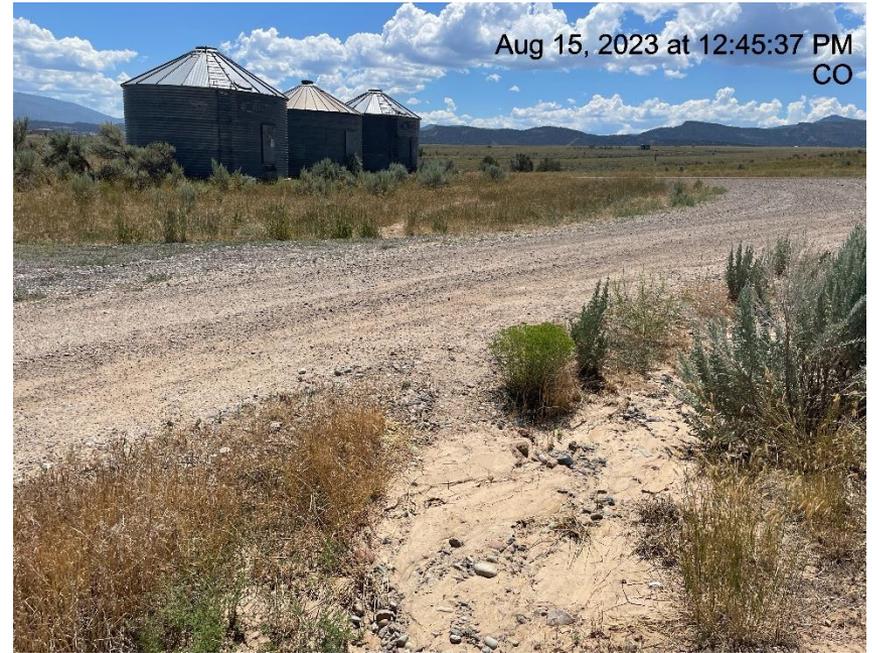
Photo # 5992 Ditch needs maintenance (west side of road just after you turn onto spur road, near aluminum shed & grain bins)
