**KT Resources LLC
WRD Wyatt 25-33
Loc ID: 316252**

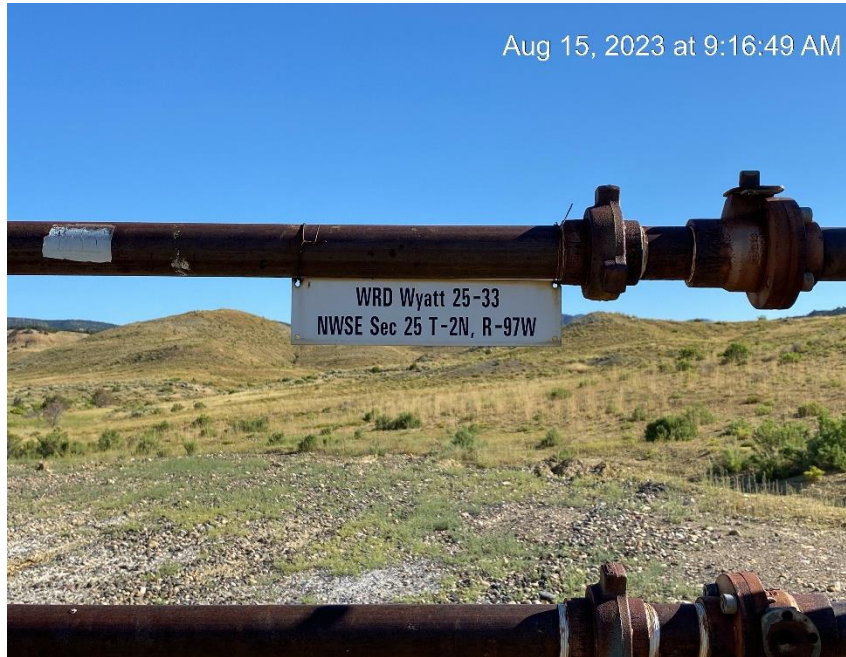
Additional information required when replaced

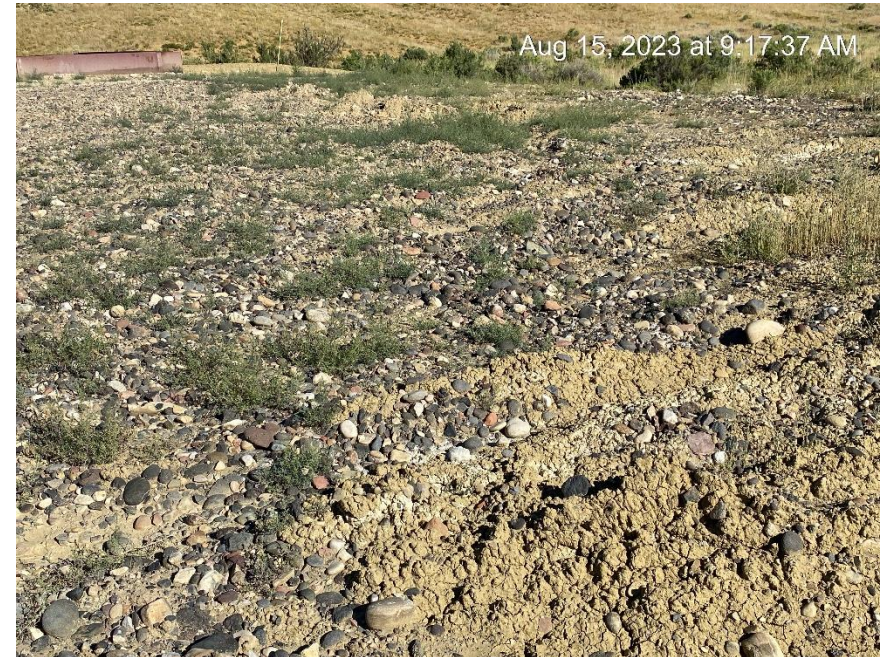
Weeds

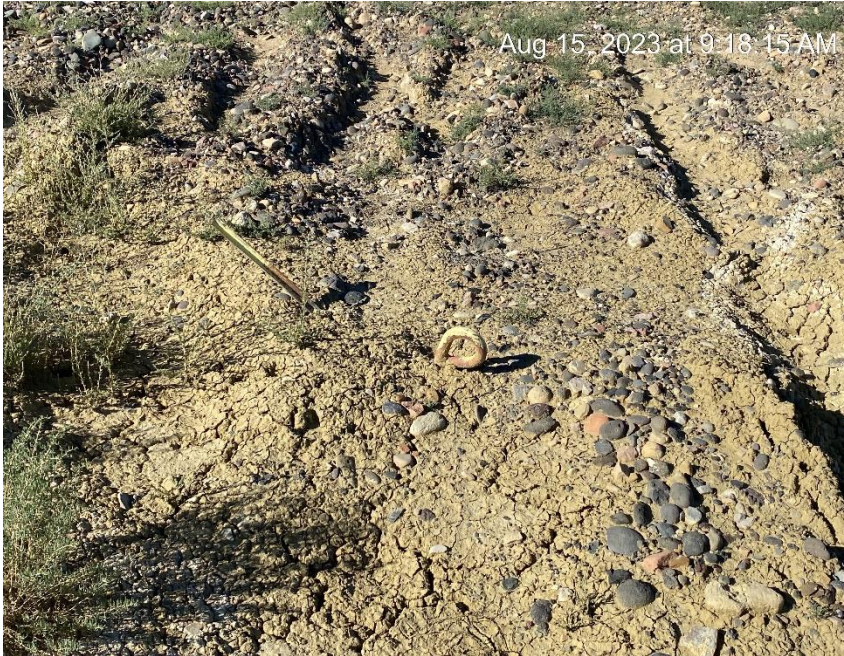
Unmarked anchor

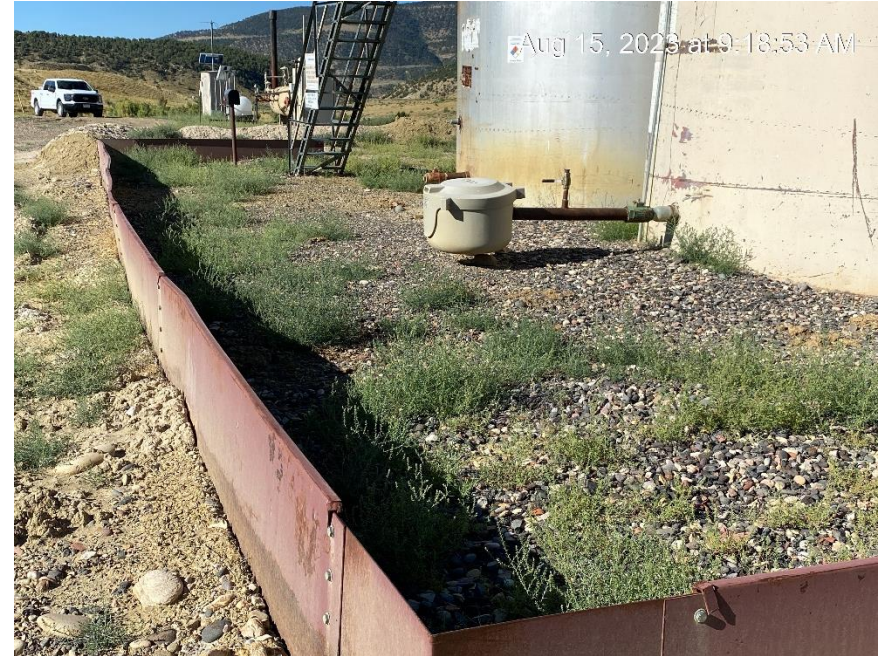
Weeds

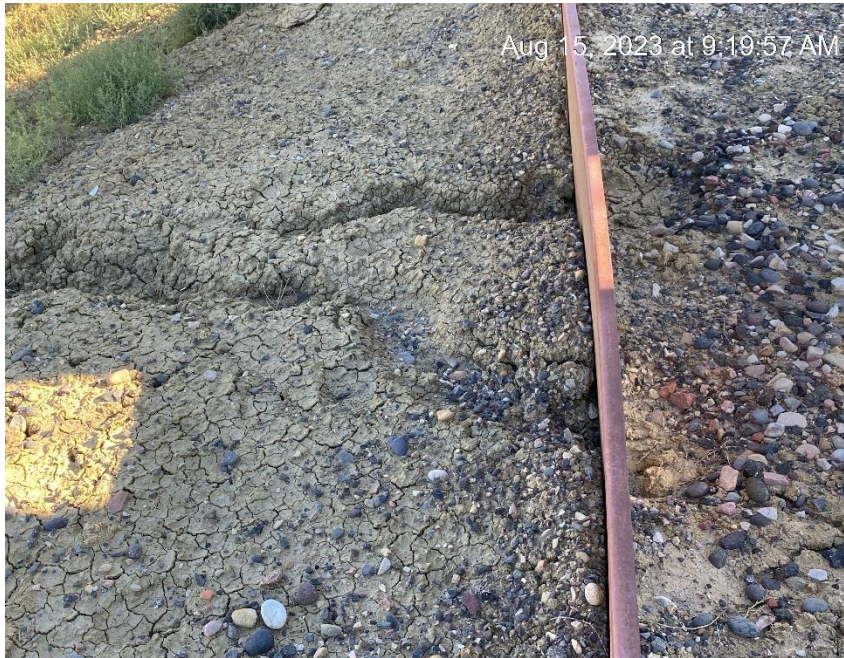
Tank berm failure

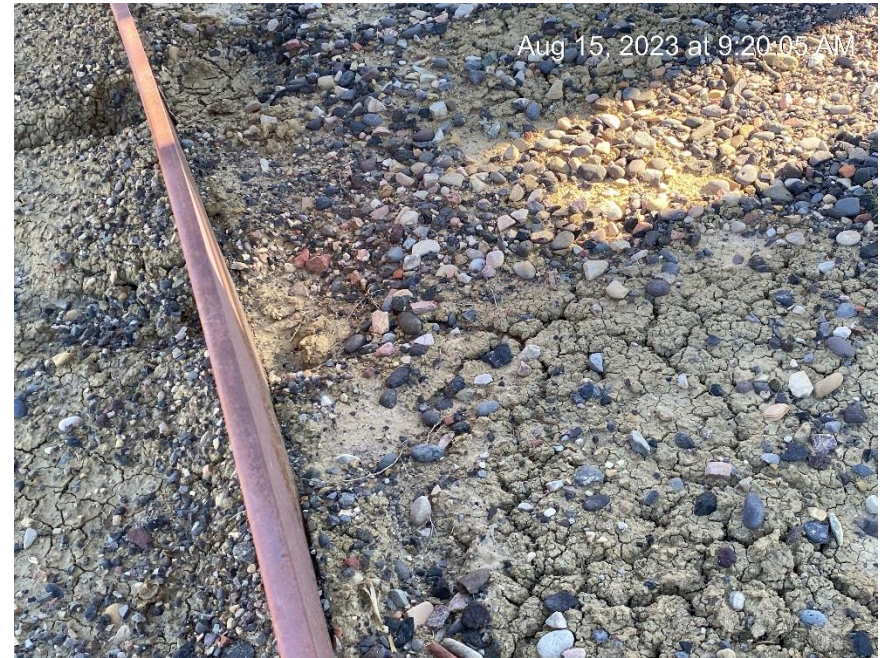
Tank berm failure

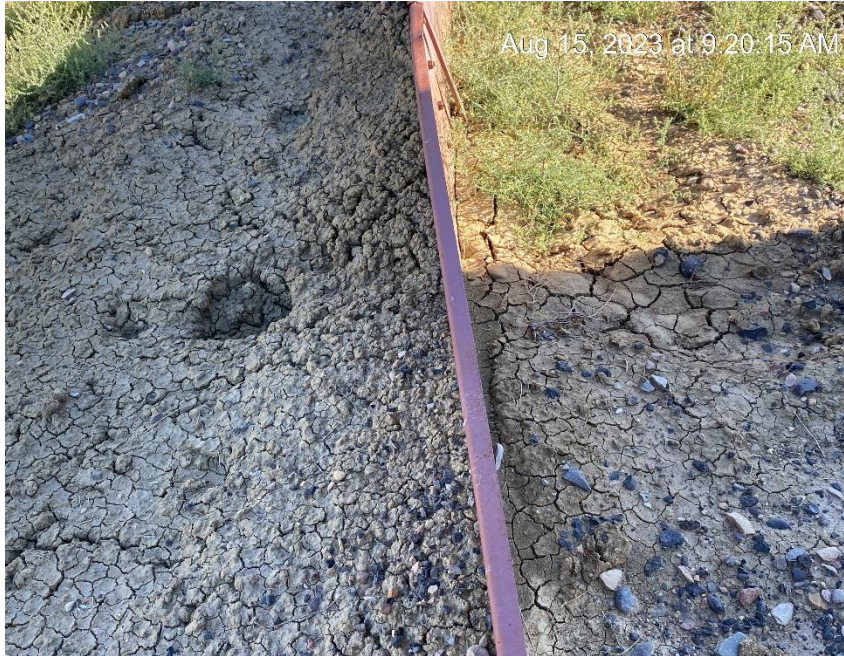
Tank berm failure

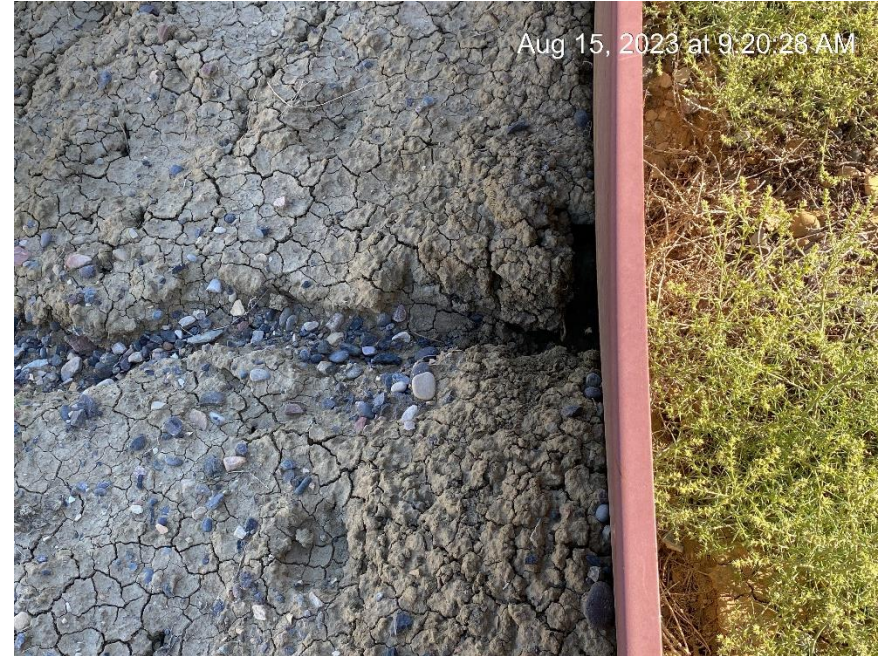
Tank berm failure

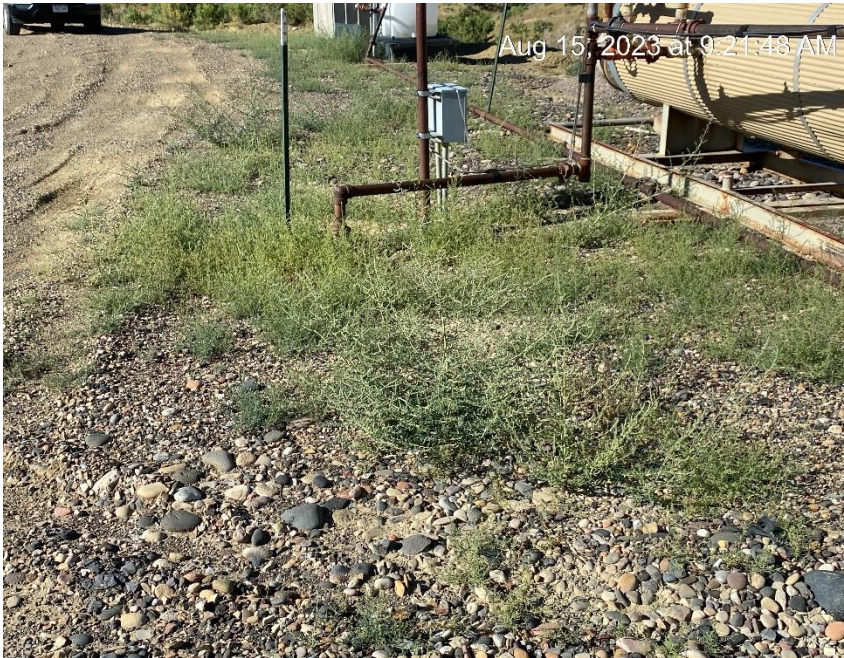
Weeds

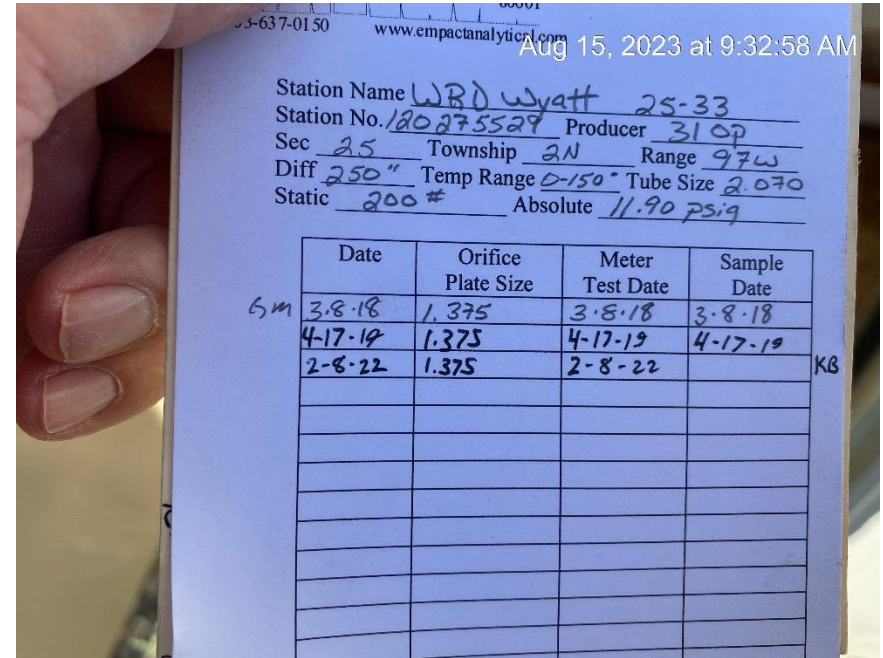
Calibration overdue

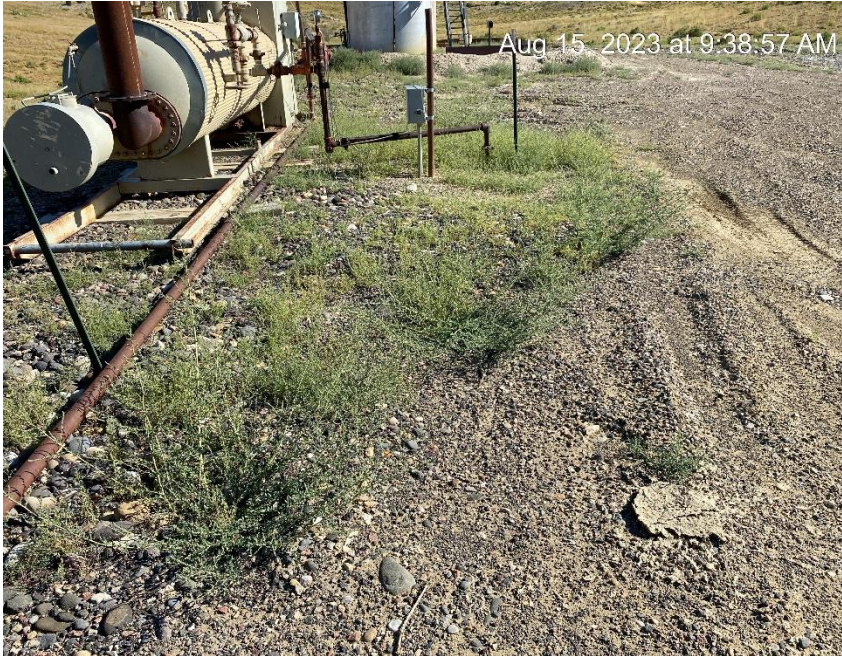
Weeds

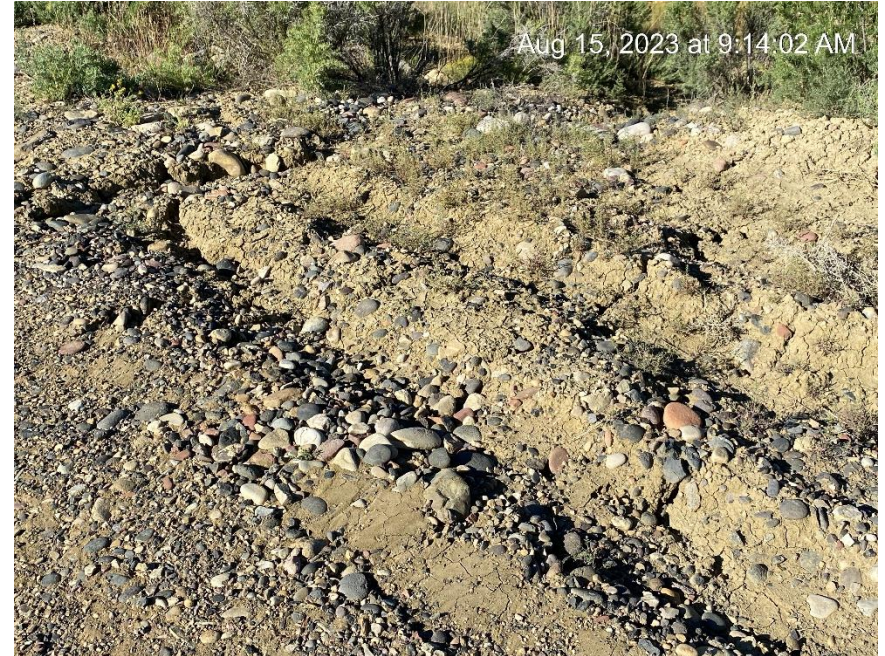
Lack of Stormwater BMPs

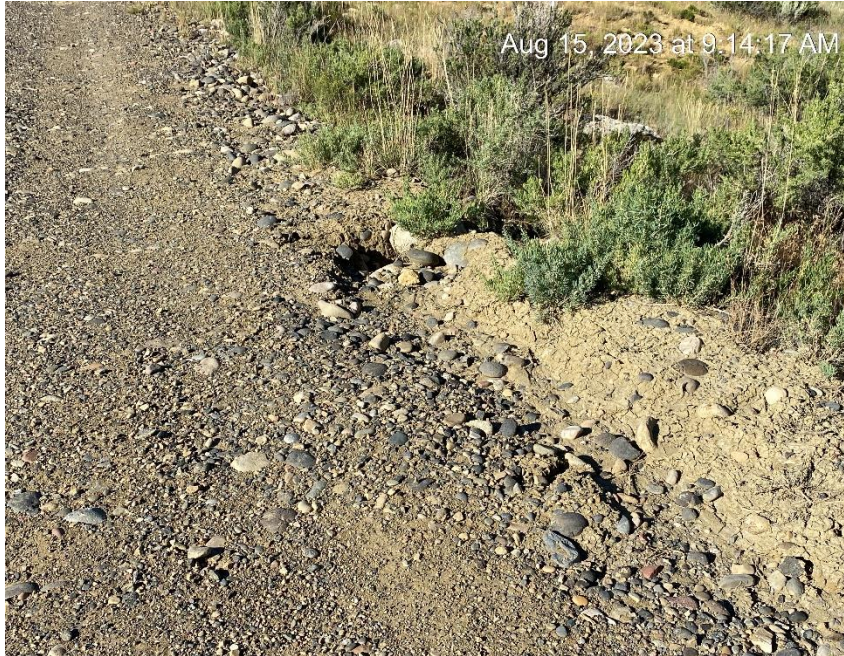
Lack of Stormwater BMPs

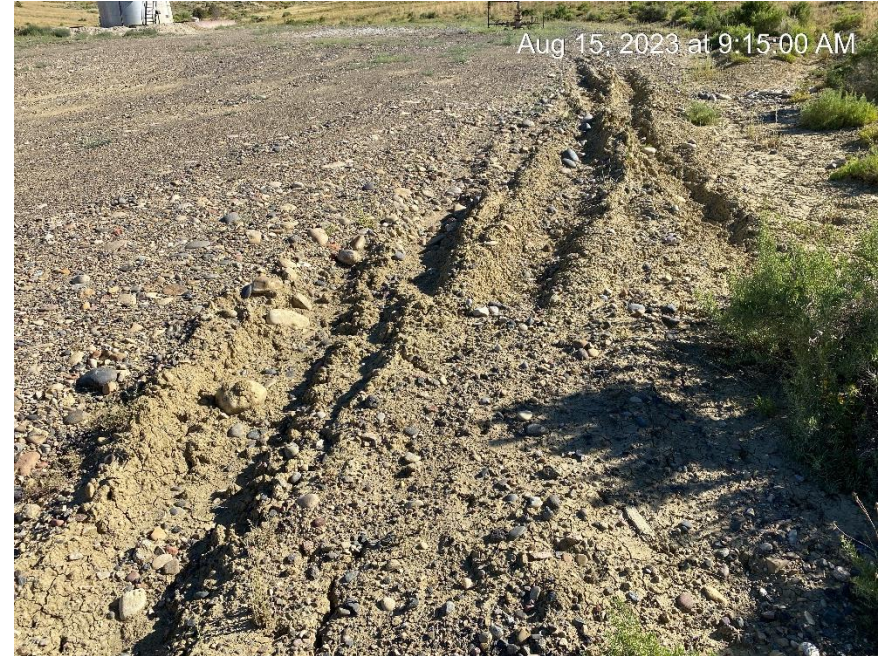
Lack of Stormwater BMPs

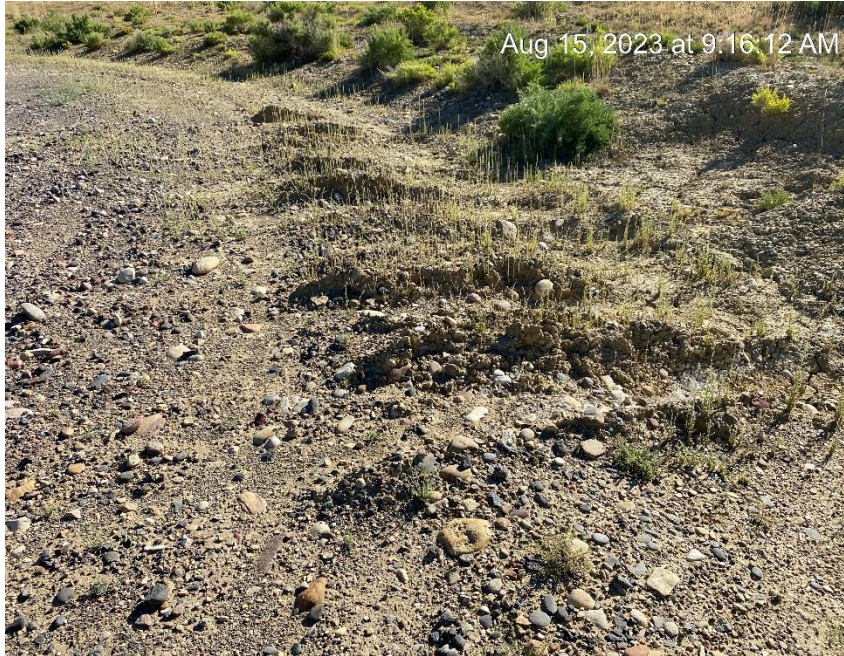
Lack of Stormwater BMPs

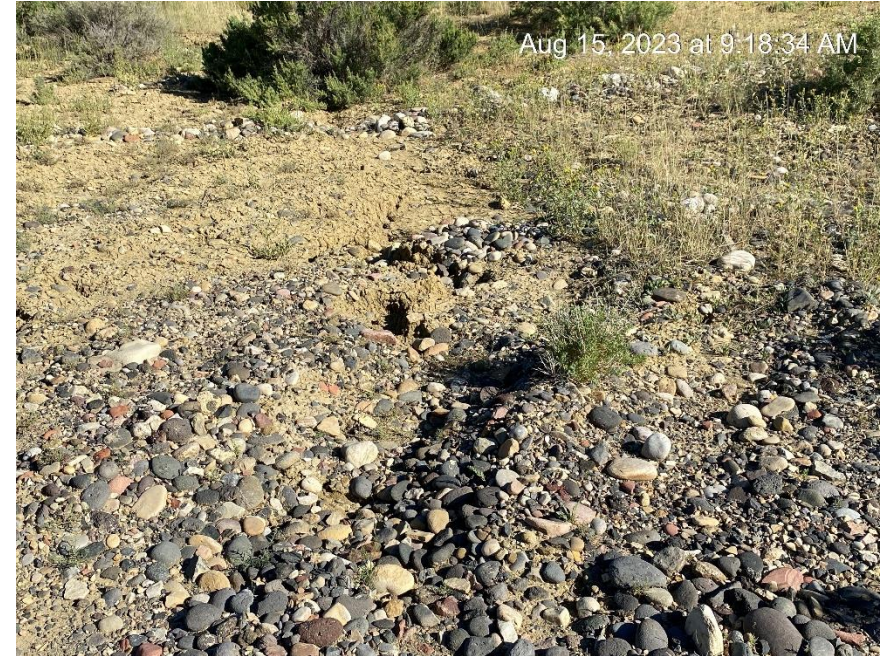
Lack of Stormwater BMPs

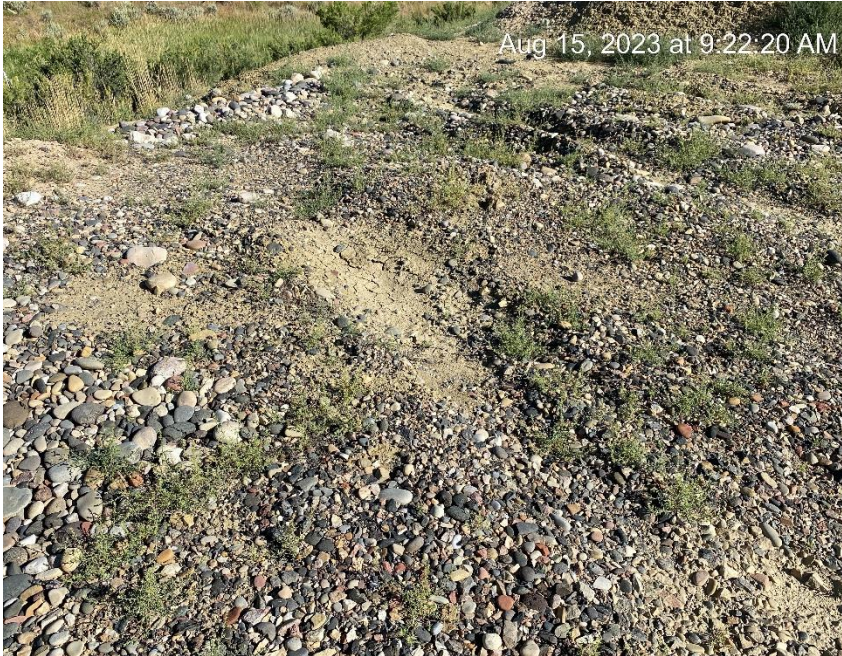
Lack of Stormwater BMPs

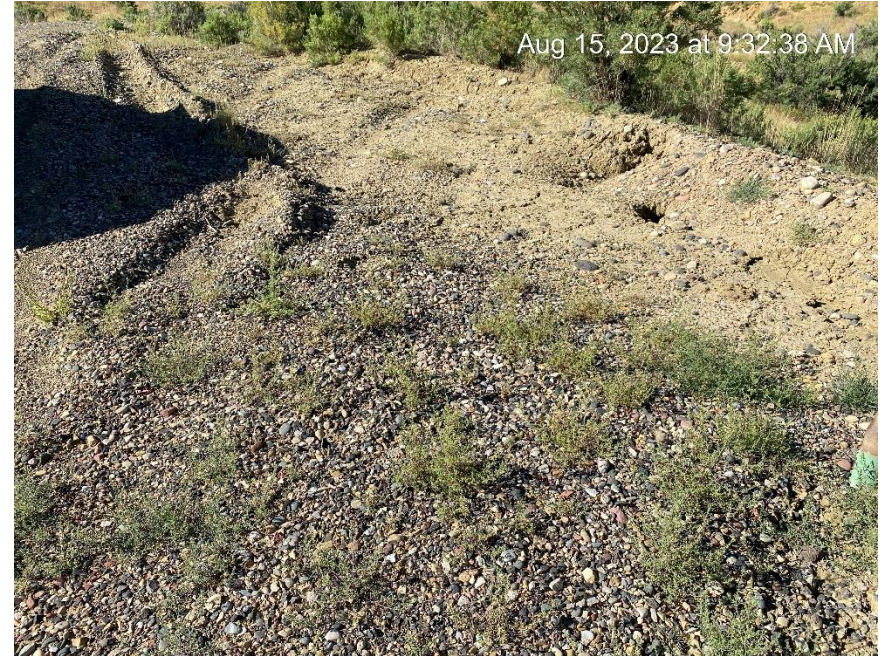
Lack of Stormwater BMPs
