KT Resources LLC
WRD Wyatt 25-44 & 25-44W
Loc ID: 336393

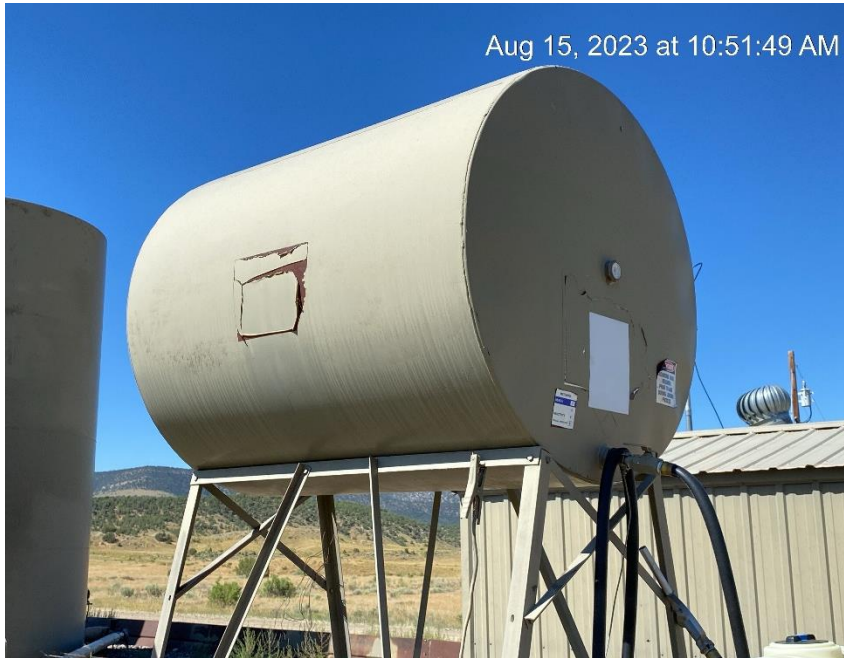
Lack of labeling

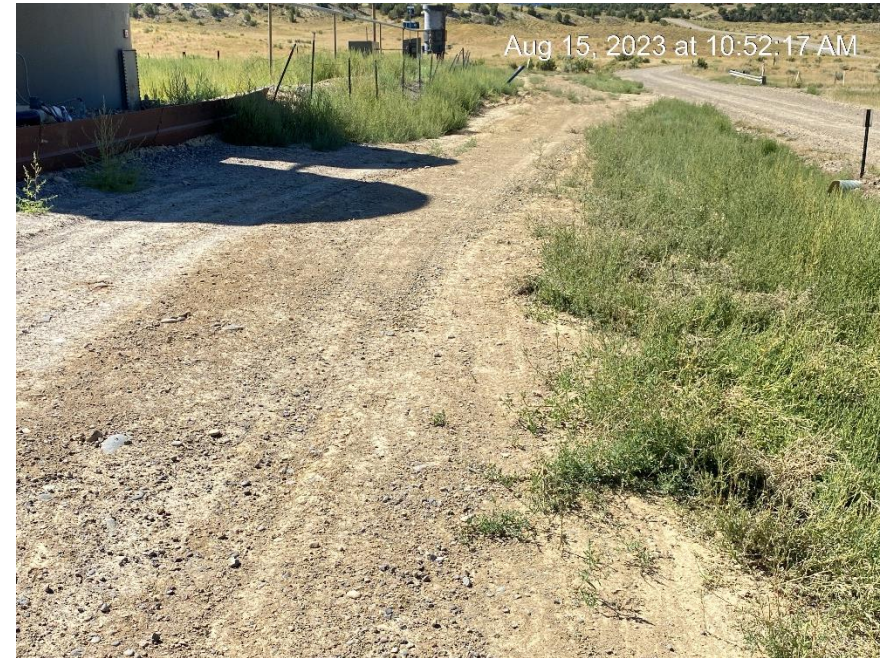
Weeds

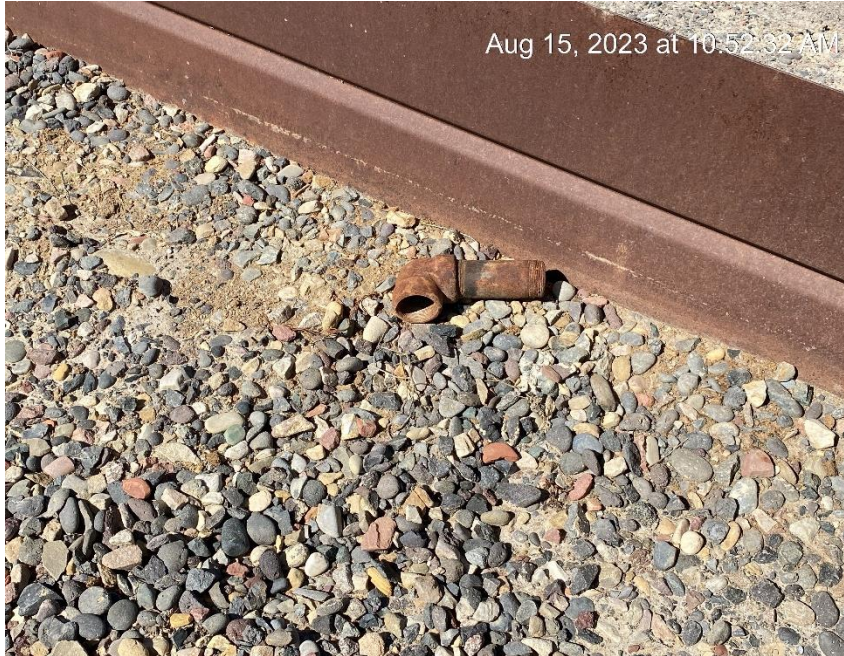
Debris

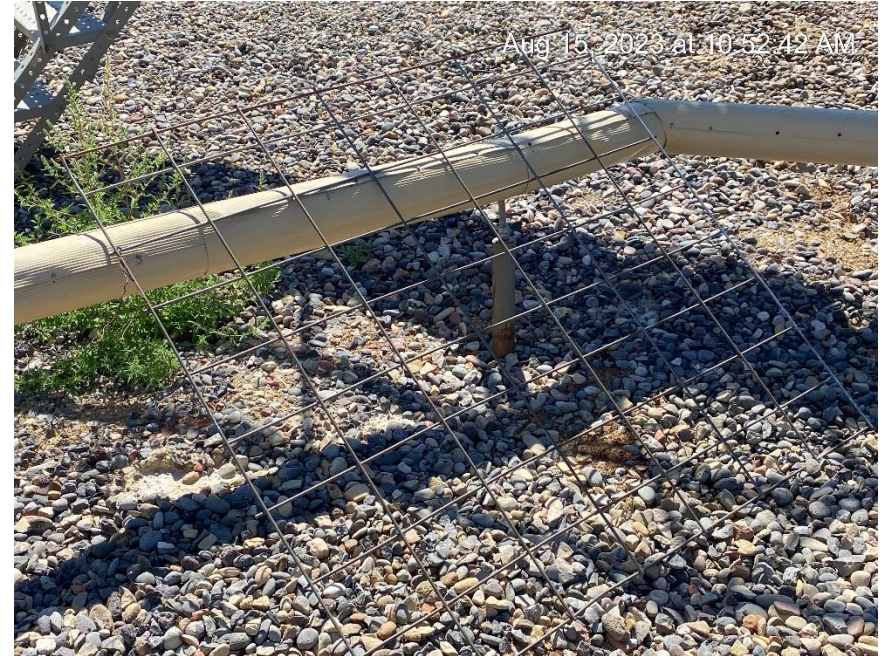
Debris

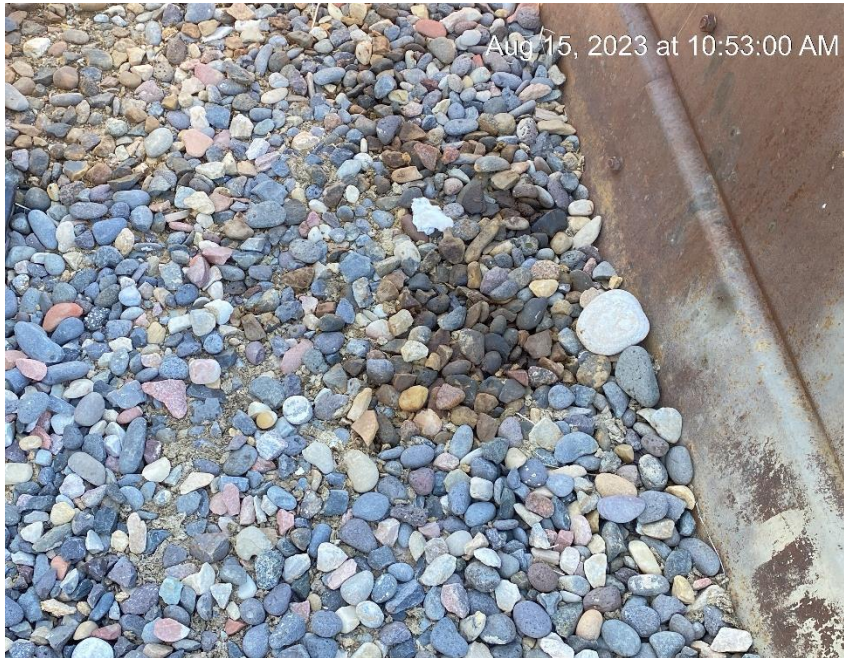
Stained soil

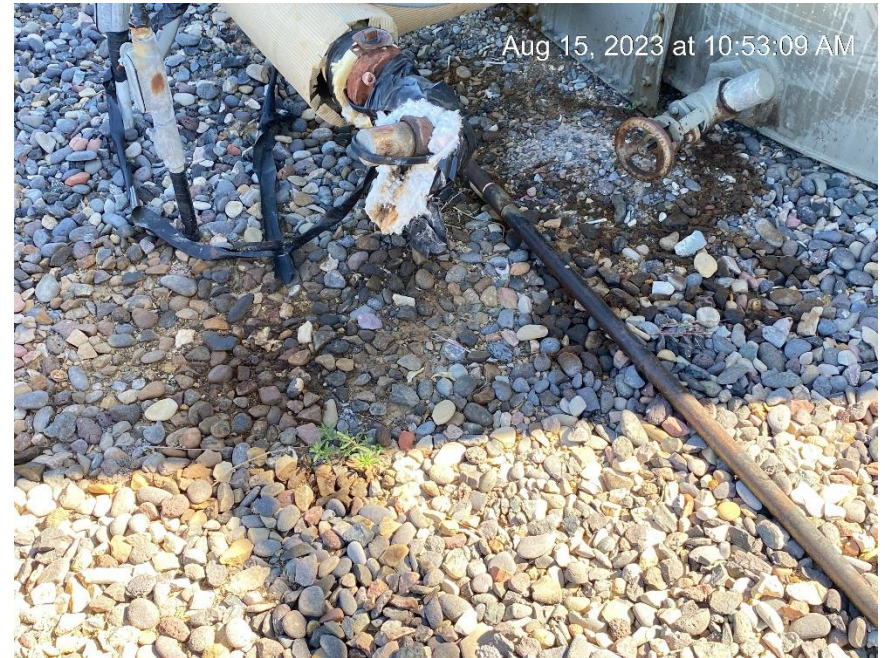
Stained soil

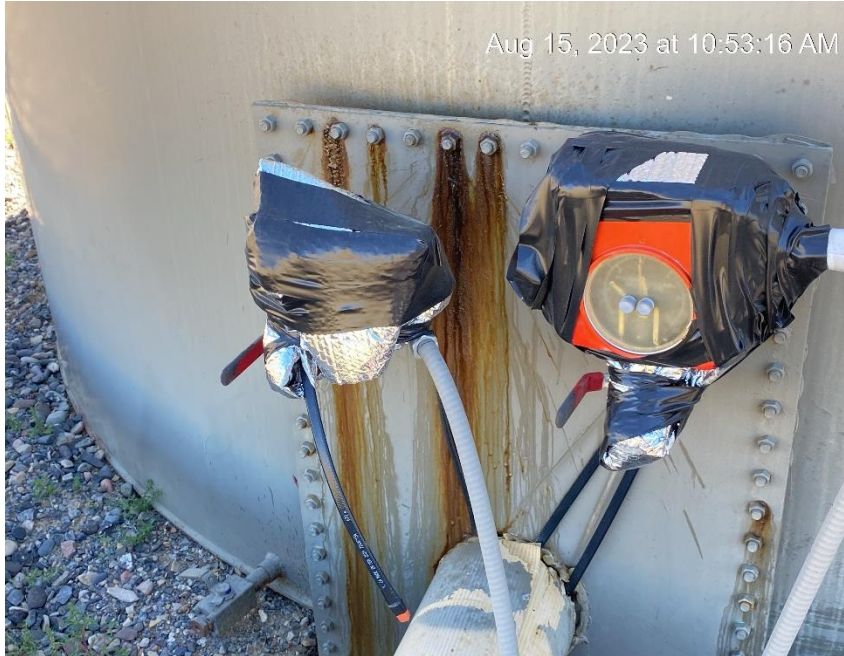
Equipment leak

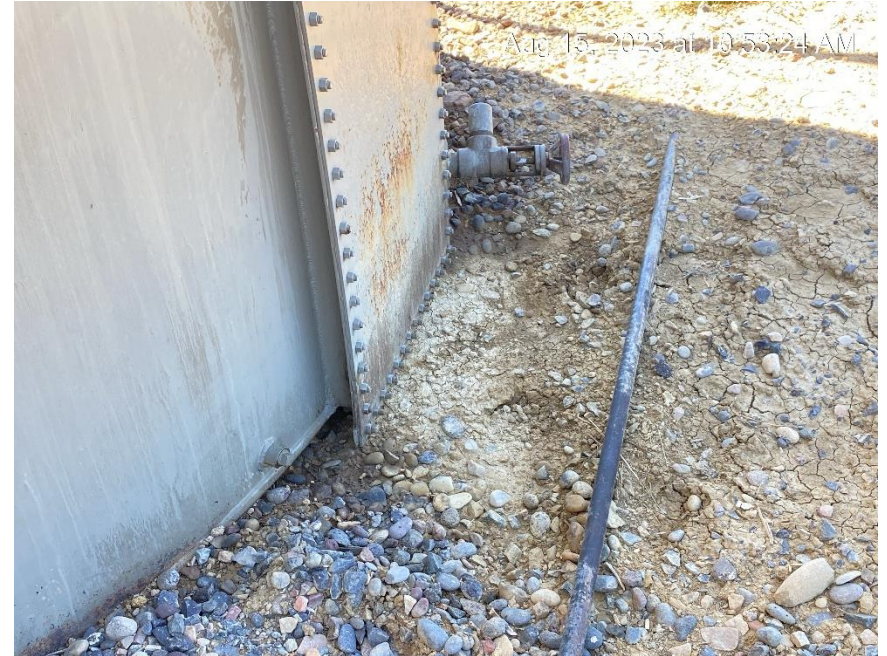
Stained soil

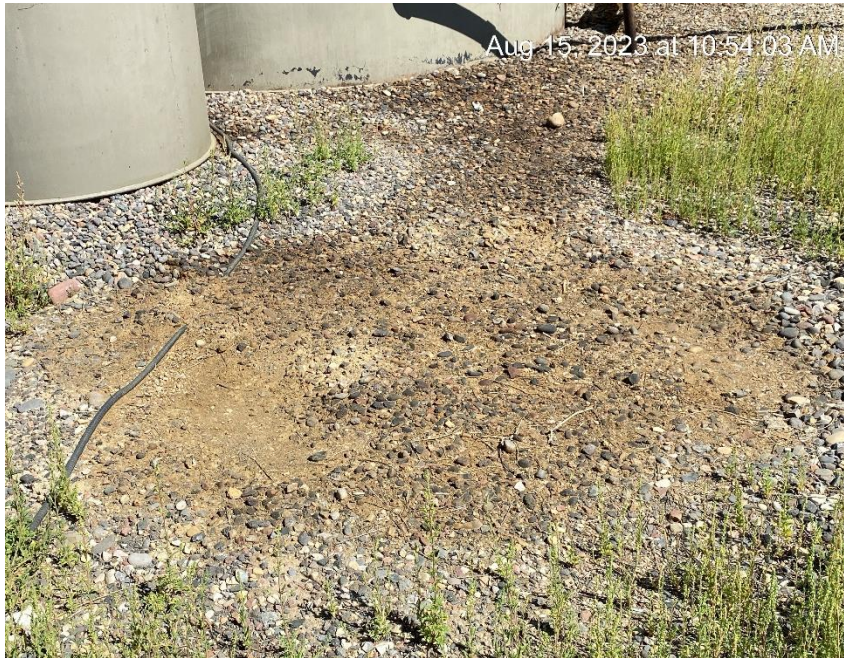
Stained soil

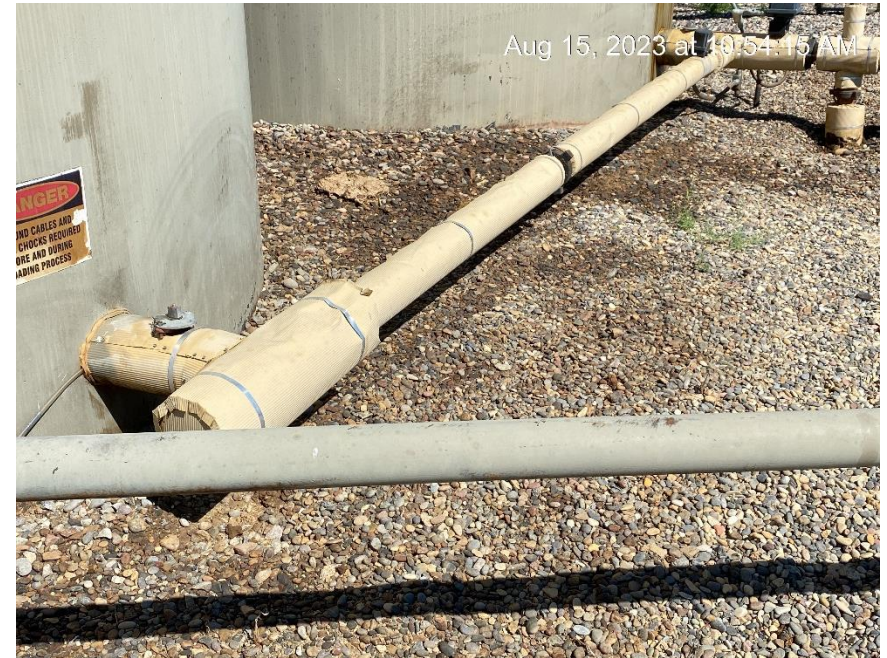
Stained soil

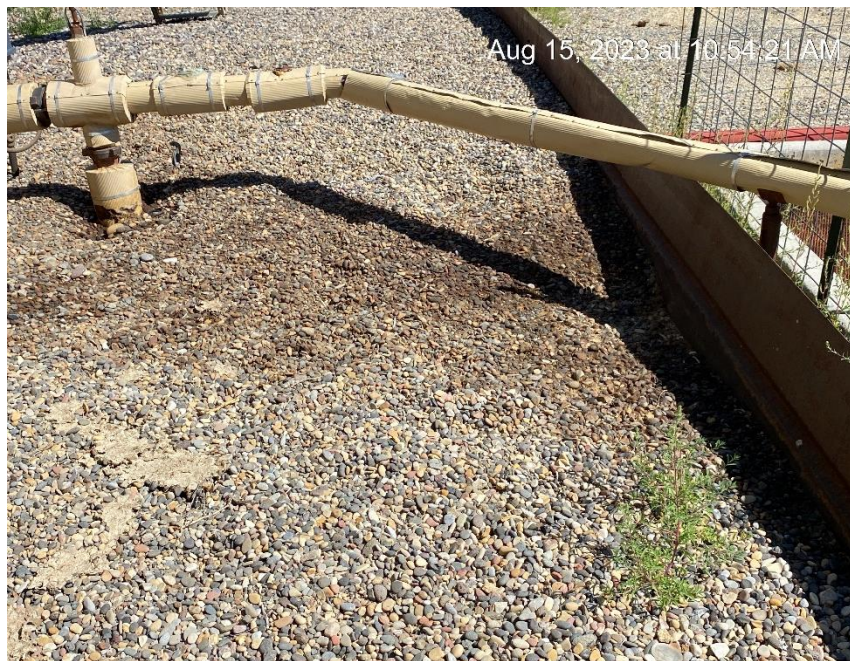
Stained soil

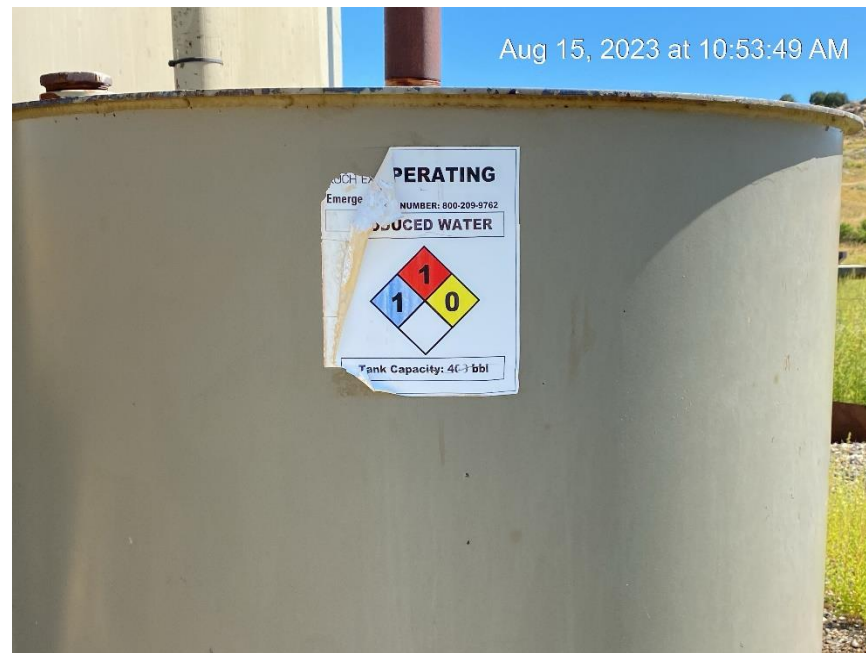
Peeling tank label

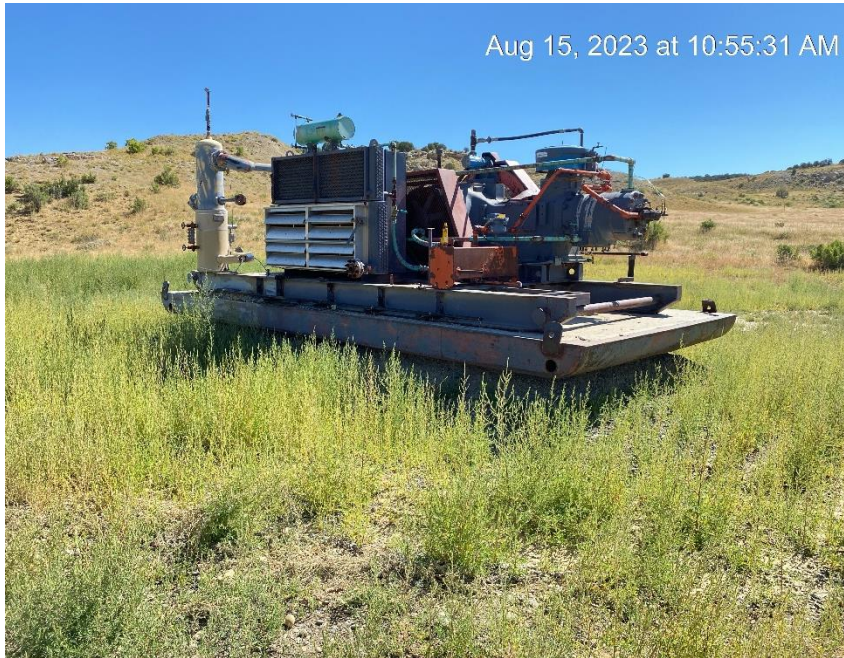
Unused equipment

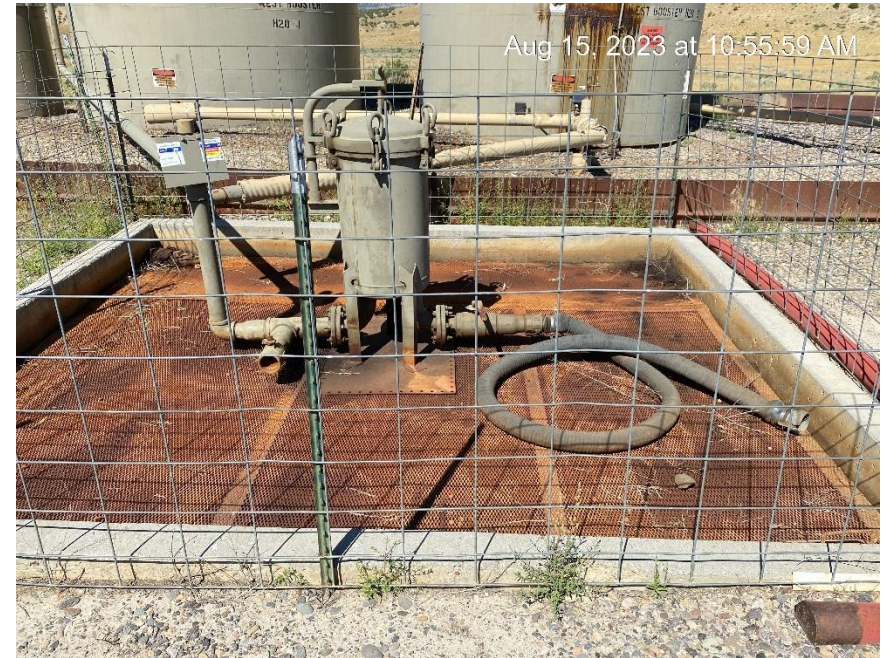
Unused equipment

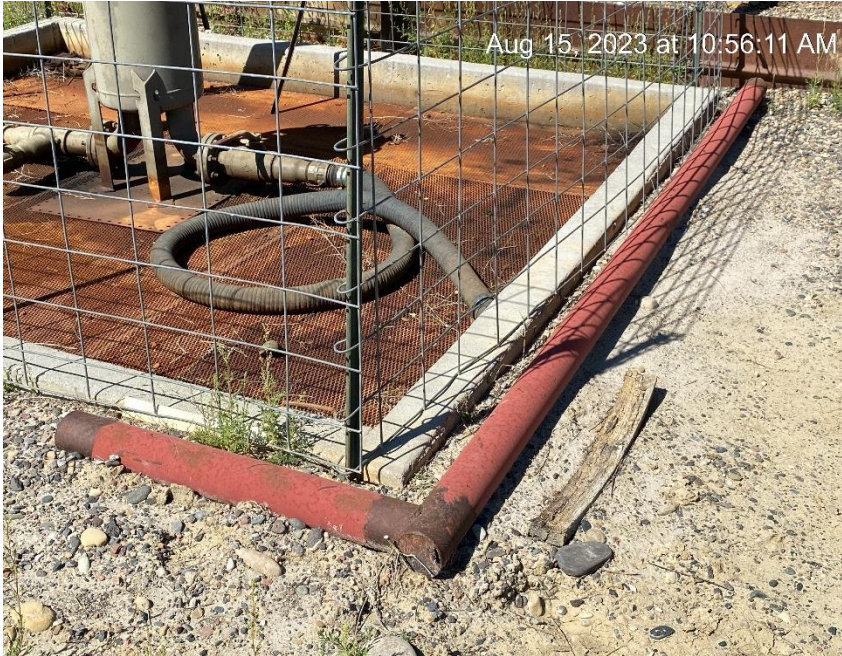
Debris

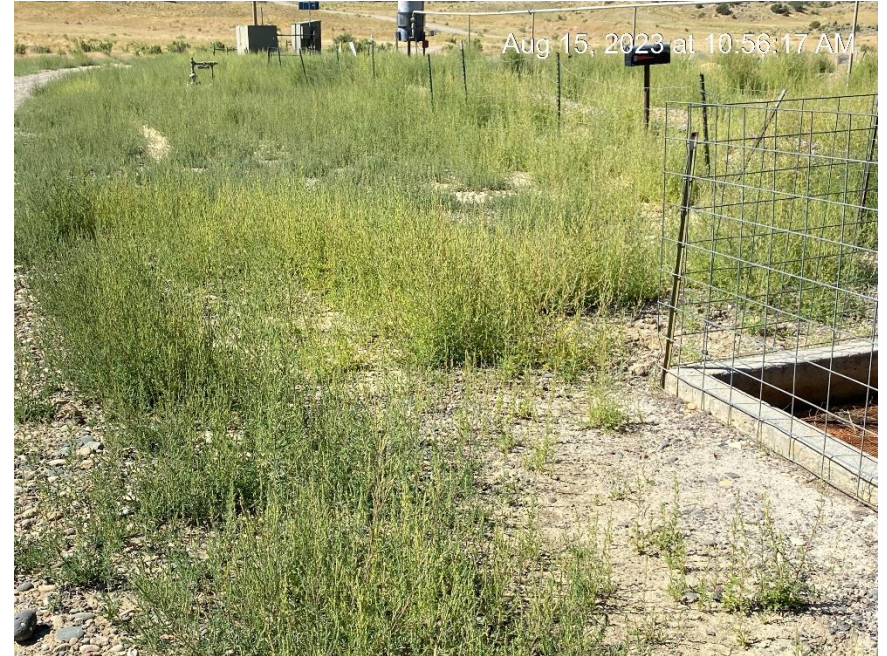
Weeds

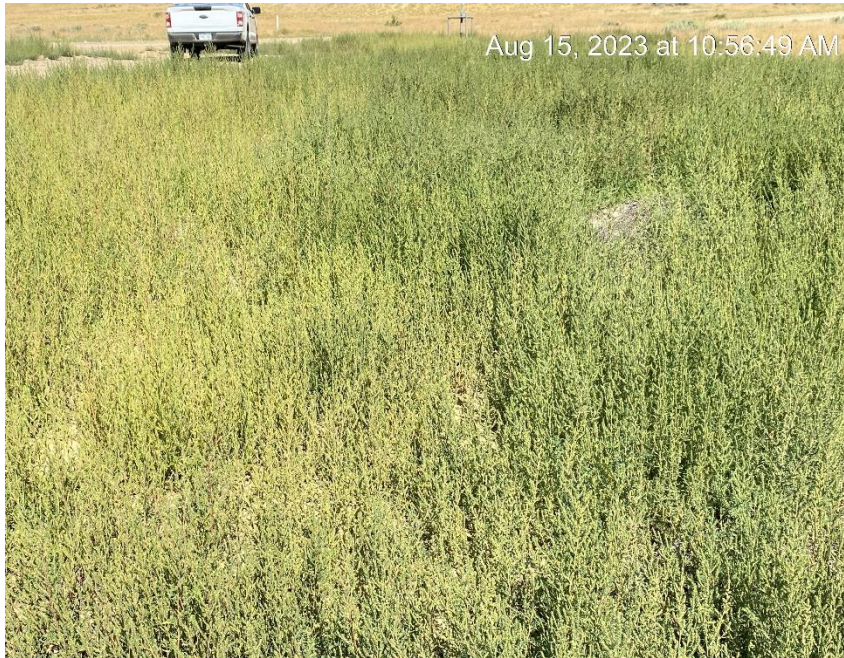
Weeds

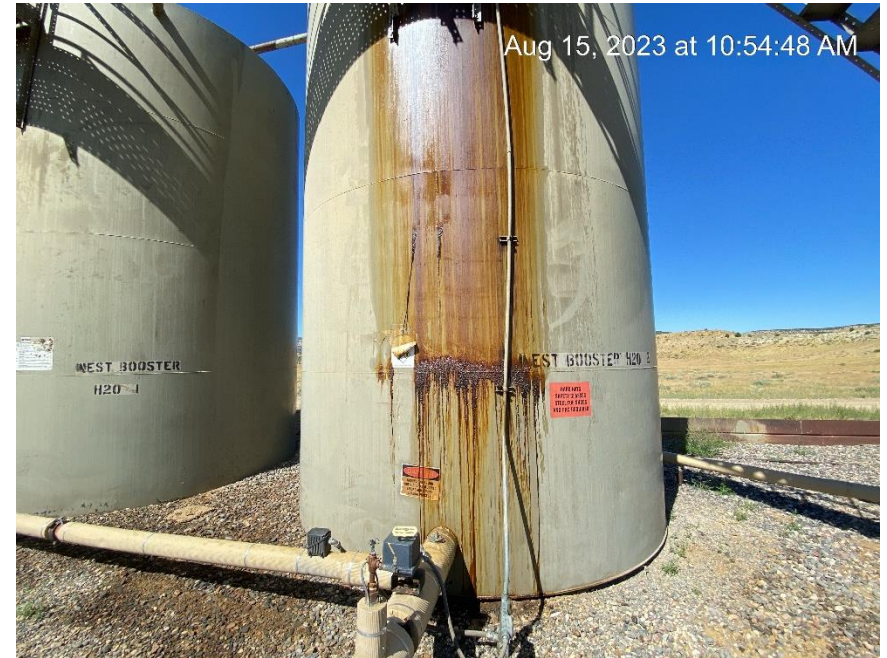
Oily waste. Peeling tank label

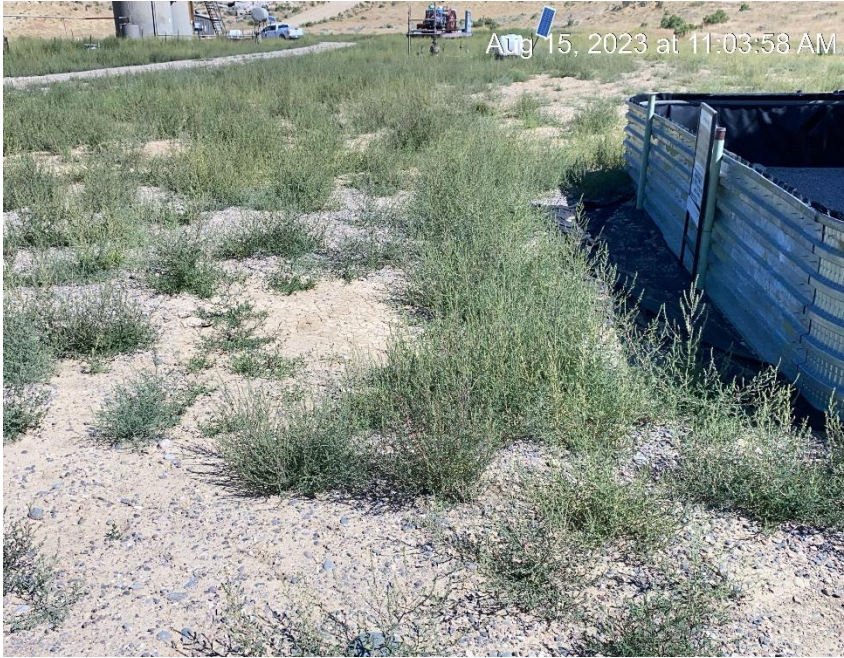
Weeds

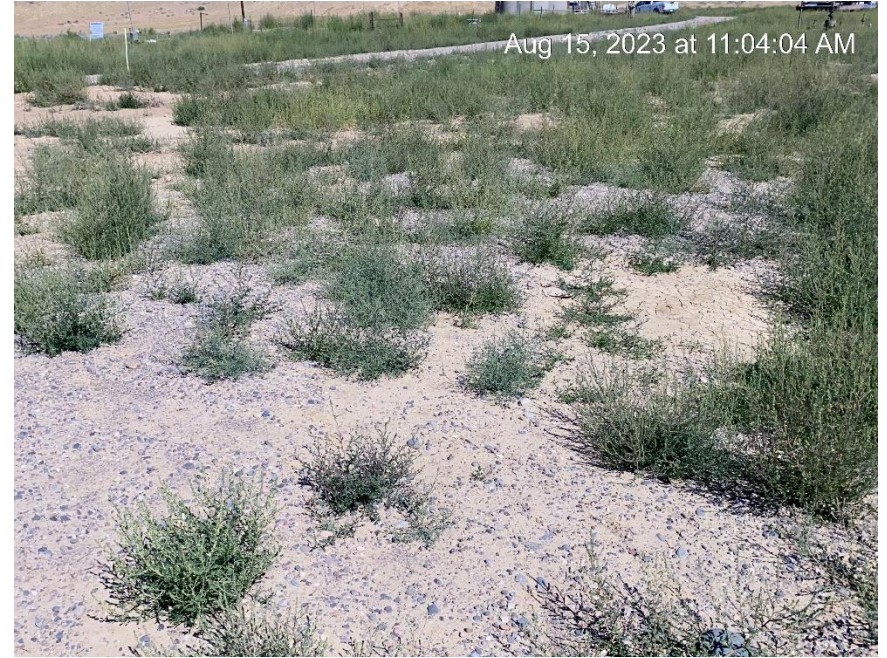
Weeds

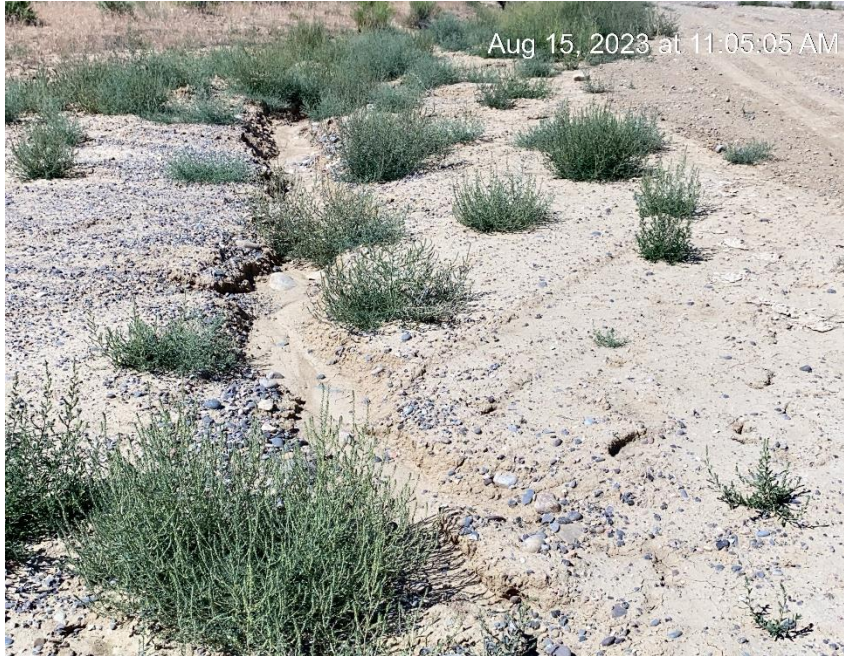
Weeds. Lack of stormwater BMPs.

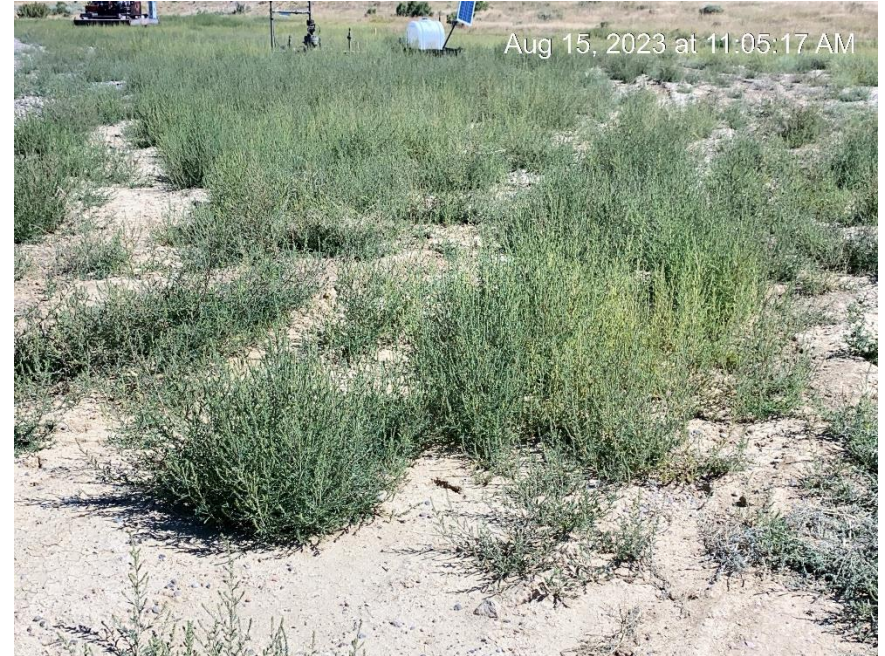
Weeds

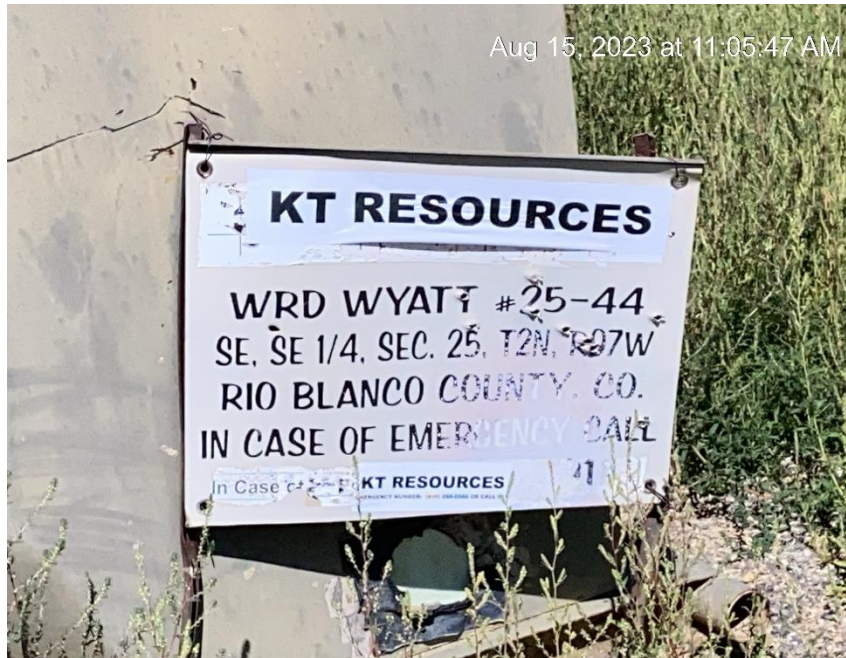
Location entrance sign lacking required information and at separator.

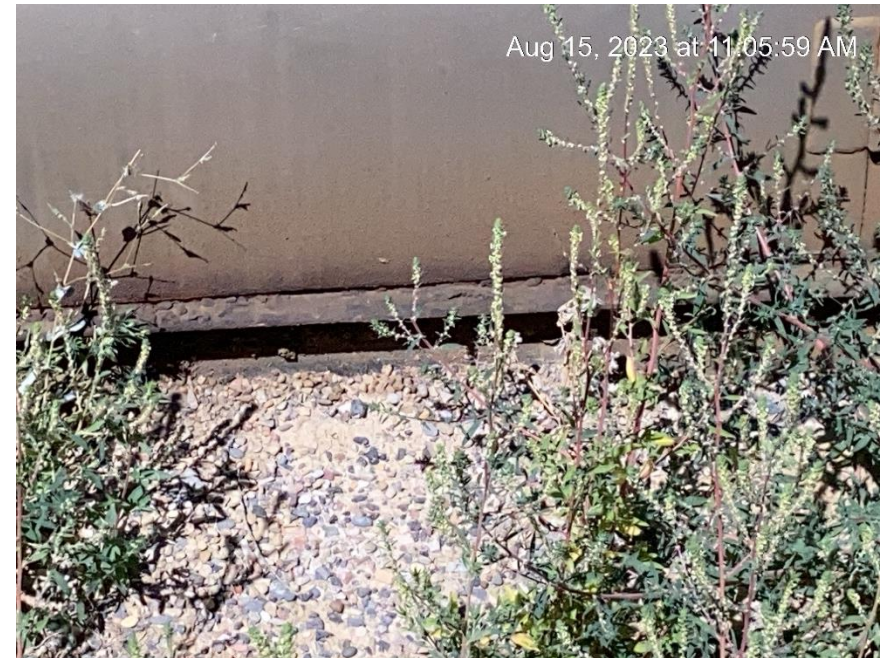
Oily waste and stained soil

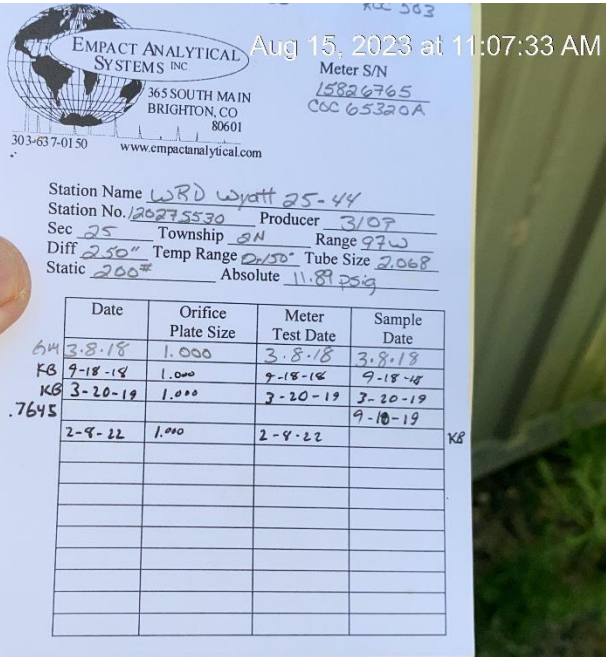
Calibration overdue

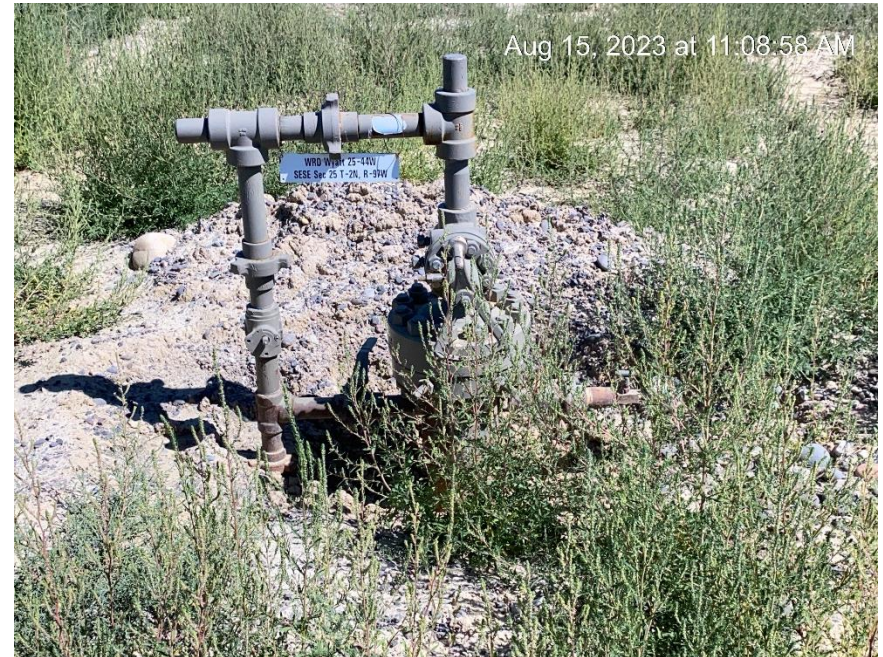
Missing required information on well sign

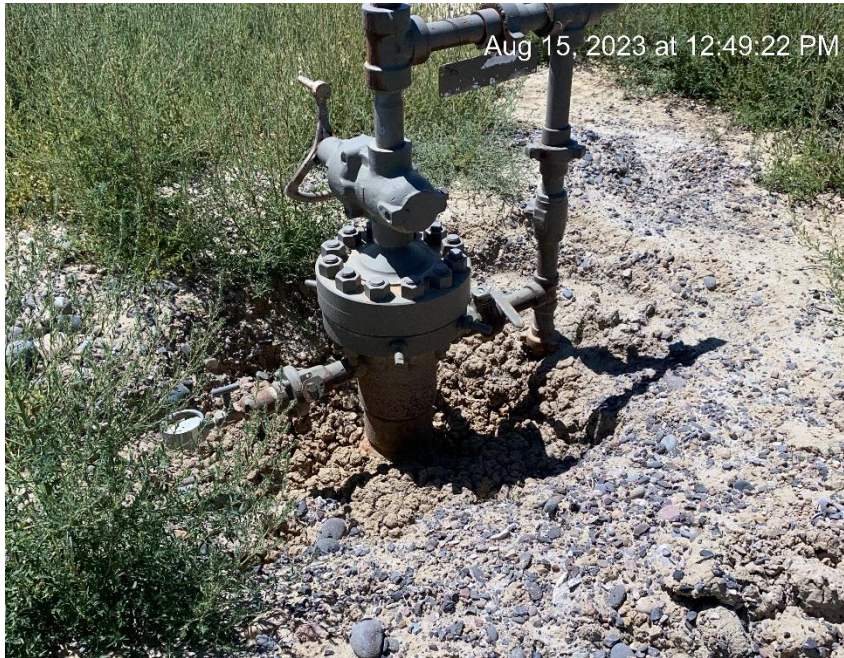
No Bradenhead access

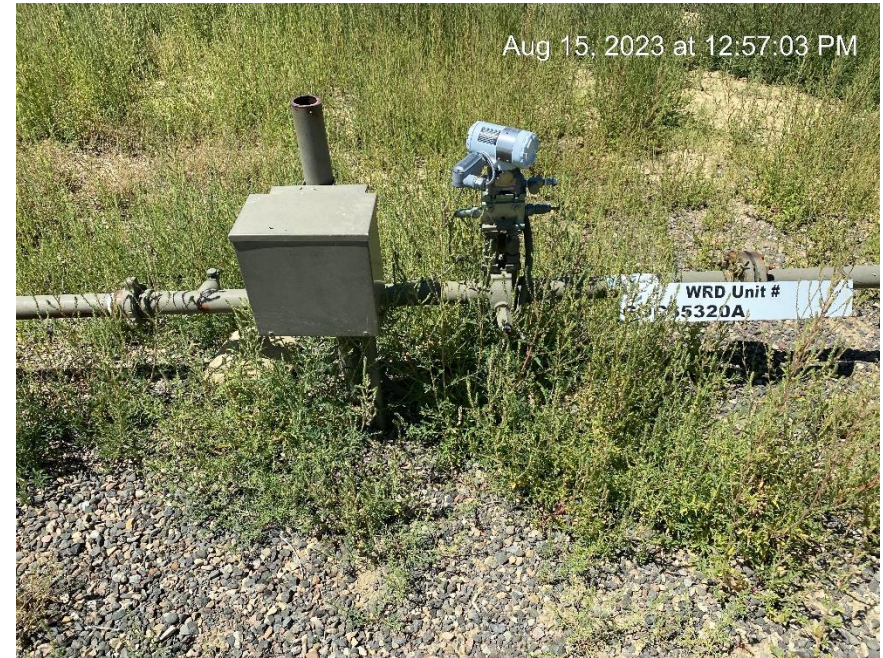
No visible display of gas calibration
