Inspection Photos

Location Name: Wayne/5N64W22 1-10

Location ID: 329128

COLORADO
Energy & Carbon Management
Commission

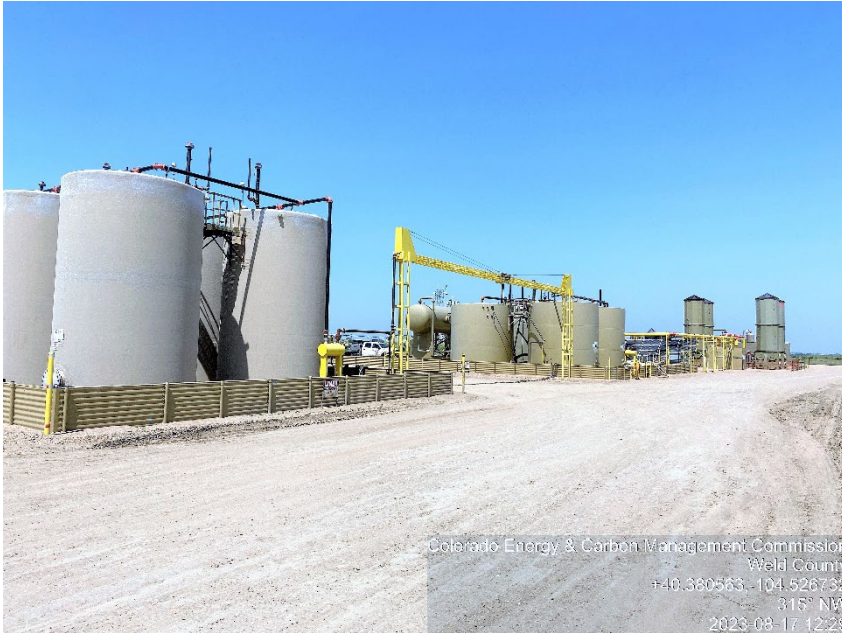
Photo #1

Wayne/5N64W22 1-10 pad

Battery site

Active

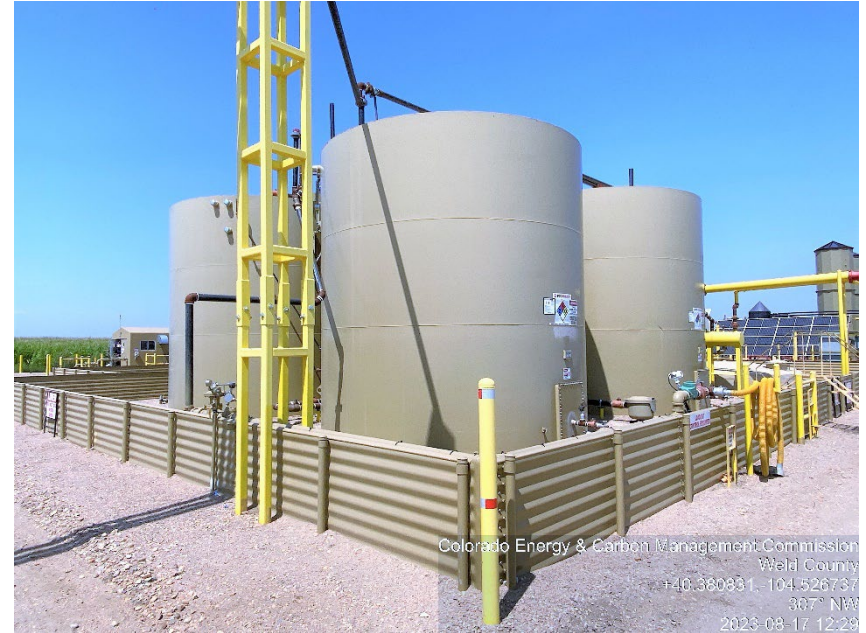
Photo #2

Wayne/5N64W22 1-10 pad

Battery site

Active

Crude oil tank(s): SE corner

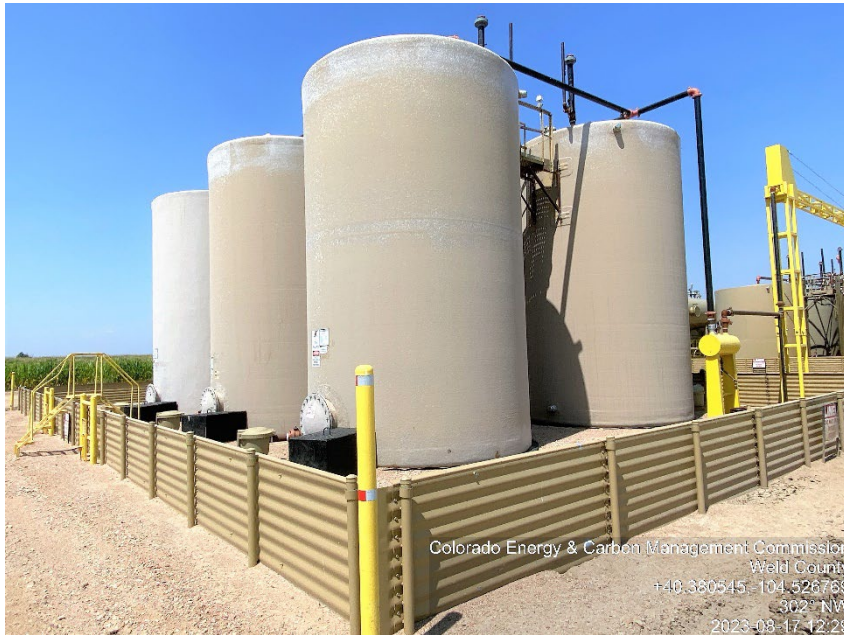
Photo #3

Wayne/5N64W22 1-10 pad

Battery site

Active

Produced H₂O tank(s): SE corner

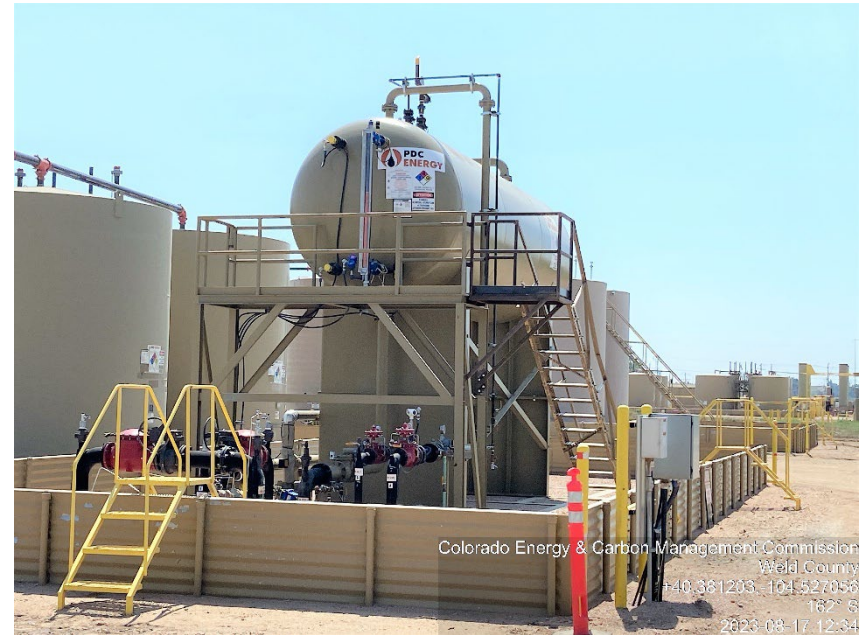
Photo #4

Wayne/5N64W22 1-10 pad

Battery site

Active

Flow through surge tank

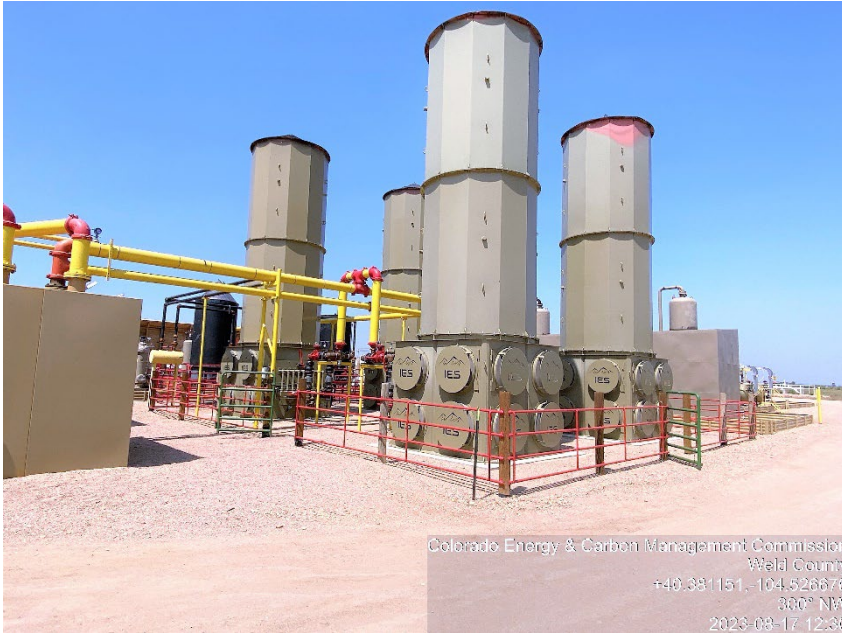
Photo #5

Wayne/5N64W22 1-10 pad

Battery site

Active

ECD(s)

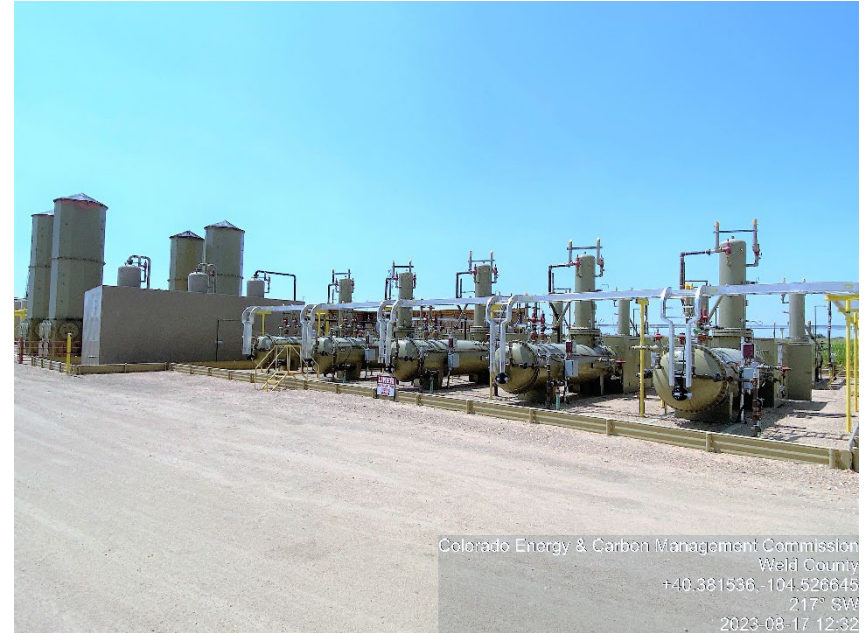
Photo #6

Wayne/5N64W22 1-10 pad

Battery site

Active

Separator(s)

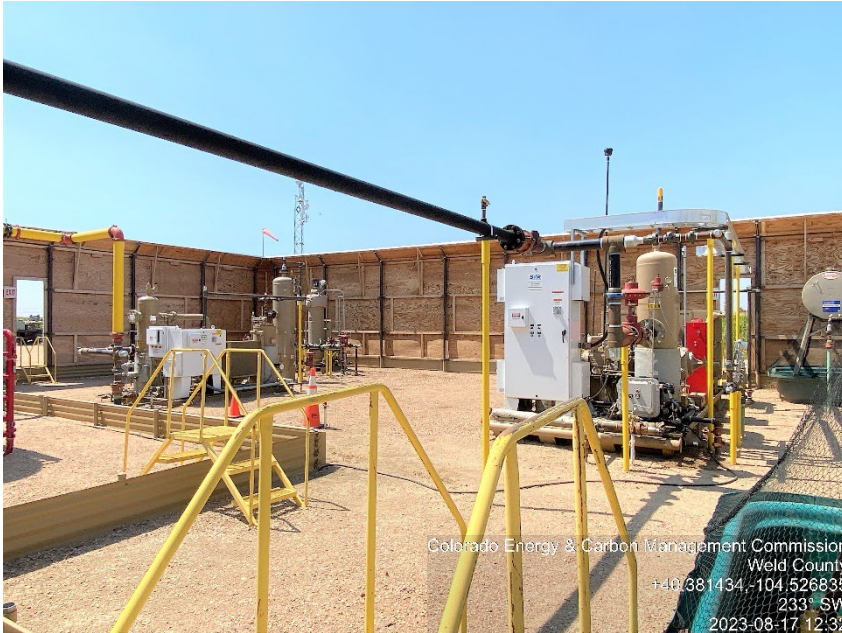
Photo #7

Wayne/5N64W22 1-10 pad

Battery site

Active

VRU, Compressor

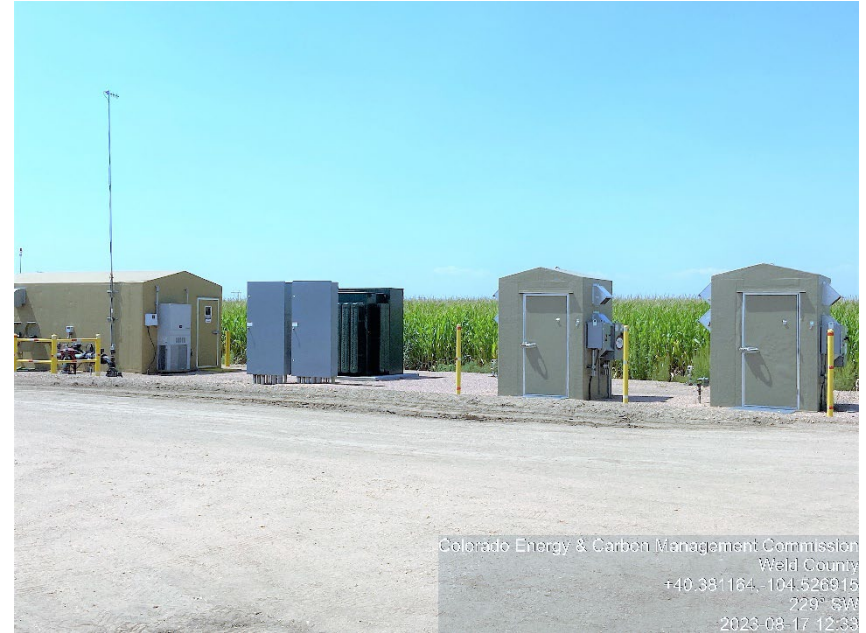
Photo #8

Wayne/5N64W22 1-10 pad

Battery site

Active

LACT, IAU(s)

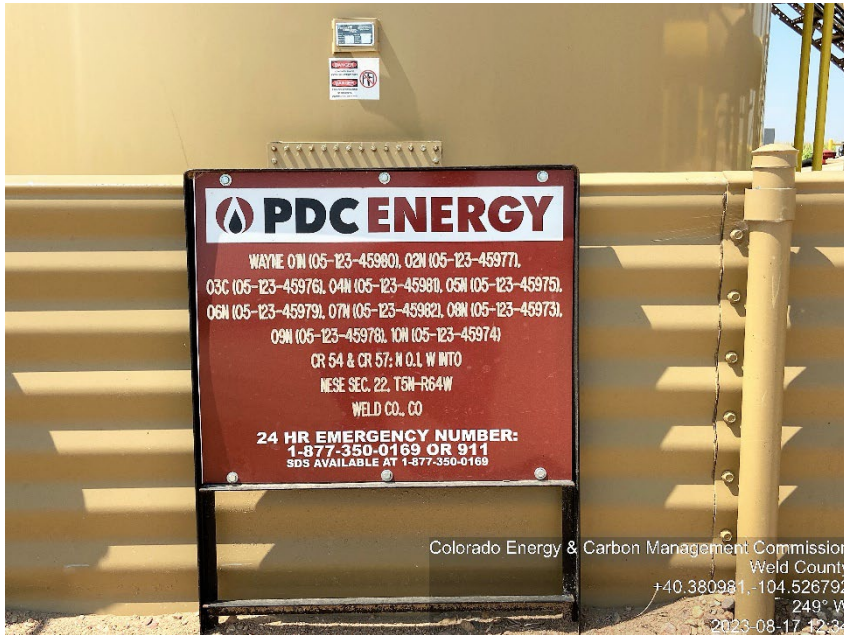
Photo #9

Wayne/5N64W22 1-10 pad

Battery site

Active

Facility / Battery sign

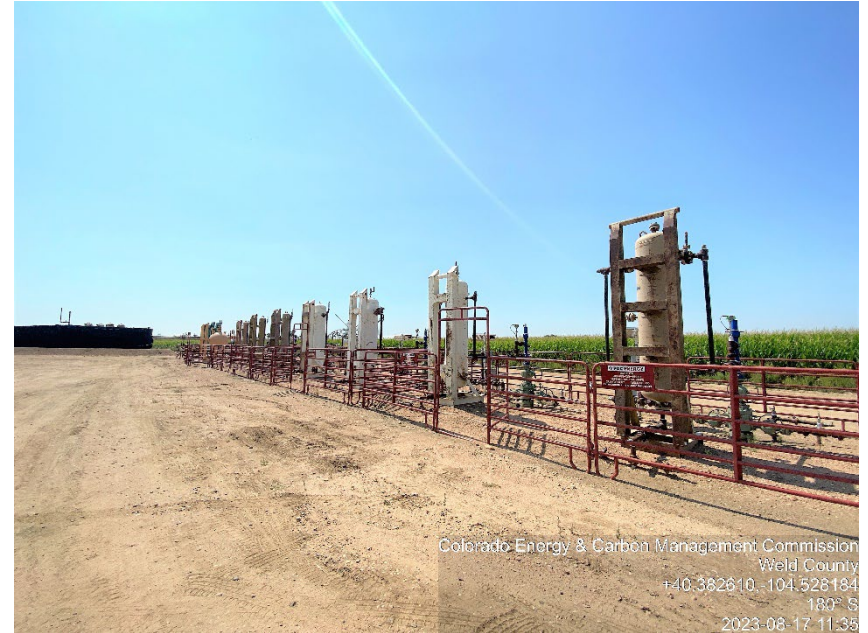
Photo #10

Wayne/5N64W22 1-10 pad

Wellsite(s): 10

Producing | PR

Well names / API: documented on FIR doc #707601687.
