# Inspection Photos

API: 071-09004

Operator: EVERGREEN NATURAL RESOURCES

Inspection Date: 8/16/2023

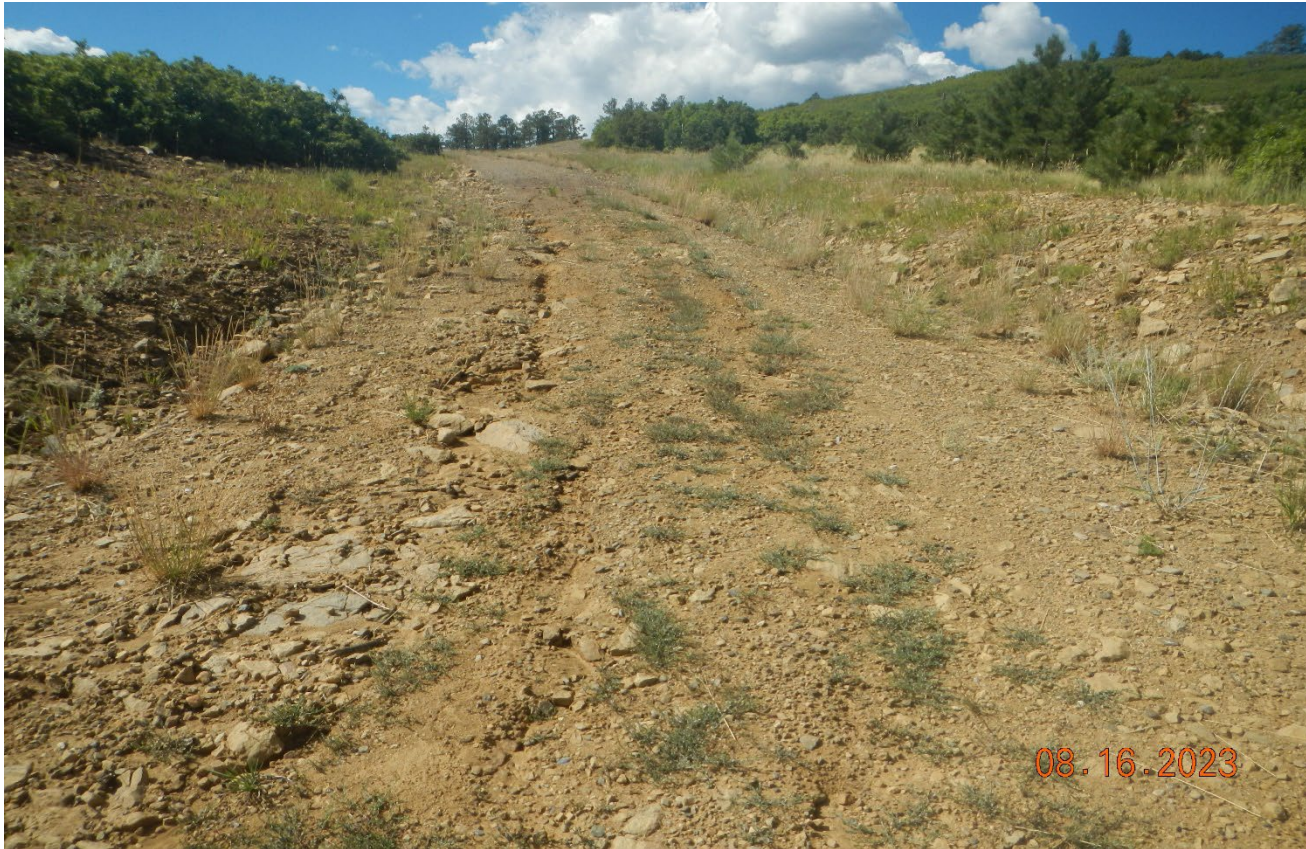
**Photo 1.** Facing southeast along the access road near the location. There is erosion along this area of the road that needs to be repaired and stabilized.

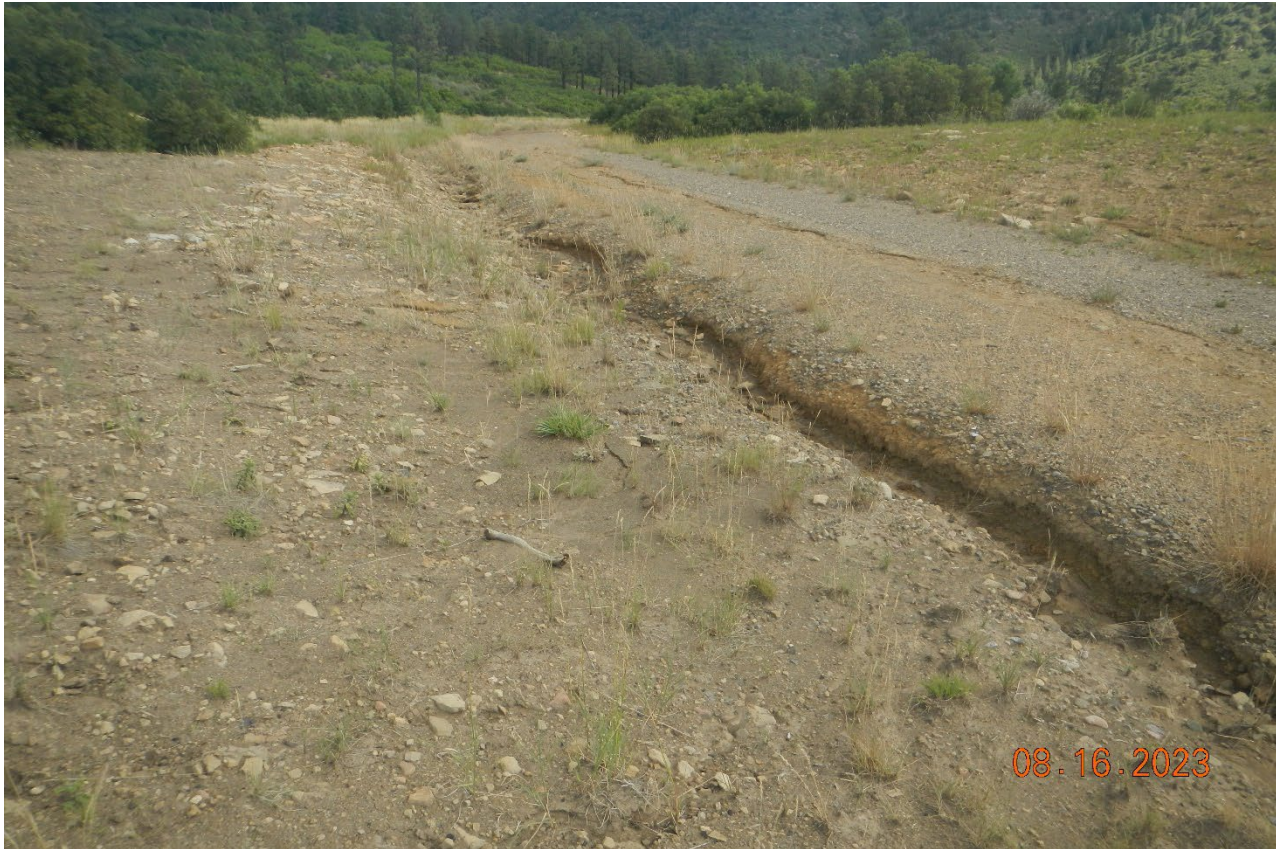
**Photo 2.** Facing north toward the access road at the location. There is erosion along the road side at the location.

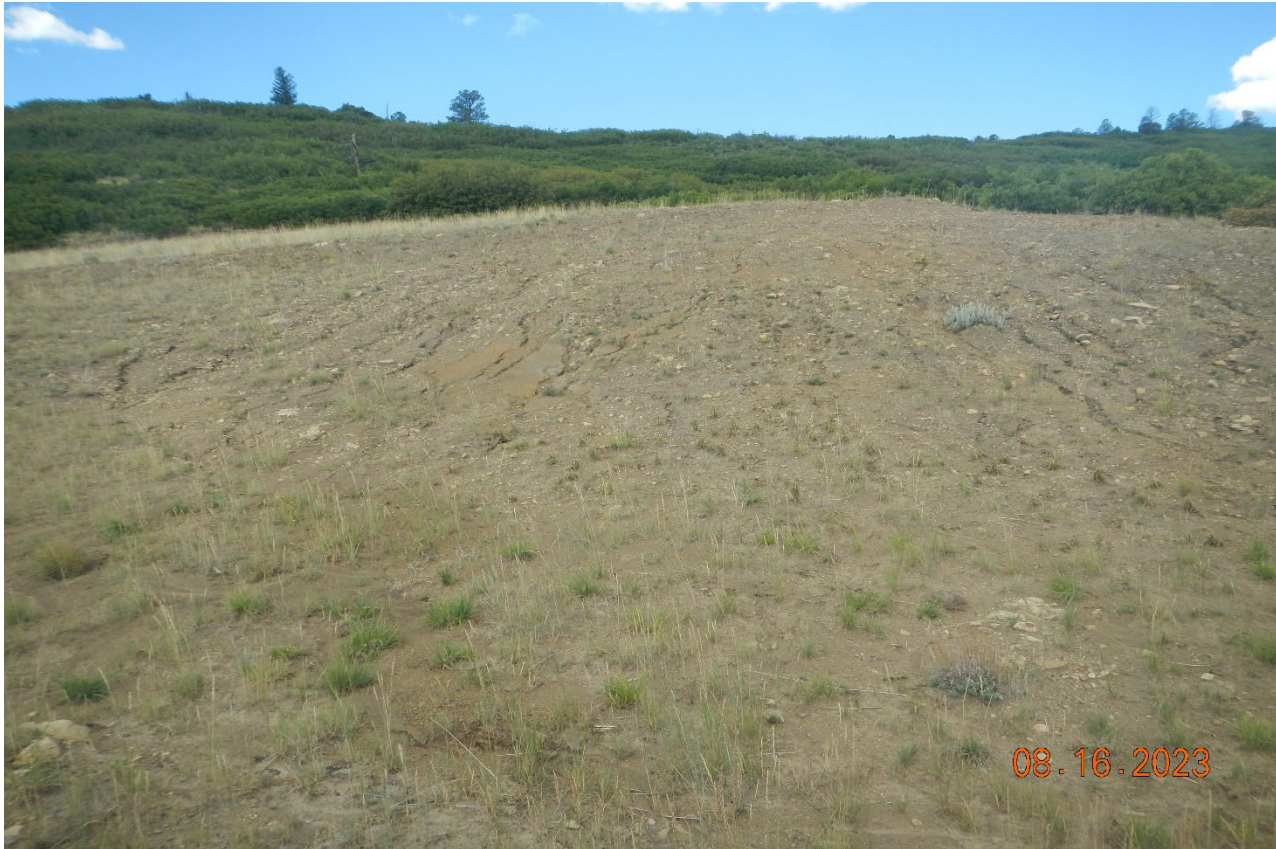
**Photo 3.** Facing southwest at the location. This portion of the location is not stabilized with vegetation cover and has signs of erosion.

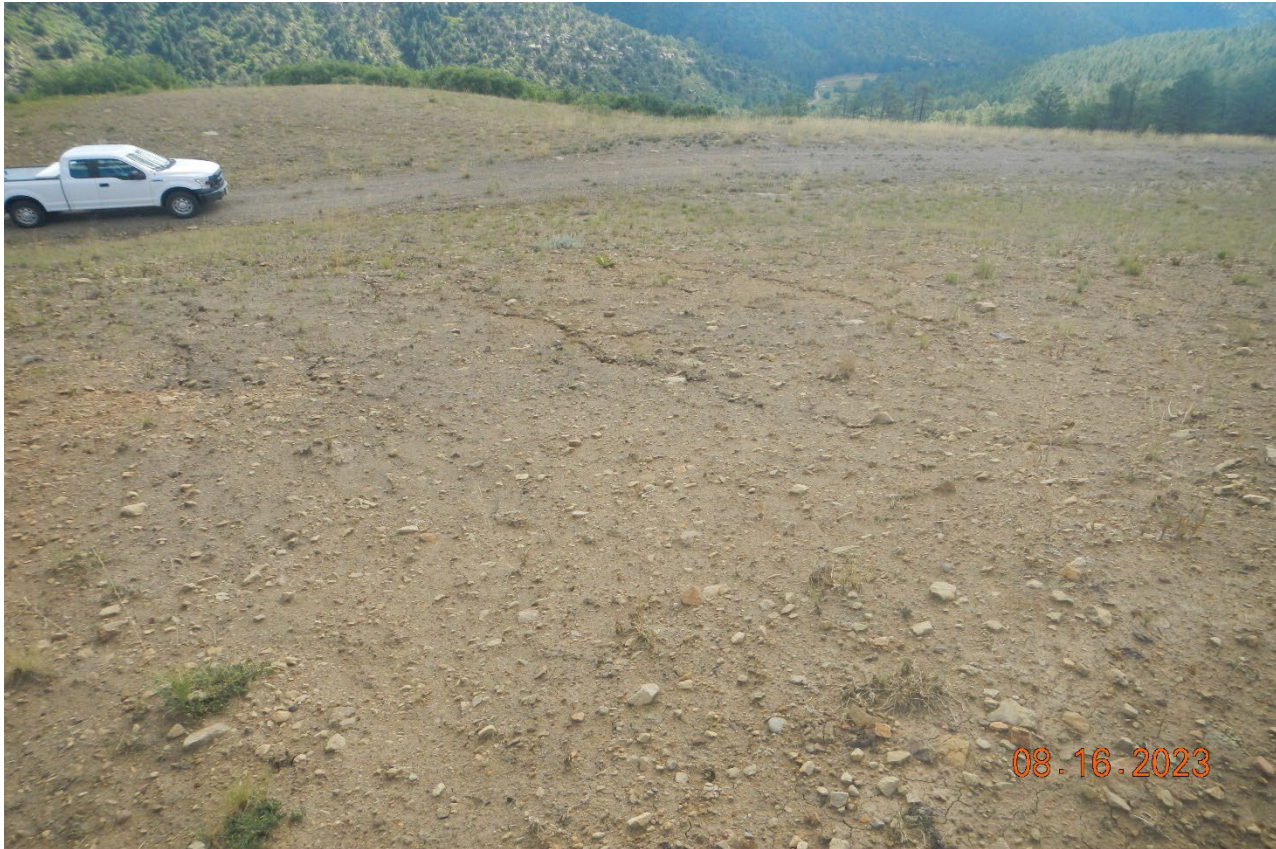
**Photo 4.** Facing east at the location. This portion of the location is not stabilized with vegetation cover and has signs of erosion.

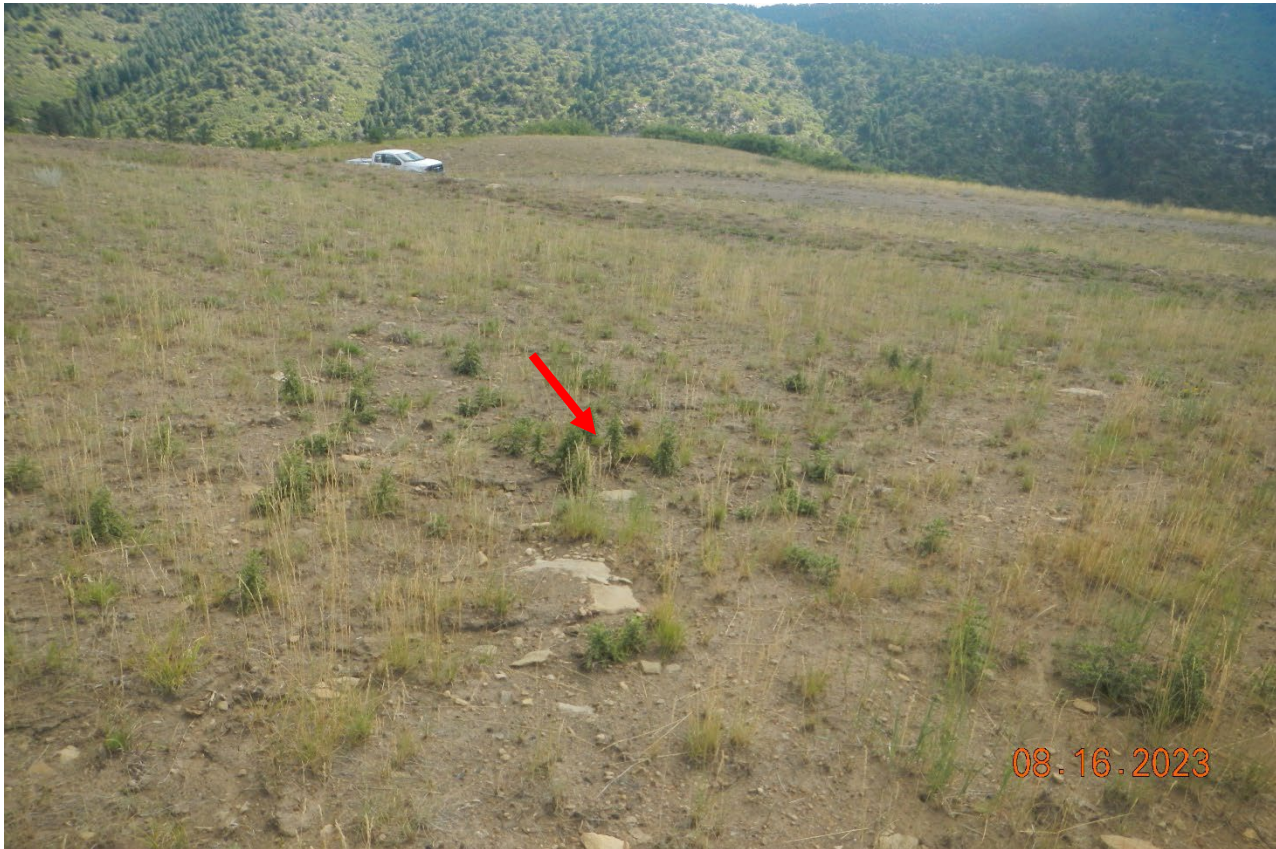
**Photo 5.** West side of the location facing northeast. There are noxious weeds at red arrow (Canada thistle). Some of the weeds were wilted from weed control but some were not controlled.

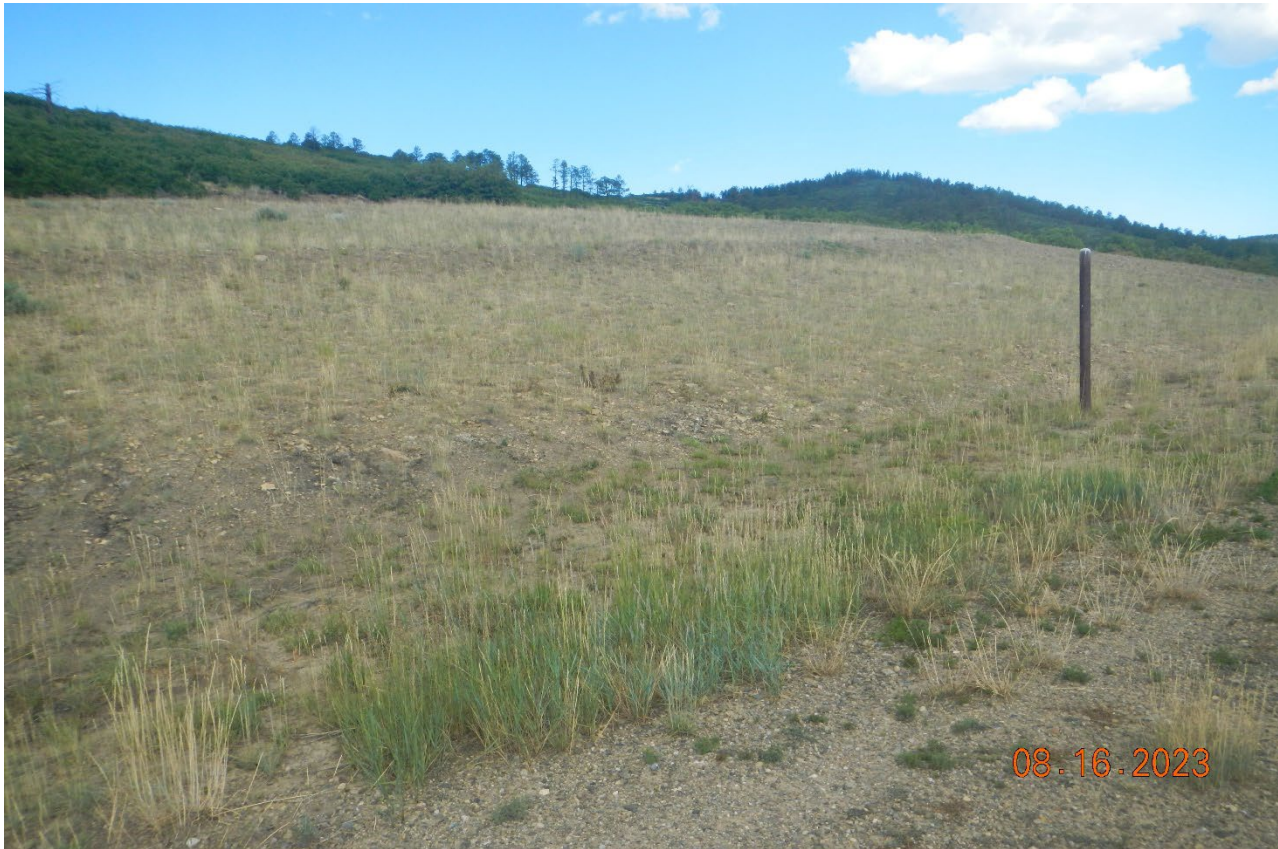
**Photo 6.** Facing northwest at the location. Well marker is shown in this photo.

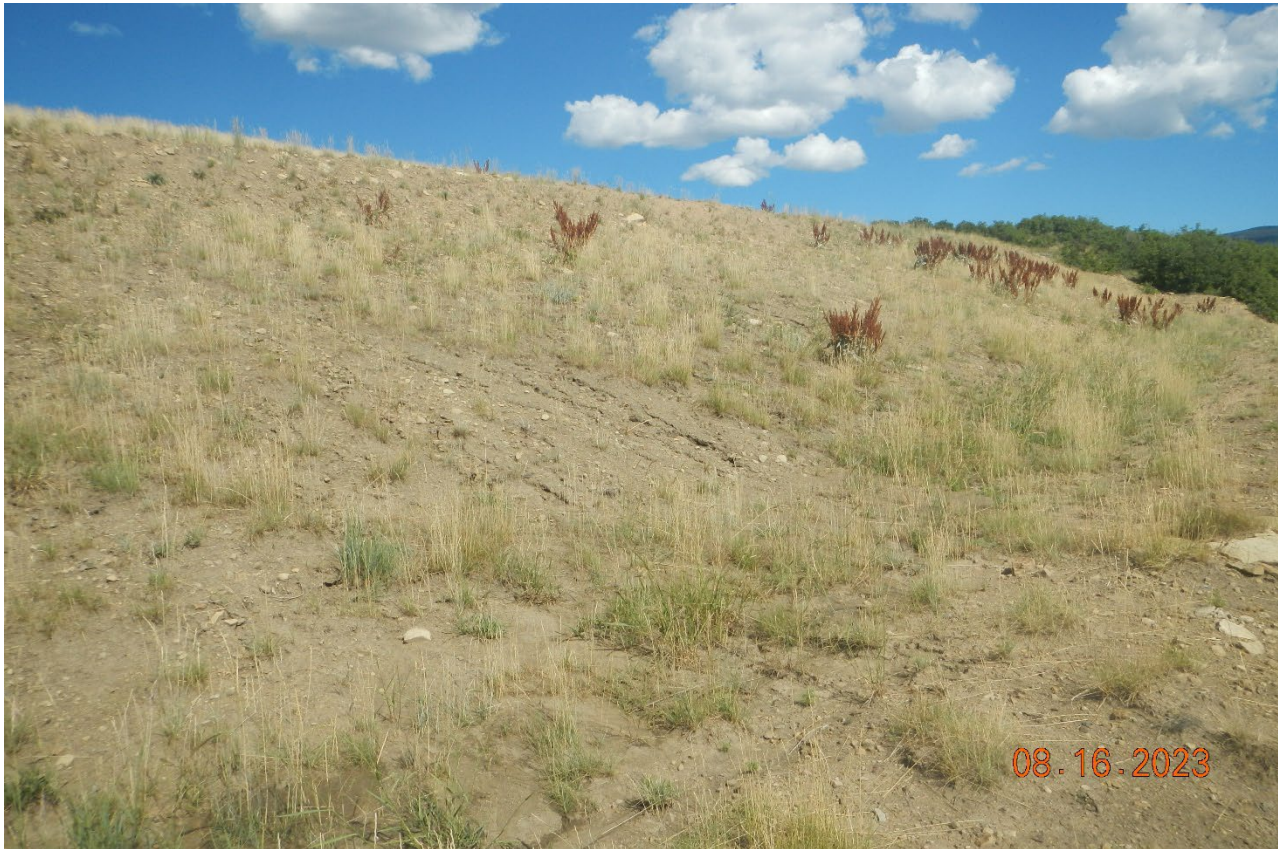
**Photo 7.** East side of the location facing northwest at the bottom slope.

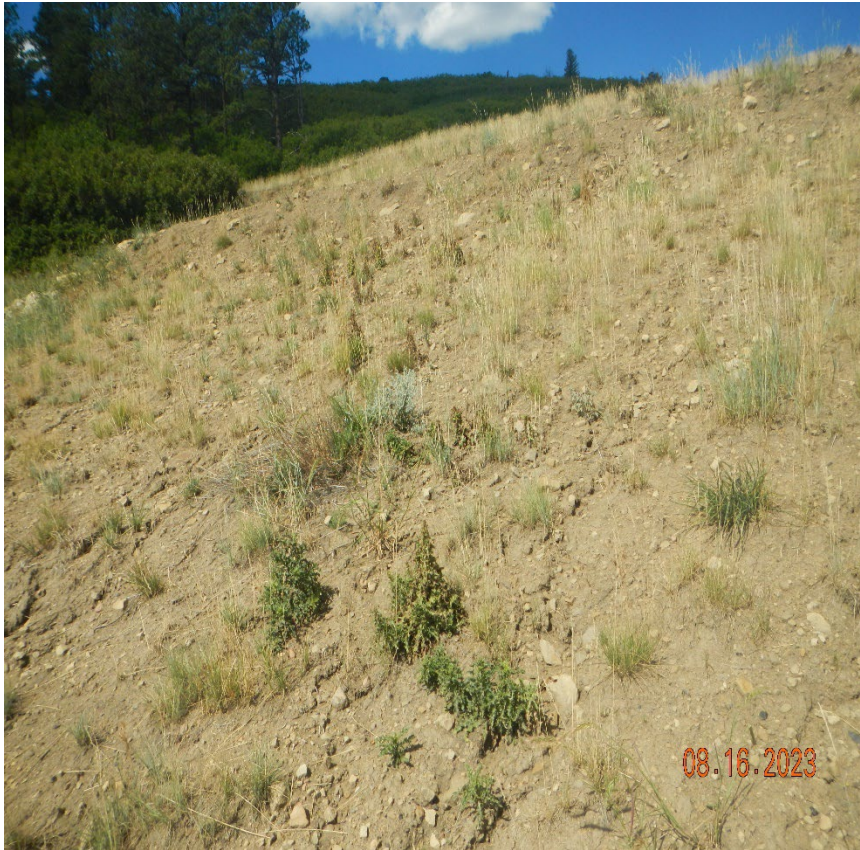
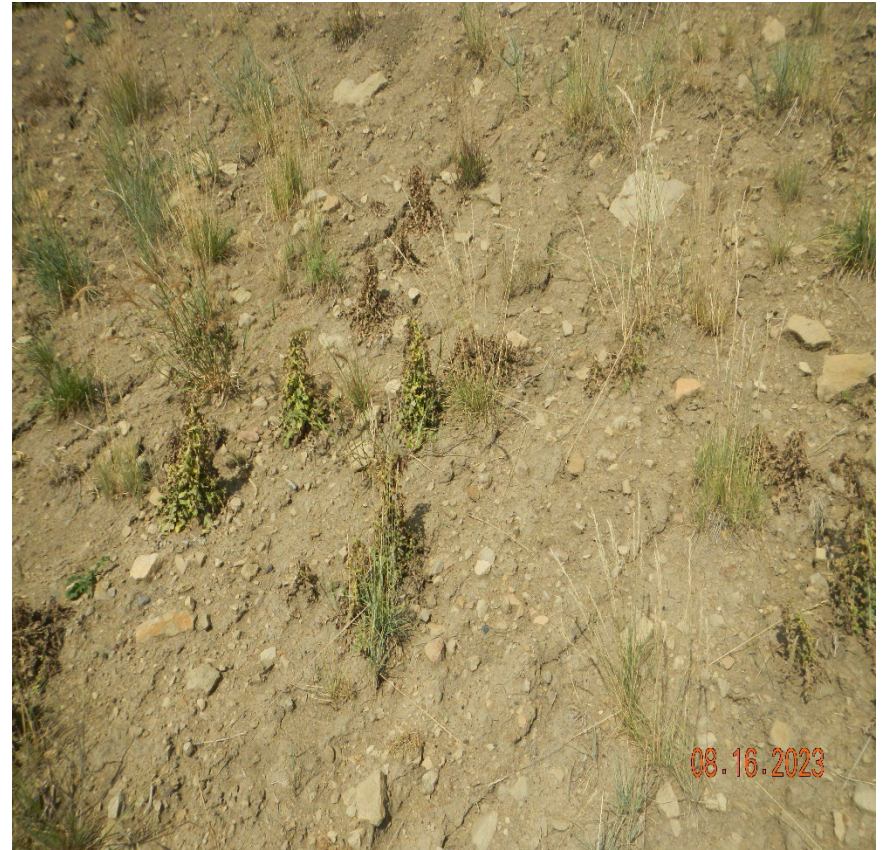
**Photo 8.** There were more noxious weeds at the northeast side of the location. Some of the noxious weeds observed were wilted from recent weed control.

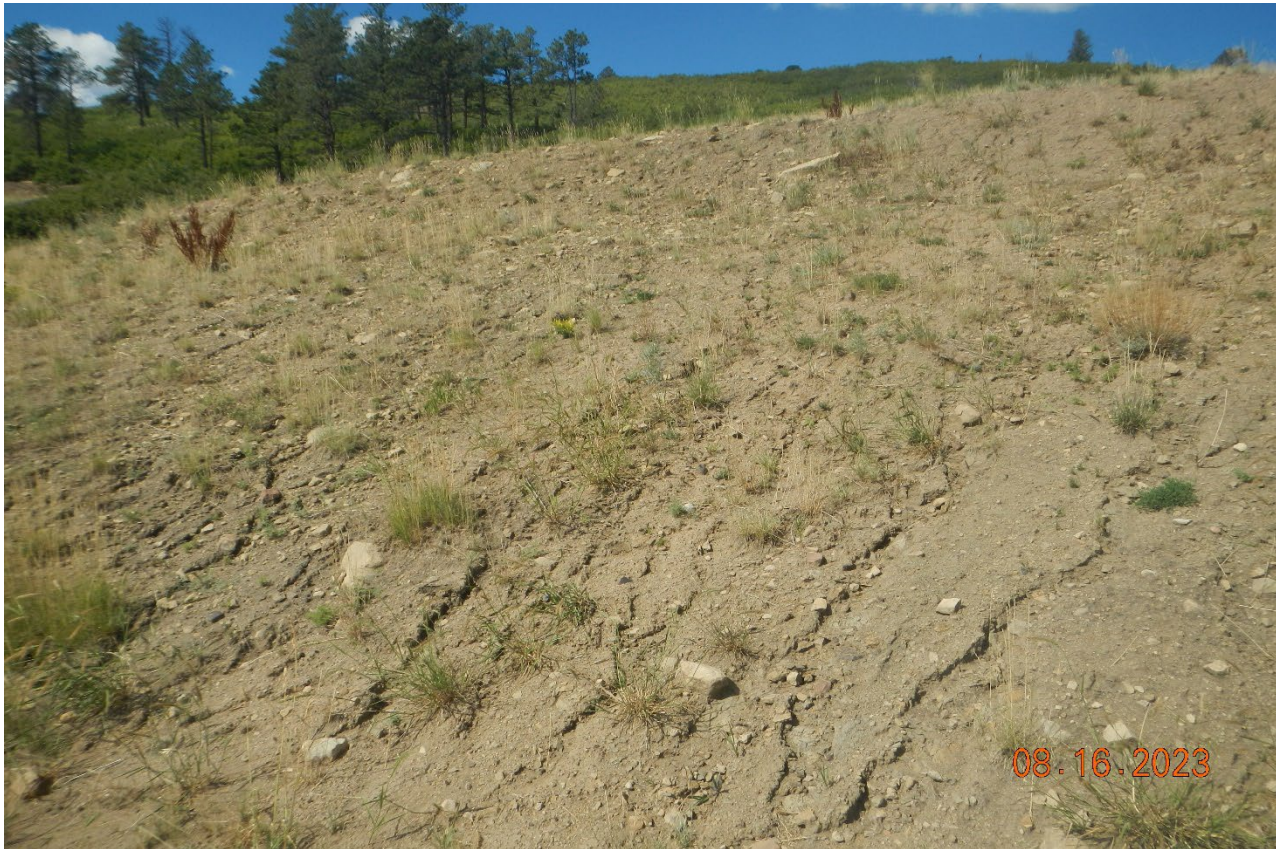
**Photo 9.** Southeast side of the location facing west. This portion of the location is not stabilized with vegetation cover and has signs of erosion.

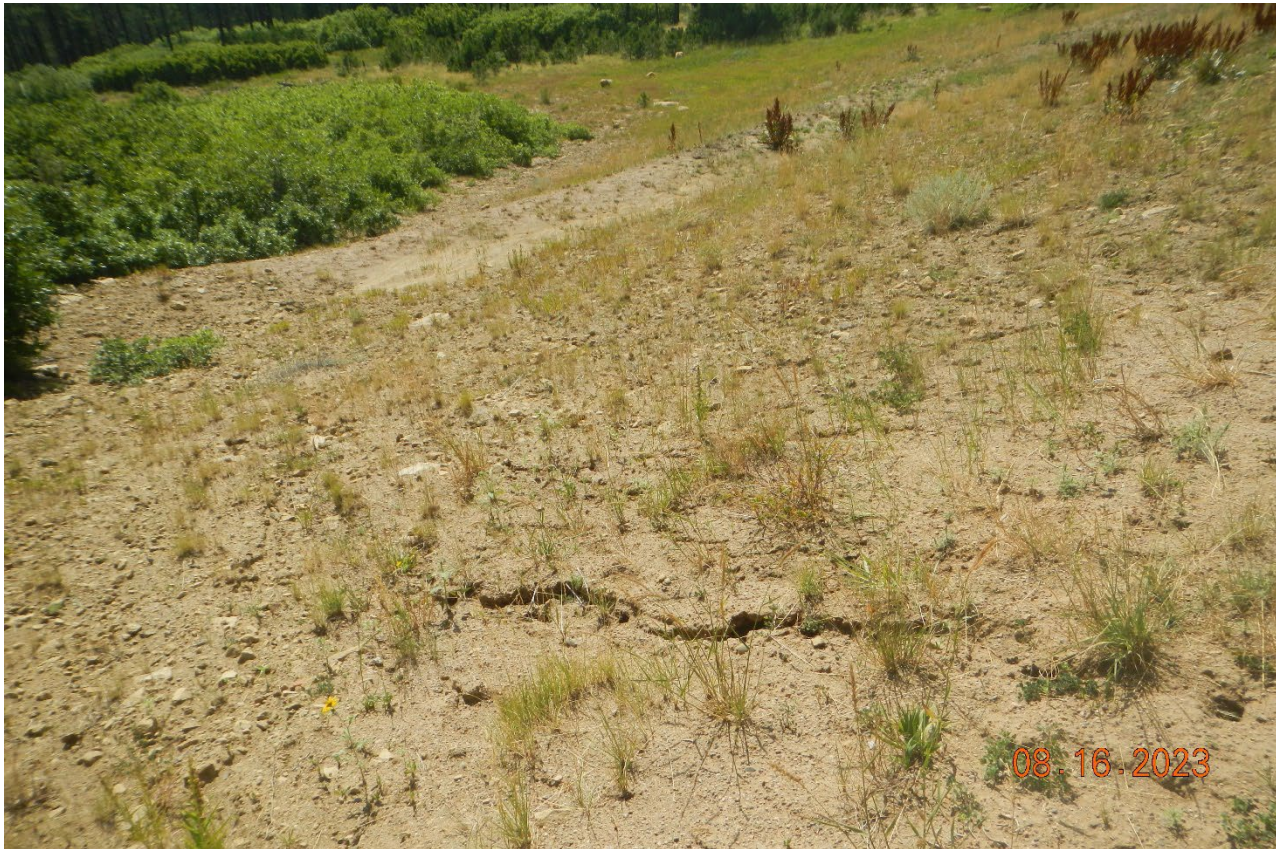
**Photo 10.** Facing southeast down the bottom of the location. This portion of the location is not stabilized with vegetation cover and has signs of erosion.

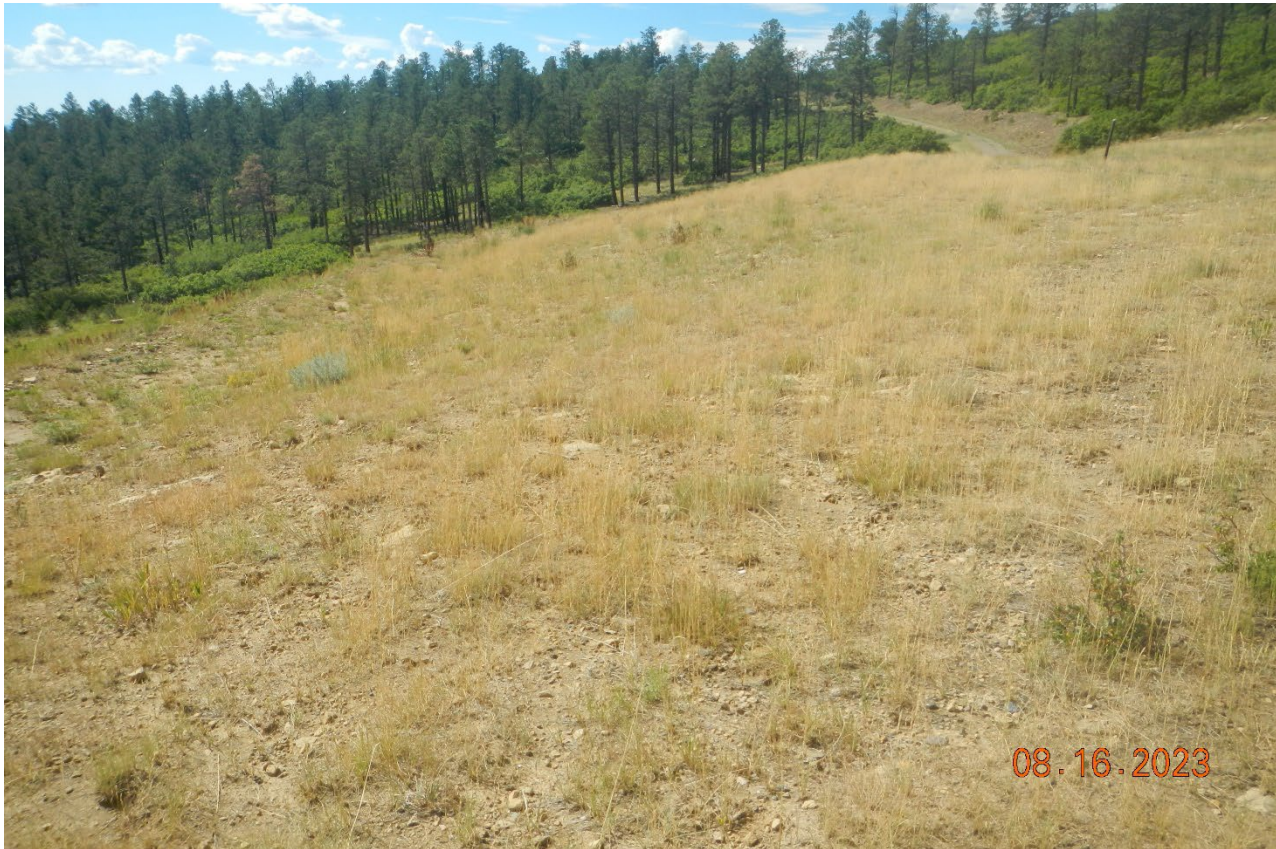
**Photo 11.** Facing south at the location. The vegetation at the mid portion of the location appears to be well established.

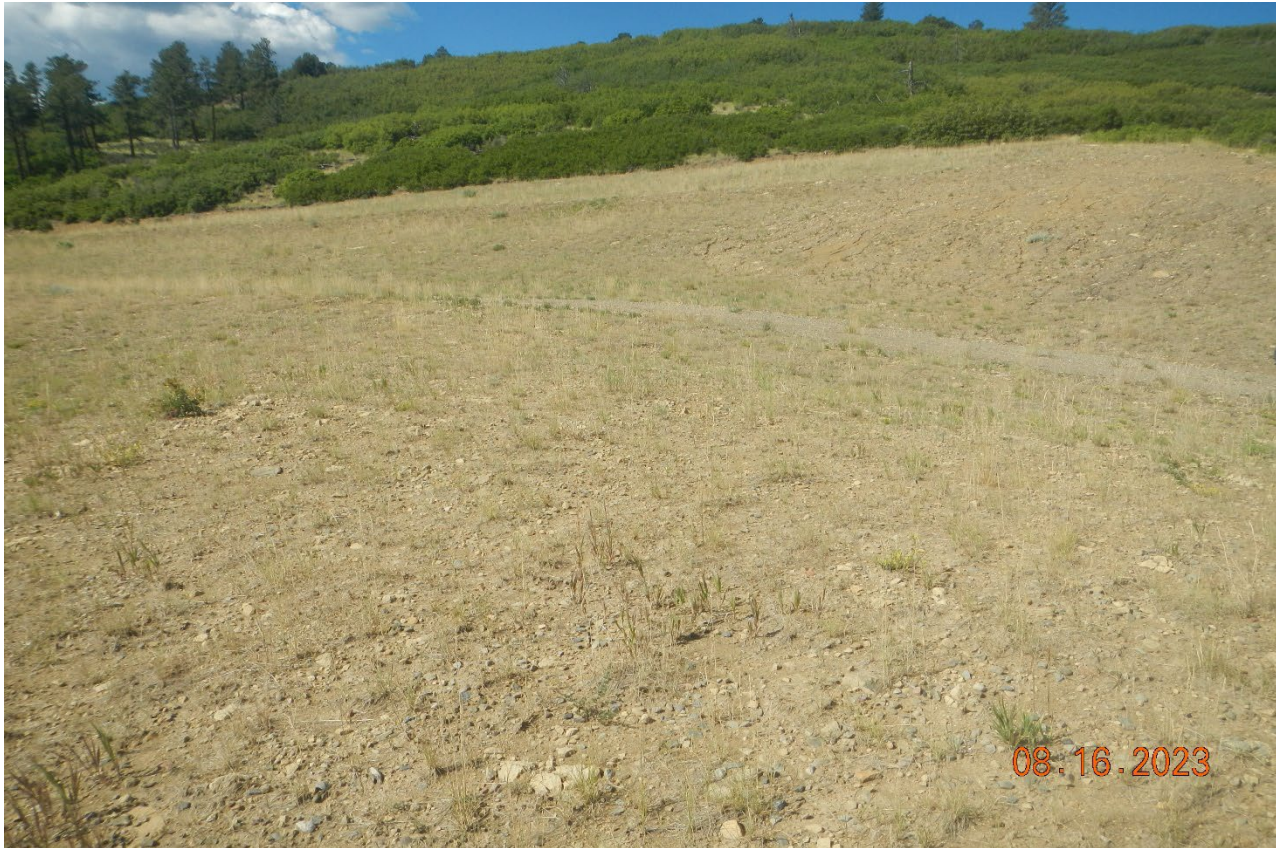
**Photo 12.** Northeast side of the location facing southwest. There are areas of the location that will need to be reseeded.
