Inspection Photos
Maralex Conley 7
API 007-06246

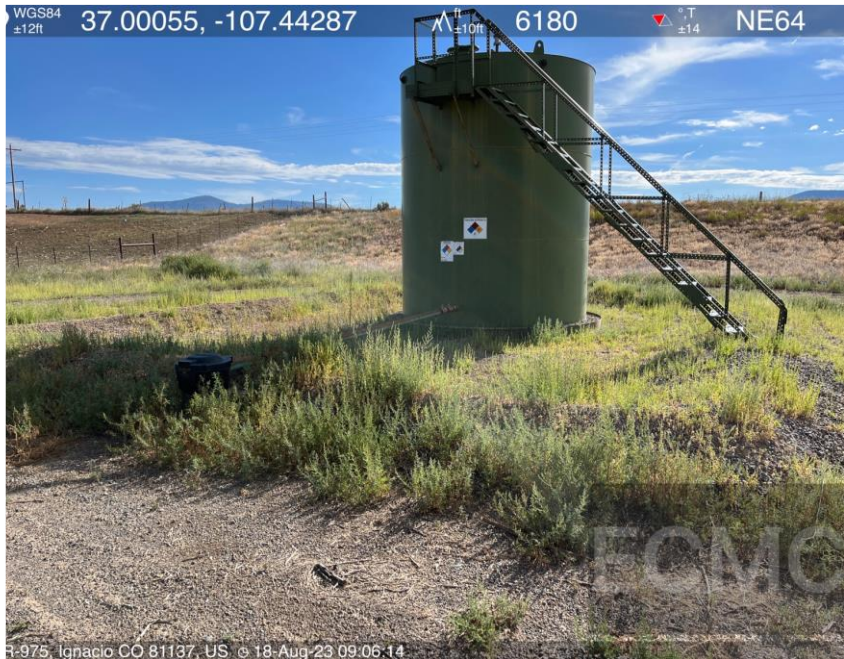
Photo #1. Weeds around containment berm.

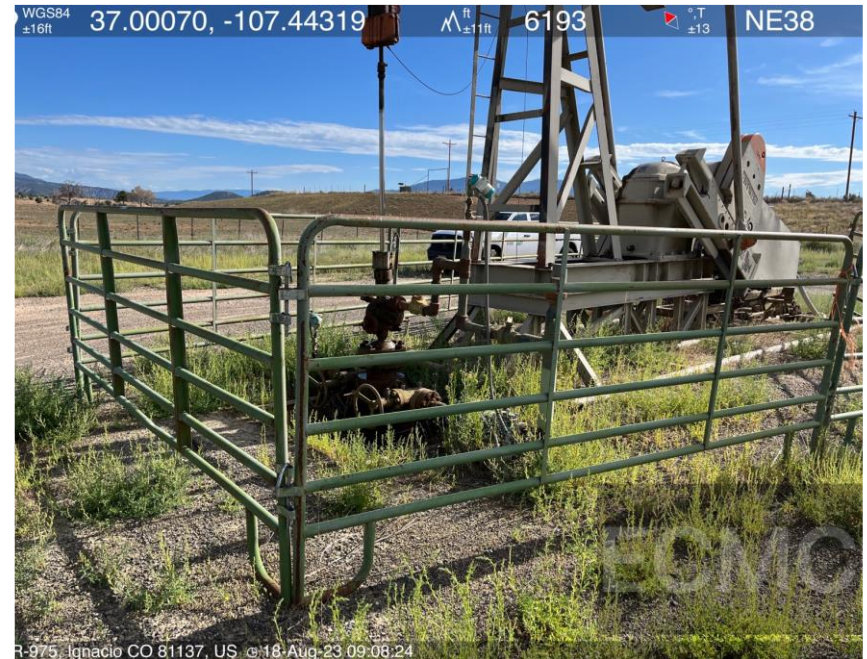
Photo #2. Weeds around the wellhead/pumpjack..

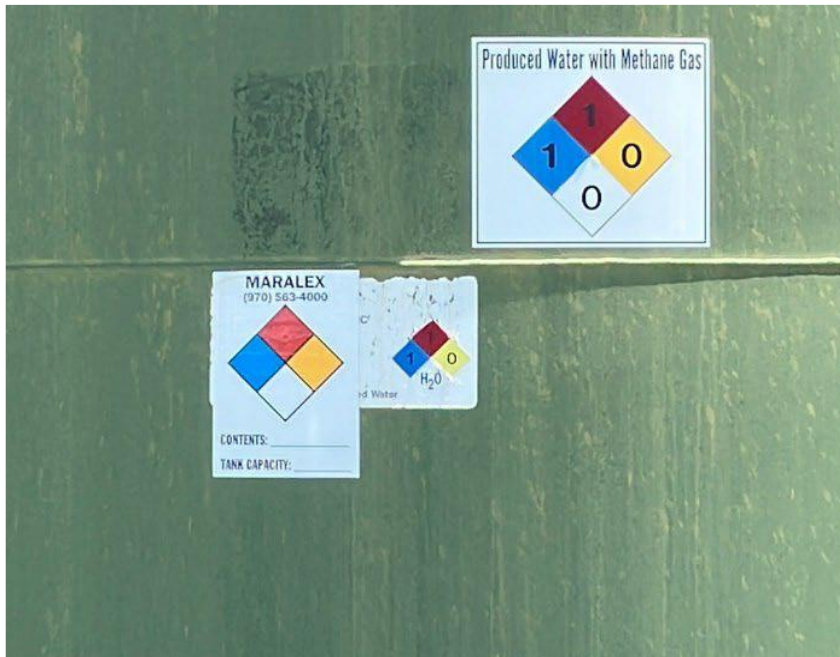
Photo #3. View of corrective action identified in Doc.#702500281.

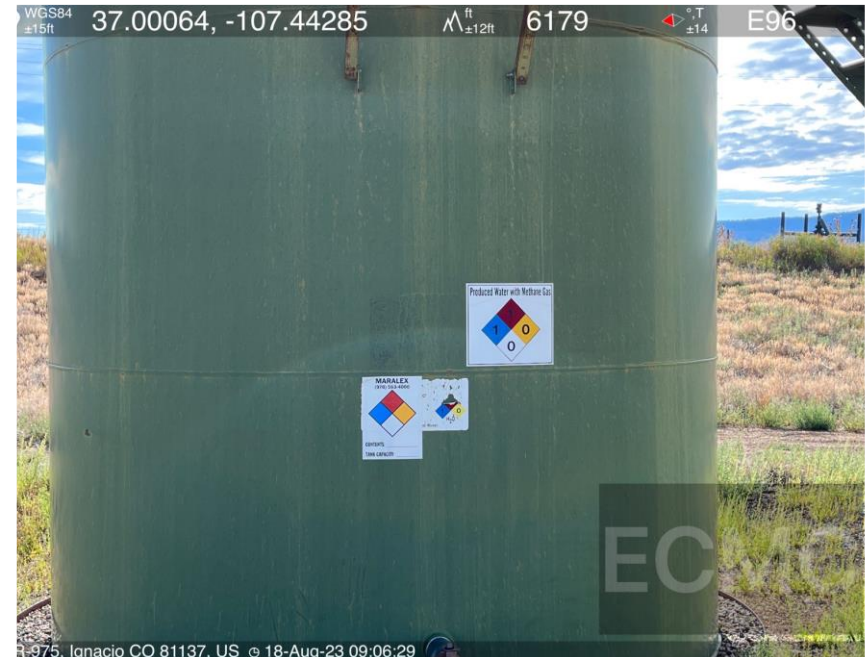
Photo #4. View of no tank volume labeling. Corrective action not completed.
