Inspection Photos
Location Name: CAERUS PICEANCE LLC L1B Pad
Location ID: 334851

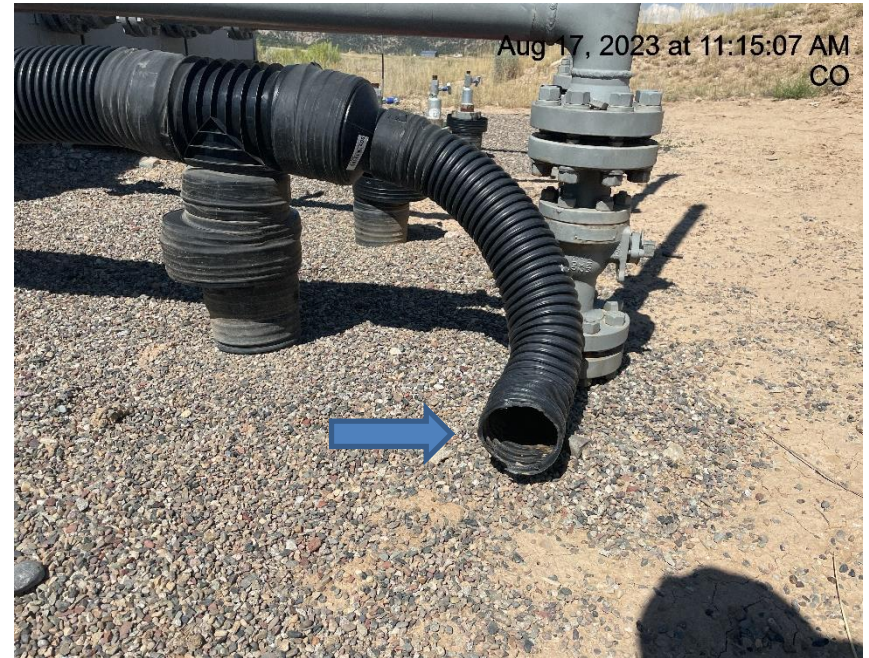
Photo # 6142 Flowline heating insulation open ended

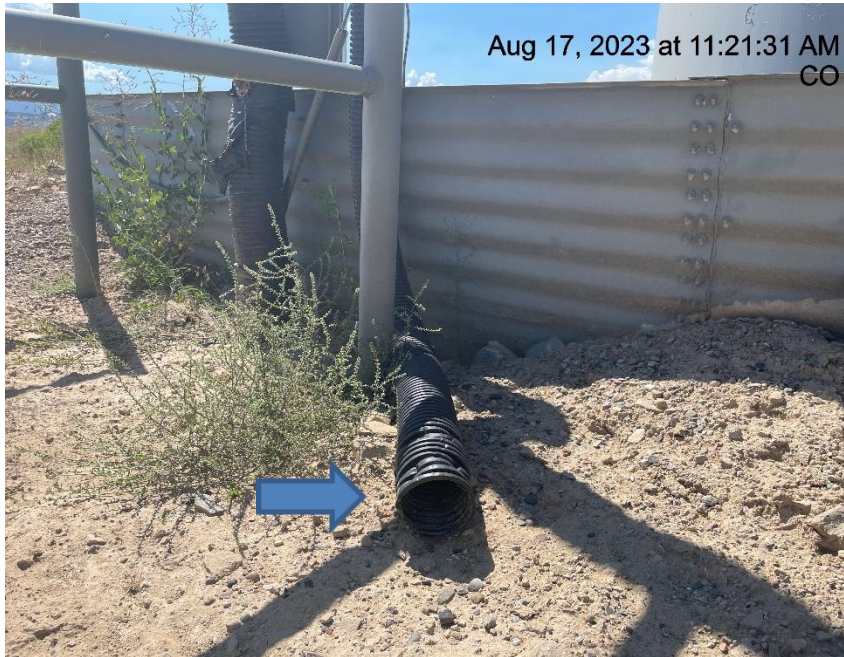
Photo # 6151 Flowline heating insulation open ended

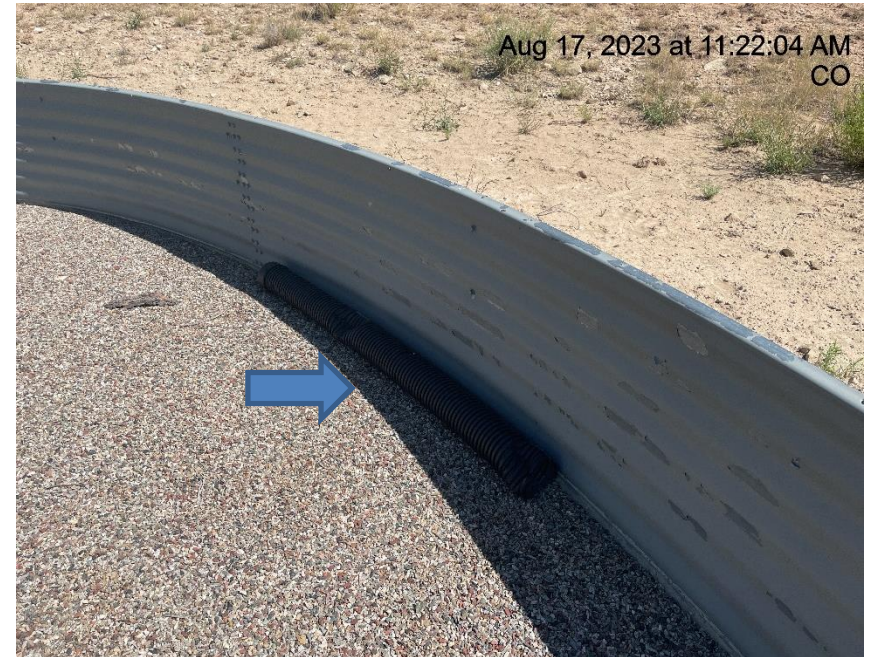
Photo # 6153 Debris
