Report of Work Completed – Reclamation Maintenance

ECMC Location Name (ID)	SECORA-633S68W/21SENE (308892)
Operator Name (Operator #)	XTO Energy, Inc (Operator #: 100264)
Operator Location Name	Secora 1
ECMC Well Name	SECORA #1
Legal Description	SENE Section 21 T33S-R68W
Coordinates (Lat/Long)	37.159490 / -104.993060
County	Las Animas County, Colorado

Confluence Compliance Companies, LLC (Confluence) prepared this Report of Work Completed (ROWC) for XTO Energy, Inc (XTO) to document maintenance performed at the Secora 1 well pad (Location) July 12 – July 20, 2023 including-stormwater control measure repair, seeding, and weed management. The Location is 1.84 miles east of Stonewall, Colorado in Las Animas County as illustrated in the attached Topographic Location Map. Additional information on the Location is provided in the title block above and attached Maintenance Site Diagram. This ROWC provides background on the Location, methods for maintenance contractor coordination and oversight, the results of maintenance efforts, and site-specific recommendations for future monitoring and/or maintenance efforts.

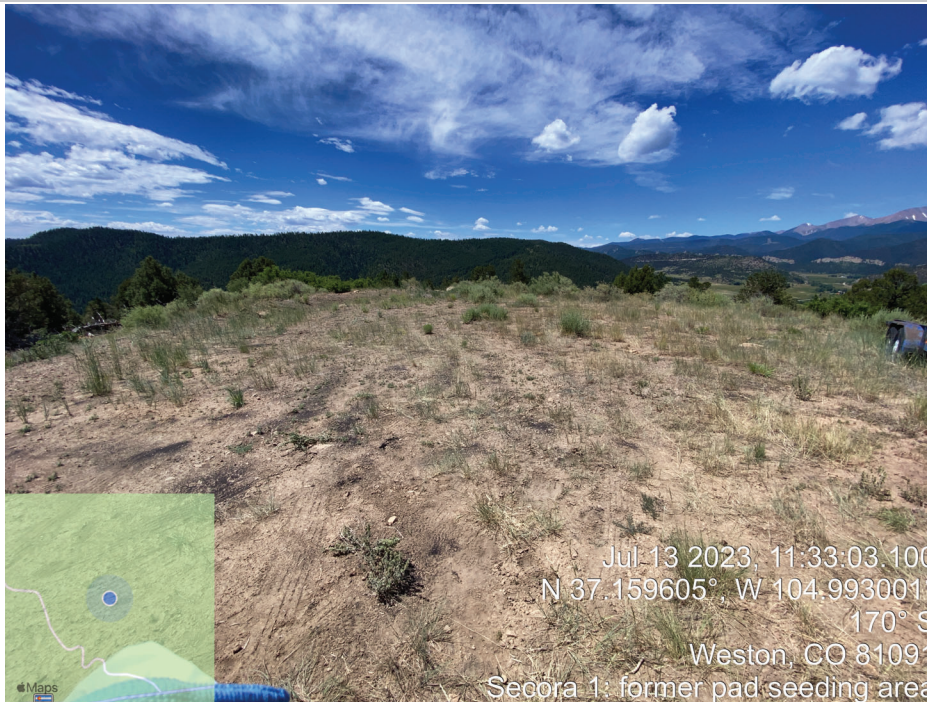
Existing vegetation within the reclaimed surface is well established, though vegetative cover was approximately 40% when compared to adjacent reference areas based on ocular assessment. The seeding area is illustrated in Photo Point 1 of the attached Maintenance Site Diagram and Maintenance Photo Log.

Photo Point 1: Former Pad Seeding Area

Confluence completed broadcast seeding and amendment application at the 0.27 acre former Secora 1 well pad July 13, 2023. Seed and amendments were broadcast onto the reclaimed surface and at least 5 feet into the adjacent landscape using a broadcast seeder designed for native seed dispersal. Broadcast seed was covered to a maximum depth of 0.5 inch by hand raking seeded areas. Soil amendment was applied at a rate of 500 lbs. per acre of Richlawn 3-6-

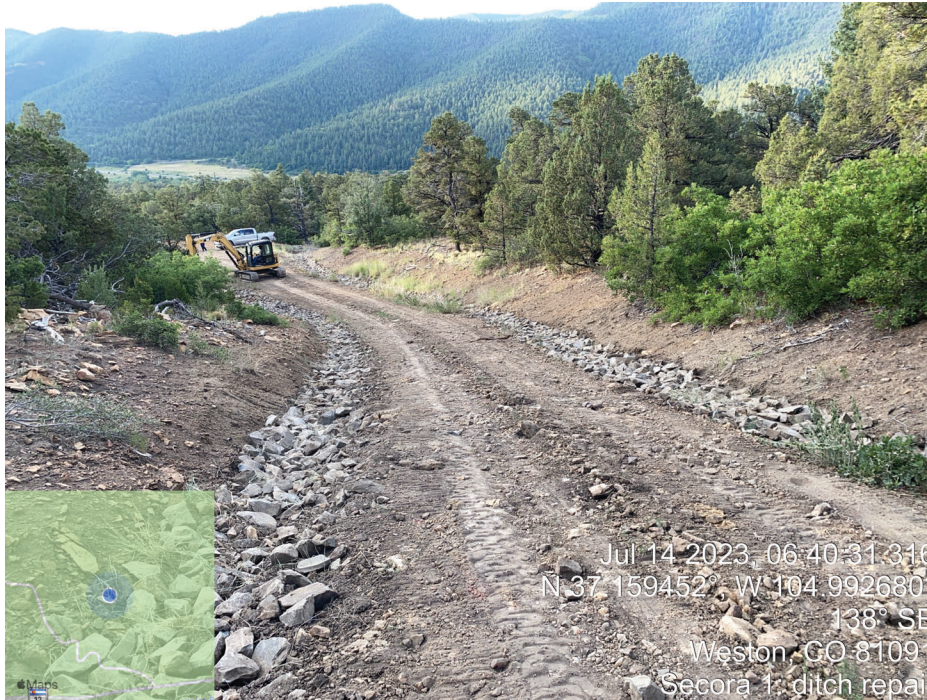
Riprap armoring was observed in the roadside ditches at the northern extent of the access road where access road slope is greater than 4:1. Sediment accumulation was observed in both riprap armored ditches. Sediment was removed and hauled off location, riprap was refreshed via removal from the ditch and reinstallation. Repair of riprap armored ditches included sediment removal and distribution of additional rock in areas where aggregate depth or cover was insufficient to stabilize the surface and reduce stormwater velocity.

Photo Point 2: Armored Ditch Repair

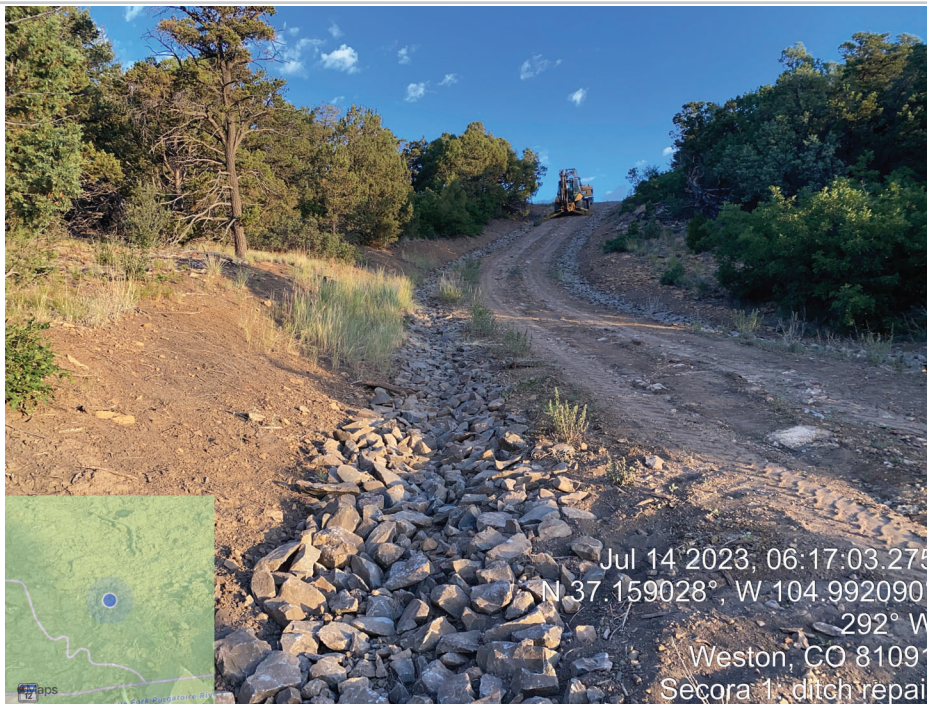
Photo Point 3: Armored Ditch Repair

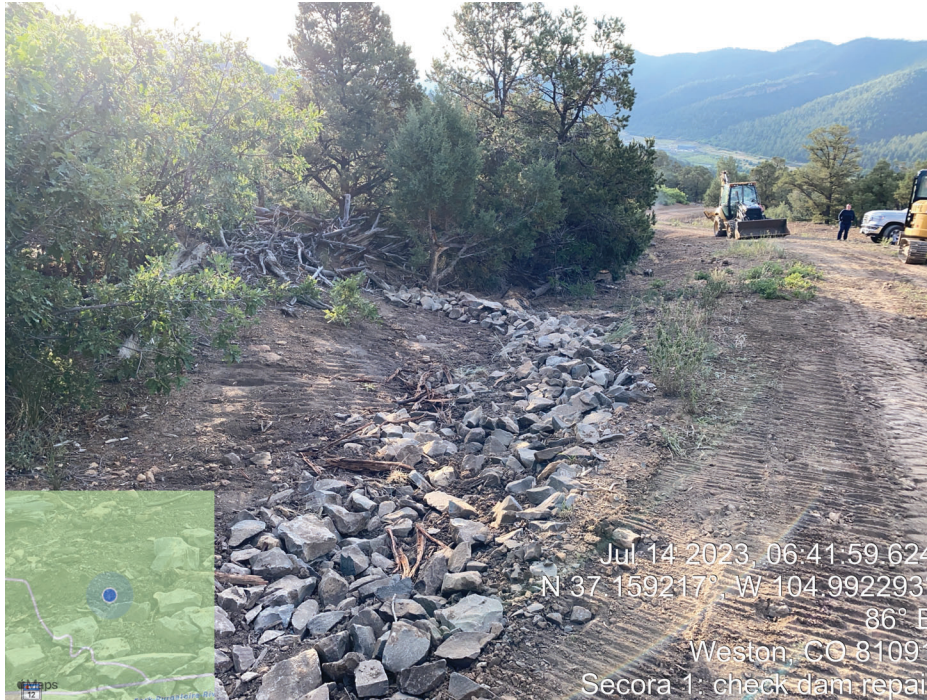
Sixteen check dams installed in roadside ditches of the Location access road were found to be sediment laden and/or required repair. Sediment was removed from each check dam and sediment was hauled offsite by subcontractors. Following sediment removal, check dams were reconstructed per EPA rock check dam or check dam turnout specifications.

Photo Point 4: Check Dam Repair

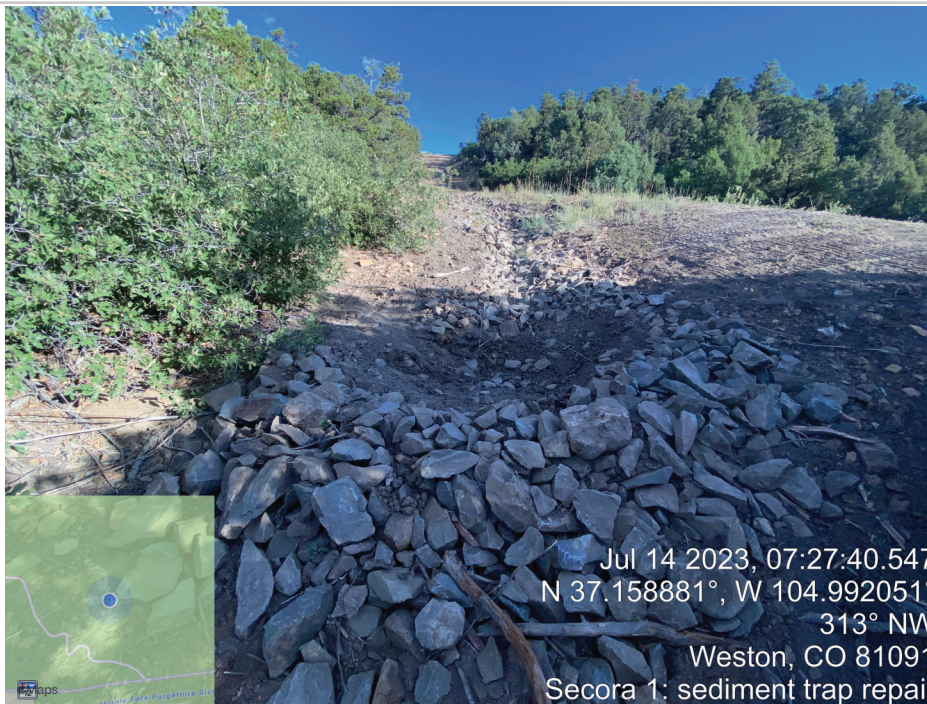
Seven sediment traps were observed on along the Location access road in areas with the highest erosional potential to divert channelized stormwater flow that could not be managed by check dams and turnouts alone. Sediment trap maintenance included sediment removal and disposal, riprap removal, regrading of trap bottom to optimize feature surface area, and riprap reinstallation.

Photo Point 5: Sediment Trap Repair

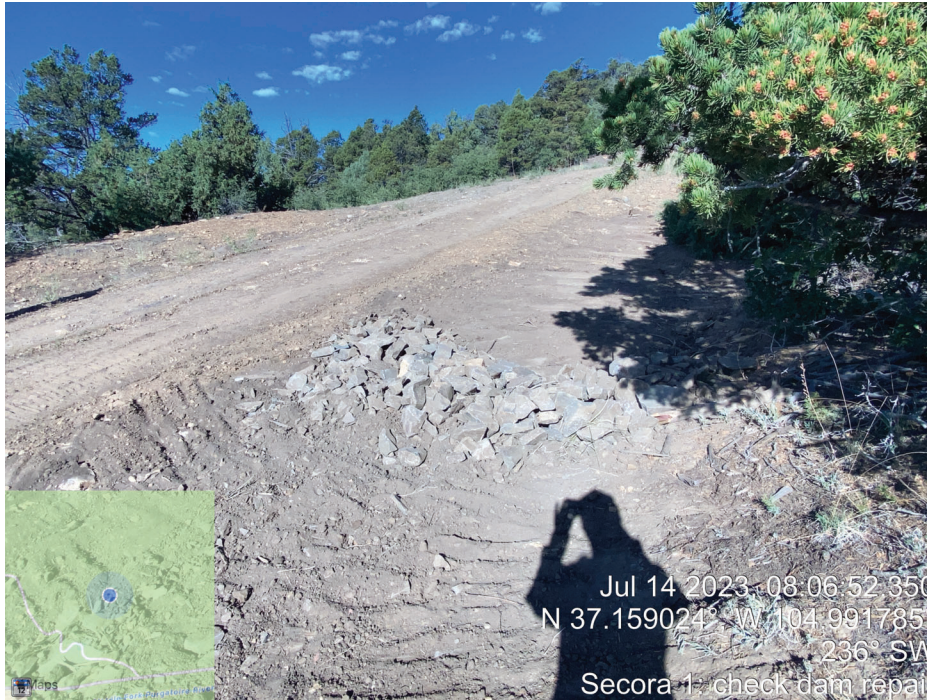
Photo Point 6: Check Dam Repair

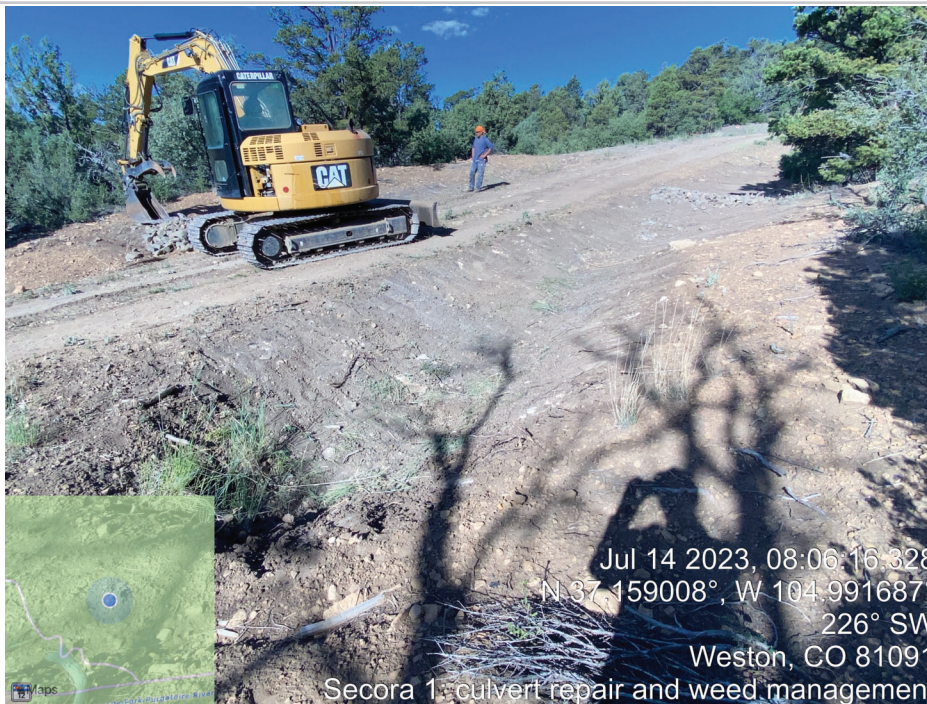
Location roadside ditches were installed strategically along the access road to convey water from storm runoff to an adequate outlet. Check dam turnouts have been installed intermittently along the access road in regions prone to concentrated flow, per EPA specifications, to deflect flow into naturally occurring drainage features. Roadside ditch repair included erosional feature repair and regrading of ditches to ensure feature bottom is parabolic or flat to decrease stormwater velocity.

Weed management efforts were completed on July 20, 2023. One live colony of Canada thistle (*Cirsium arvense*) was observed at Photo Point 7 as illustrated in the attached Maintenance Site Diagram and Maintenance Photo Log. Approximately 20 individual plants were mechanically removed and plant material was bagged and disposed of offsite. Other weeds observed on location include Common mullein (*Verbascum Thapsus*), Horehound (*Marrubium vulgare*), Prickly lettuce (*Lactuca serriola*), Yellow sweetclover (*Melilotus officinalis*), and Kochia (*Bassia scoparia*). Herbicide was applied to portions of the reclaimed surface and access road easements. Treatment was spot-specific, applied only where listed noxious weeds or undesirable species appeared on Location, to minimize the potential for damage to desirable vegetative cover.

Photo Point 7: Noxious Weed Removal, Ditch Repair, Culvert Inlet Maintenance

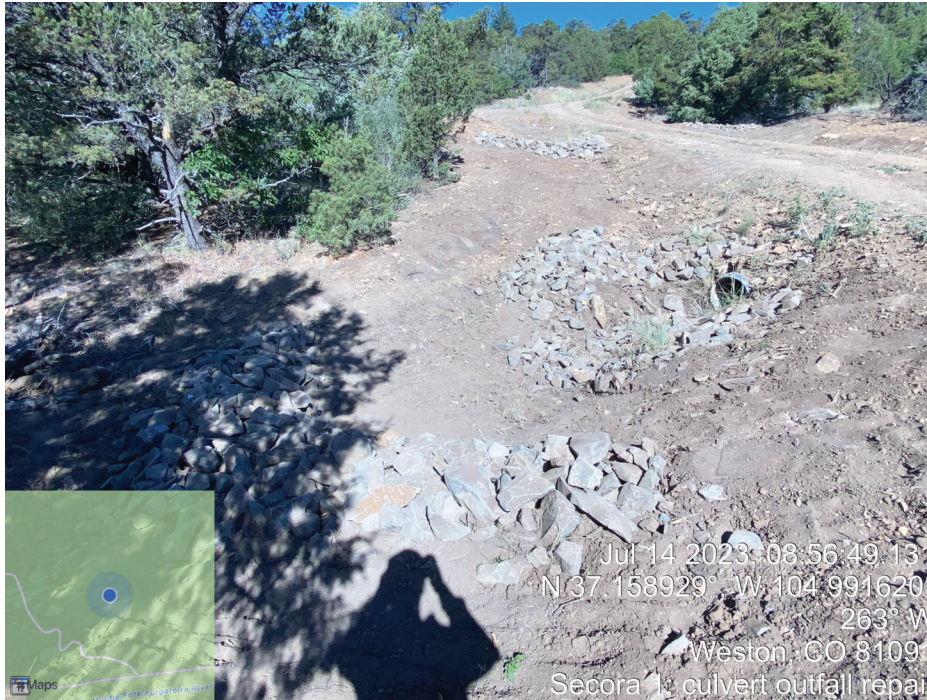
Photo Point 8: Check Dam Repair, Culvert Outfall Maintenance

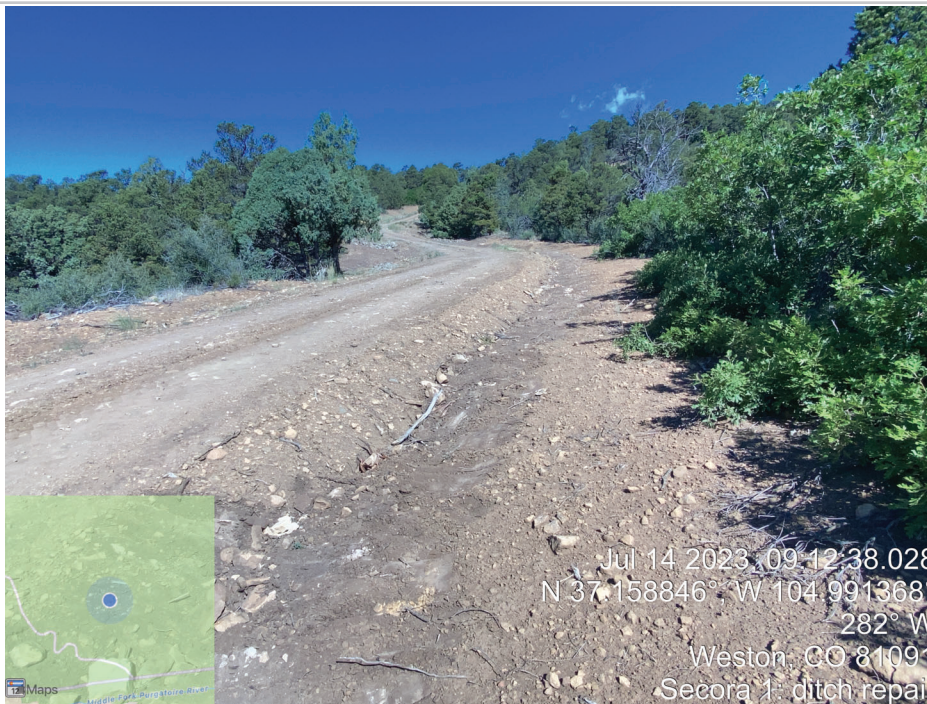
Photo Point 9: Ditch Repair

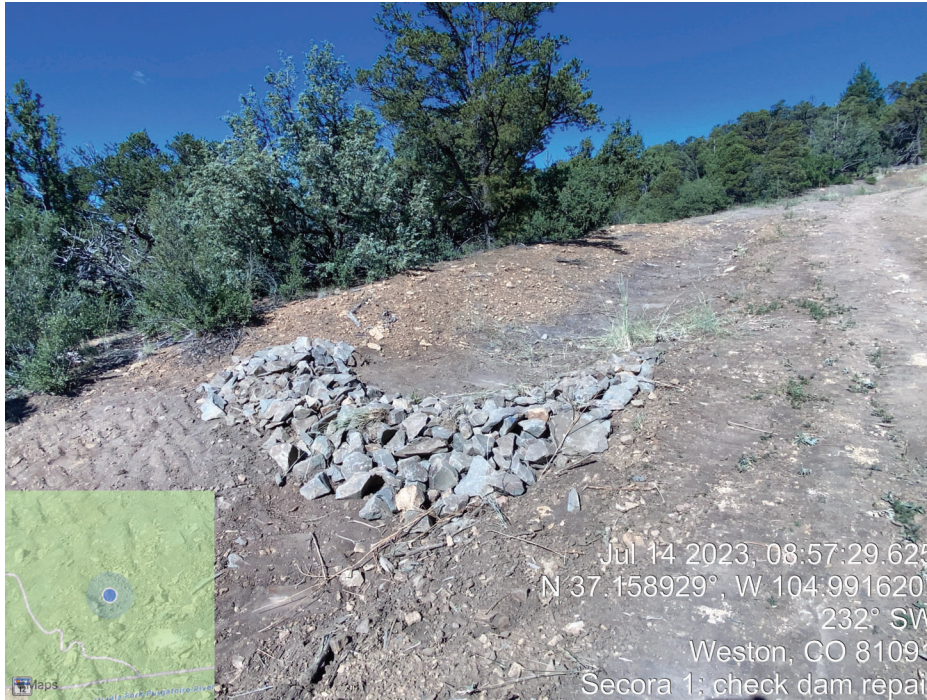
Photo Point 10: Check Dam Repair

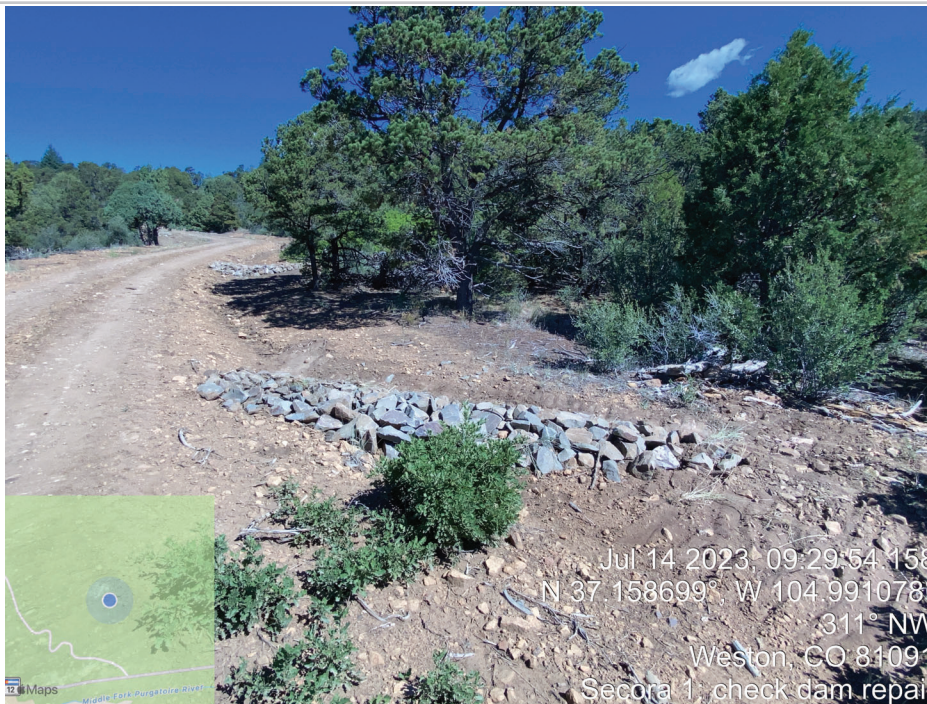
Photo Point 11: Check Dam Repair

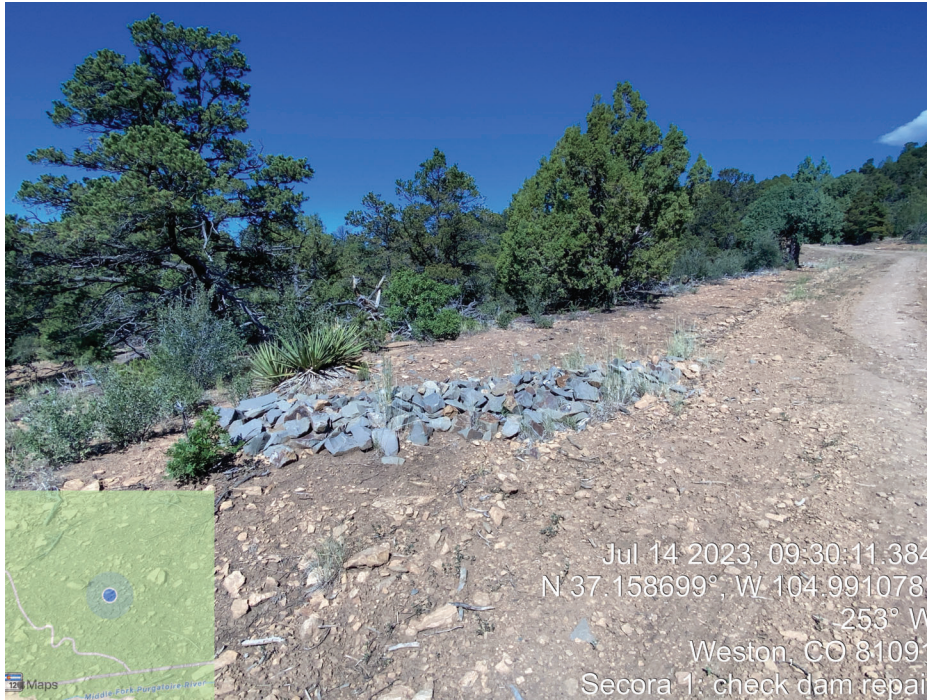
Photo Point 12: Check Dam Repair

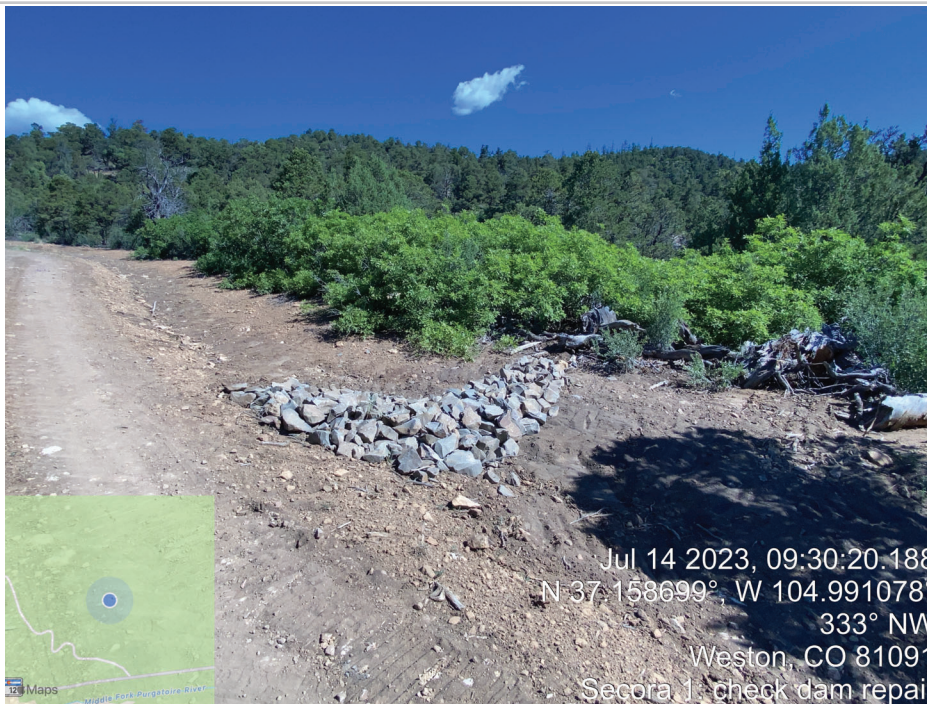
Photo Point 13: Check Dam Repair

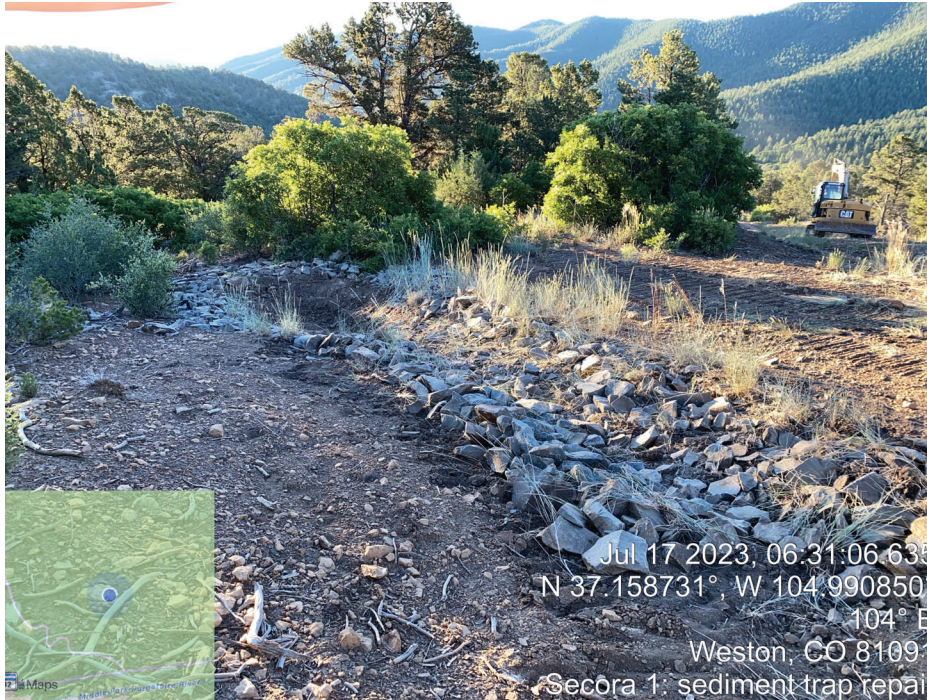
Photo Point 14: Sediment Trap Repair

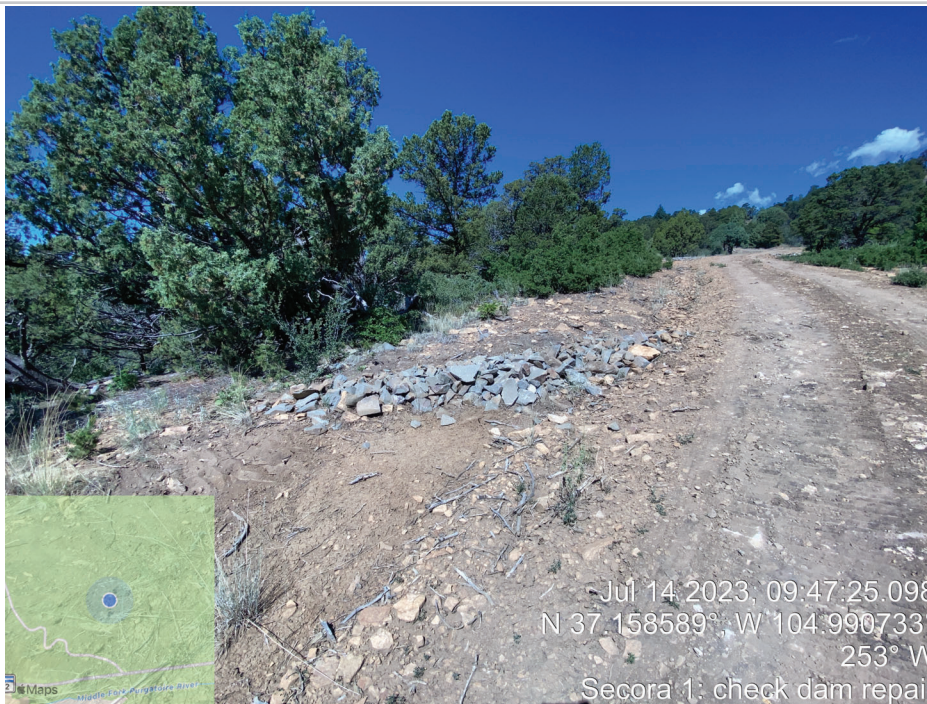
Photo Point 15: Check Dam Repair

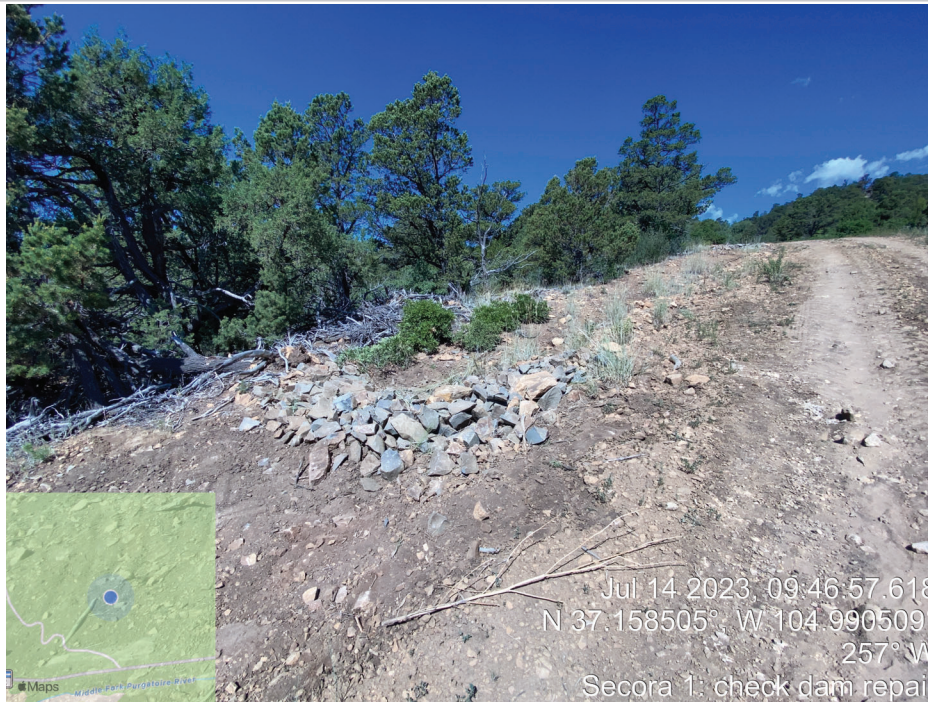
Photo Point 16: Check Dam Repair Coordinates: 37.158447, -104.990574

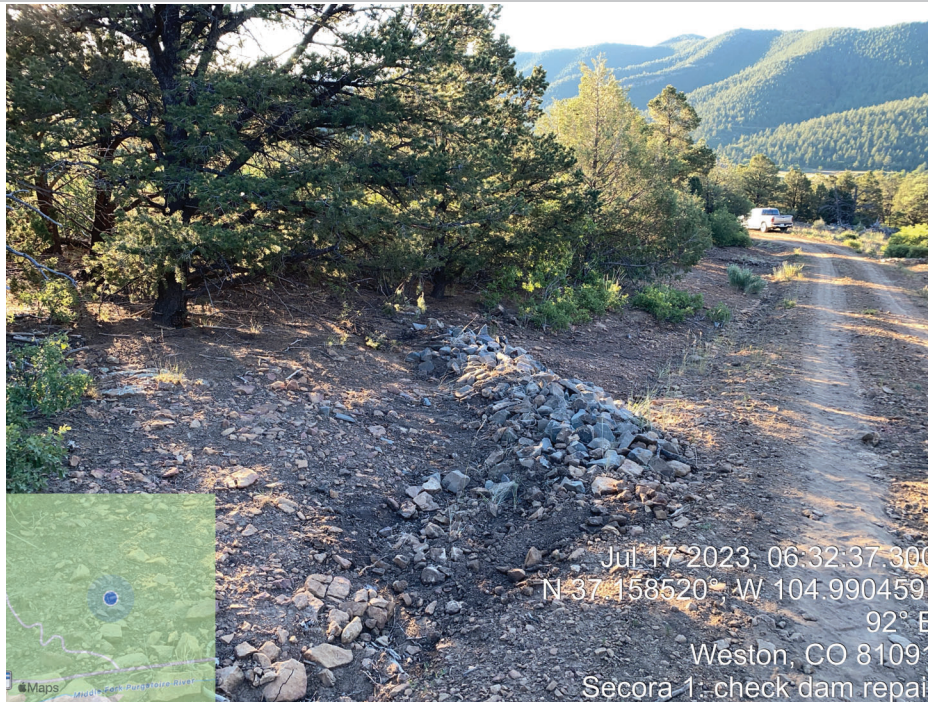
Photo Point 17: Check Dam Repair Coordinates: 37.158520, -104.990459

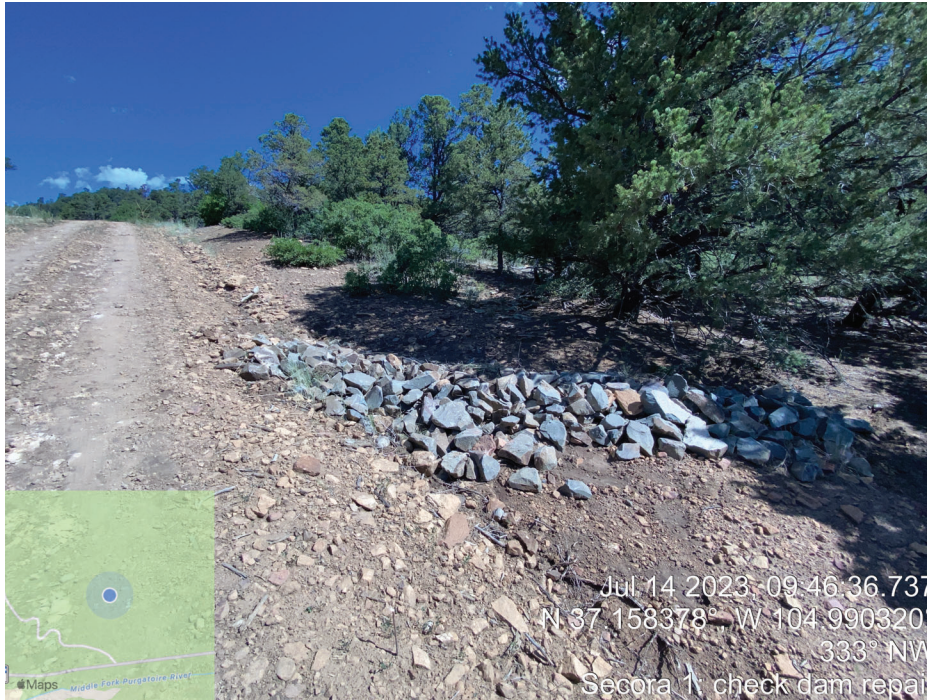
Photo Point 18: Check Dam Repair

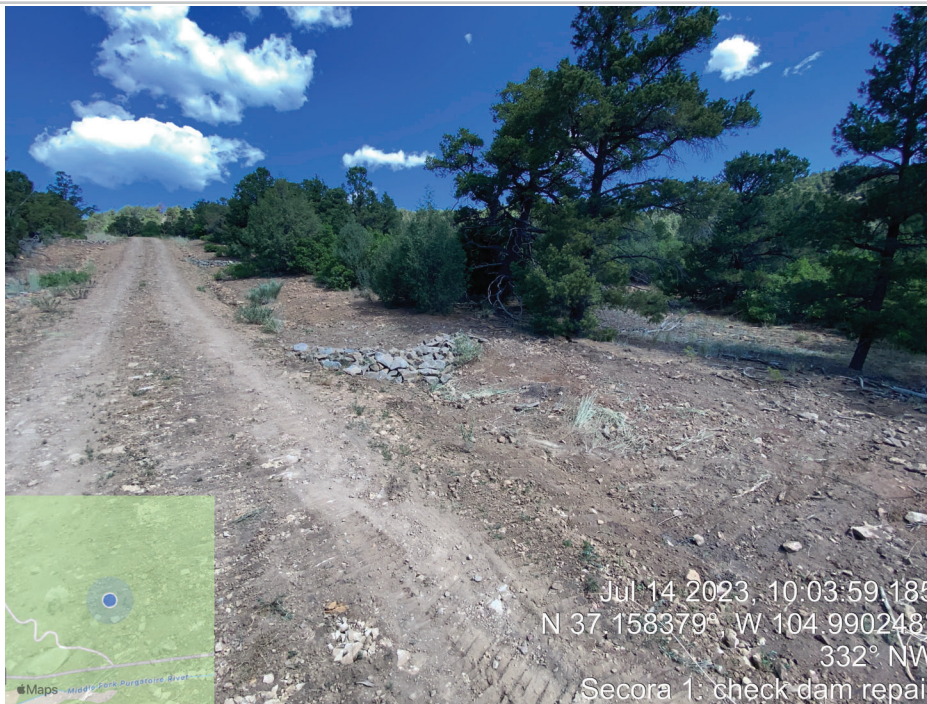
Photo Point 19: Check Dam Repair

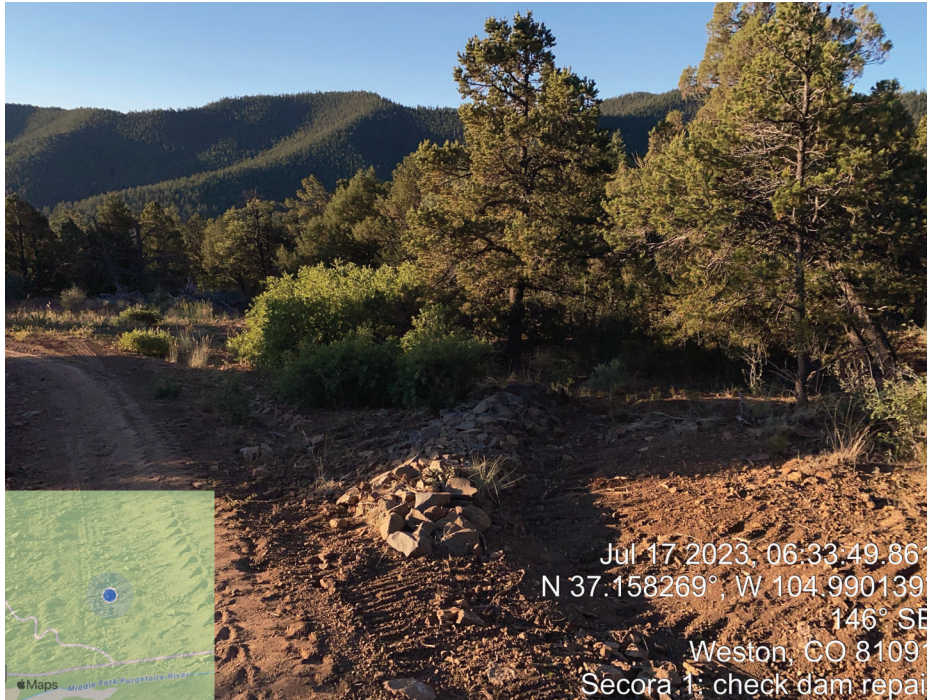
Photo Point 20: Check Dam Repair

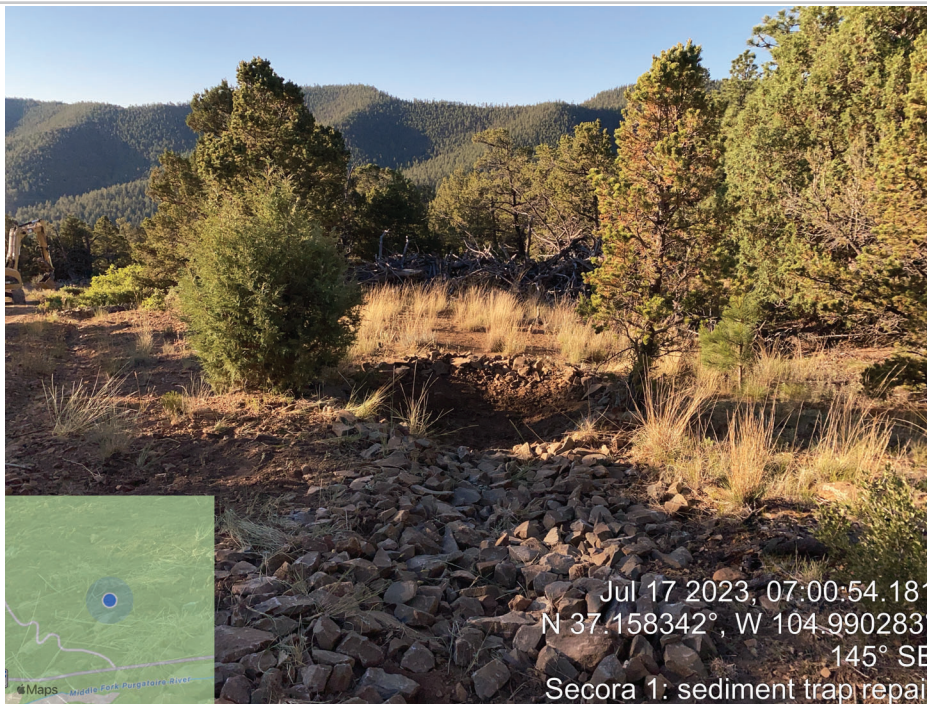
Photo Point 21: Sediment Trap Repair

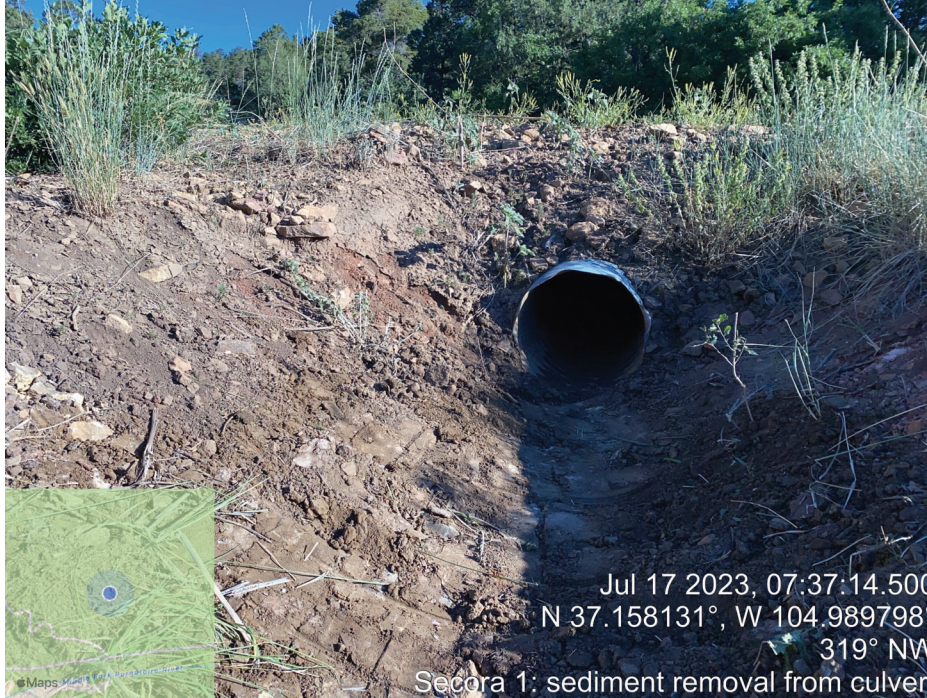
Four corrugated steel culverts were observed on the Location access road. All culverts were evaluated for sedimentation and other obstructions. One culvert (Photo Point 22) was found to be sediment laden. Sediment was removed and hauled offsite by subcontractors.

Photo Point 22: Culvert Maintenance

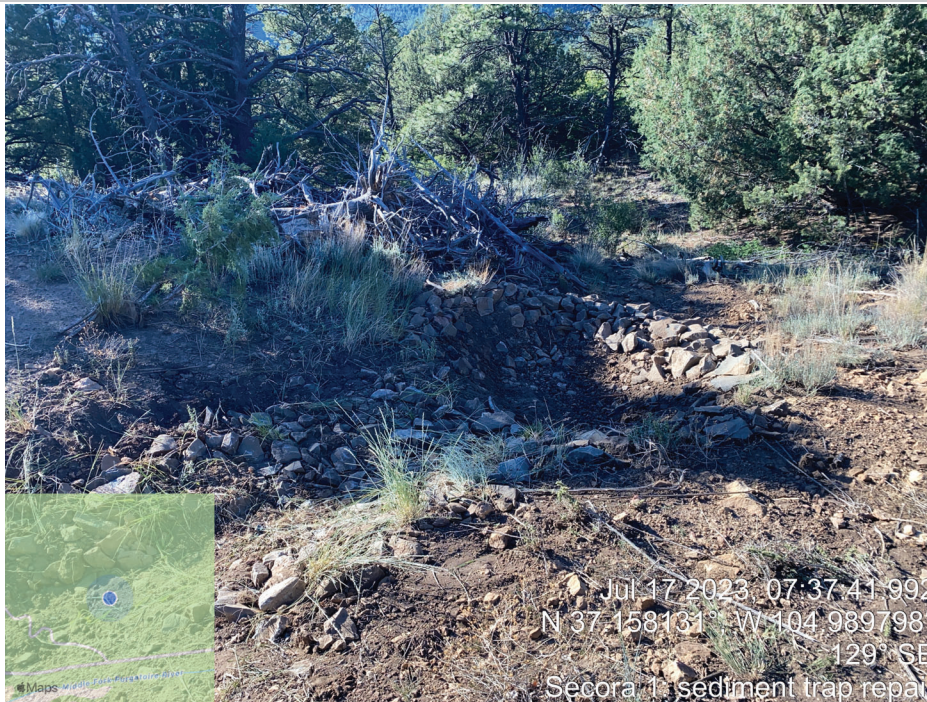
Photo Point 23: Sediment Trap Maintenance

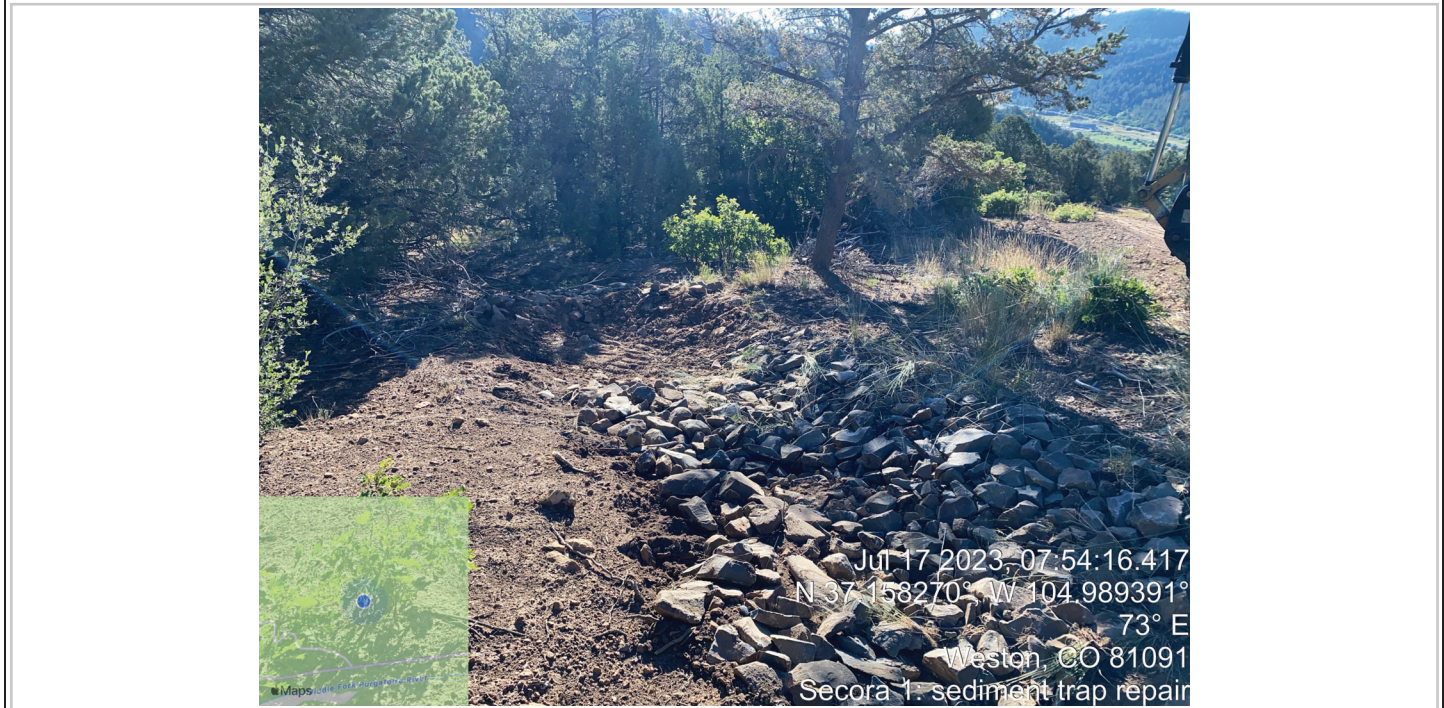
Photo Point 24: Sediment Trap Repair Coordinates: 37.158270, -104.989391

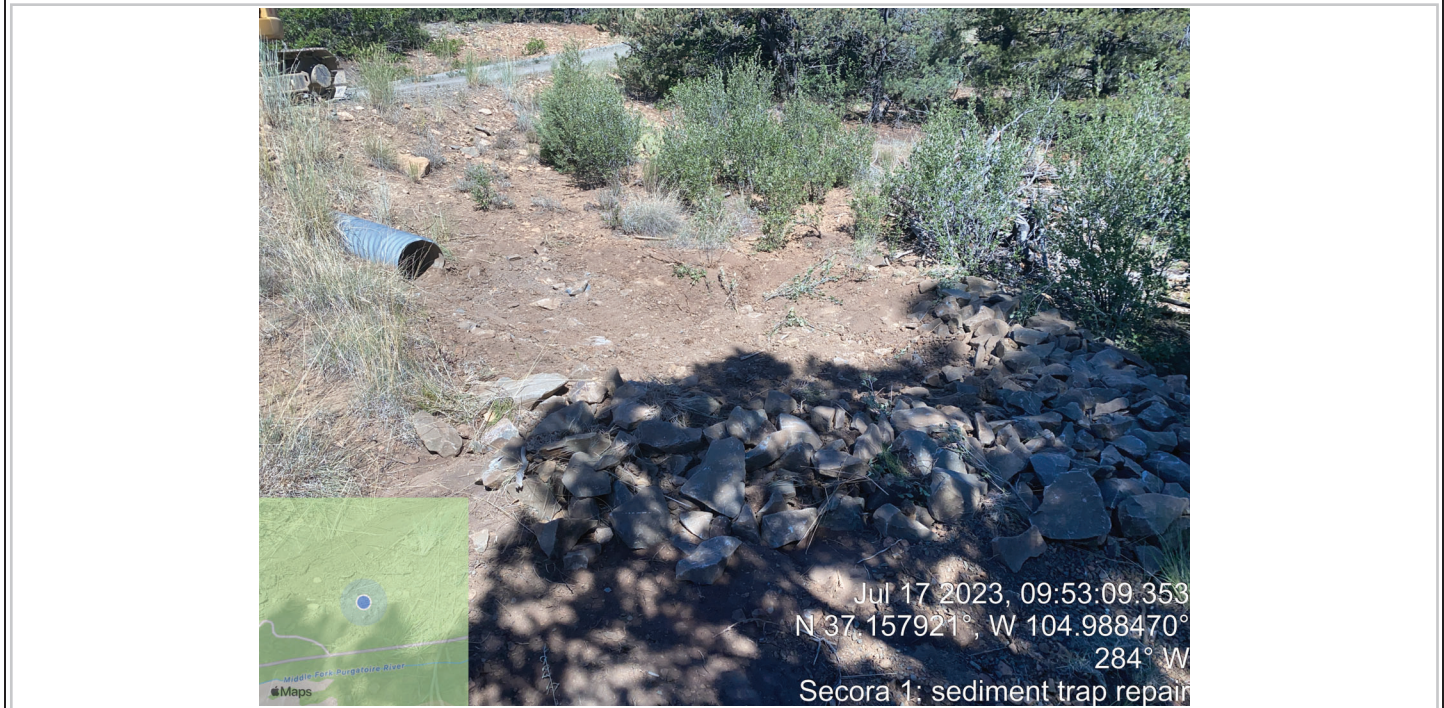
Photo Point 25: Culvert Maintenance, Sediment Trap Repair Coordinates: 37.158027, -104.988499

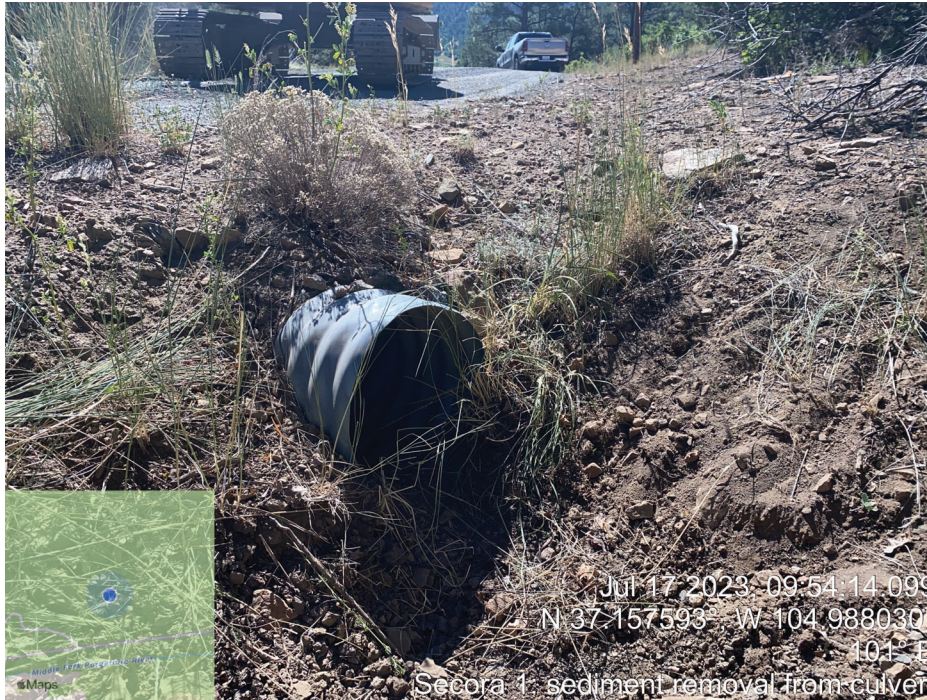
Photo Point 26: Culvert Maintenance

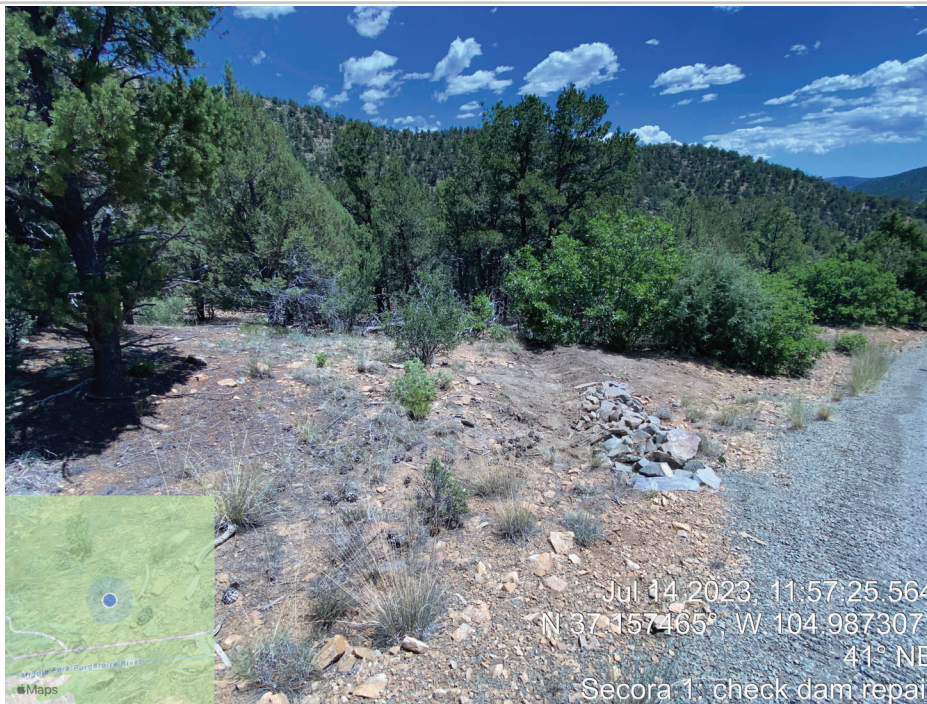
Photo Point 27: Check Dam Turnout Maintenance

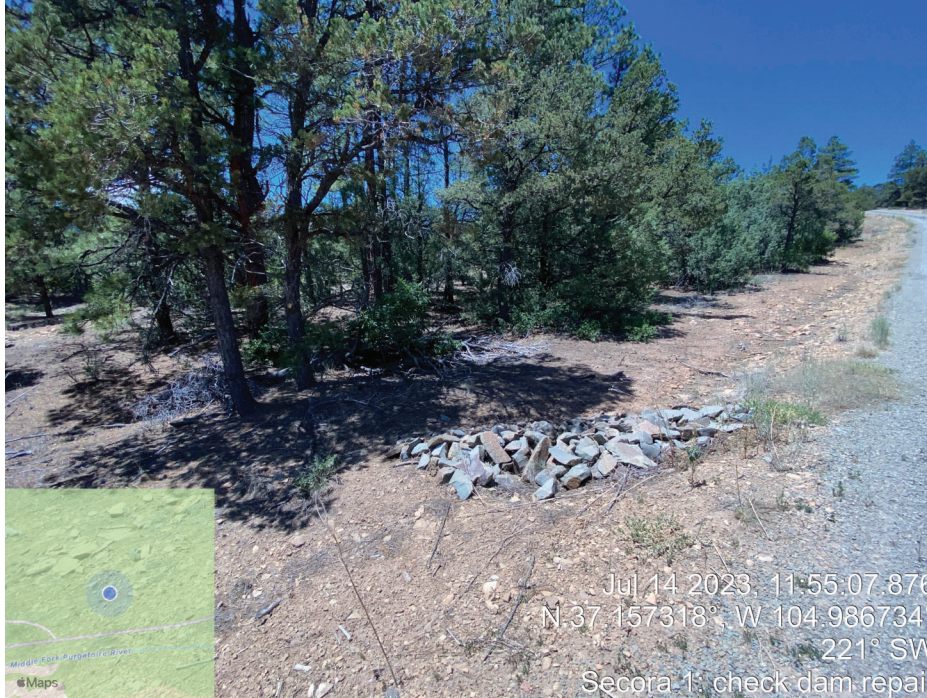
Photo Point 28: Check Dam Repair

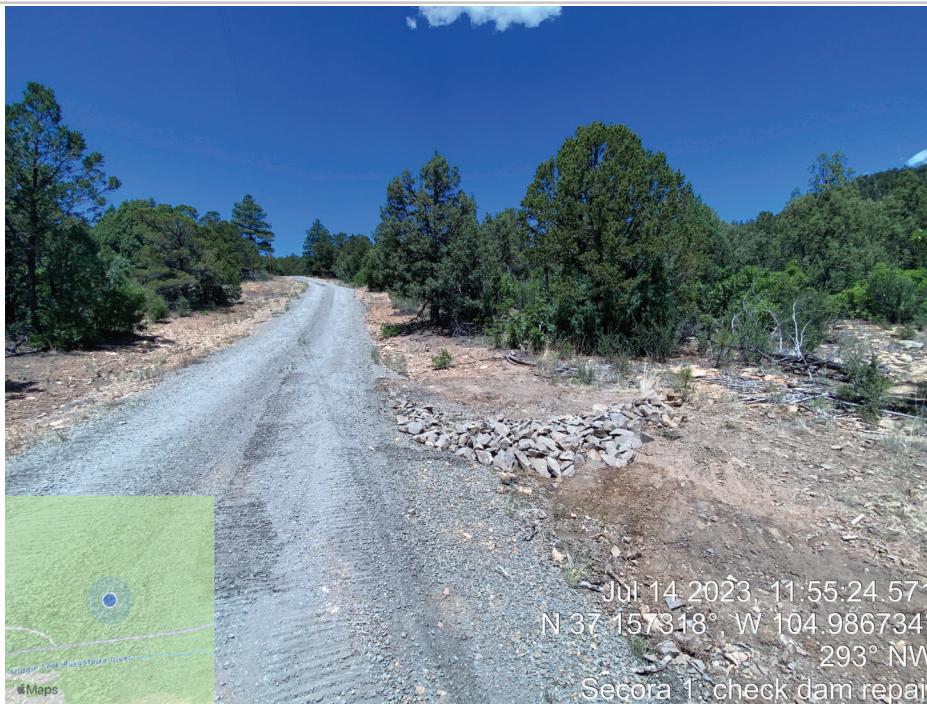
Photo Point 29: Check Dam Maintenance

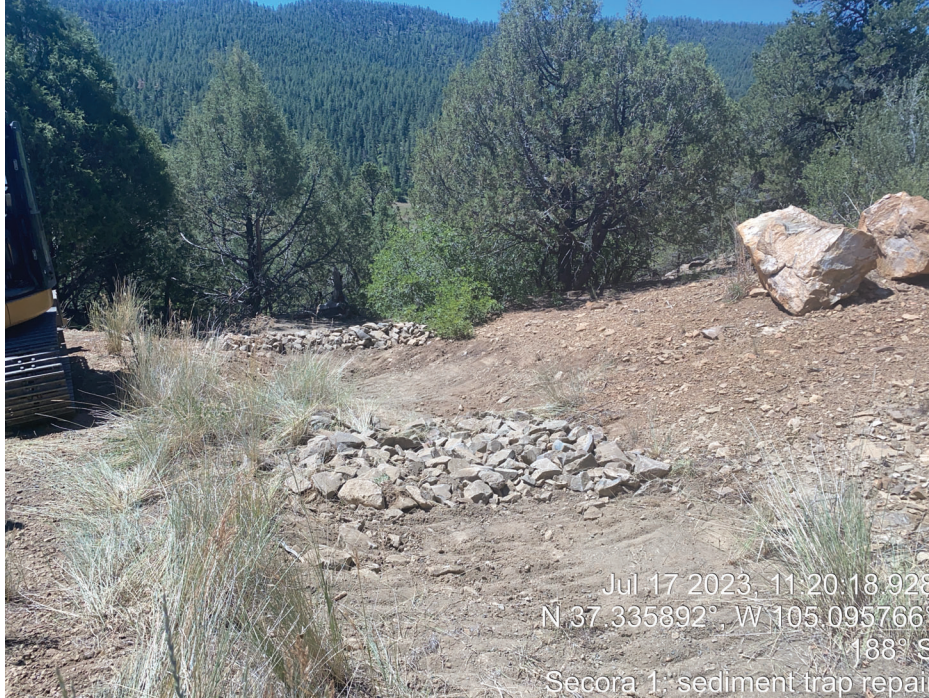
Photo Point 30: Sediment Trap Repair
