Scout Energy Management LLC
U P 12-27
Loc ID: 314607

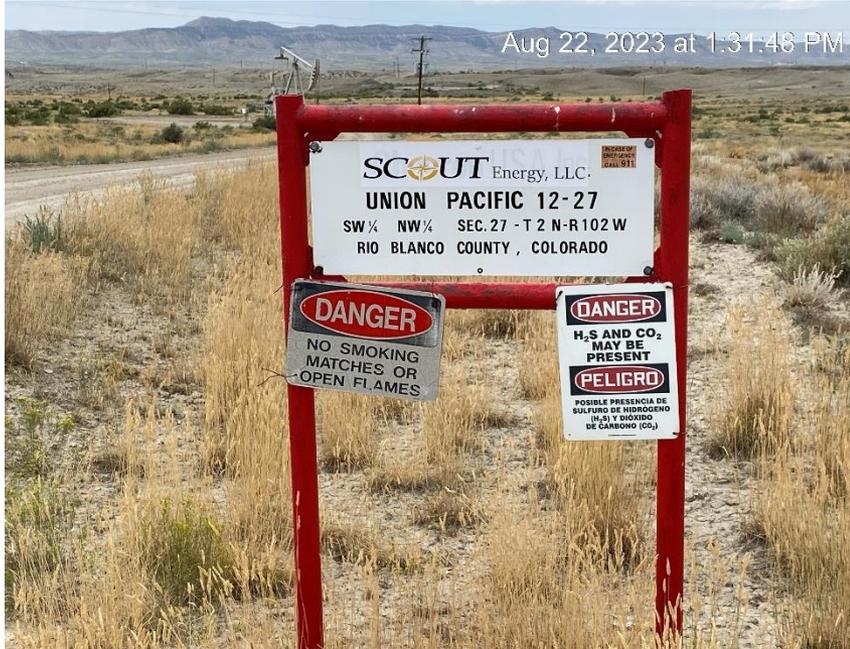
Entrance sign if replaced will require additional information.

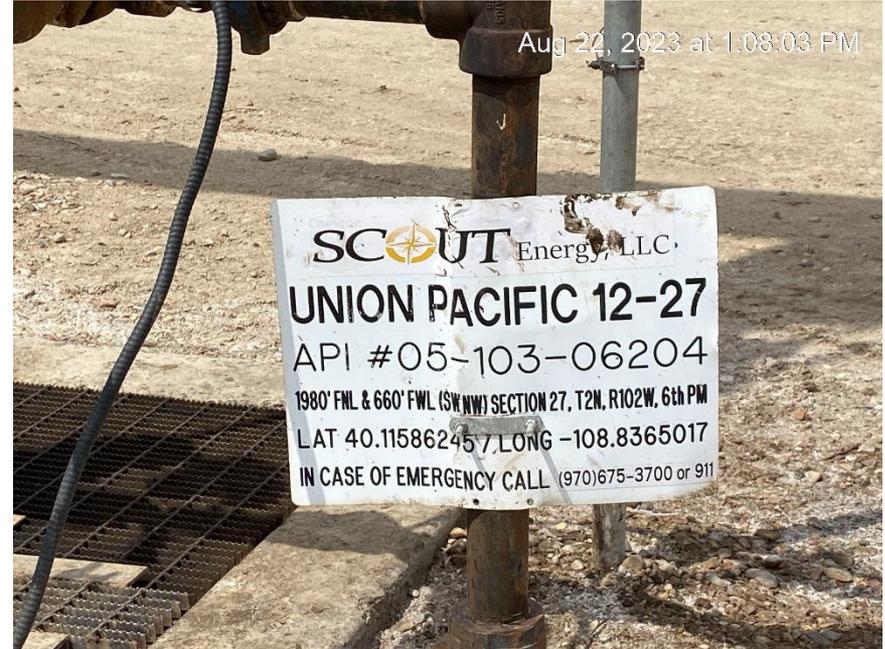
Well sign missing required information

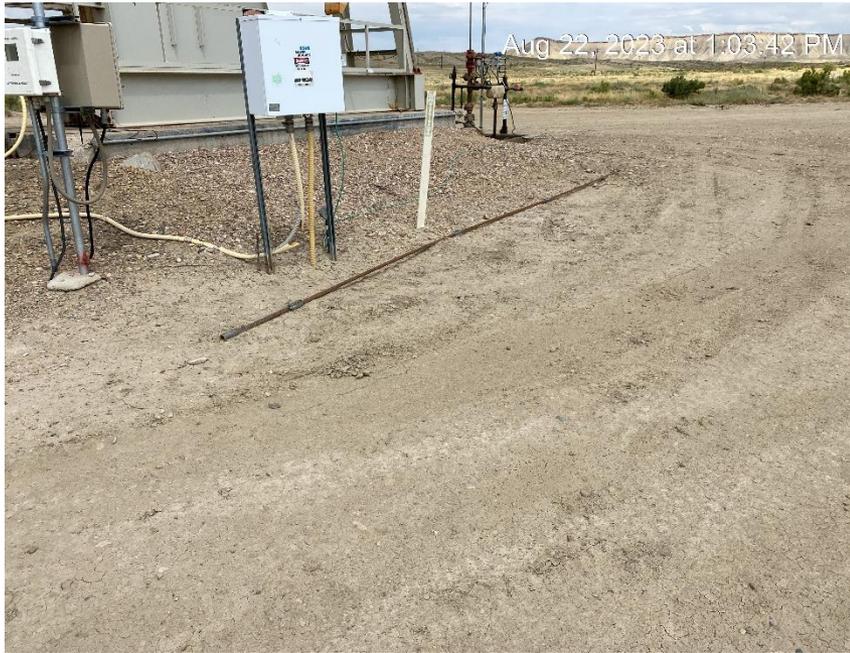
Debris

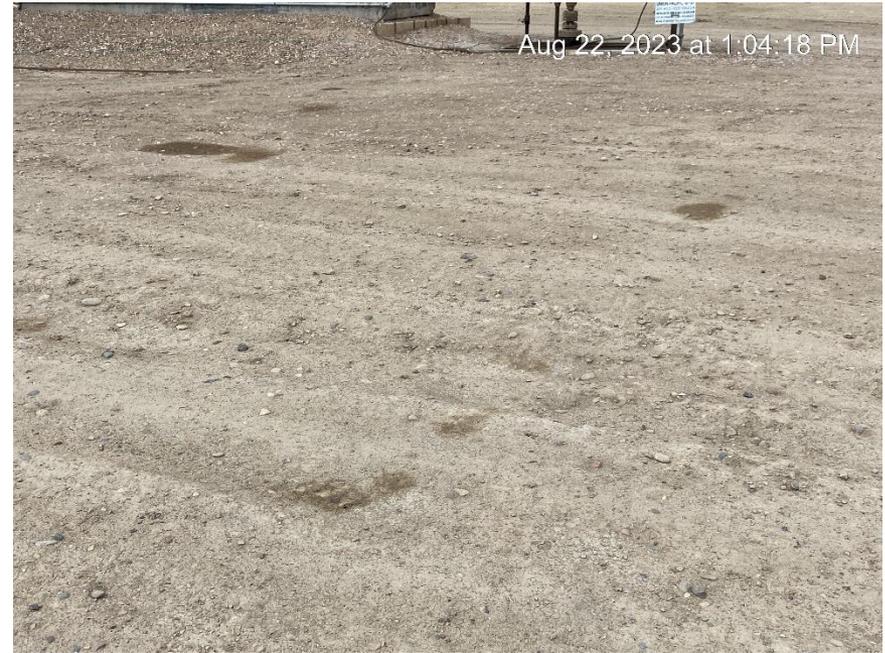
Stained soils

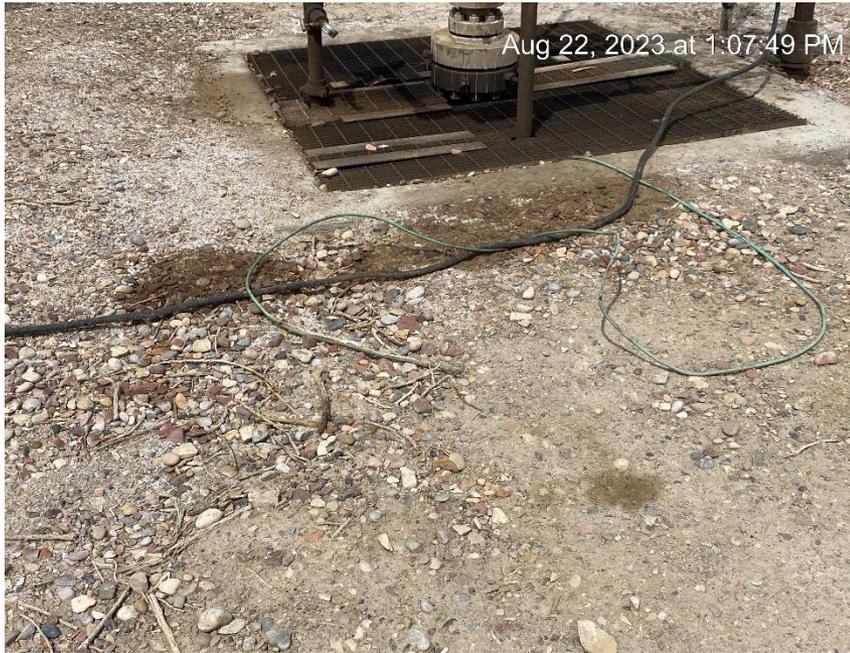
Debris. Stained soil.

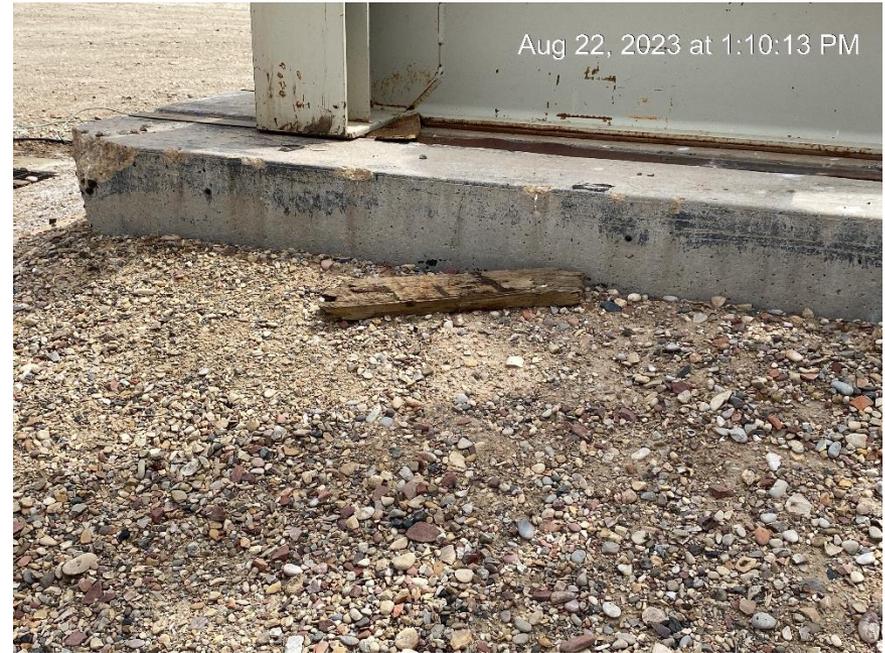
Debris

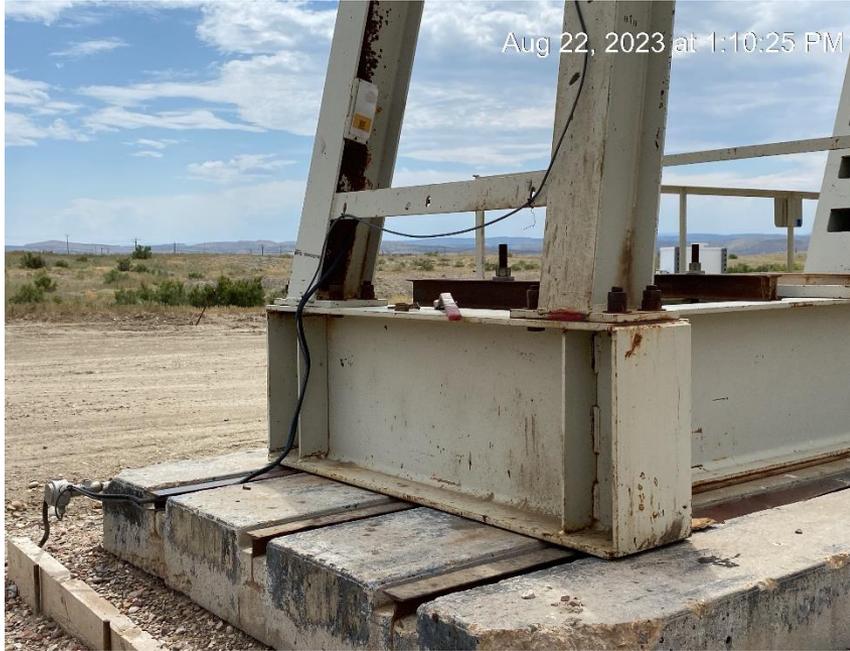
Debris on pumping unit
