**Storm Water Management and Erosion control**  
**Location Name: CAERUS PICEANCE LLC CASS-GARBER Pad**  
**Location ID: 334129**

**Location Overview: Location is within Black Bear Habitat & in close proximity to High Priority/Density Habitat areas.**

**Section/Township/Range: 1 8S96W**

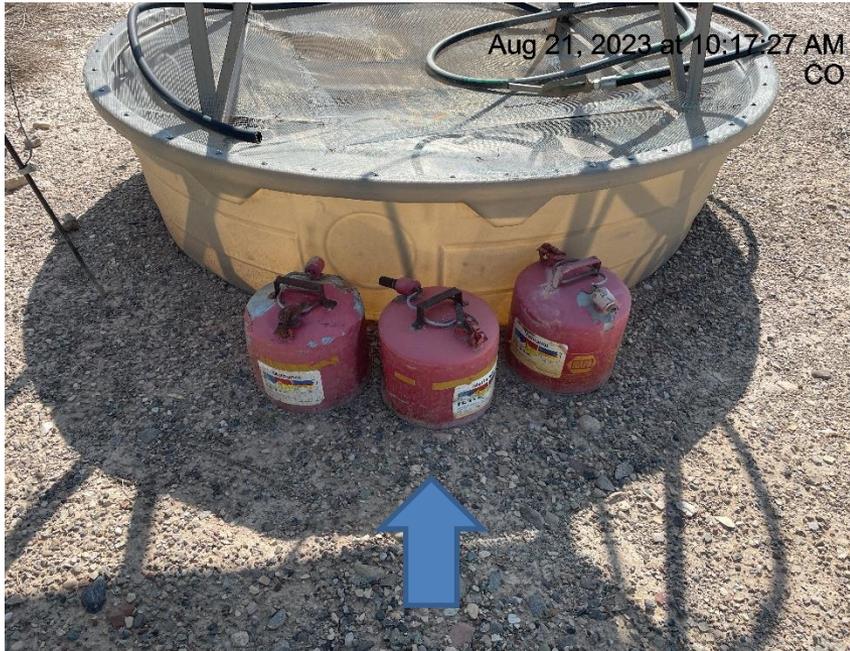
**Photo # 6737 Improperly stored chemicals/chemical containers**

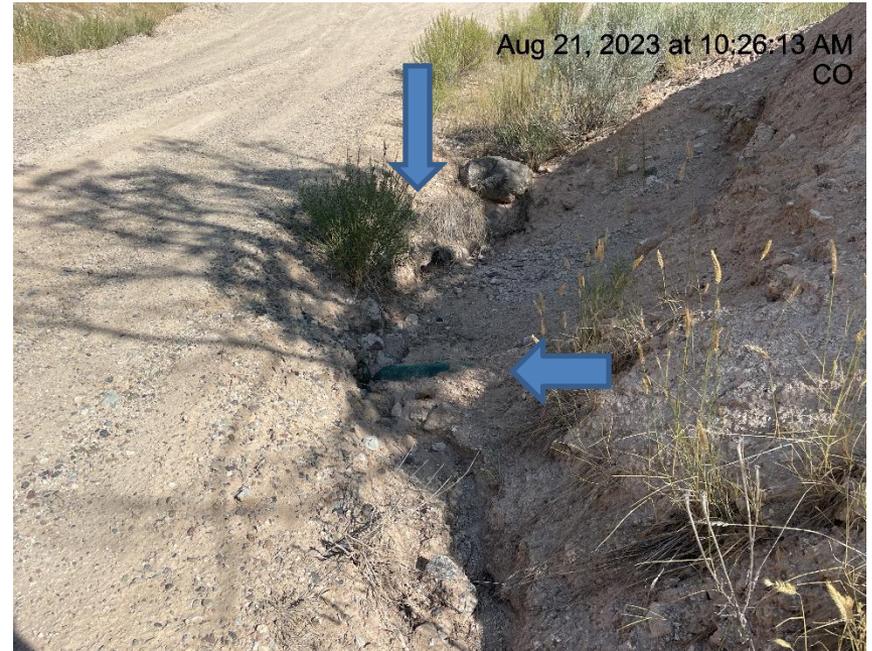
**Photo # 6753 Check dam & culvert inlet/BMP's need maintenance (near entrance to location) Slope showing signs of lack of stabilization**

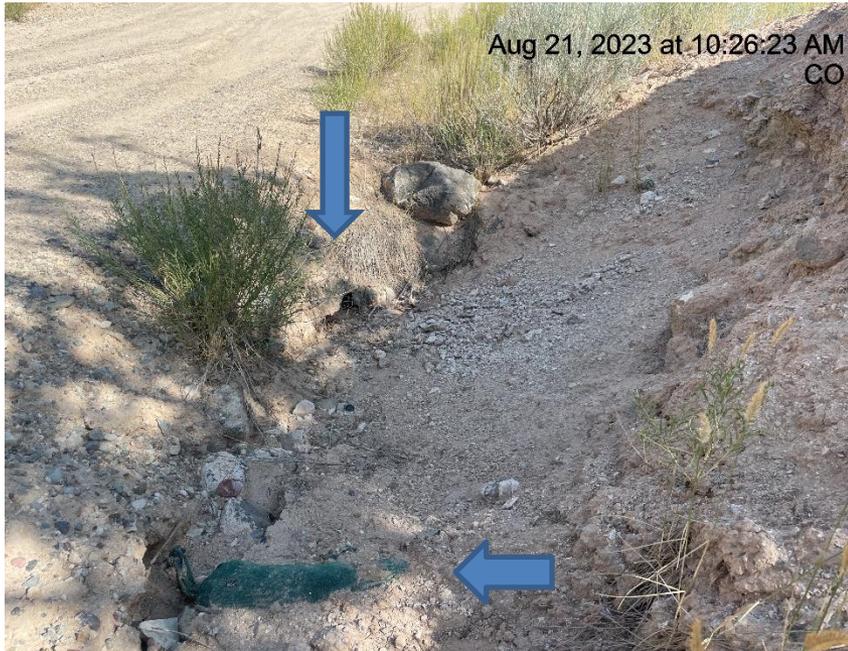
**Photo # 6754 Check dam & culvert inlet/BMP's need maintenance (near entrance to location) Slope showing signs of lack of stabilization**

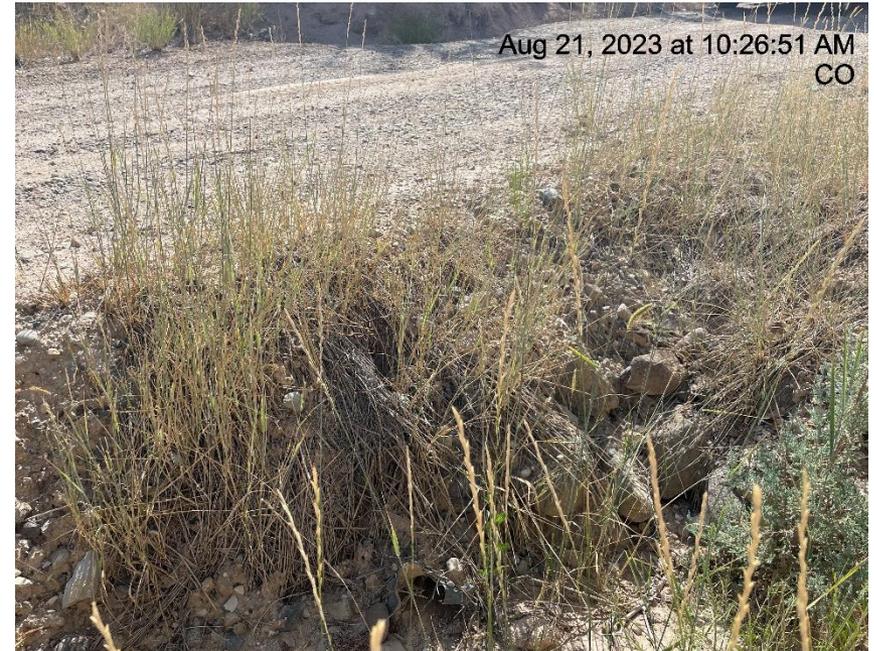
**Photo # 6755 Culvert outlet needs maintenance (near entrance to location)**

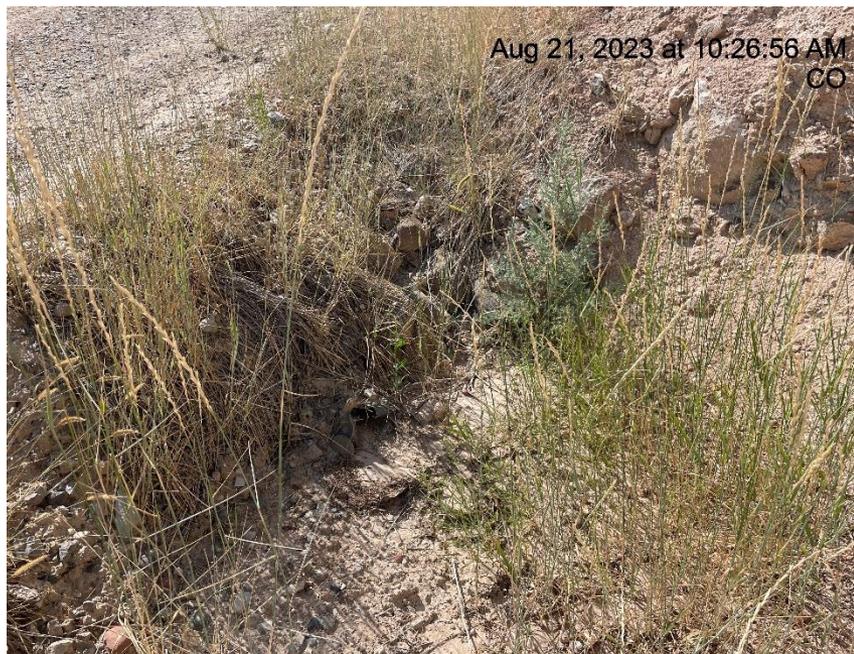
**Photo # 6755 Culvert outlet needs maintenance (near entrance to location)**

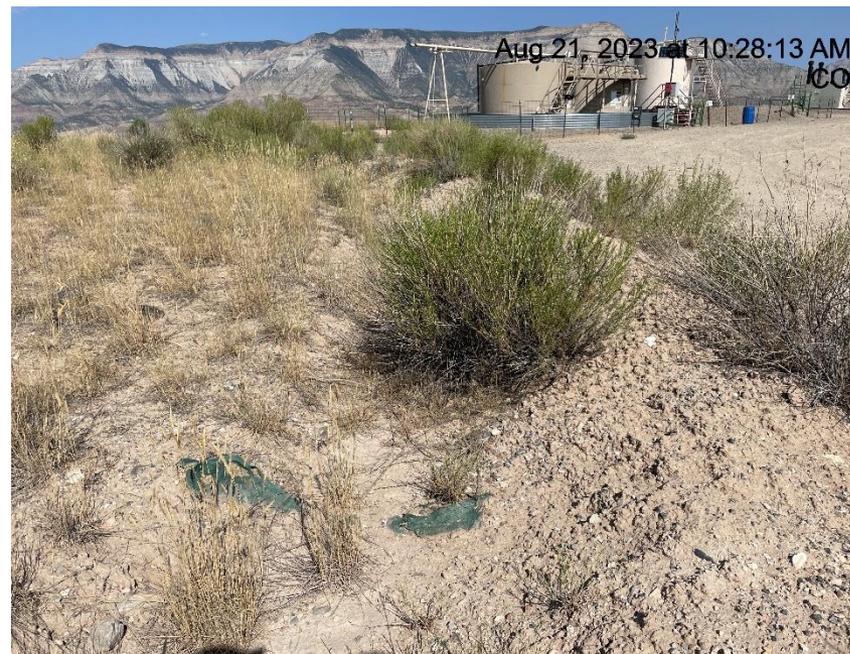
**Photo # 6761 Check dams need maintenance**

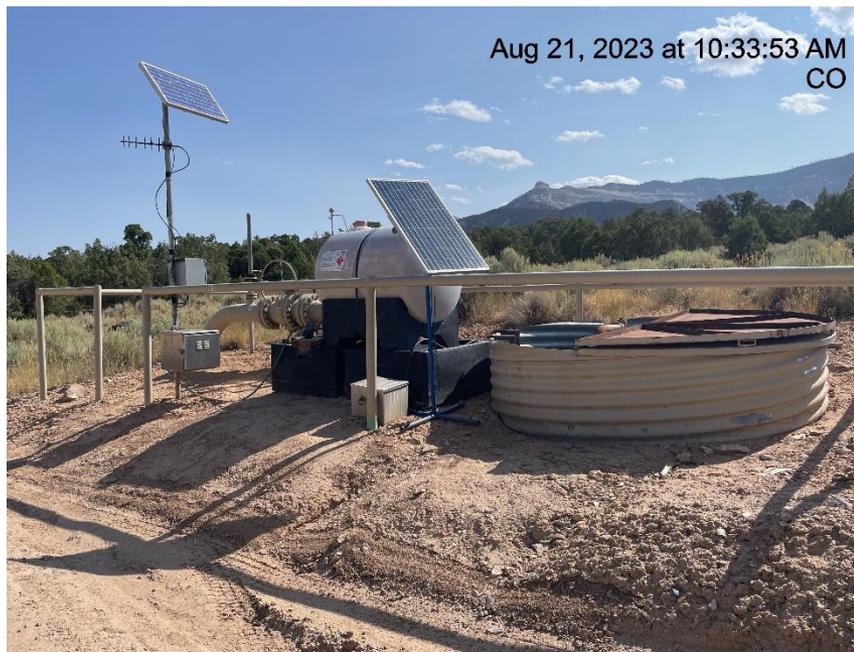
Aug 21, 2023 at 10:33:53 AM  
CO

**Photo # 6768 Failure to maintain chemical BMP/chemical containment approximately 3/8<sup>th</sup> full of fluid (approximately 5/10<sup>th</sup> of a mile down lease road & 50-75 yards past spur road turnoff to CASS-GARBER pad)**

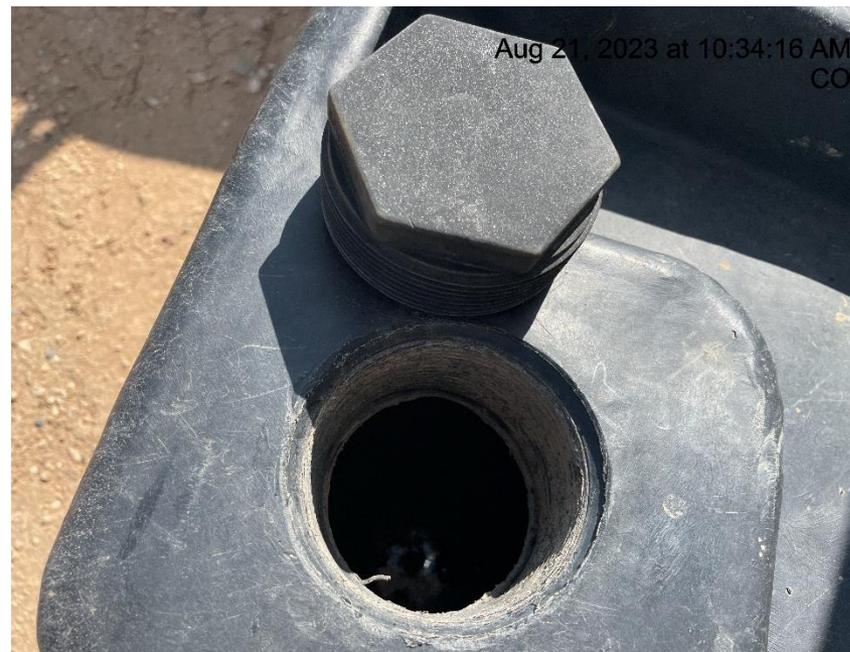
Aug 21, 2023 at 10:34:16 AM  
CO

**Photo # 6771 Failure to maintain chemical BMP/chemical containment approximately 3/8<sup>th</sup> full of fluid (approximately 5/10<sup>th</sup> of a mile down lease road & 50-75 yards past spur road turnoff to CASS-GARBER pad)**
