Inspection Photos

Location Name: CAERUS PICEANCE LLC CASS-GARBER Pad

Location ID: 334129

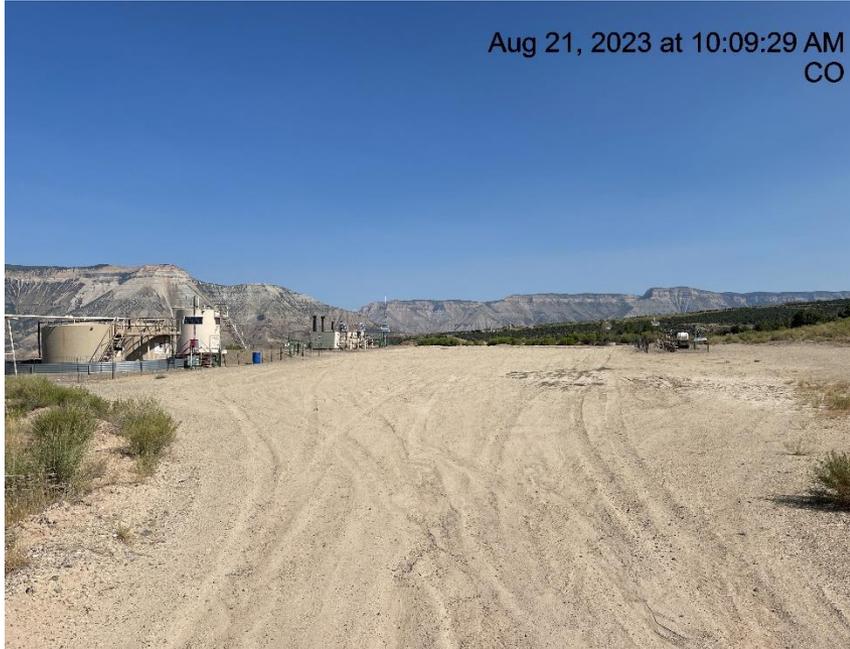
Photo # 6715 From entrance to location

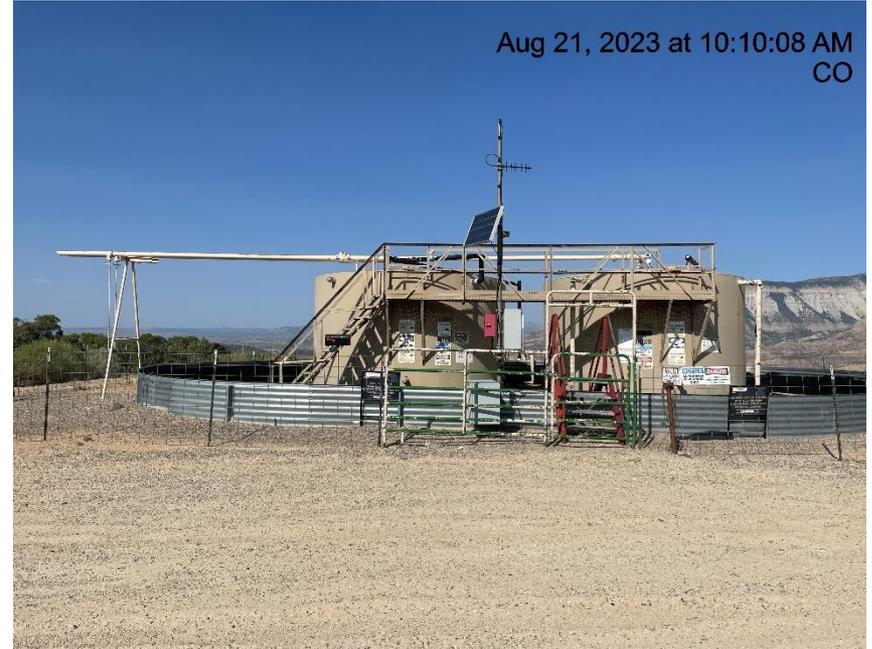
Photo # 6717 Location

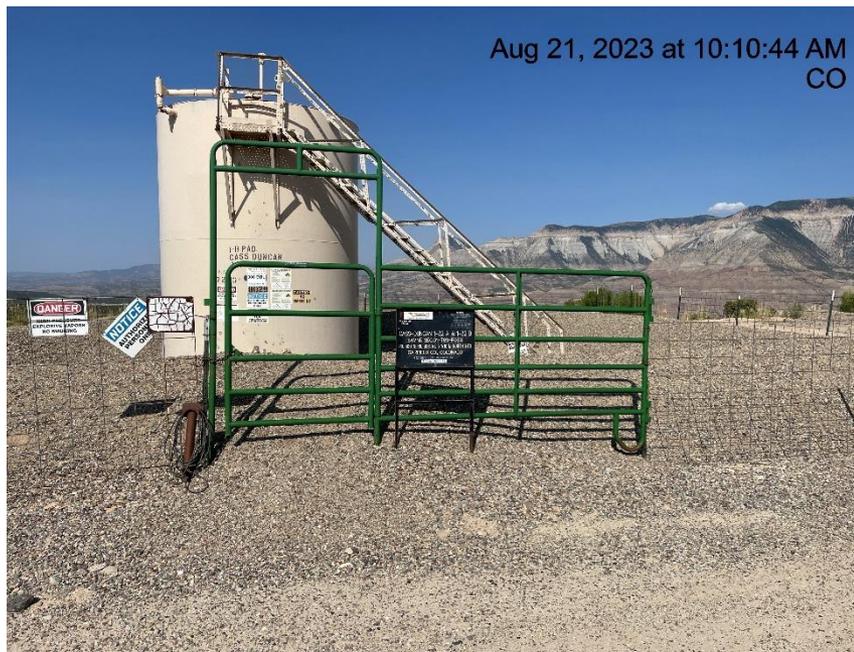
Photo # 6719 Location

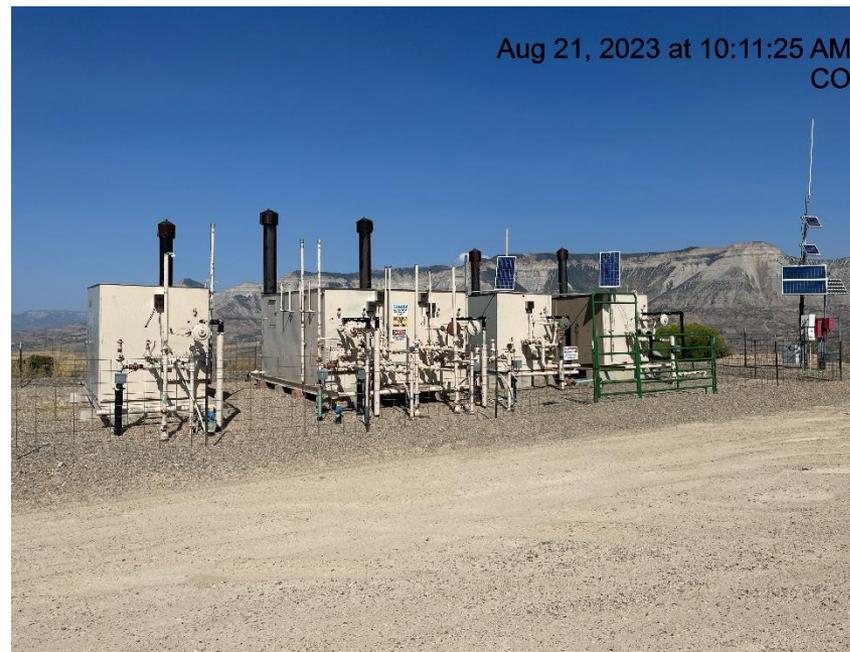
Photo # 6722 Location

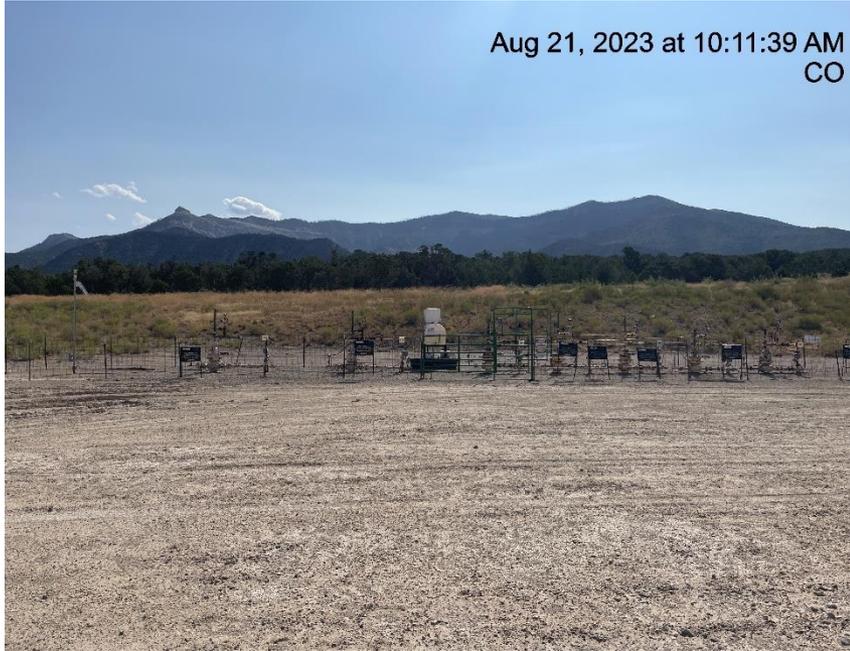
Photo # 6723 Location

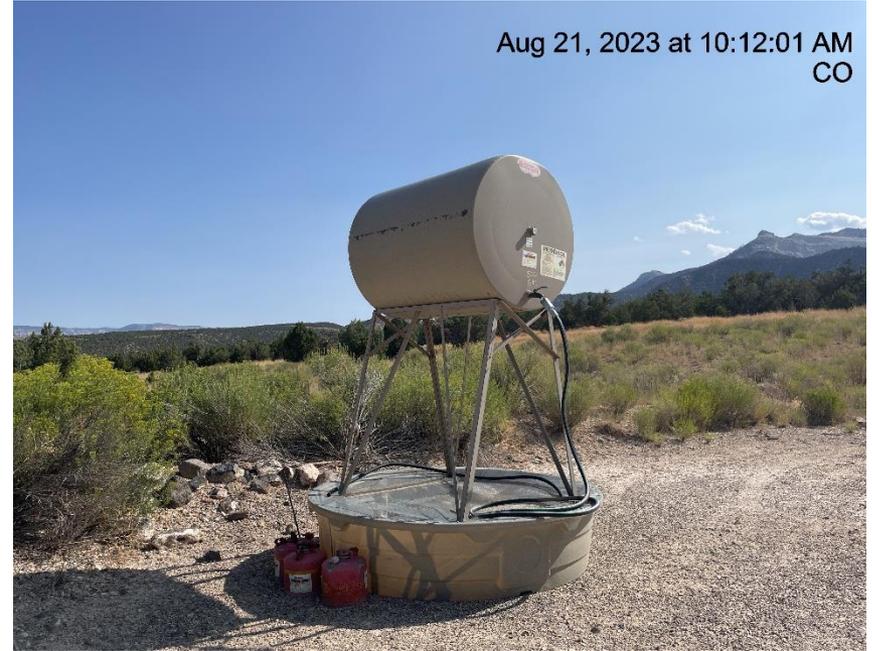
Photo # 6724 Location

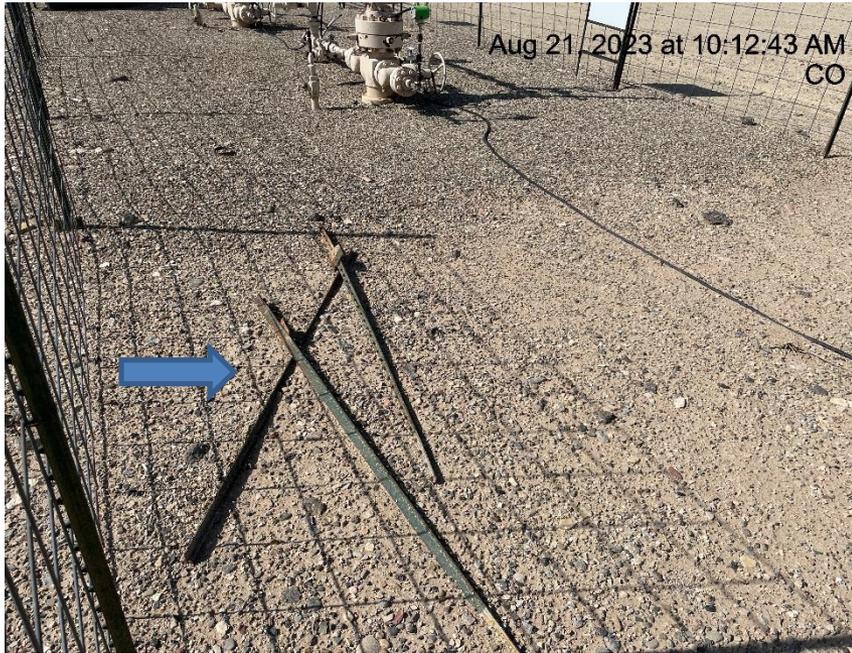
Photo # 6726 Debris

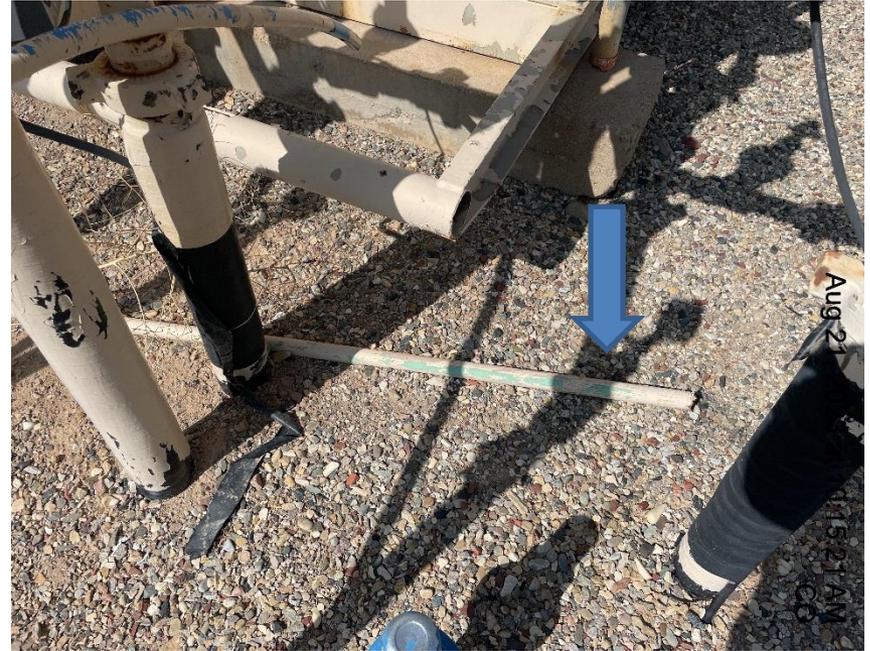
Photo # 6730 Debris

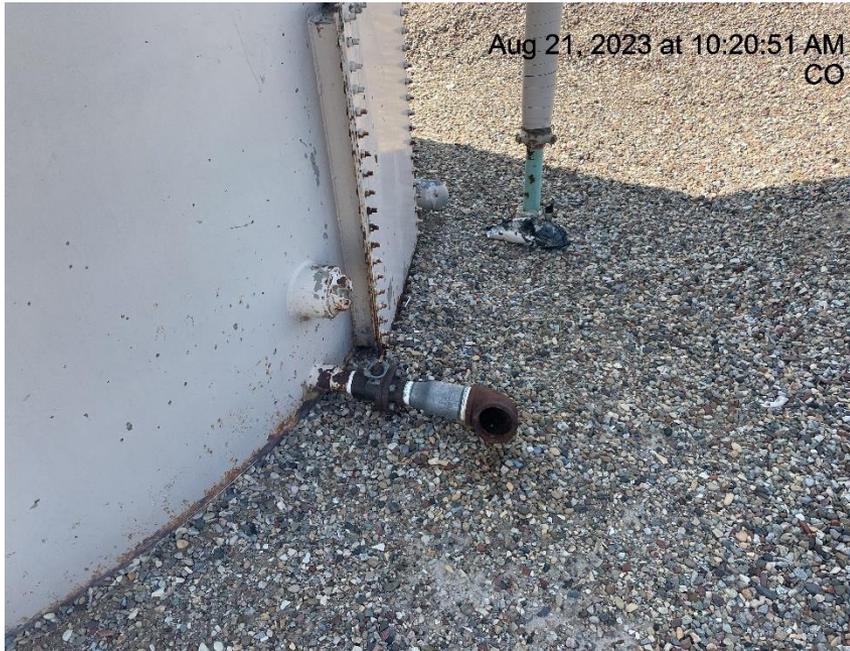
Photo # 6741 Open ended load line

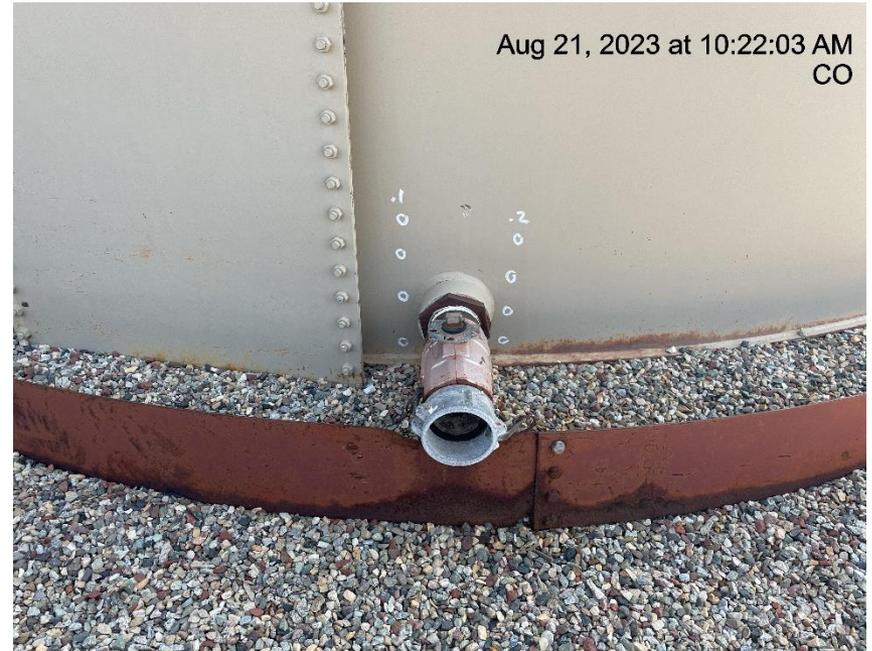
Photo # 6744 Open ended load line

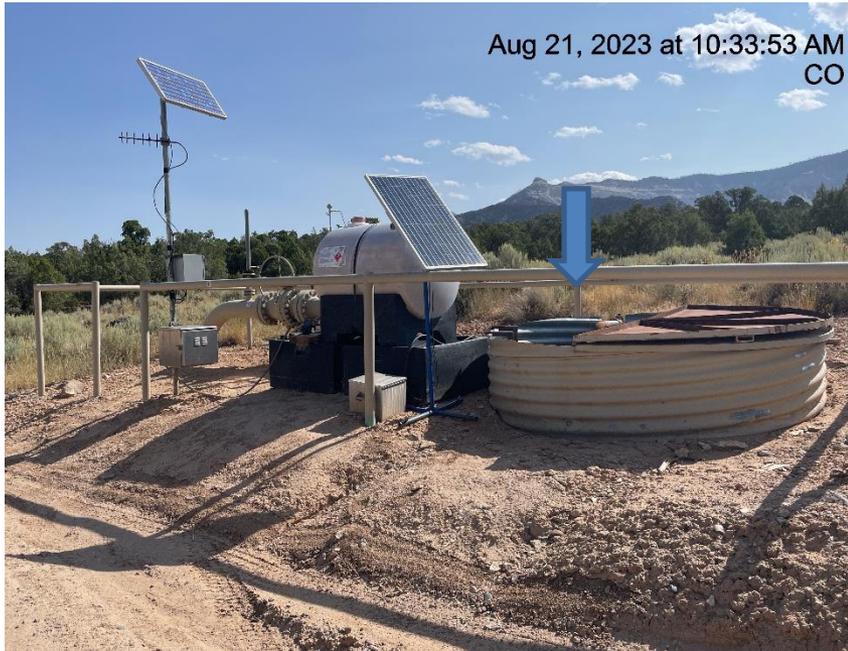
Photo # 6768 Open cellar/wildlife hazard (approximately 5/10th of a mile down lease road & 50-75 yards past spur road turnoff to CASS-GARBER pad)

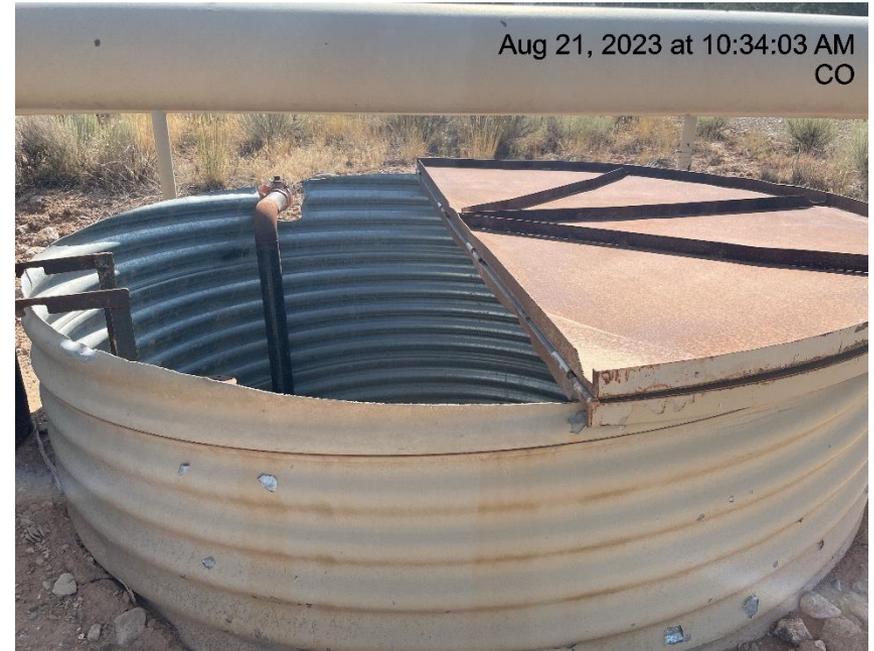
Photo # 6769 Open cellar/wildlife hazard Open cellar/wildlife hazard (approximately 5/10th of a mile down lease road & 50-75 yards past spur road turnoff to CASS-GARBER pad)

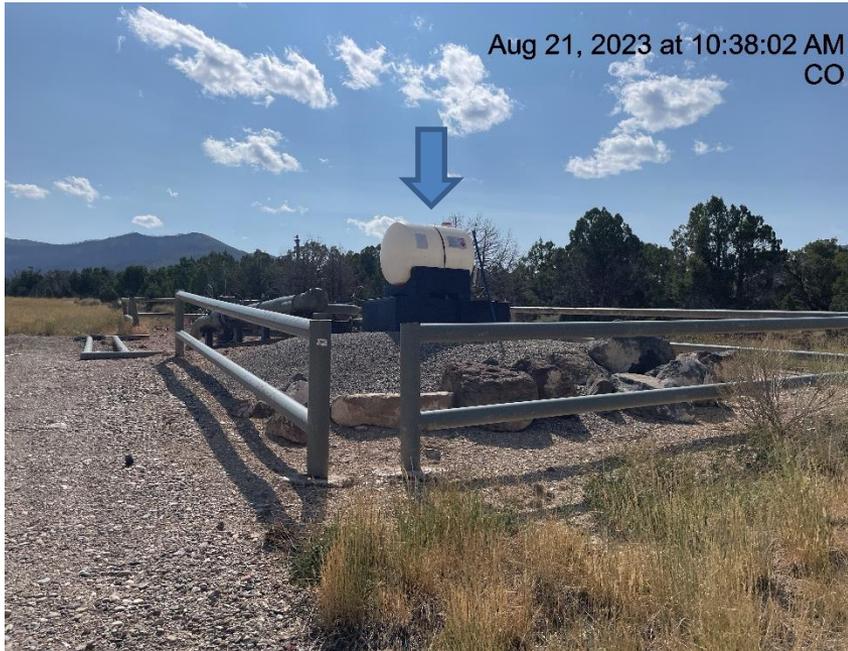
Photo # 6790 Unused equipment (approximately 2/10th of mile from start of lease road at pig station)

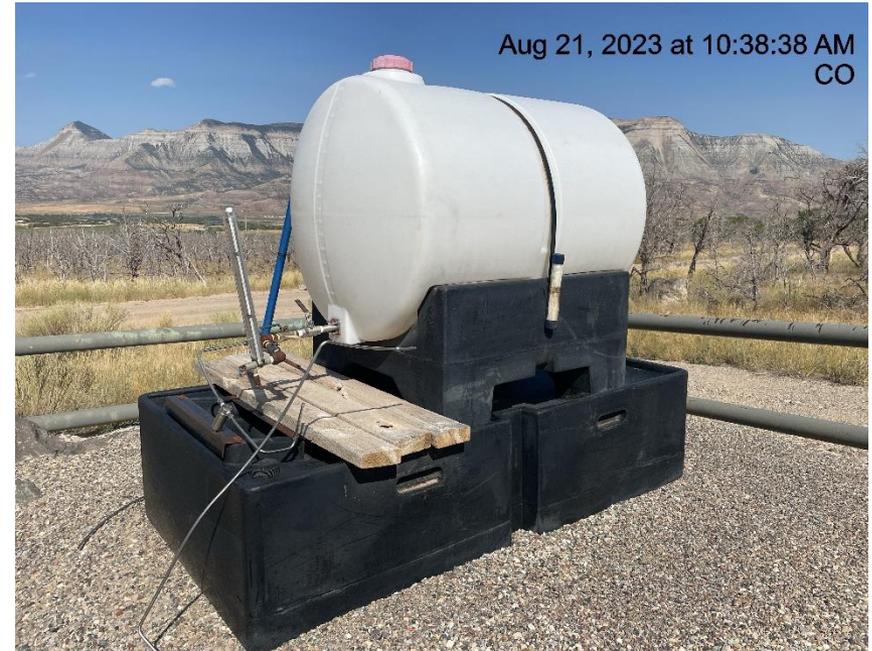
Photo # 6791 Unused equipment (approximately 2/10th of mile from start of lease road at pig station)

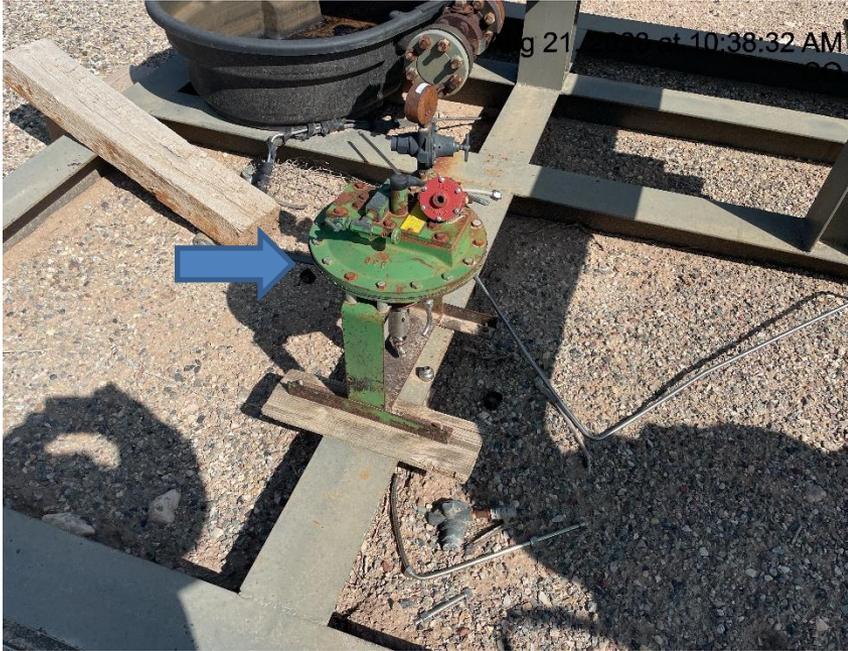
Photo # 6792 Unused equipment (approximately 2/10th of mile from start of lease road at pig station)
