Third Party Flowline Abandon in place Verification Letter

Wardell 7A 3

Client: Crestone Peak Resources Operating LLC

Facility Name: Wellhead Line 7 SESE

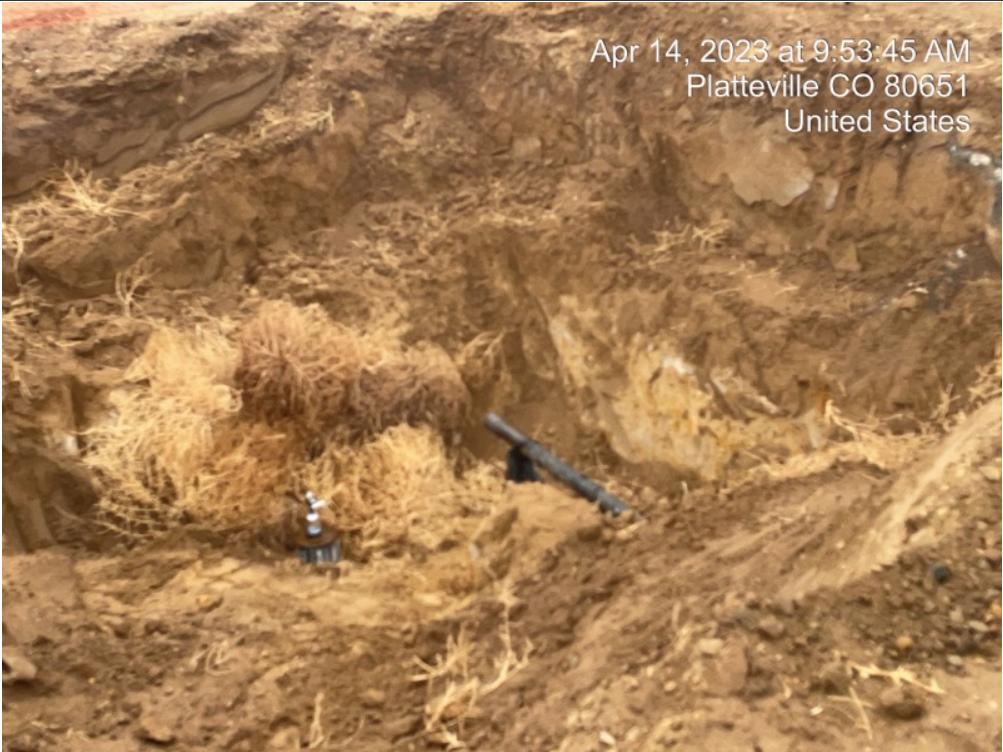
Information		Photo
Photo #: Location: Description:	3 Wellhead Wardell 7A-3 End A prior to flushing activity

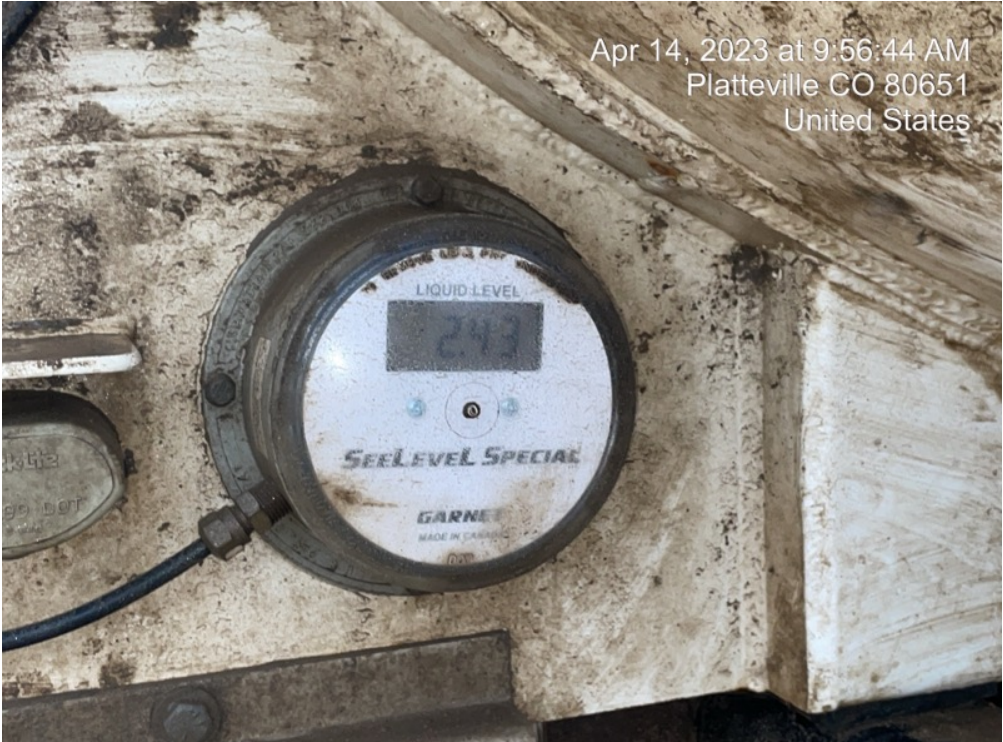
<p>Apr 14, 2023 at 9:53:45 AM Platteville CO 80651 United States</p>
Photo #: Location: Description:	4 Wellhead Meter on vacuum truck prior to flushing activity

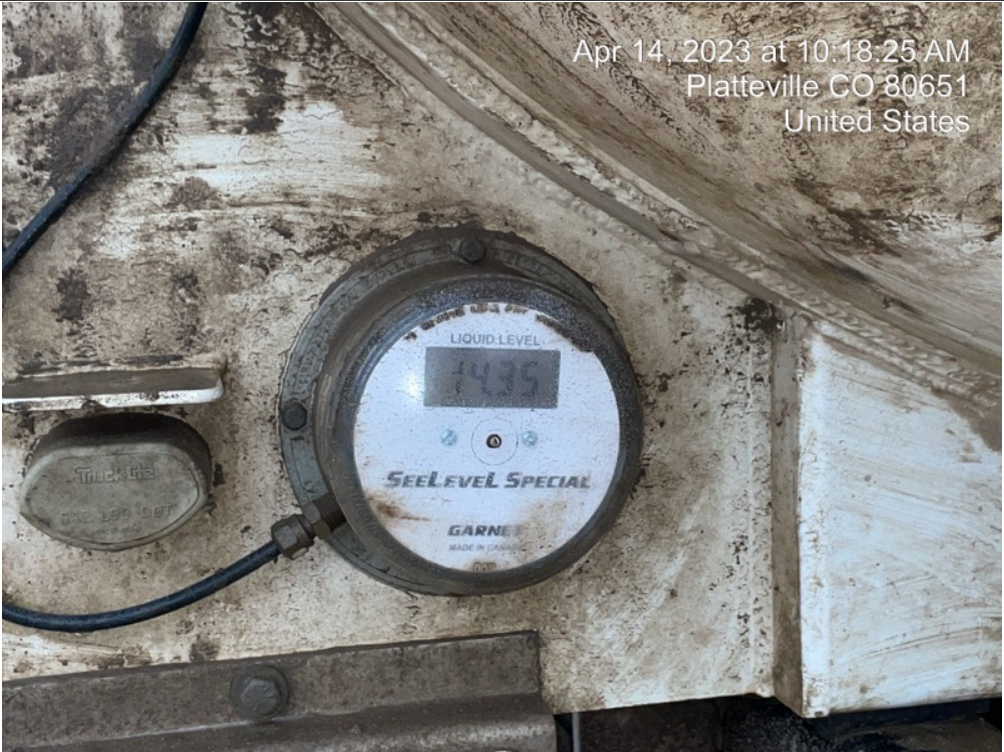
Information		Photo
Photo #: Location: Description:	5 Wellhead Meter on vacuum truck post flushing activity

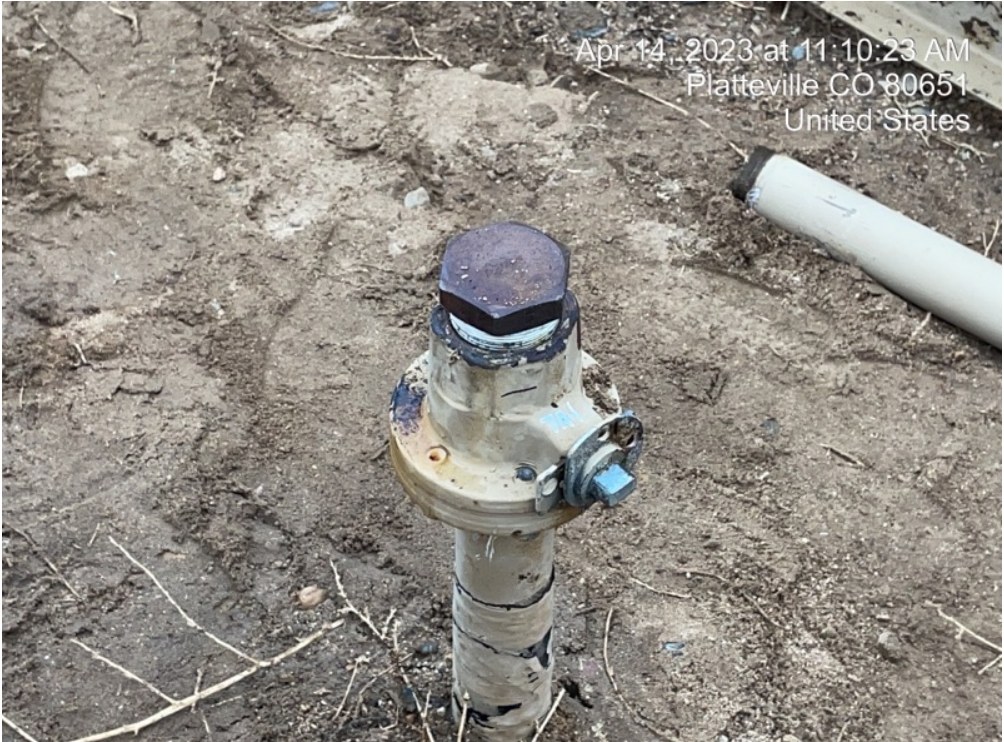
<p data-bbox="1136 357 1542 462">Apr 14, 2023 at 10:18:25 AM Platteville CO 80651 United States</p>
Photo #: Location: Description:	6 Separator End B post flushing activity

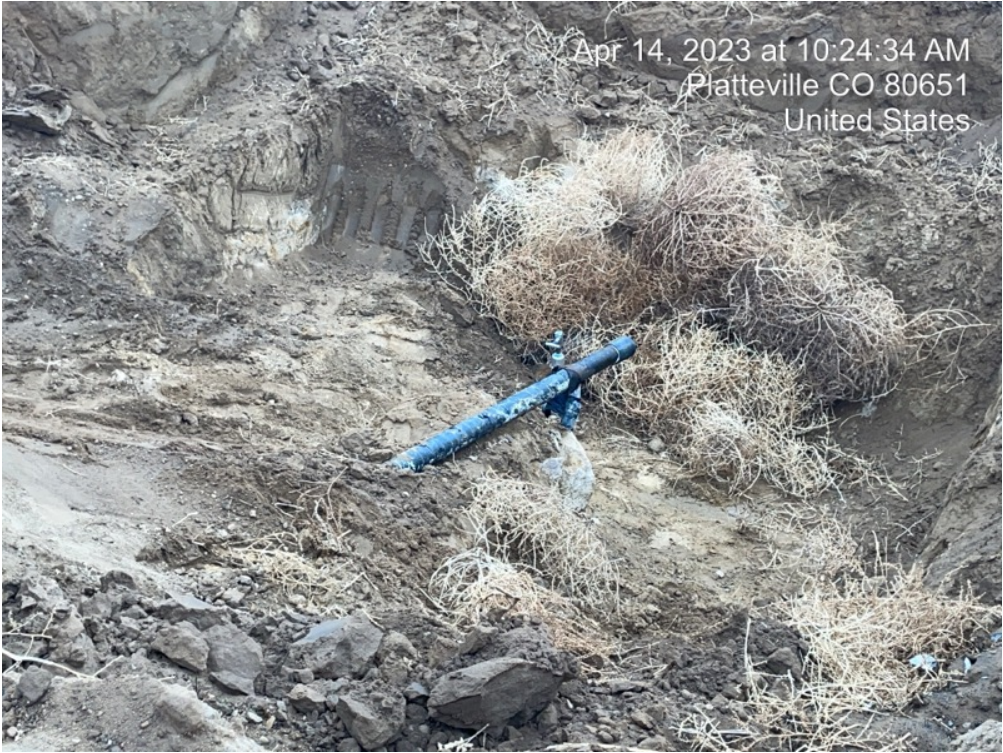
Information		Photo
Photo #: Location: Description:	7 Wellhead End A post flushing activity
