Inspection Photos

API: 061-06394

Operator: STRACHAN EXPLORATION INC

Inspection Date: 8/24/2023

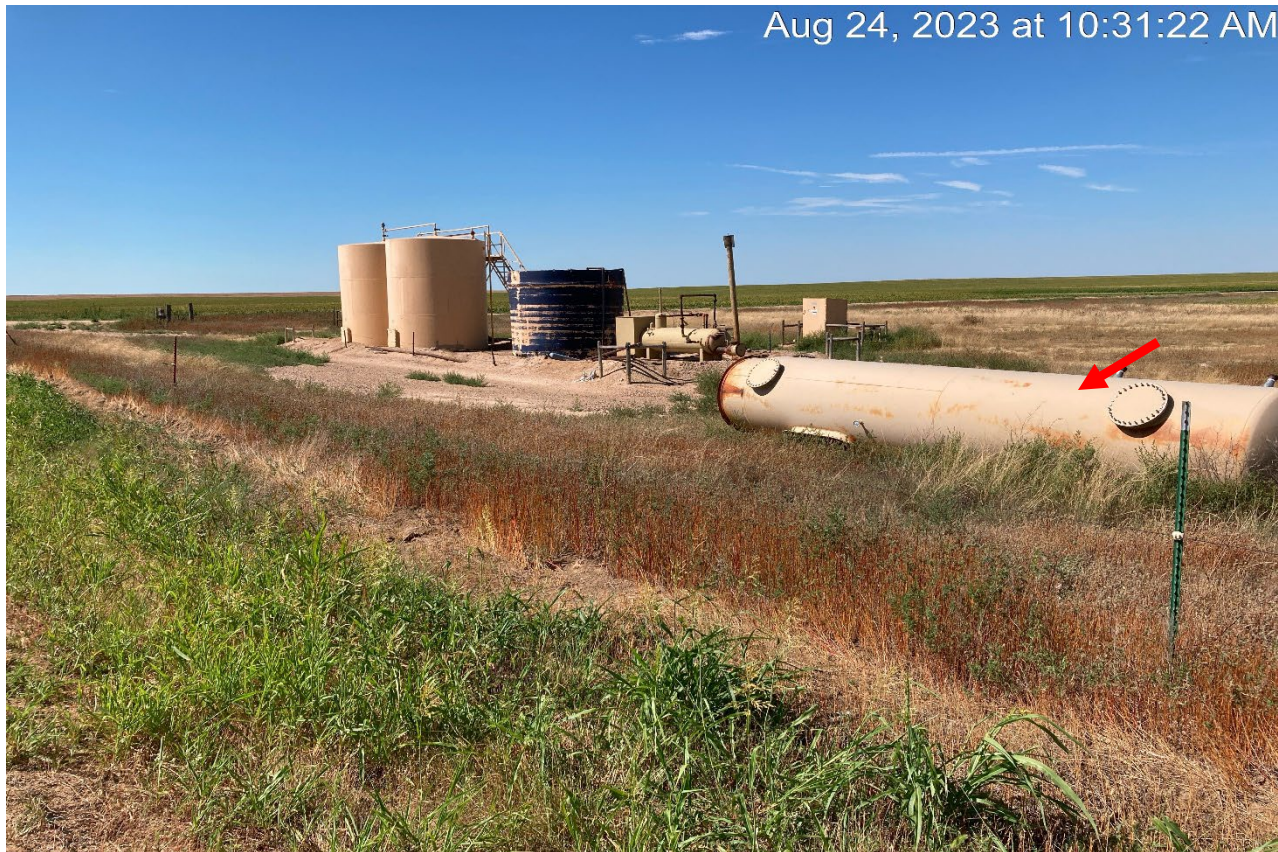
Photo 1. Facing toward the offsite tank battery location. This tank at red arrow is not in use and needs to be removed.

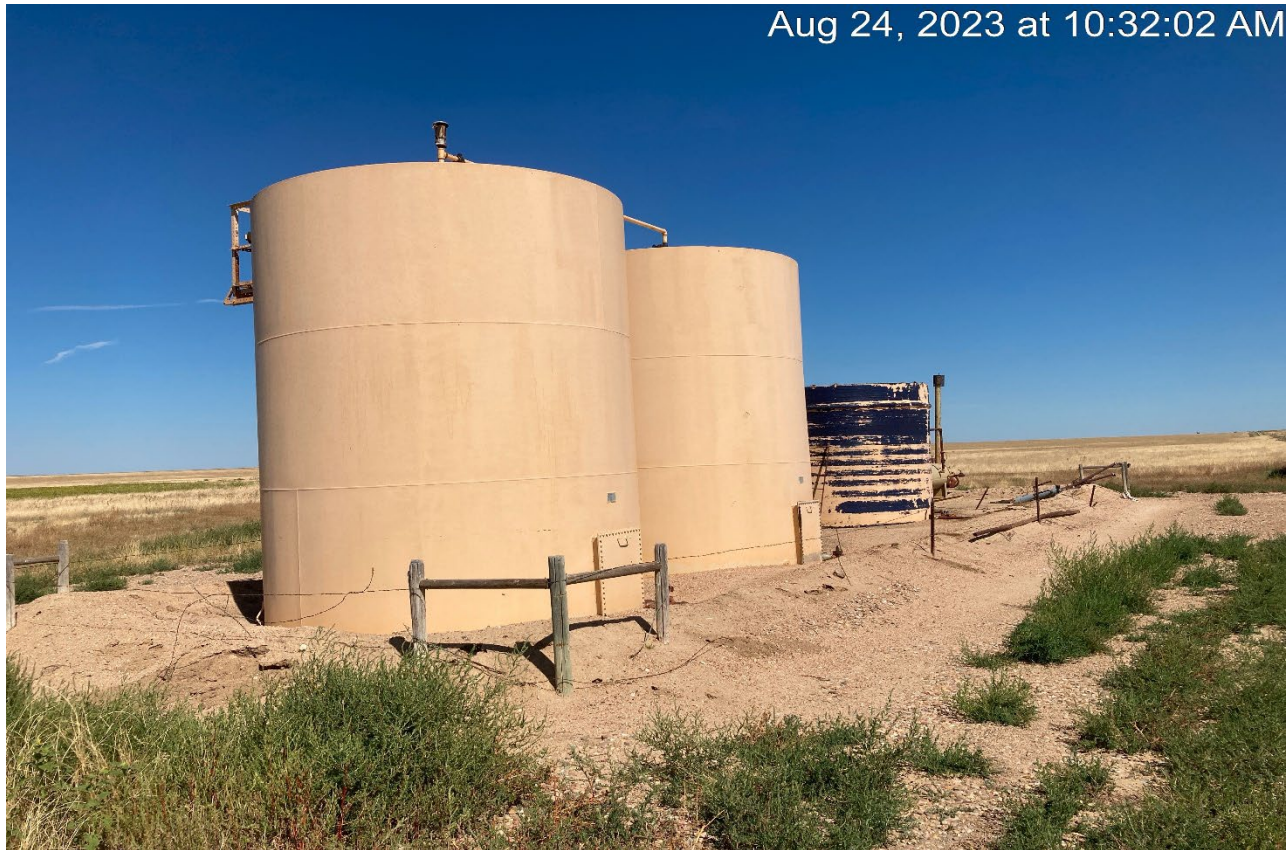
Photo 2. fence around the tank is inadequate to prevent livestock entry and is not maintained. The berm around the tank is insufficient to contain a spill (150% of tank capacity) and has animal borrows the sides.

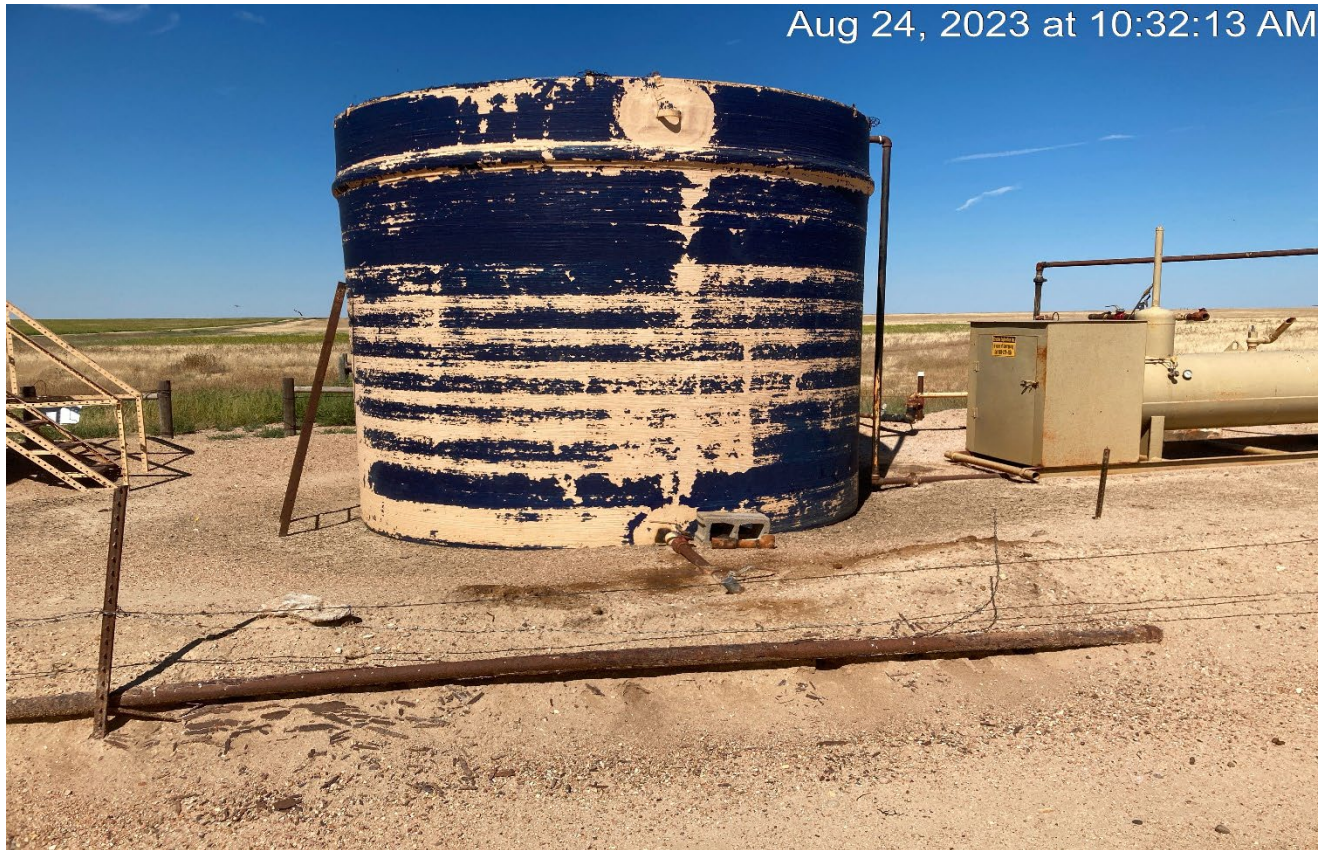
Photo 3. There is stained soils that need to be cleaned up

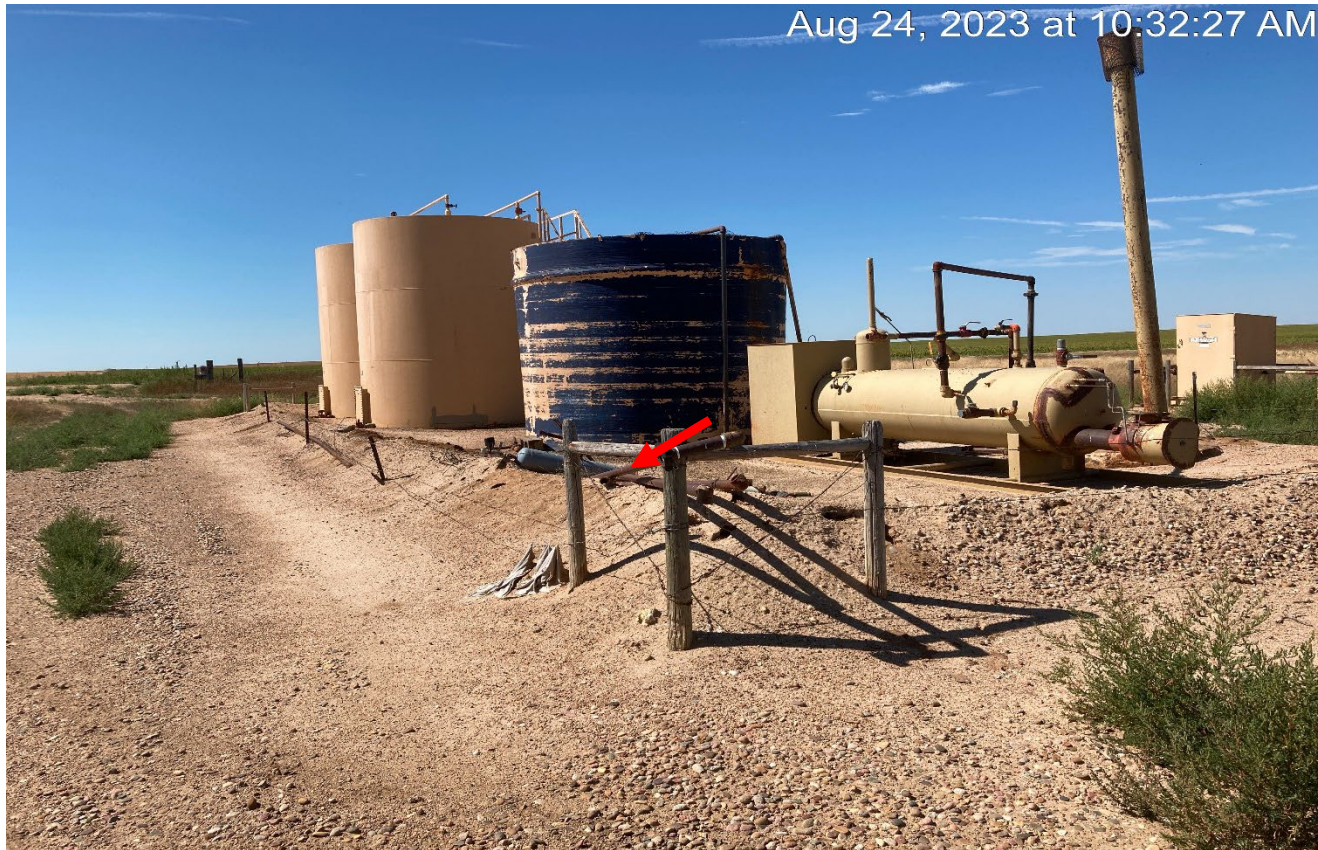
Photo 4. There is unused disconnected pipe that needs to be removed.

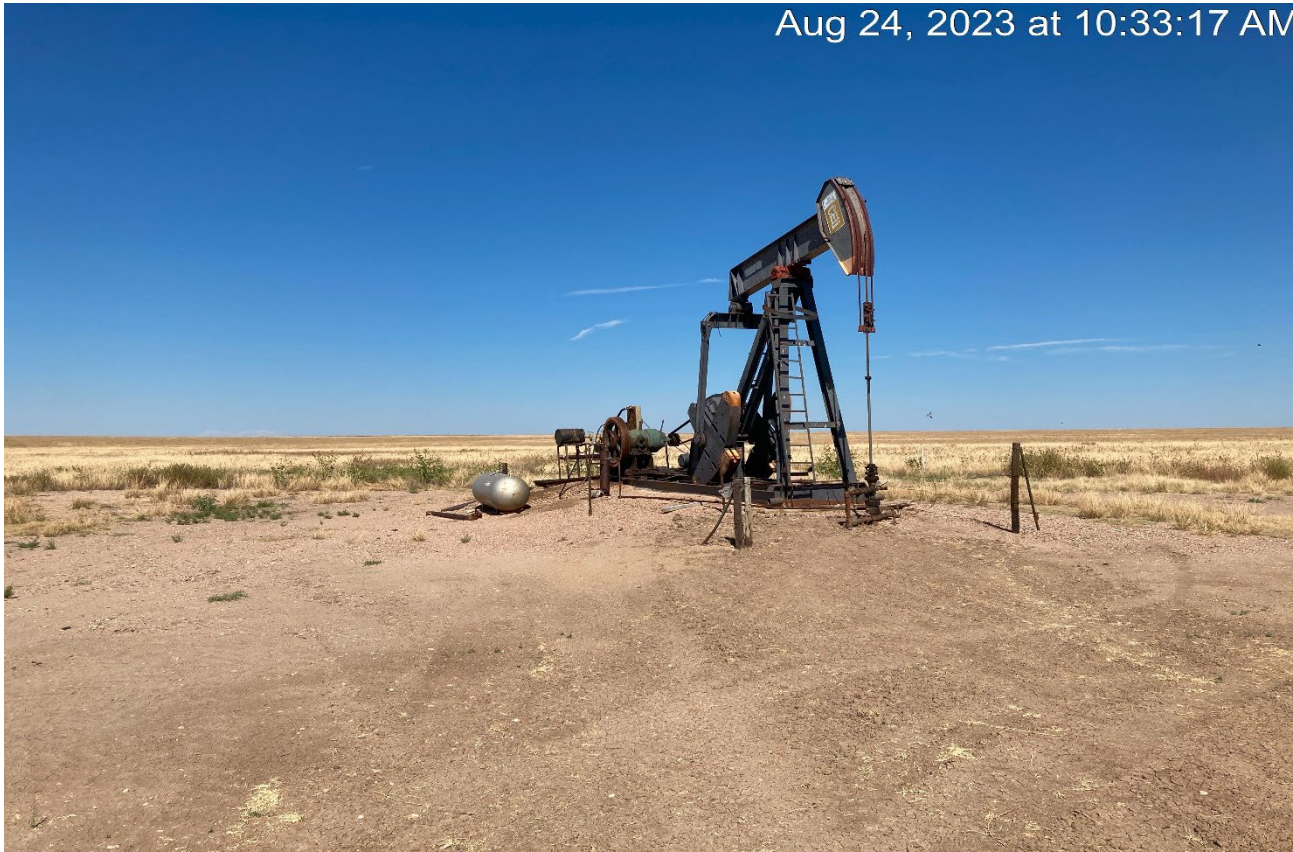
Photo 5. Facing northwest toward the wellsite.

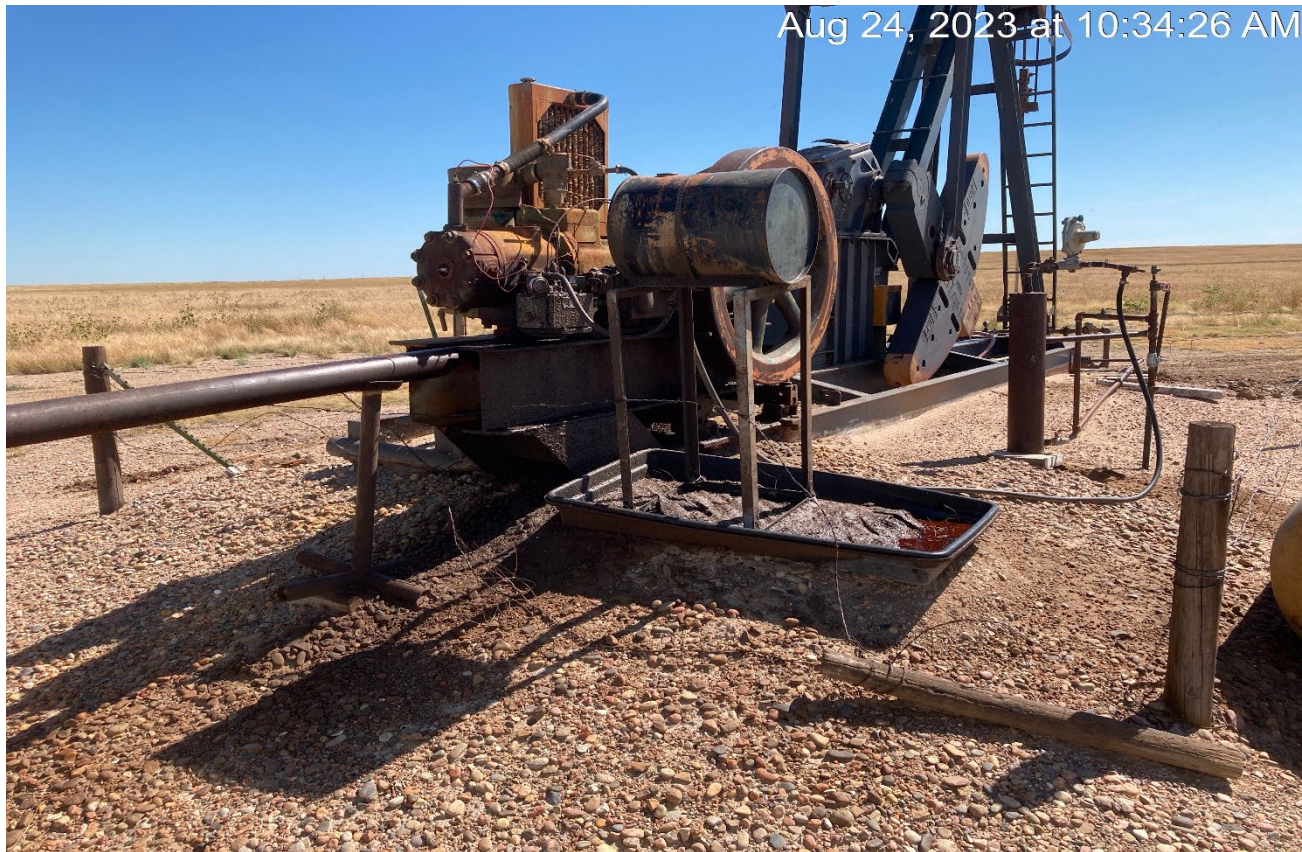
Photo 6. There is oily fluid in the containment next to the pump jack. Oily fluid has spilled onto the ground and needs to be cleaned up.
