# Inspection Photos

API: 061-06403

Operator: STRACHAN EXPLORATION INC

Inspection Date: 8/24/2023

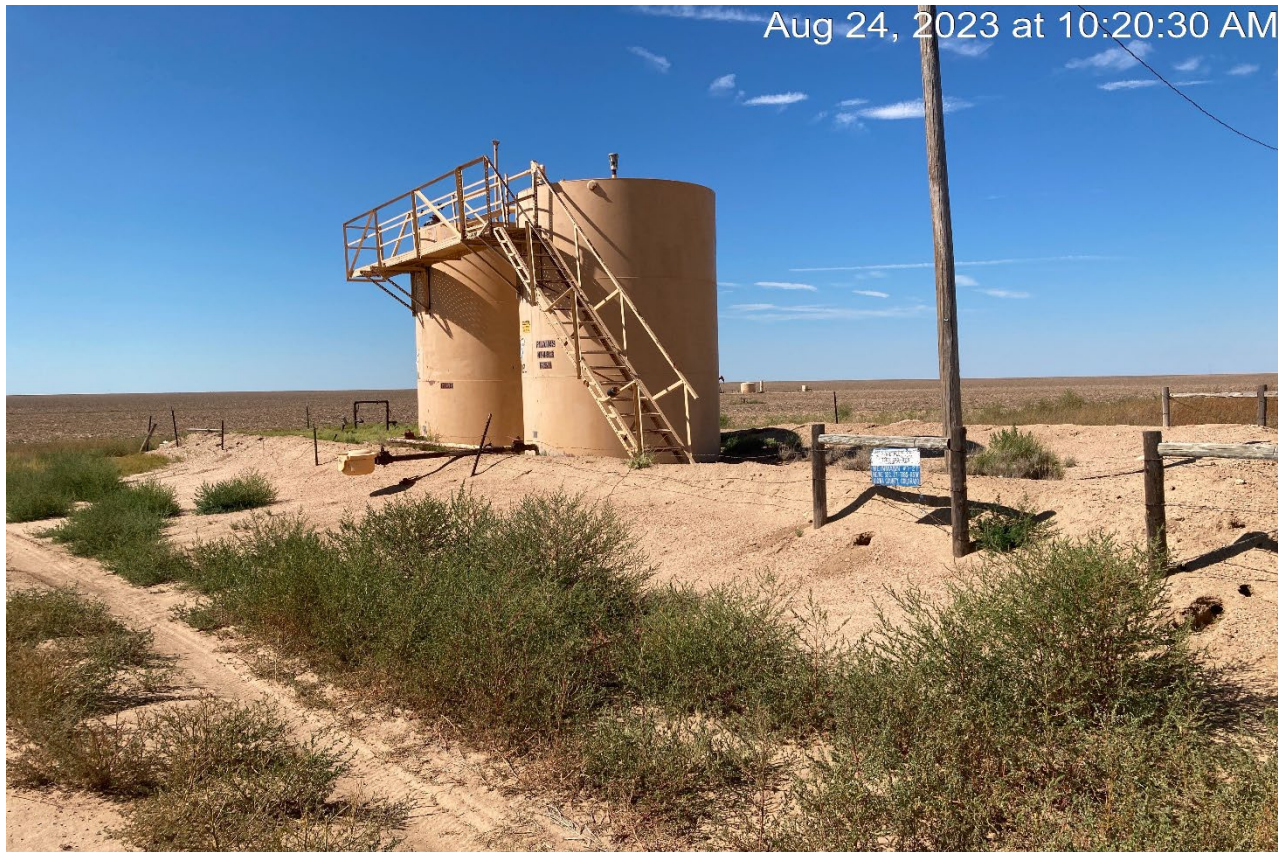
**Photo 1.** Facing toward the offsite tank battery location.

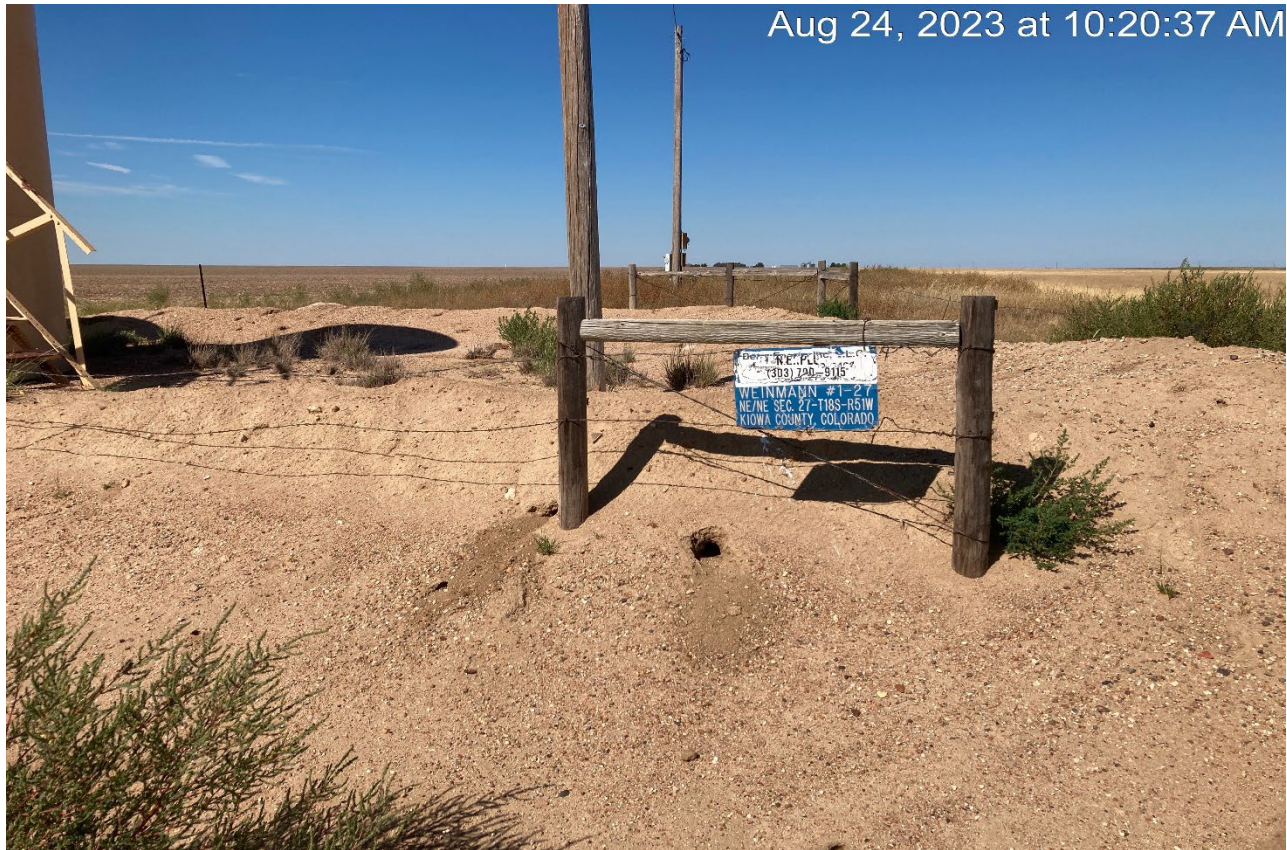
**Photo 2.** The sign is faded and does not meet the signage requirements of Rule 605.e.

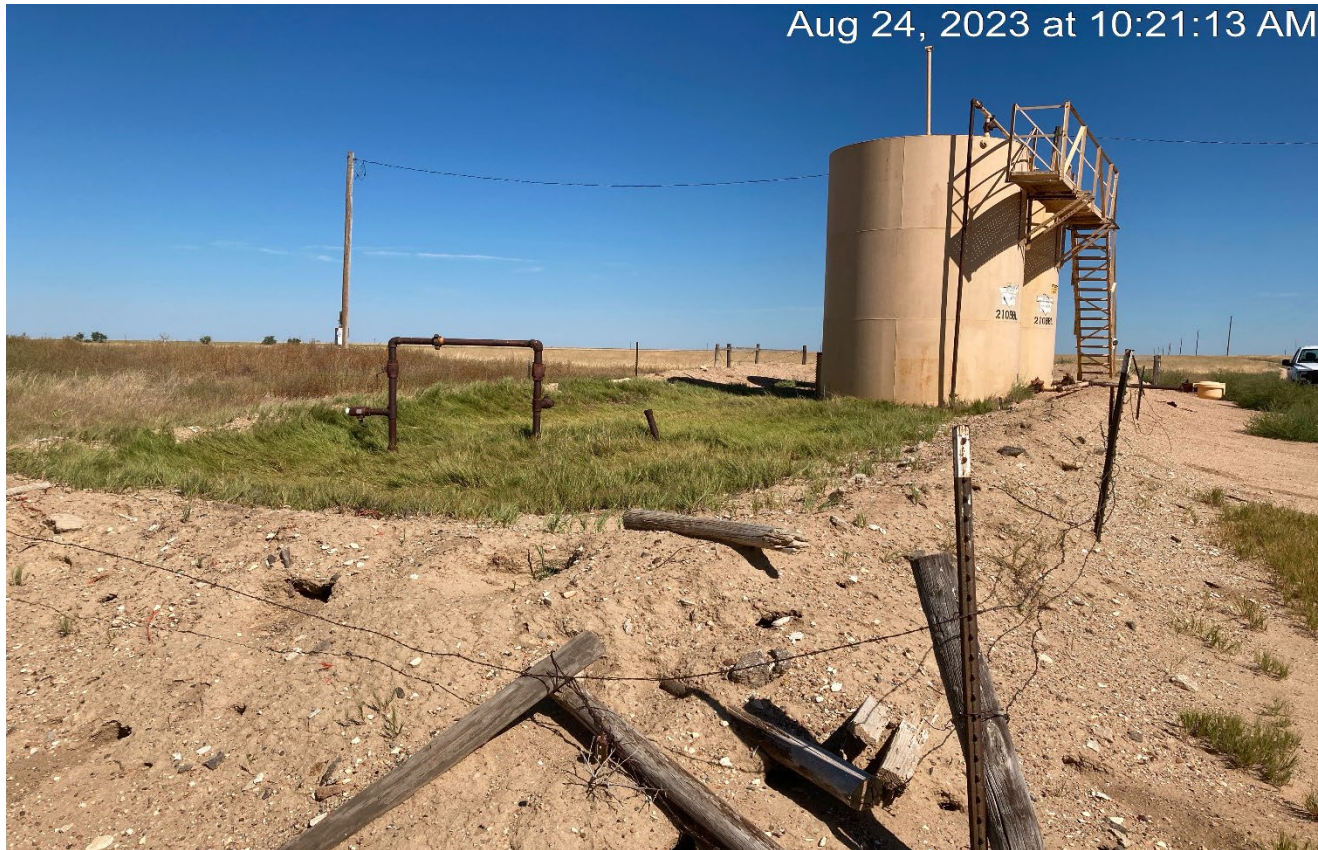
**Photo 3.** The fence around the tank battery is inadequate to prevent livestock entry and is not maintained.

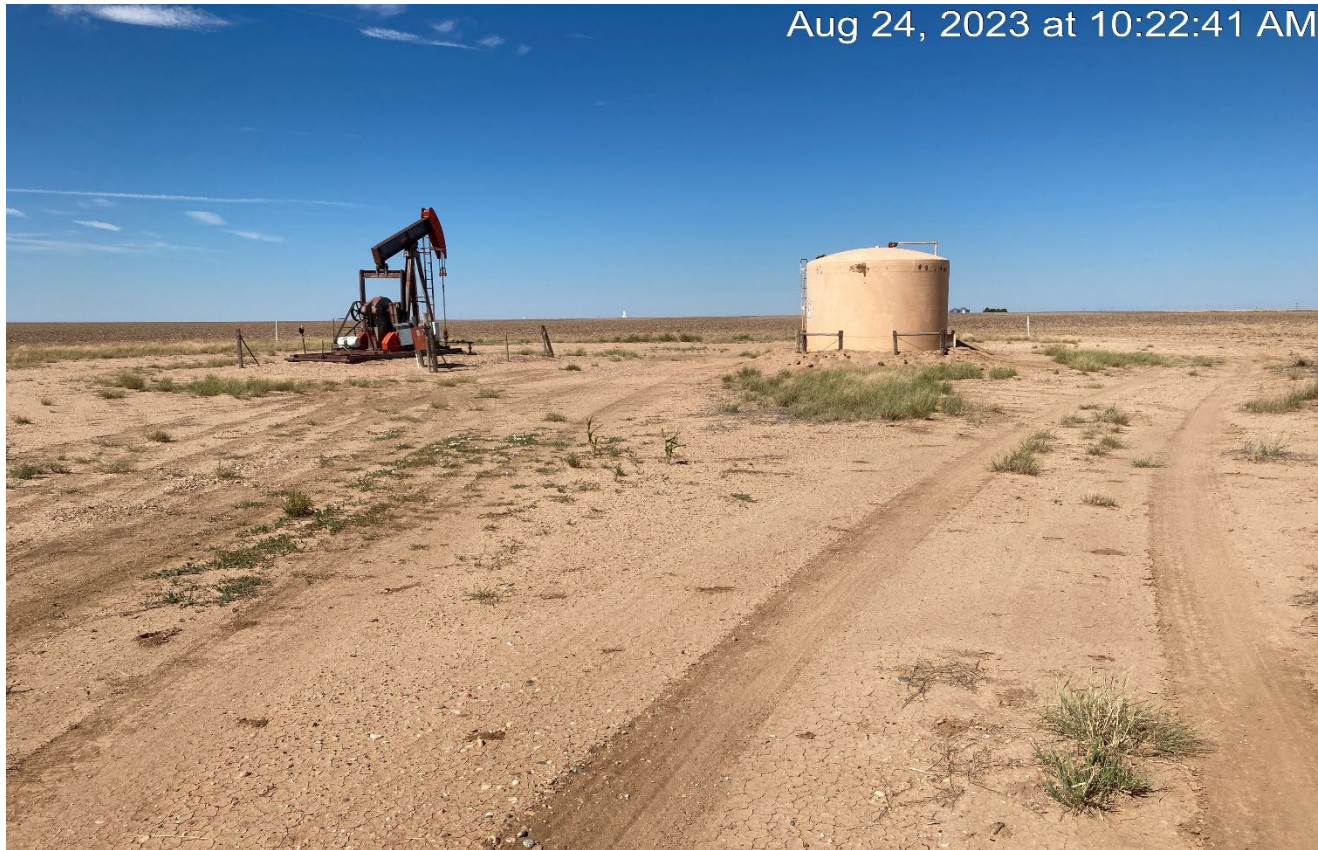
**Photo 4.** Facing southwest toward the wellsite..

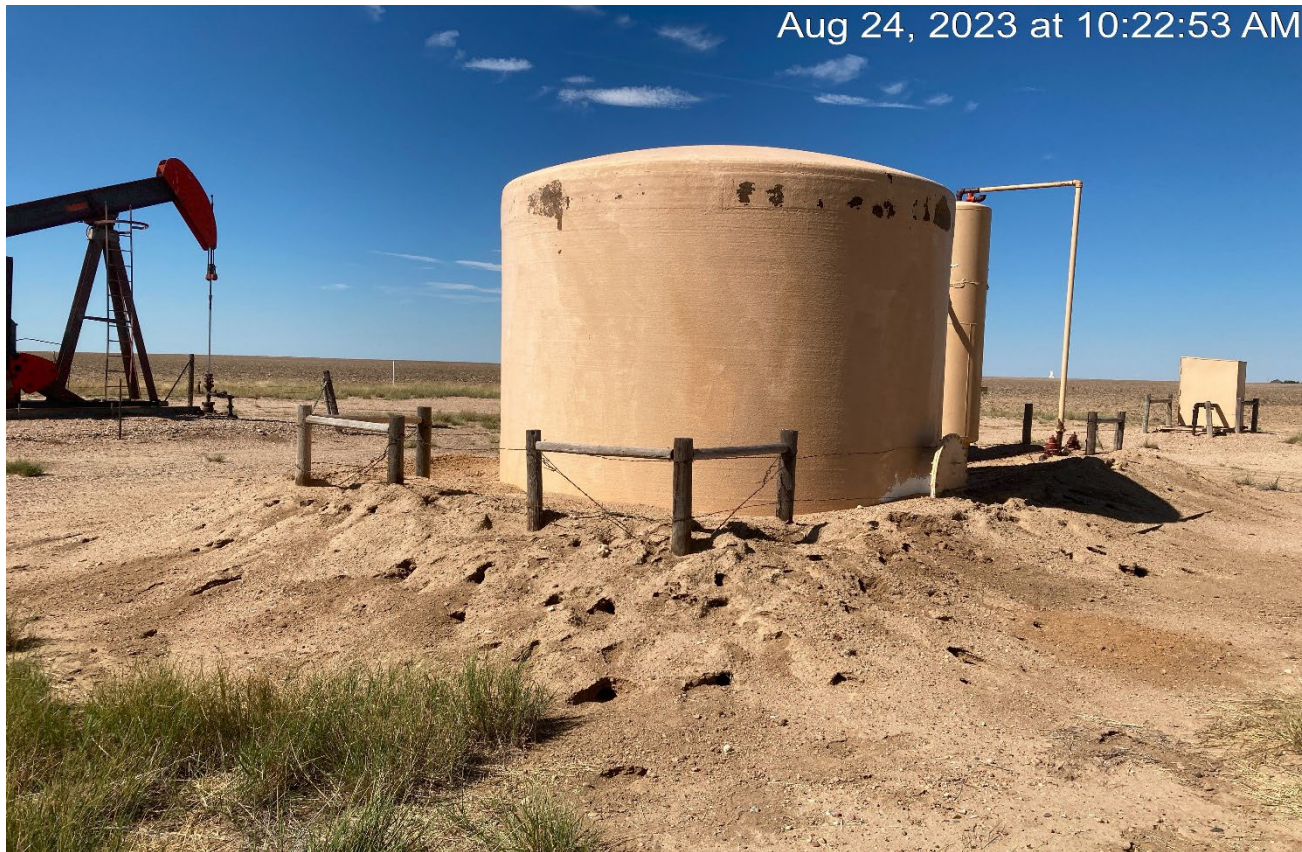
**Photo 5.** Facing toward the tank. The berm around the tank is inadequate to contain a spill.

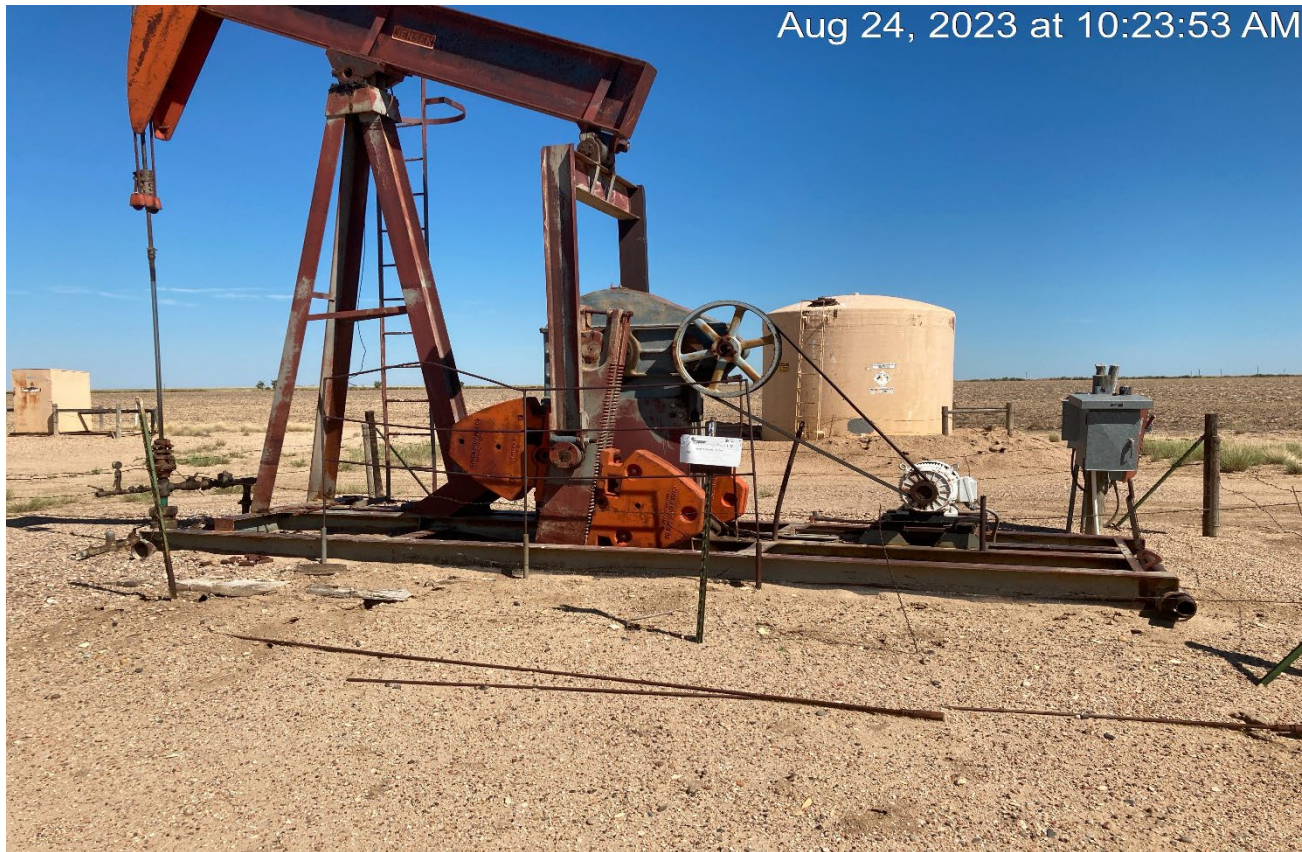
**Photo 6.** The well sign is faded and does not meet the signage requirements.
