Inspection Photos

API: 061-06368

Operator: STRACHAN EXPLORATION INC

Inspection Date: 8/24/2023

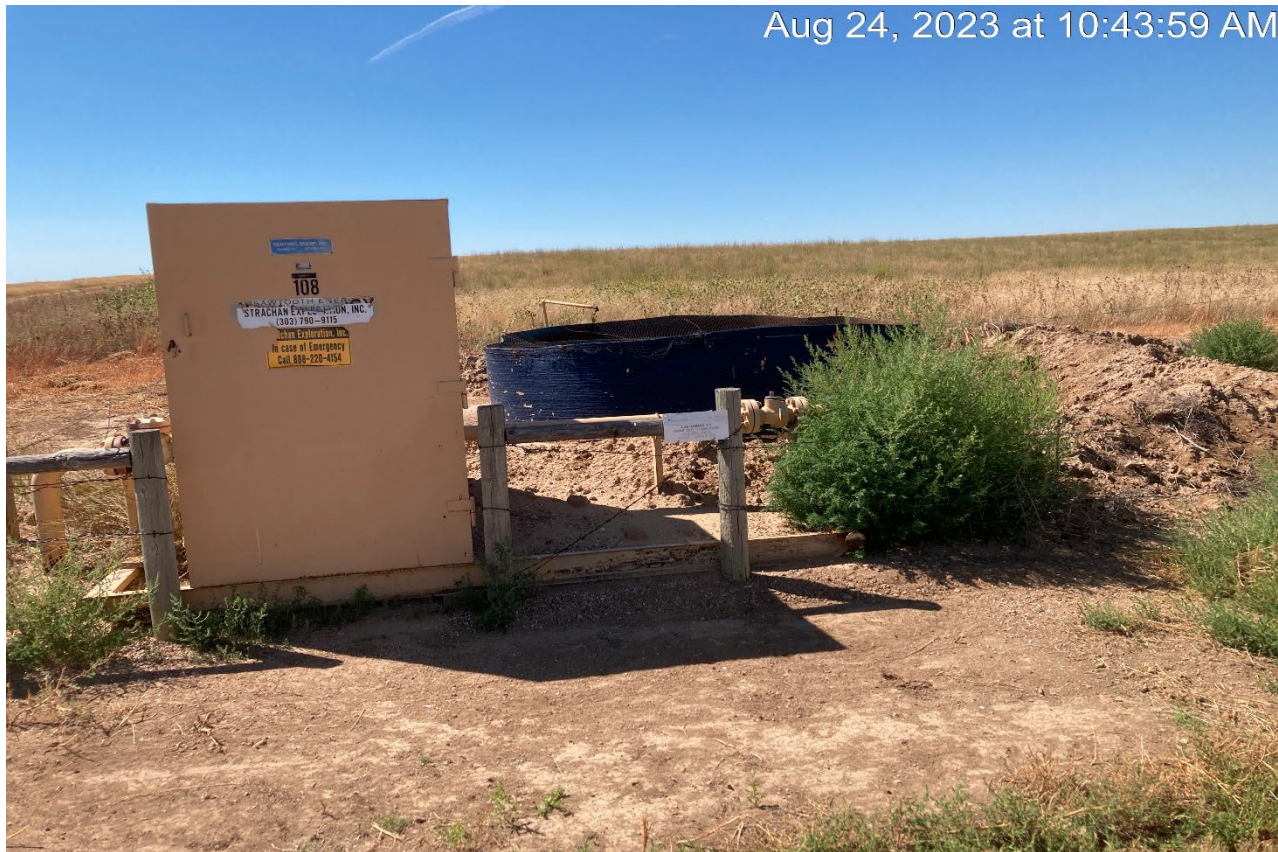
Photo 1. Facing toward the offsite meter run and open top condensate tank located about 2000' east of the wellsite.

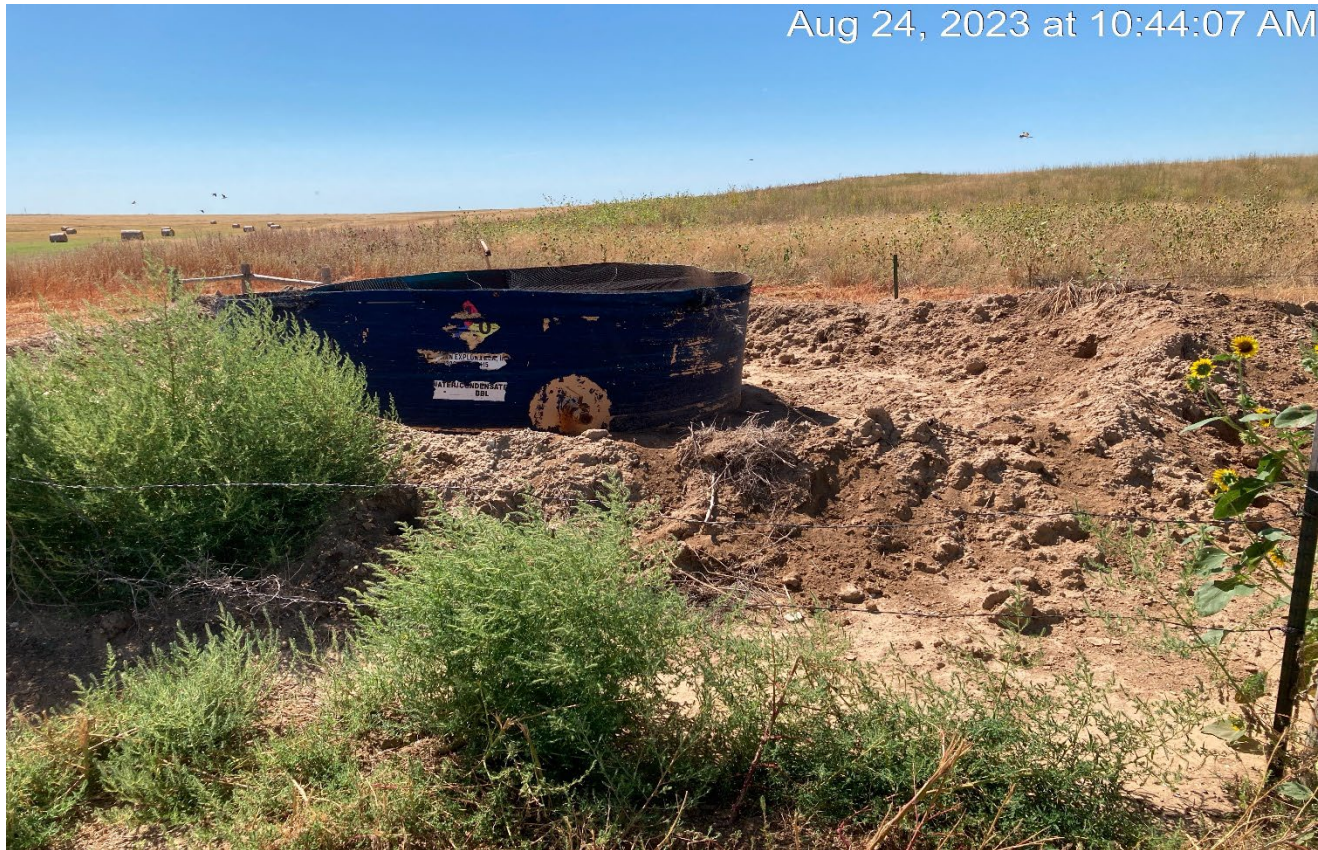
Photo 2. The berm around the tank has been built up however soils were not compacted to be impermeable.

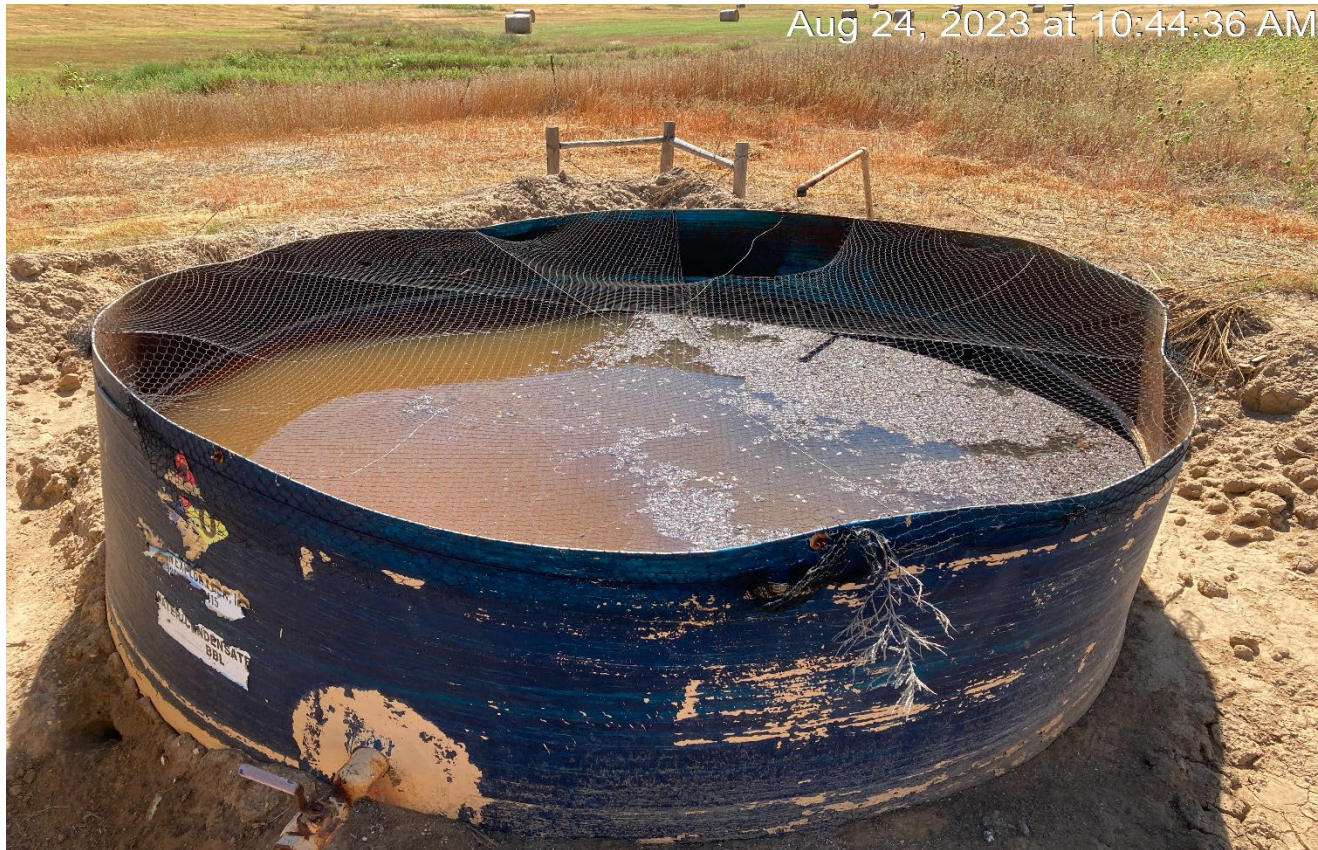
Photo 3. The netting on the open top tank is torn and needs repair. Previous corrective action was not completed.

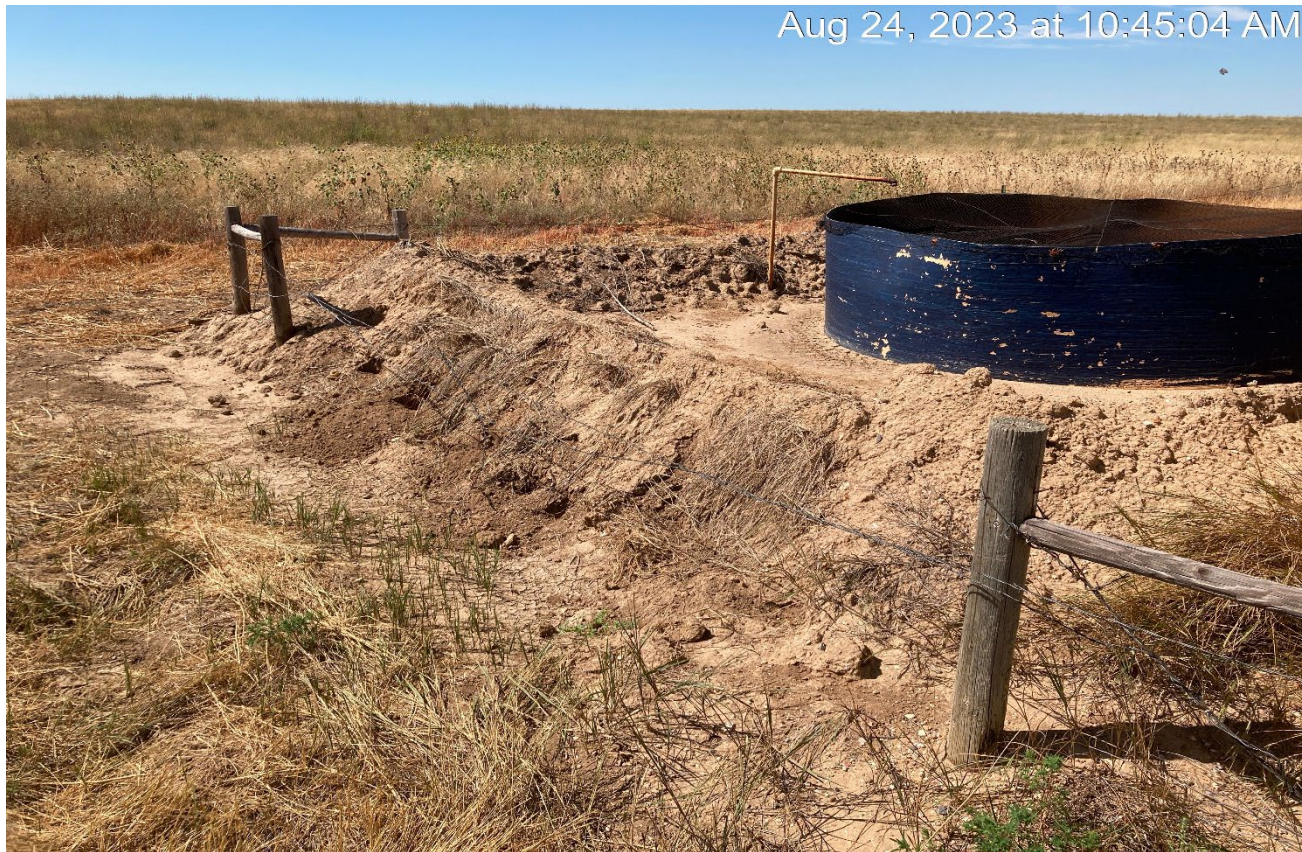
Photo 4. The fence around the open top tank is inadequate to prevent livestock entry and is not maintained. Previous corrective action was not completed.

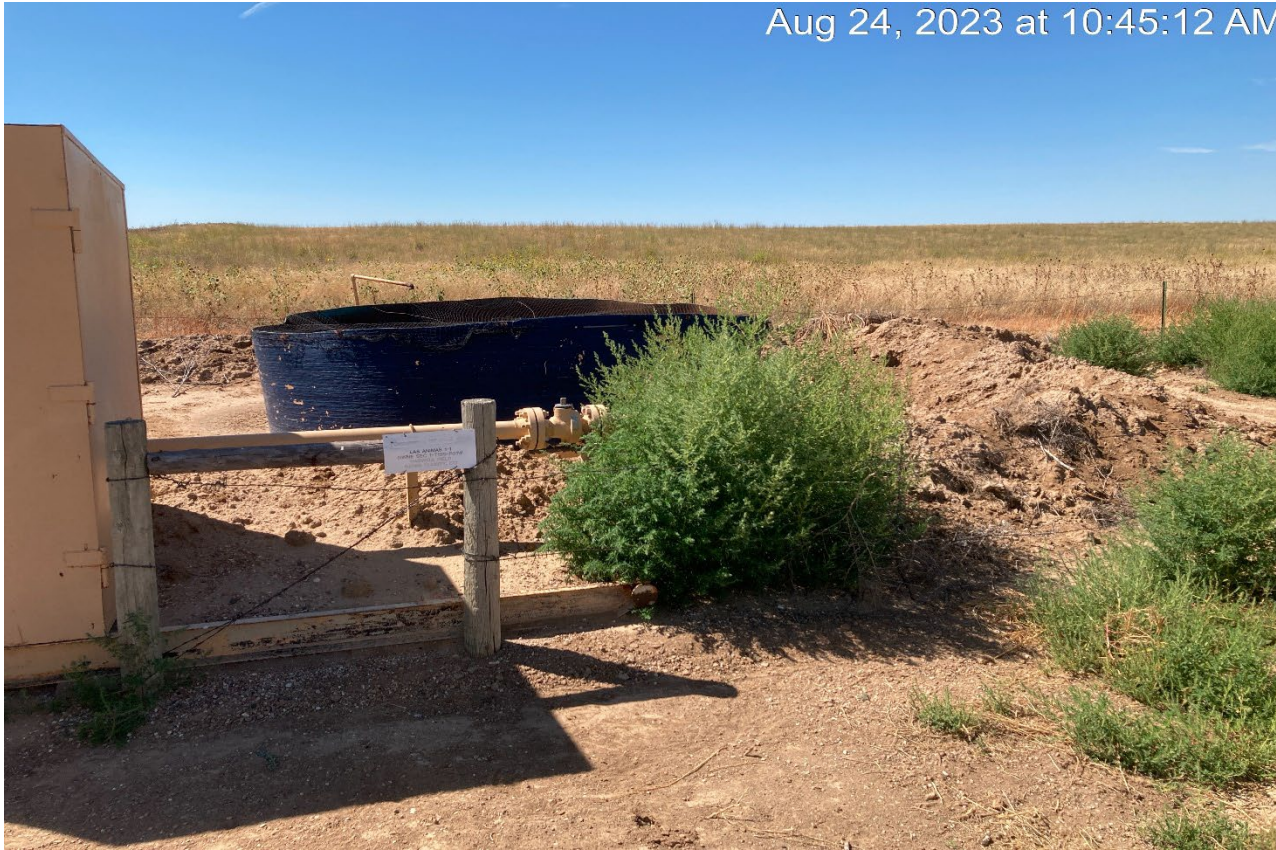
Photo 5. The offsite tank battery sign is faded and does not meet the signage requirement of rule 605.

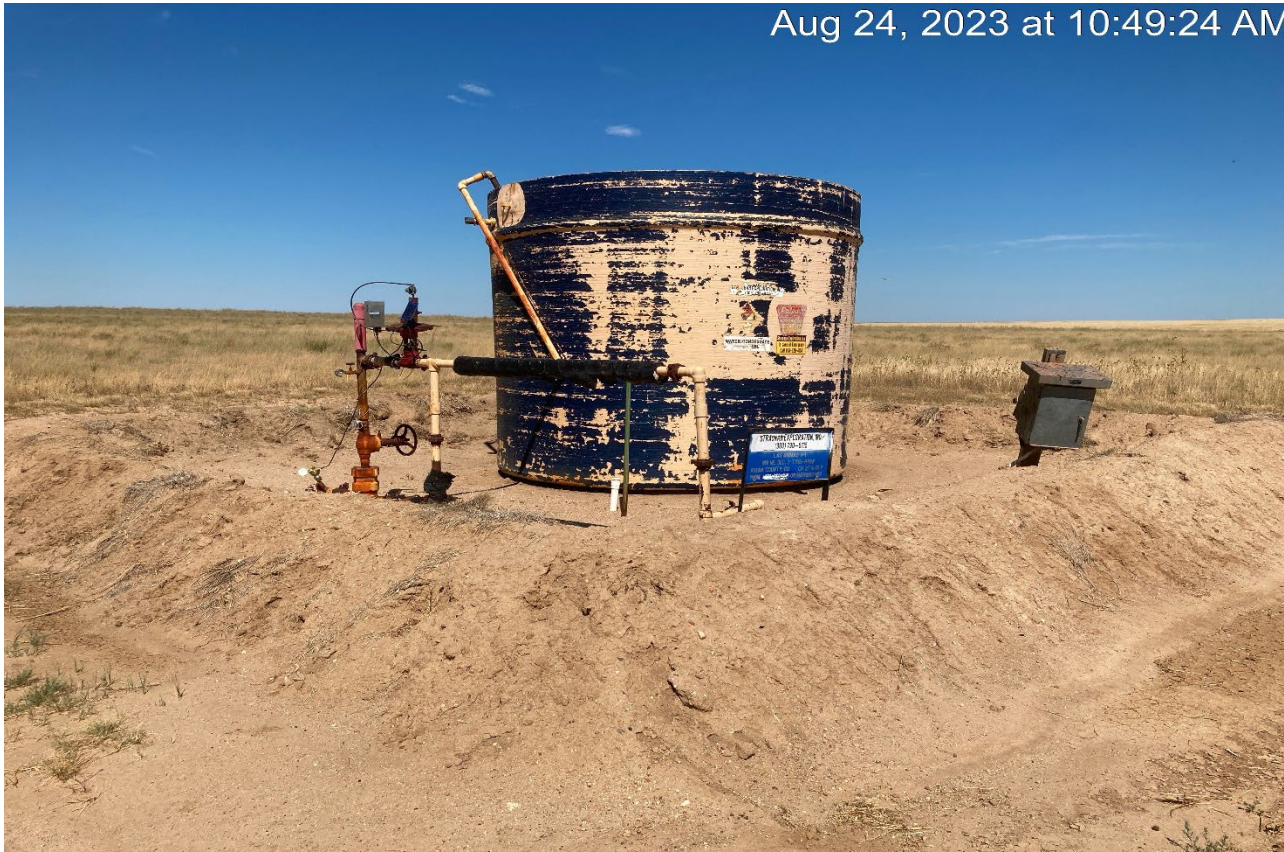
Photo 6. Facing toward the wellsite. The labeling on the tank is faded and peeled off. The berm around the tank has been built up however soils were not compacted to be impermeable.

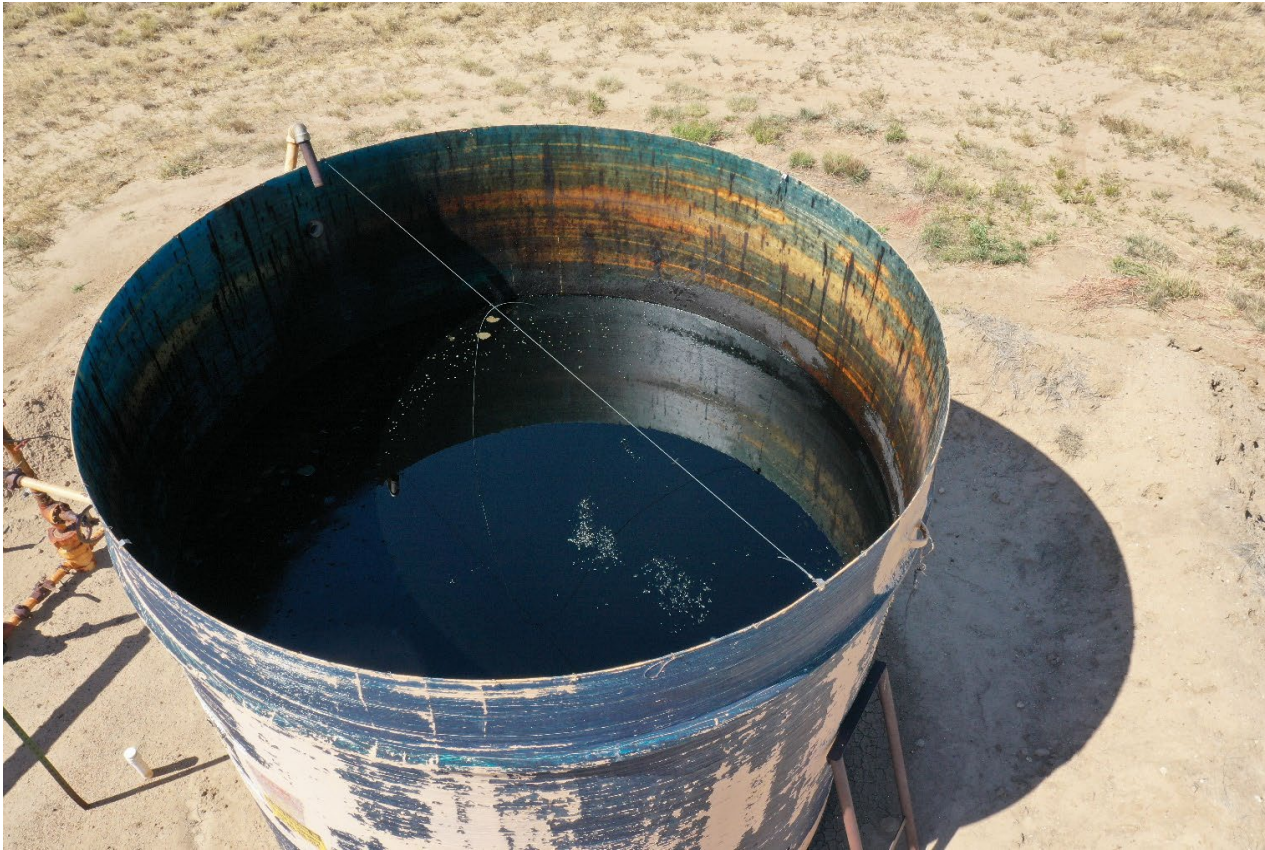
Photo 7. Drone photo looking down at the open top tanks shows no netting over the tank. Tank is approximately $\frac{3}{4}$ full of crude oil. Previous corrective action was not completed.
