Inspection Photos

API: 061-06365

Operator: STRACHAN EXPLORATION INC

Inspection Date: 8/24/2023

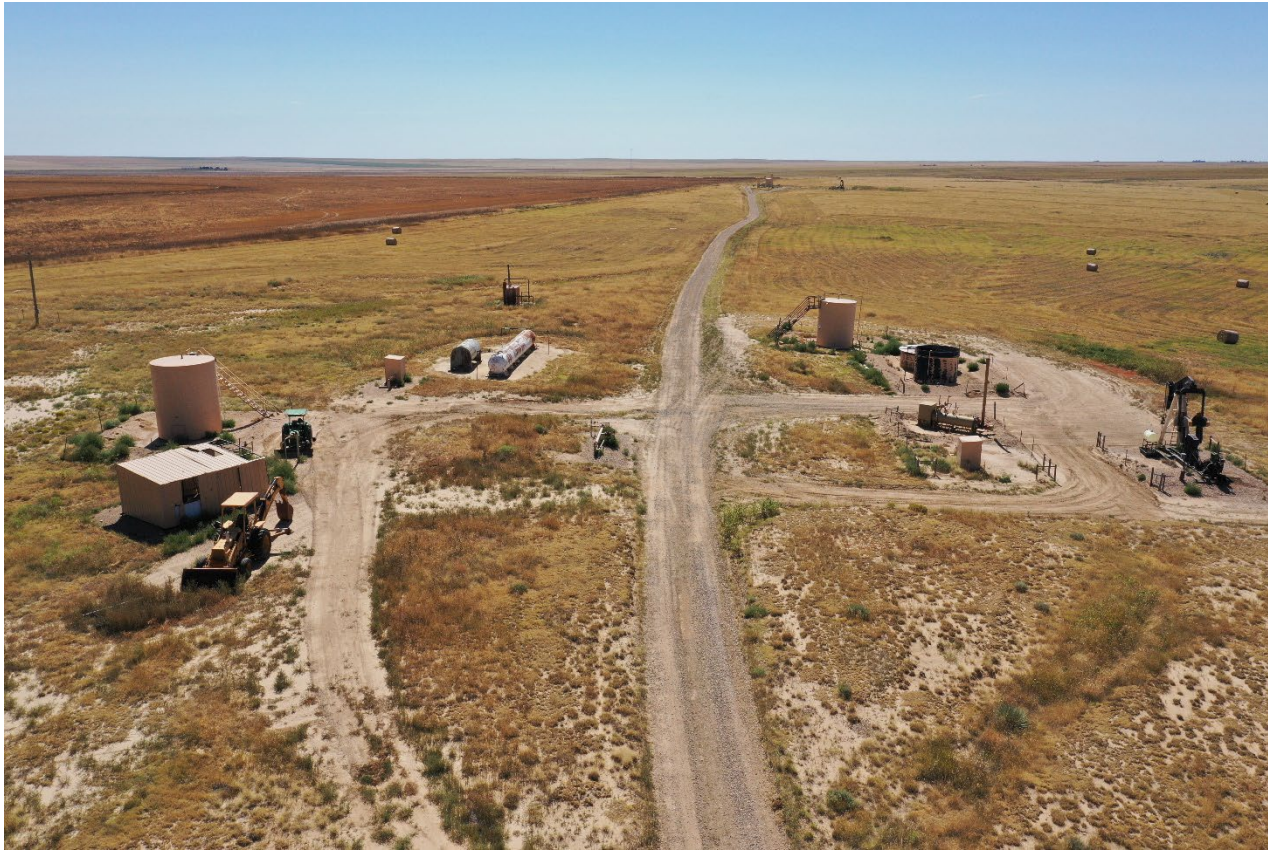
Photo 1. Drone aerial photo facing east toward the location.

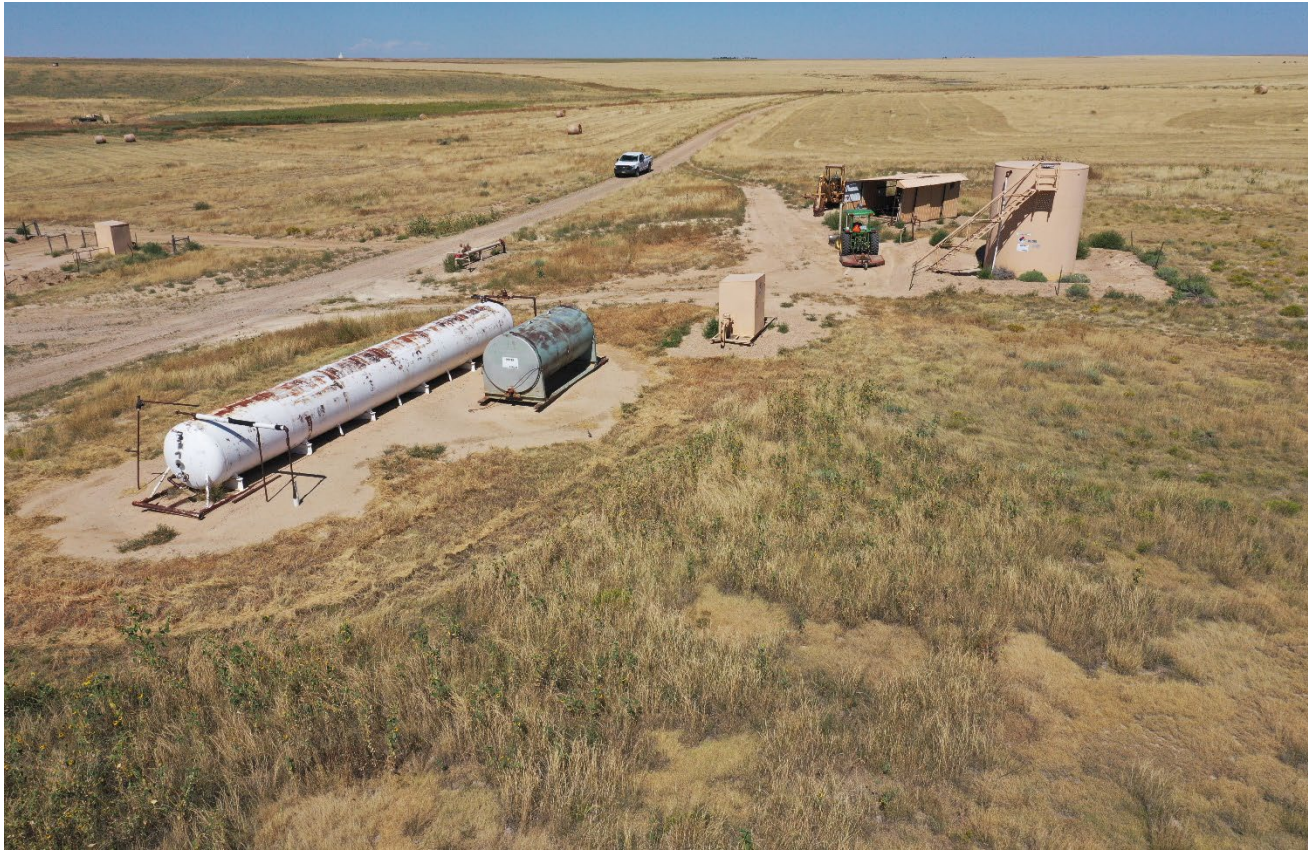
Photo 2. Drone aerial photo facing west at the north side of the location

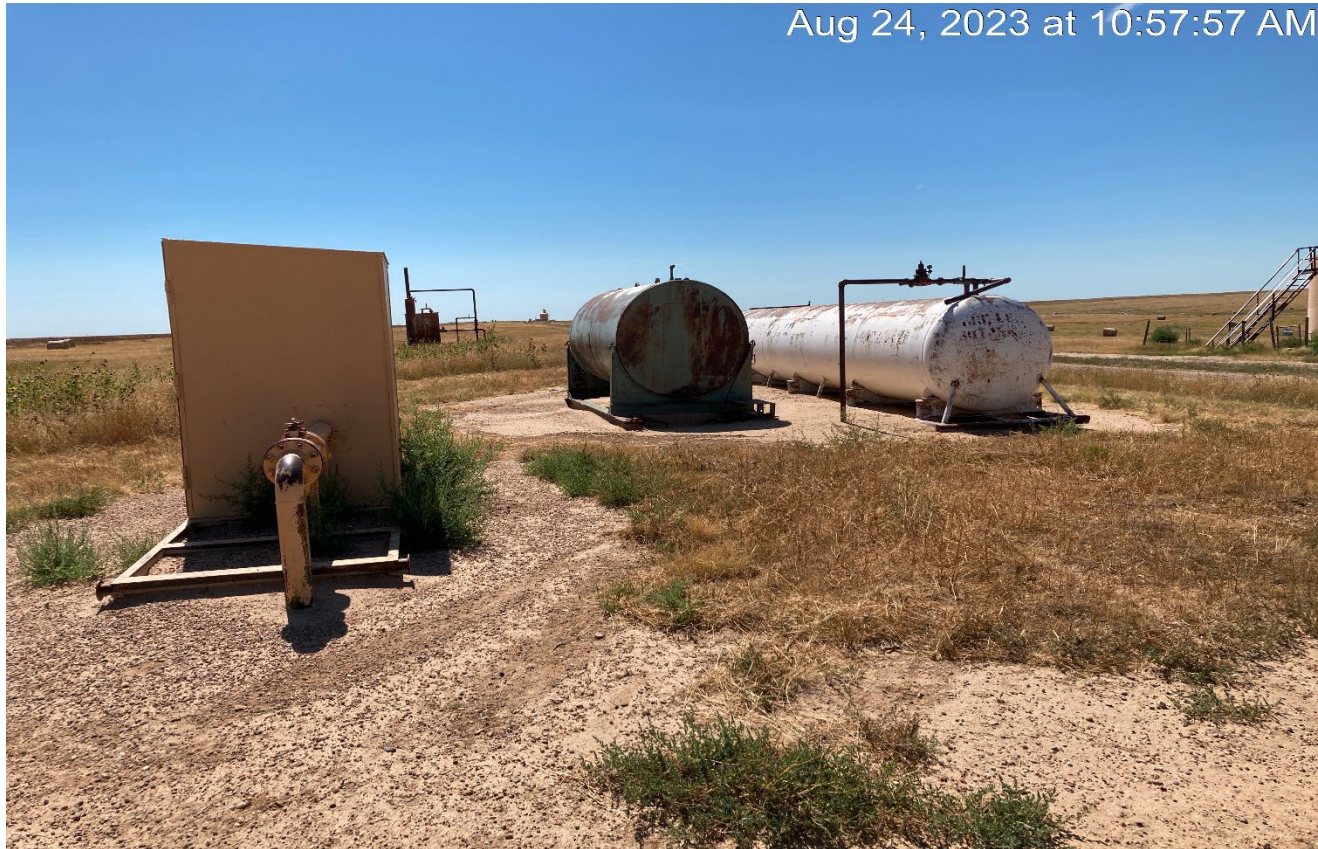
Photo 3. Facing southeast at the location. The two large volume tanks do not have proper labeling or secondary containment. If the tanks are unused then they need to be removed. Previous corrective action was not completed.

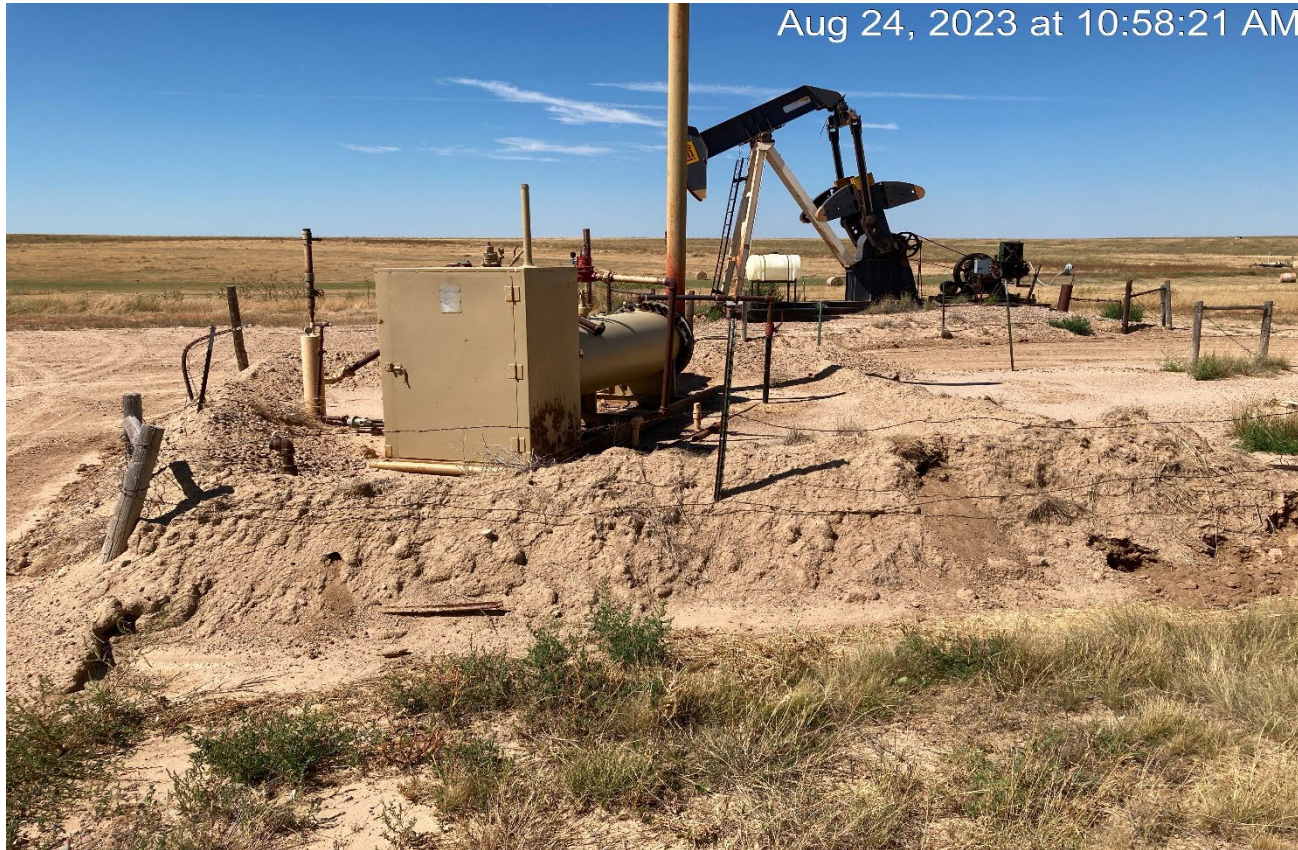
Photo 4. The south toward the wellsite and production equipment. The fence around the equipment is inadequate to prevent livestock entry. Cattle track have been observed inside the 2 strand fence.

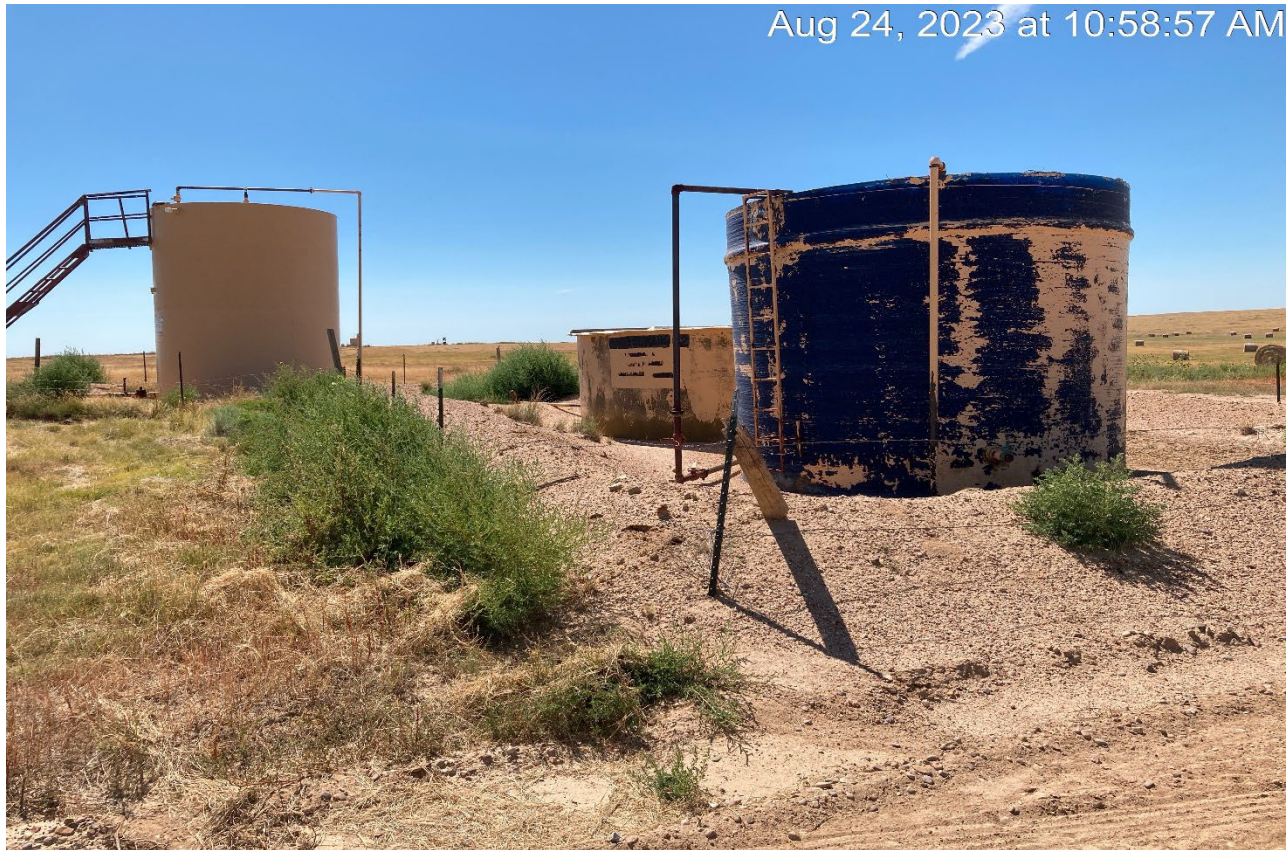
Photo 5. Facing southeast toward the tanks. Fencing is inadequate around the tanks.

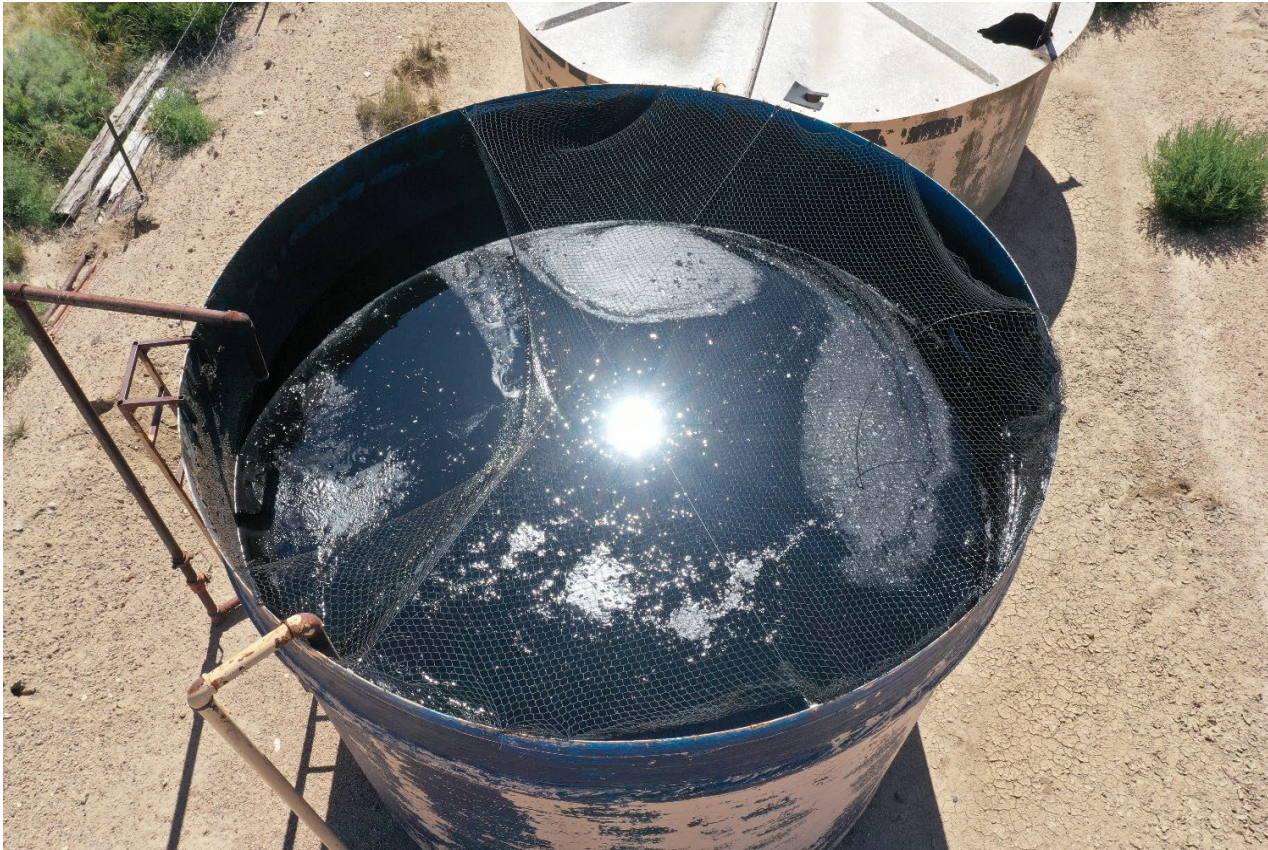
Photo 6. The netting on the open top tank needs to be repaired to prevent wildlife entry.

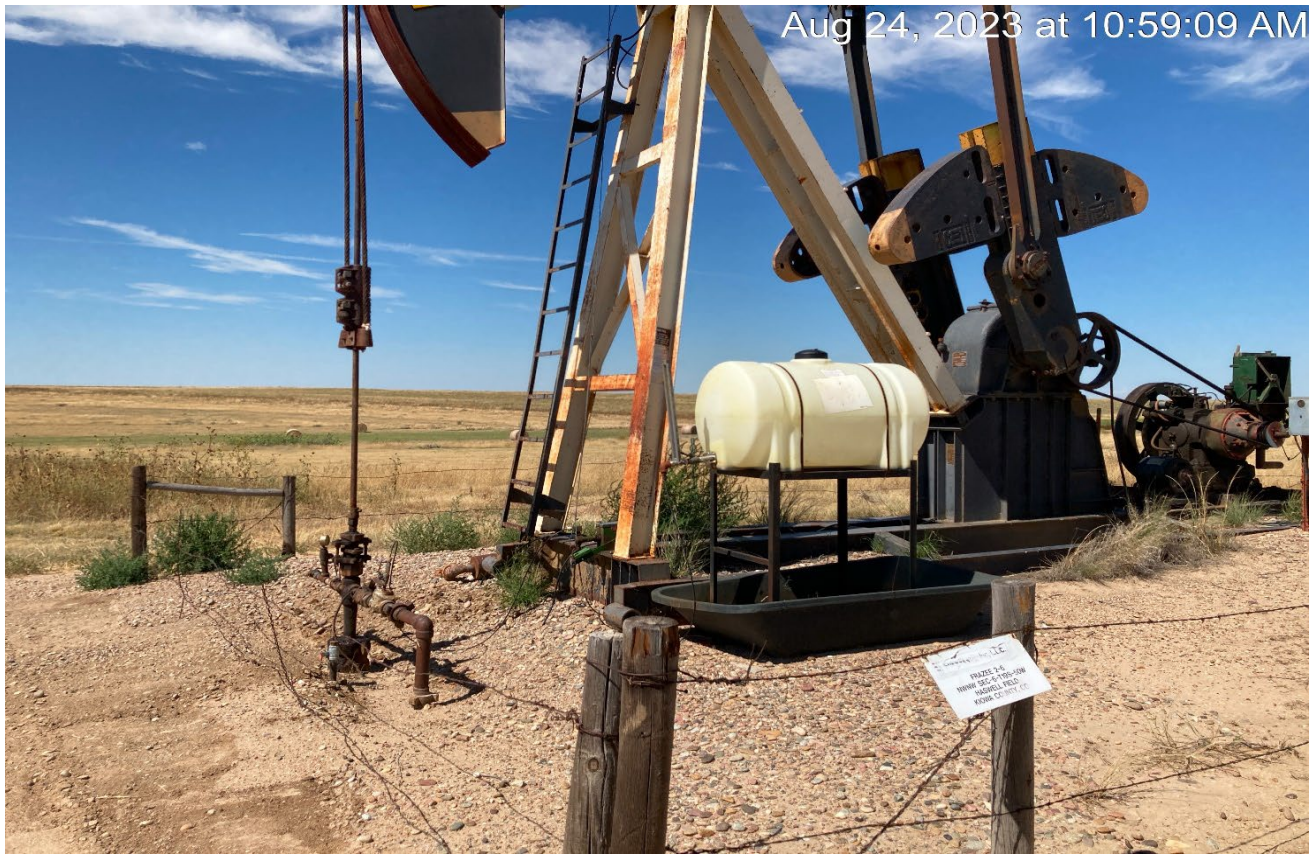
Photo 7. Facing toward the pumpjack.

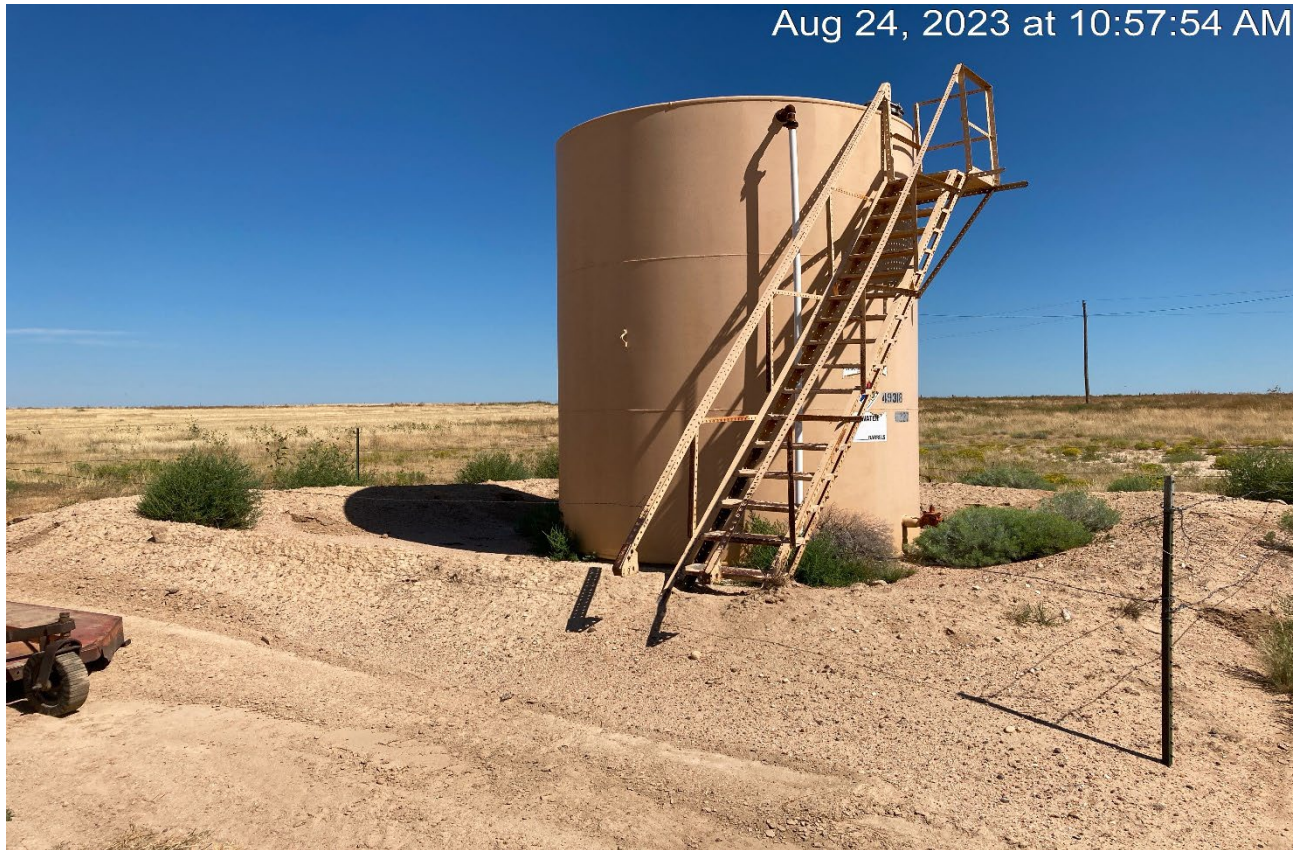
Photo 8. Facing at the north side of the location. The fence around the tank battery is inadequate to prevent livestock entry and is not maintained. Berm is insufficient to contain a spill (150% of tank capacity). Previous corrective action was not completed.
