# Inspection Photos

API: 061-06296

Operator: STRACHAN EXPLORATION INC

Inspection Date: 8/24/2023

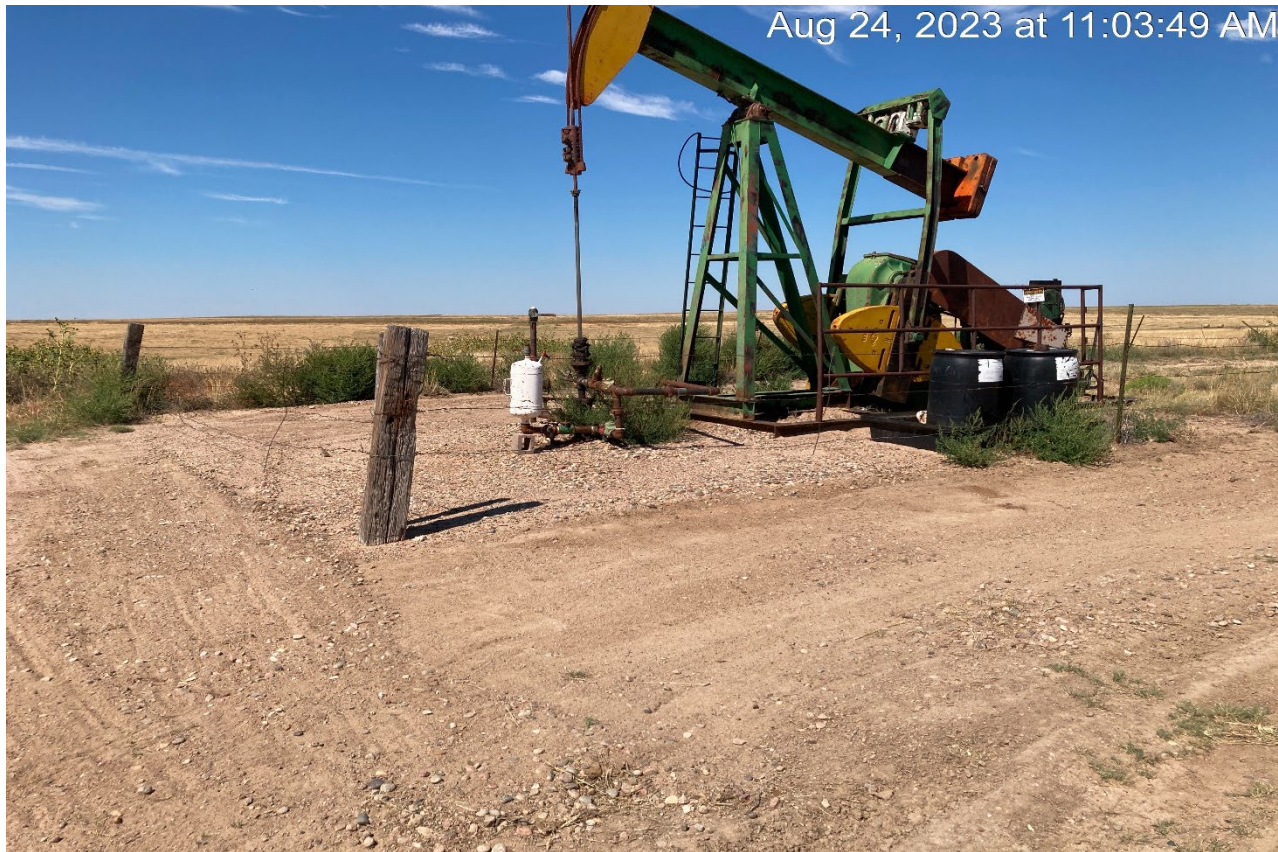
**Photo 1.** Facing toward the wellsite.

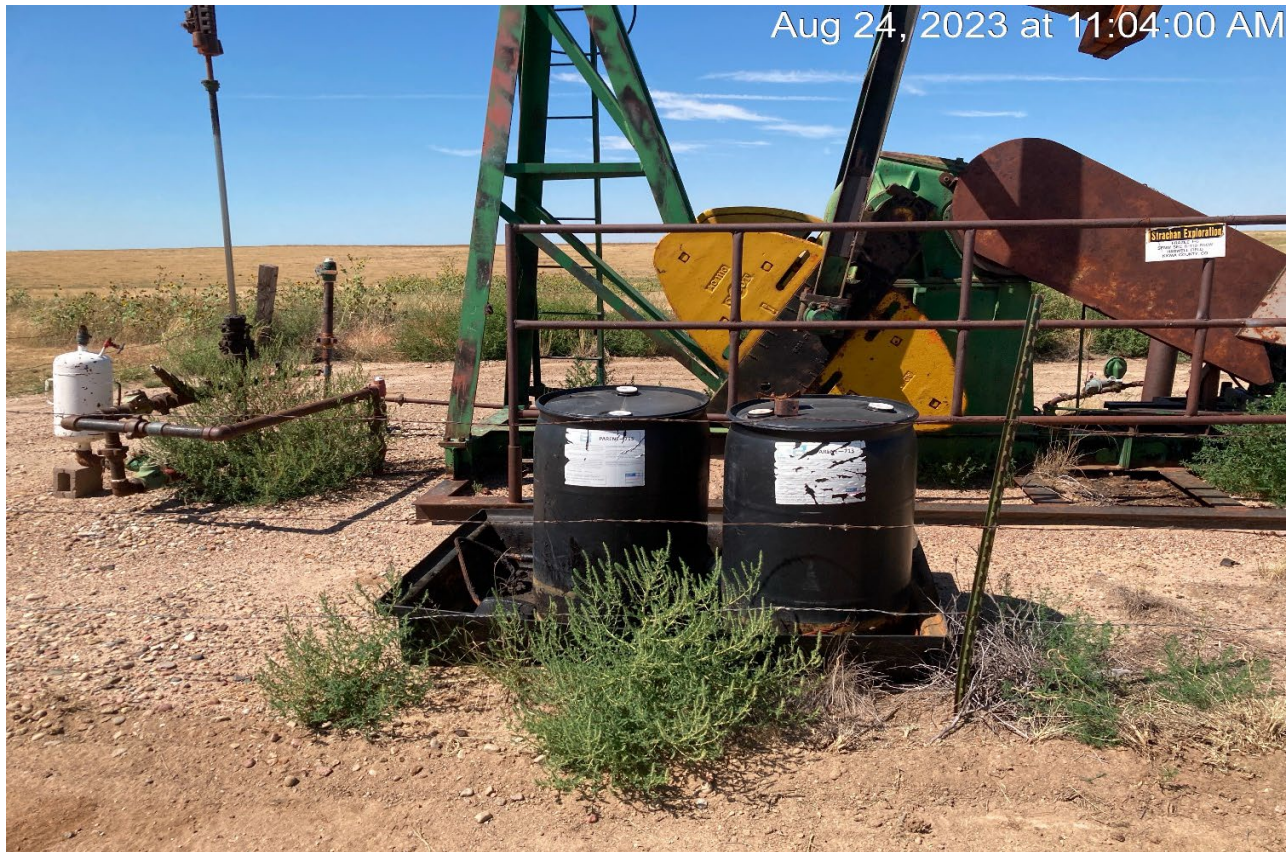
**Photo 2.** It appears oily soils were cleaned up around the barrel containment.

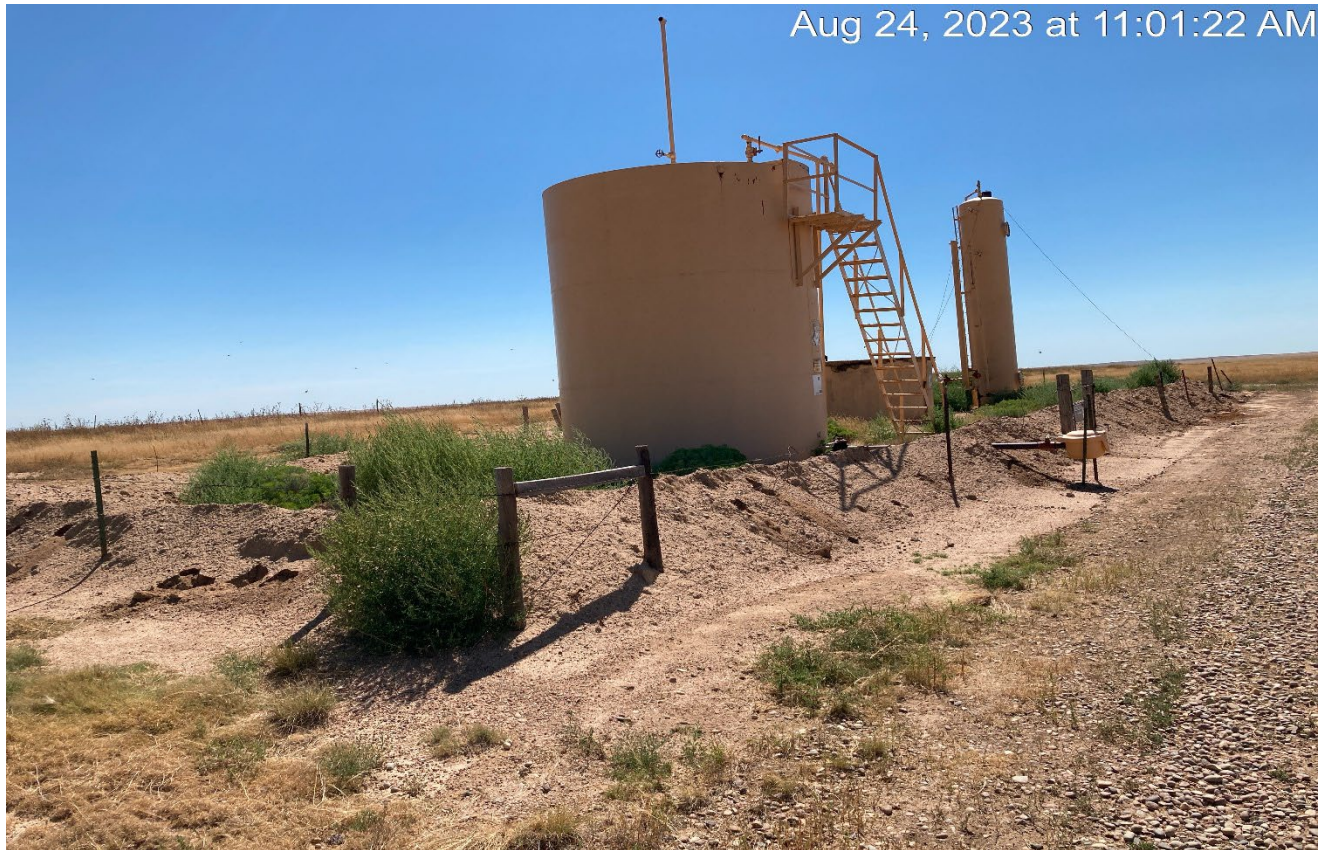
**Photo 3.** Facing northeast toward the tank battery.

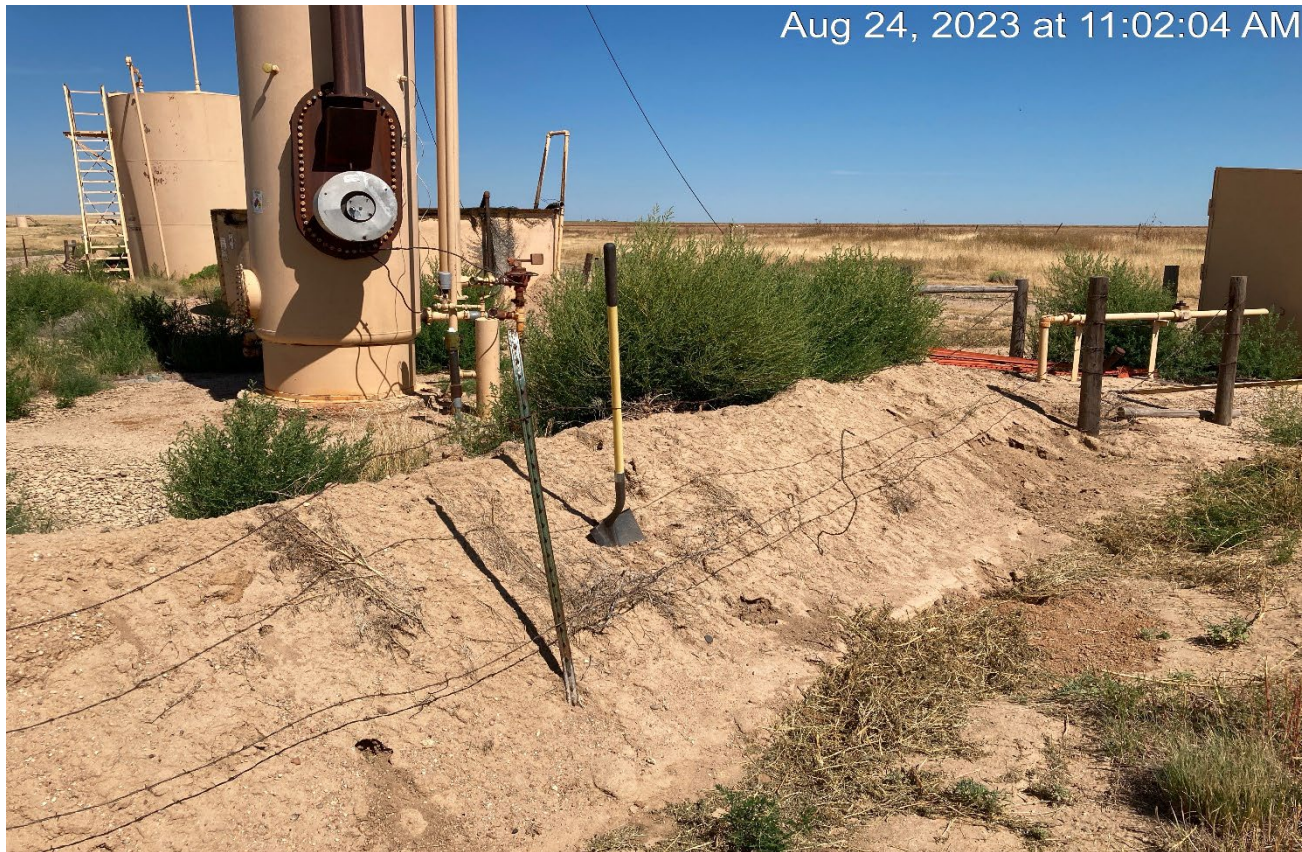
**Photo 4.** The fence around the tank battery is inadequate to prevent livestock entry and is not maintained. Previous corrective action was not completed.

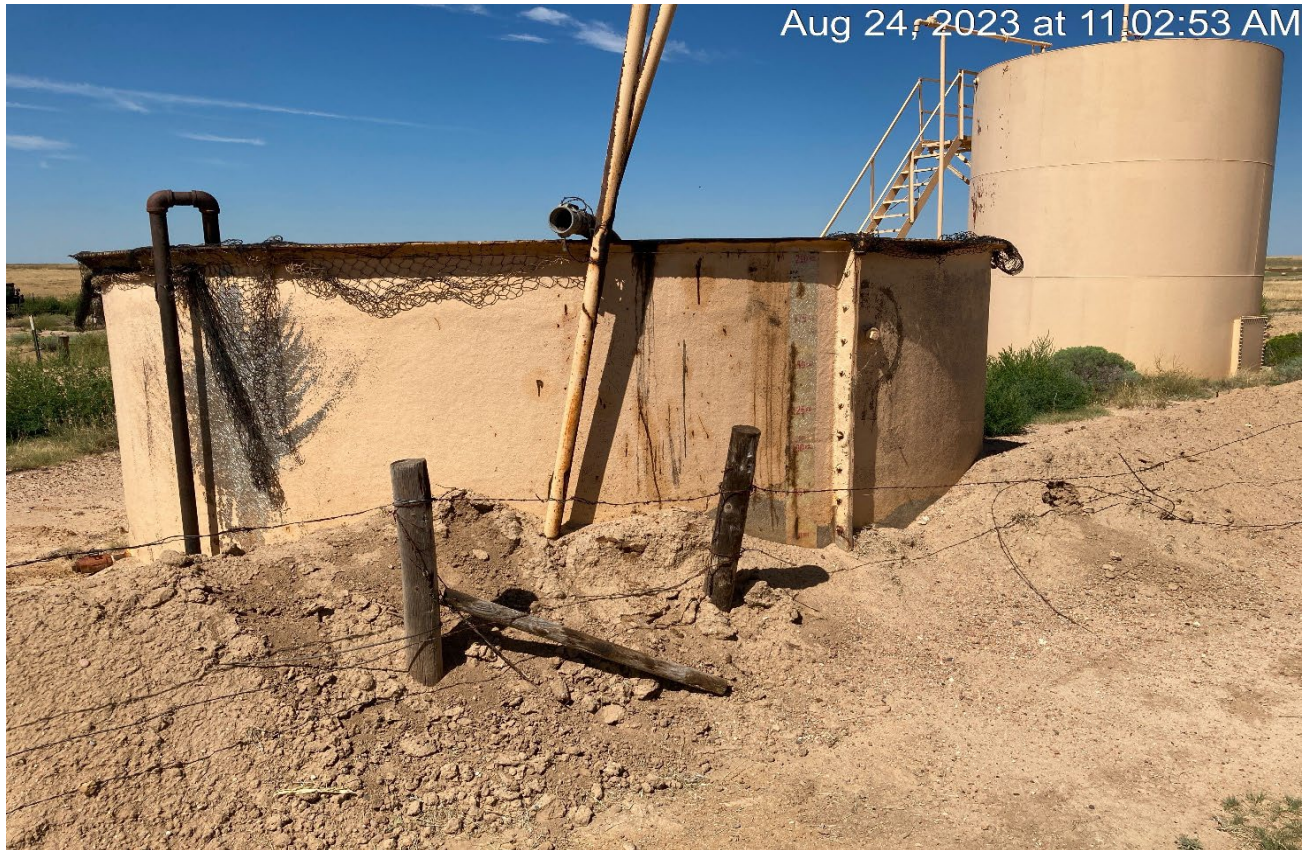
**Photo 5.** The berm is inadequate to contain a spill as it is piled up against the tank and would spill over the berm along this side. Previous corrective action was not completed.
