Inspection Photos  
well 0057-06374  
Inspection  
Date:8/18/2023

**COLORADO**  
Oil & Gas Conservation  
Commission  
Department of Natural Resources

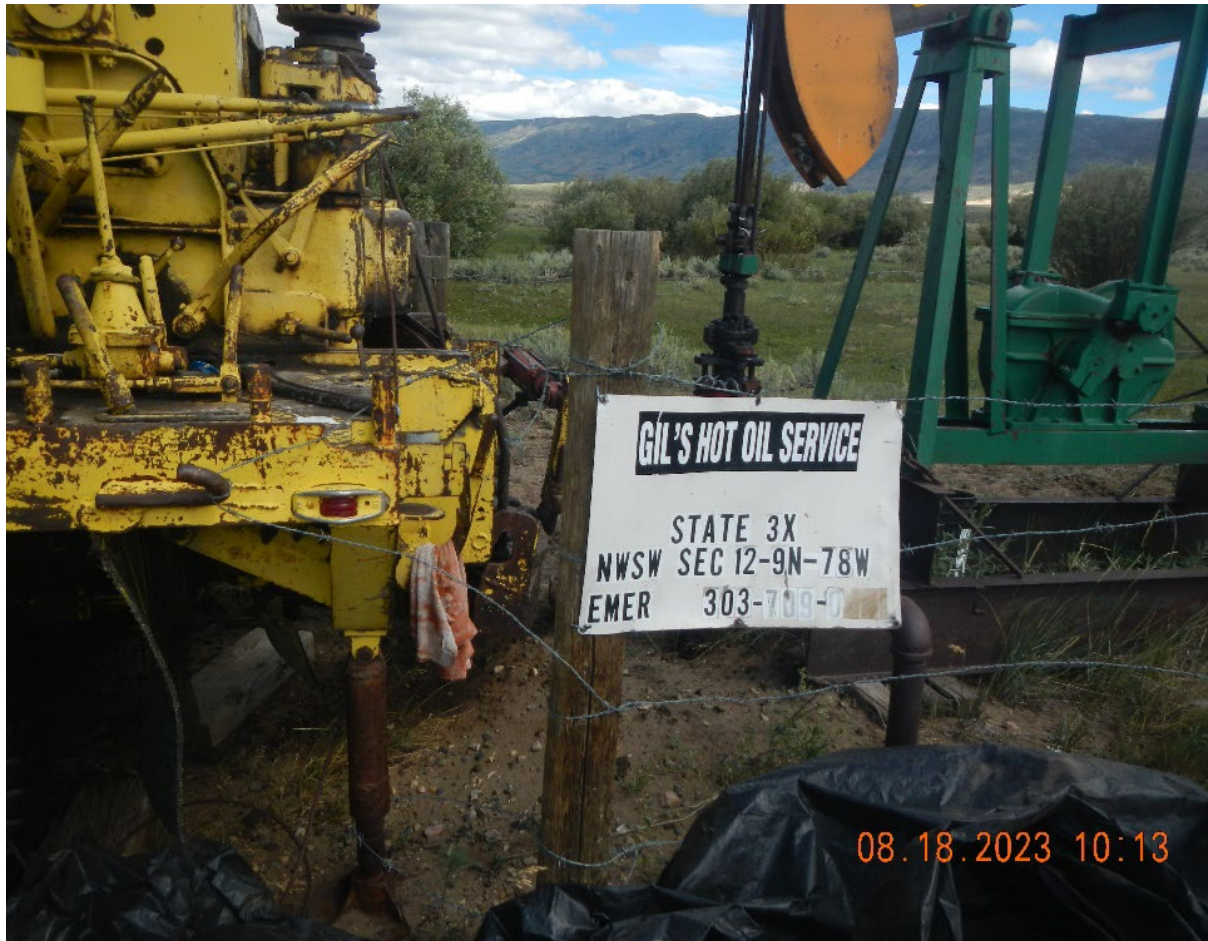
Photo #1 sign at Wellhead. There is an old pulling unit at the wellhead. The rig is laid down on the truck. There is other workover debris and trash at the well. There is a Warning Letter, doc 2193064 in the well file for a lack of MIT on this TA well. To date (8/24/2023) there is no record of this well being MIT'd.

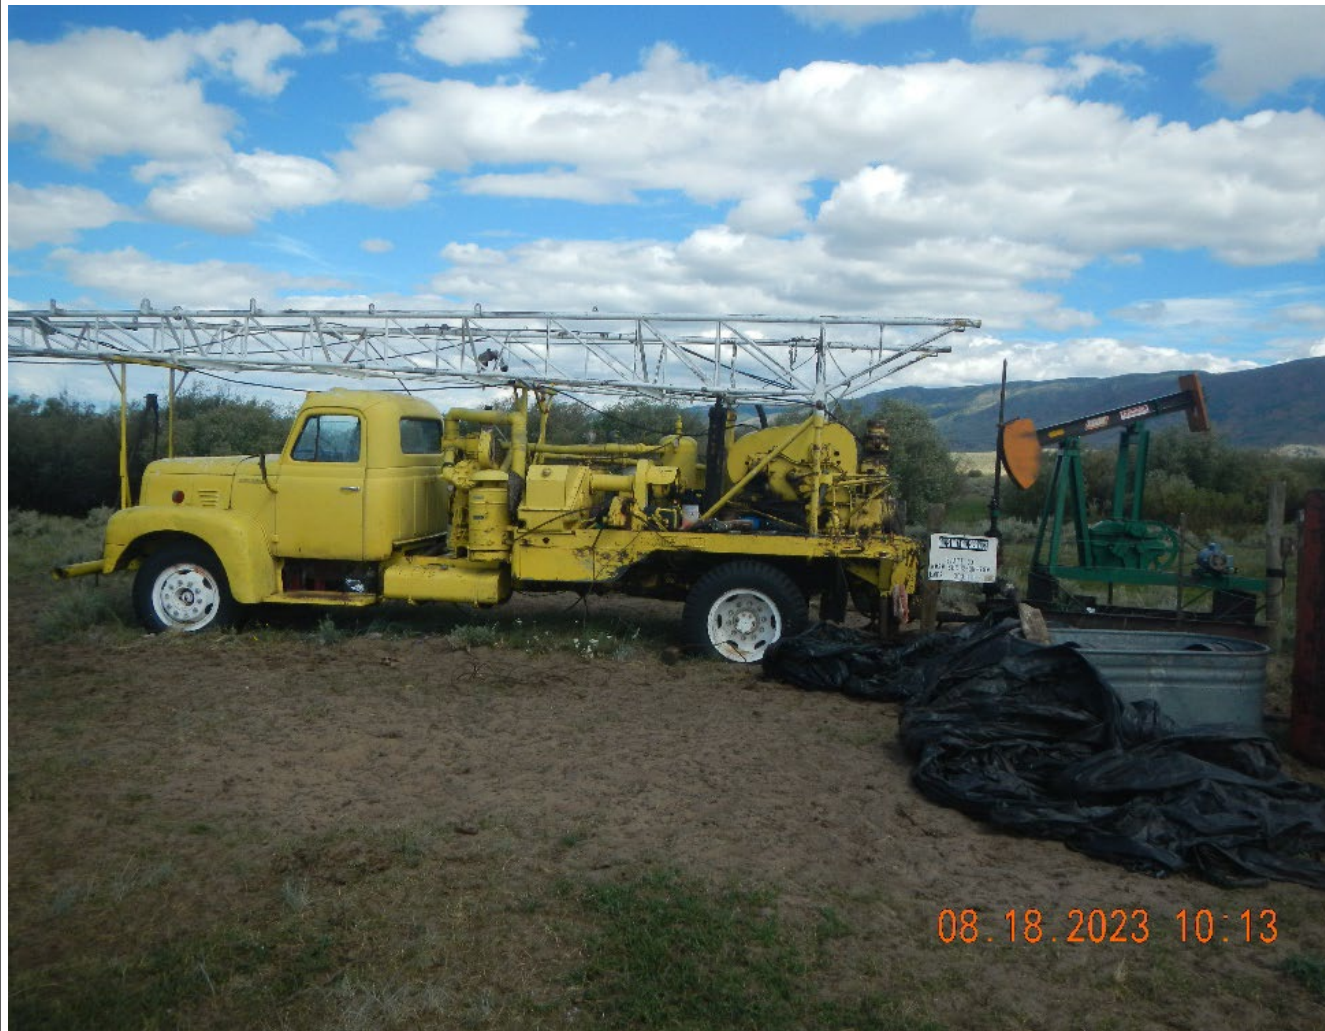
Photo #2 Old rig at well, multiple tanks, trash and debris.

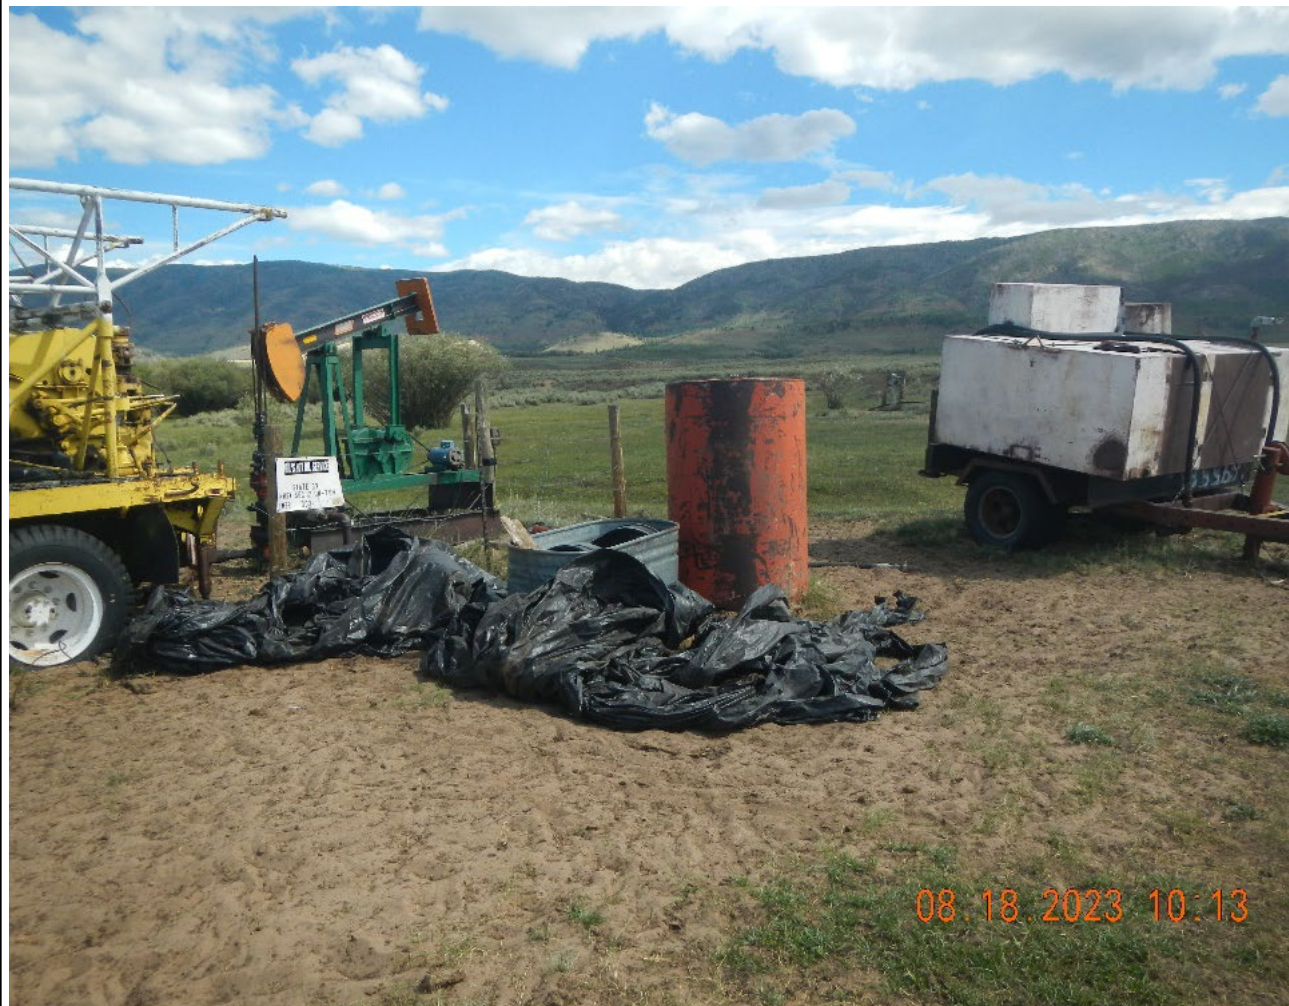
Photo #3 3 temporary tanks near well and trash. The well itself has a three wire fence.

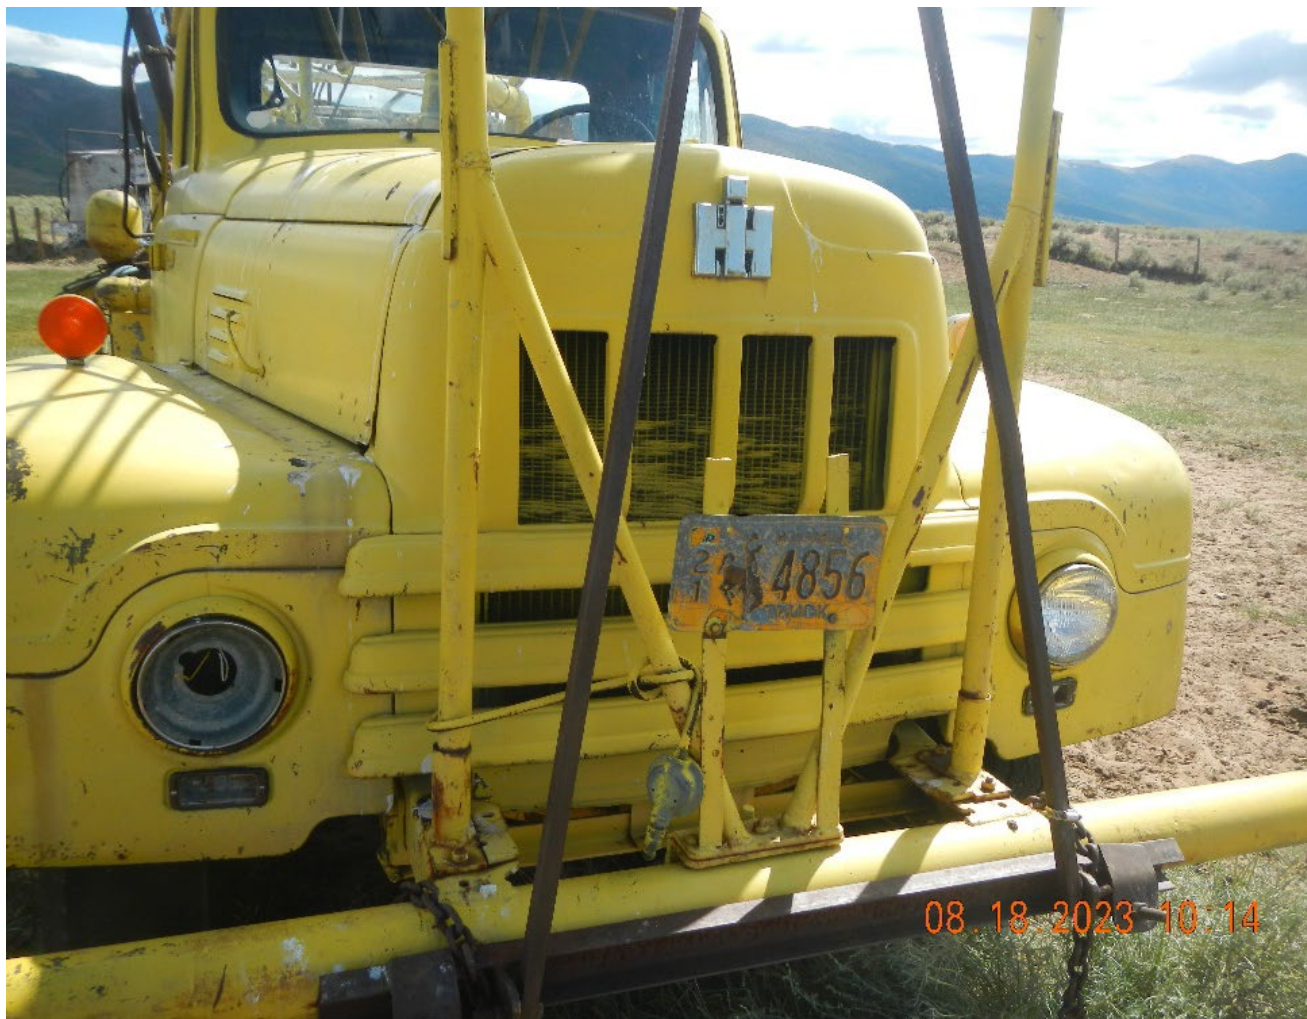
Photo #4 Old International Rig on location.

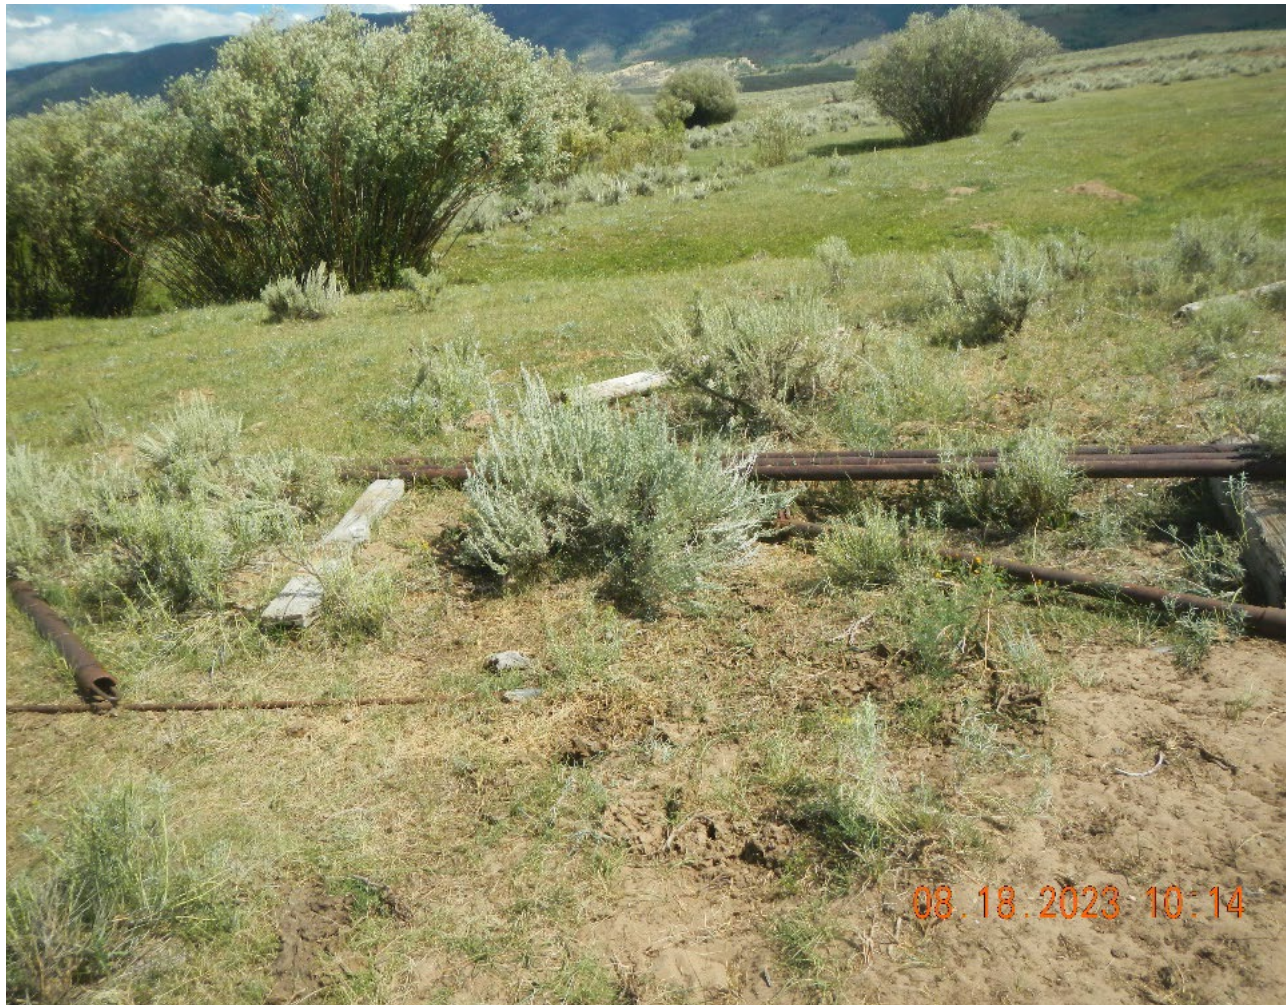
Photo #5 debris from Work over.

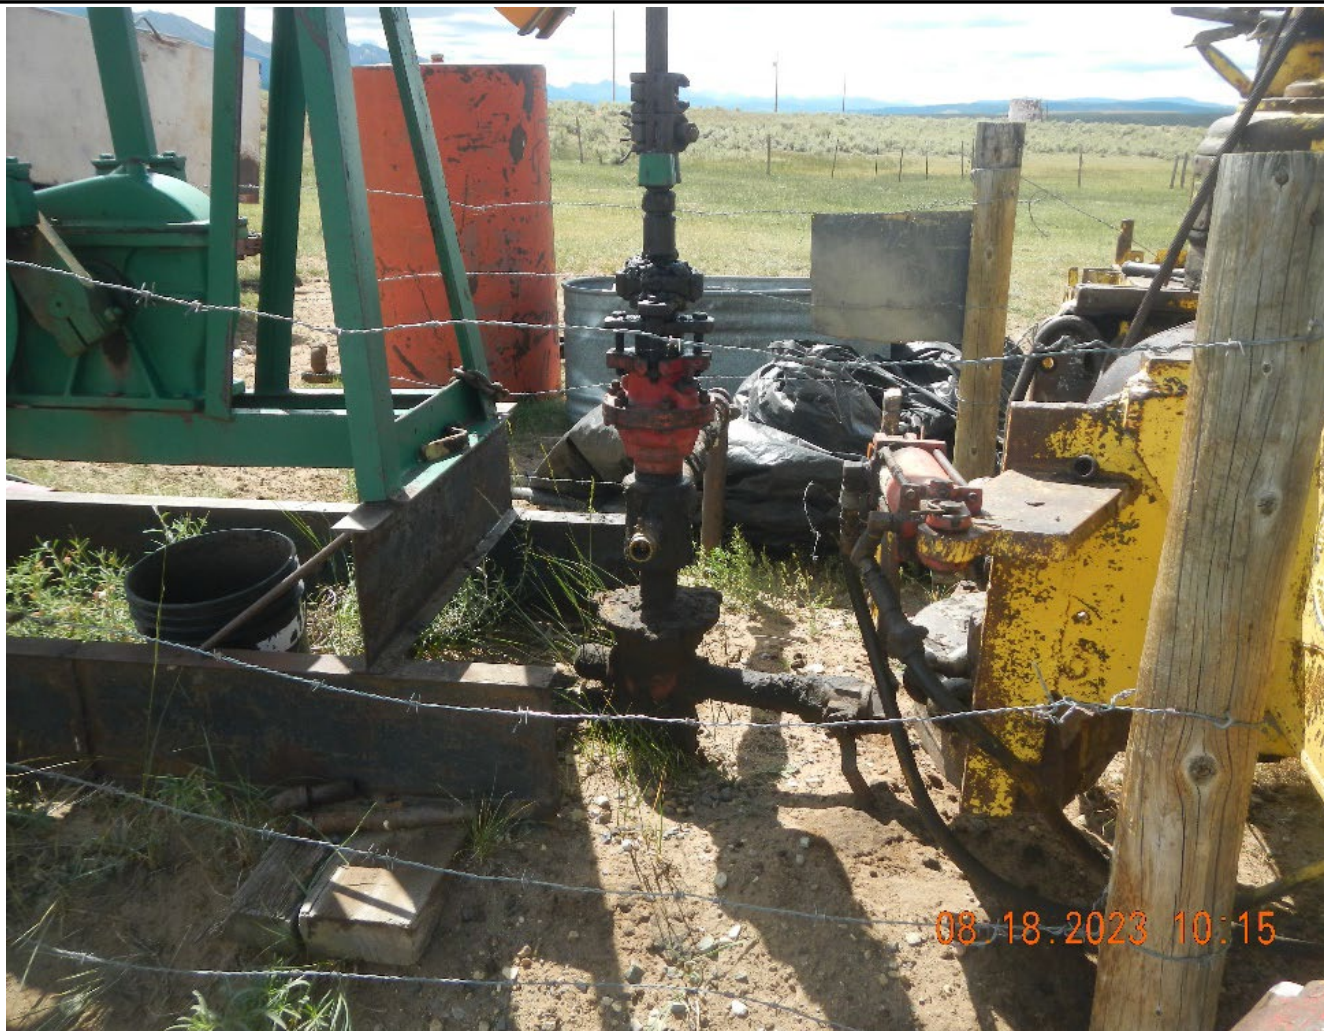
Photo #6 close up of wellhead and workover debris.

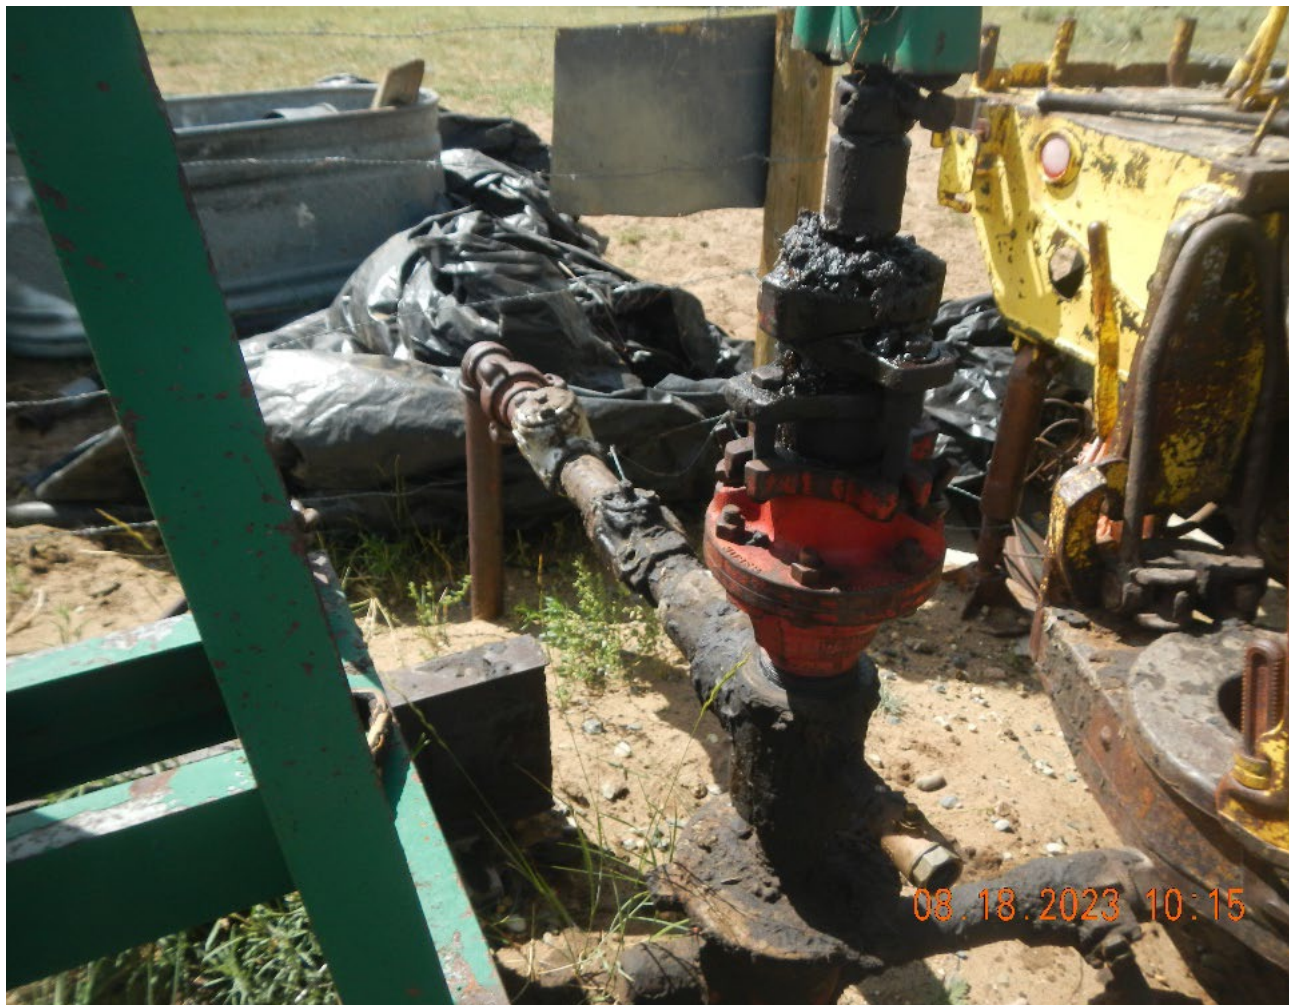
**Photo #7 waxy buildup.**

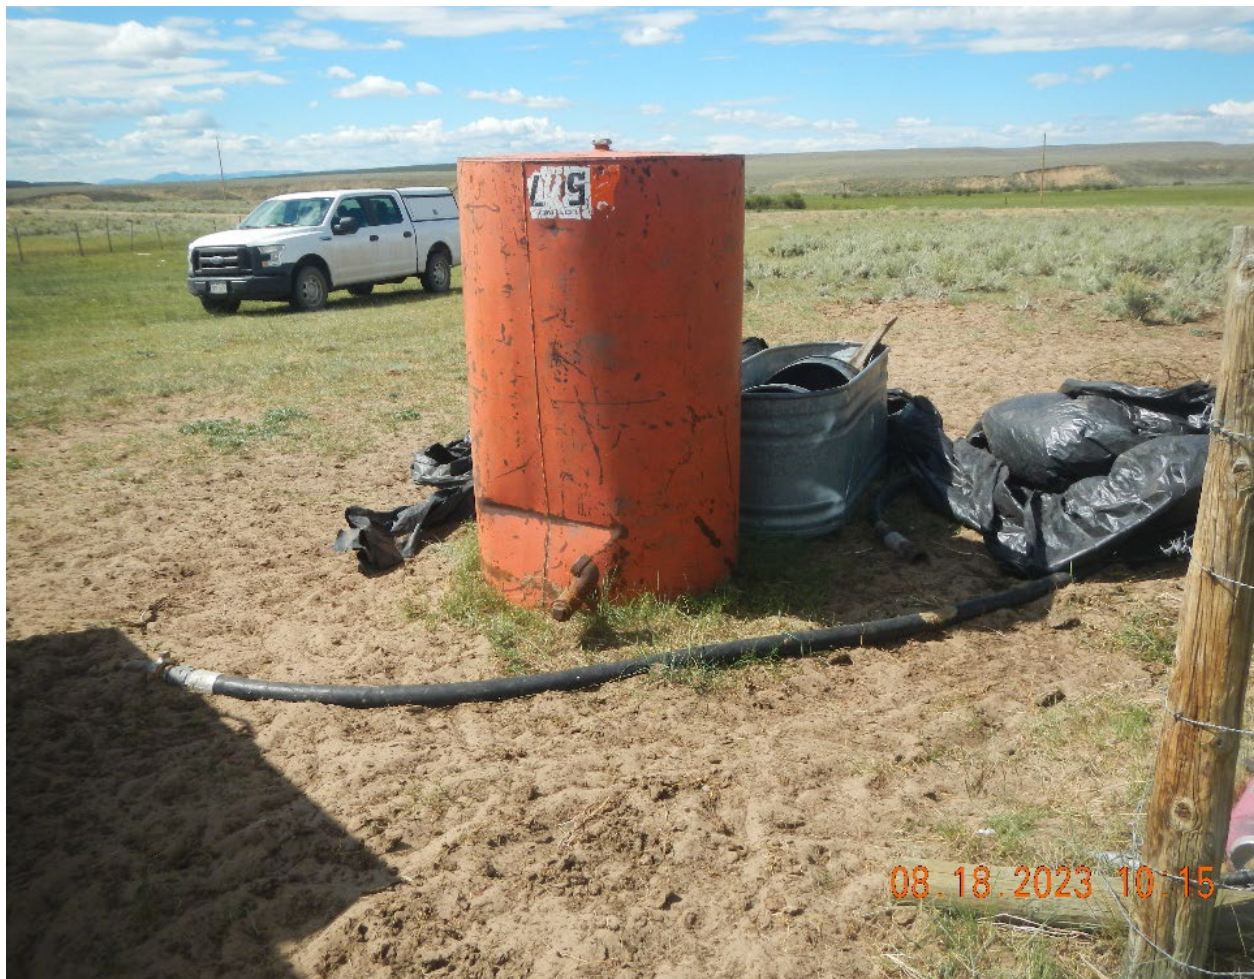
**Photo #8 trash and debris.**

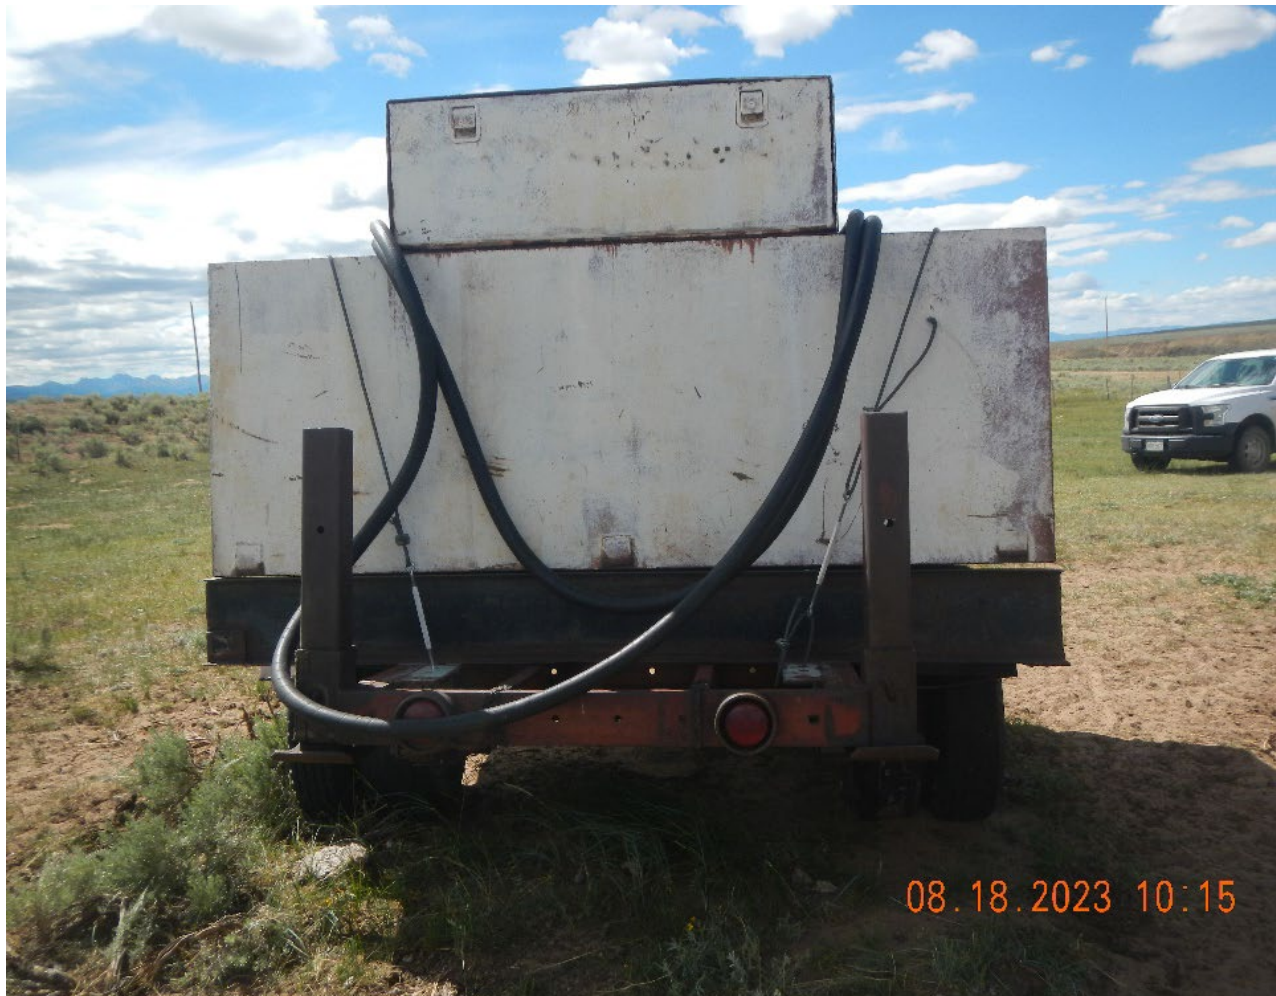
**Photo #9 Trailer tank on location.**

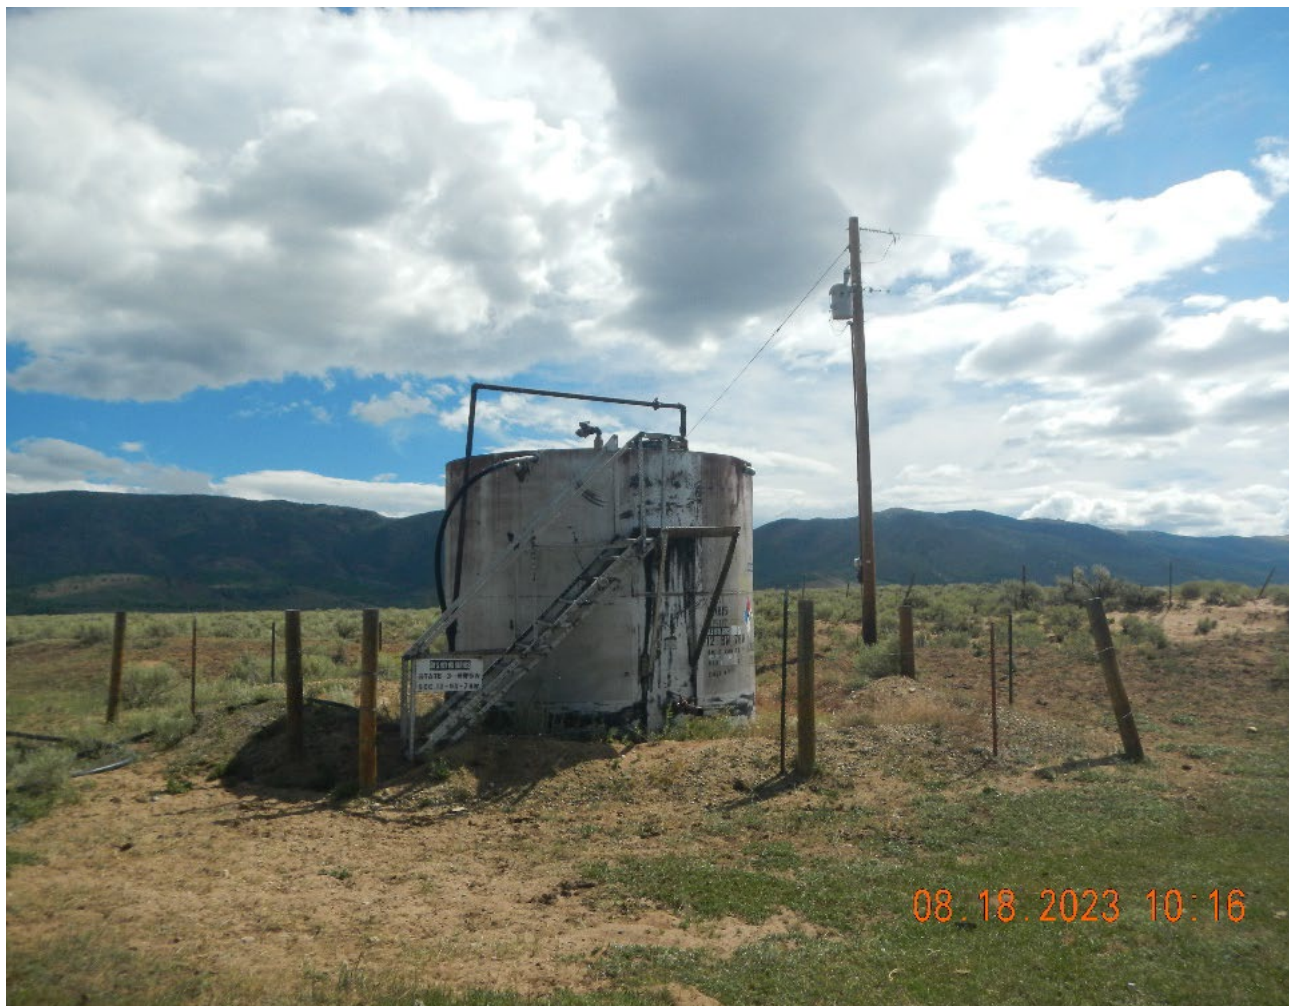
**Photo #10 Production tank near Irrigation Ditch.**

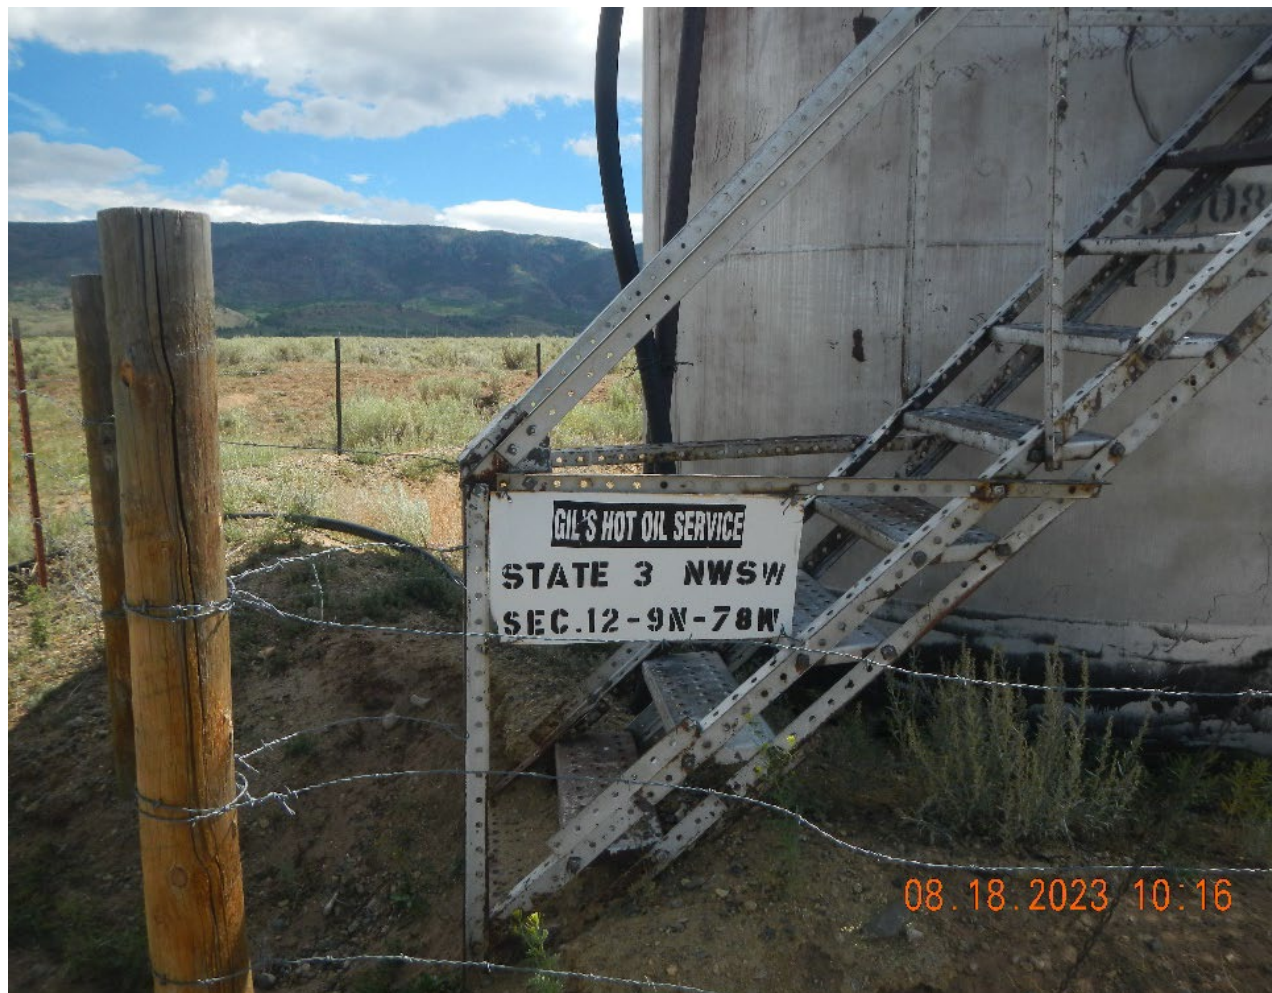
Photo #11 Sign at Production Tank.

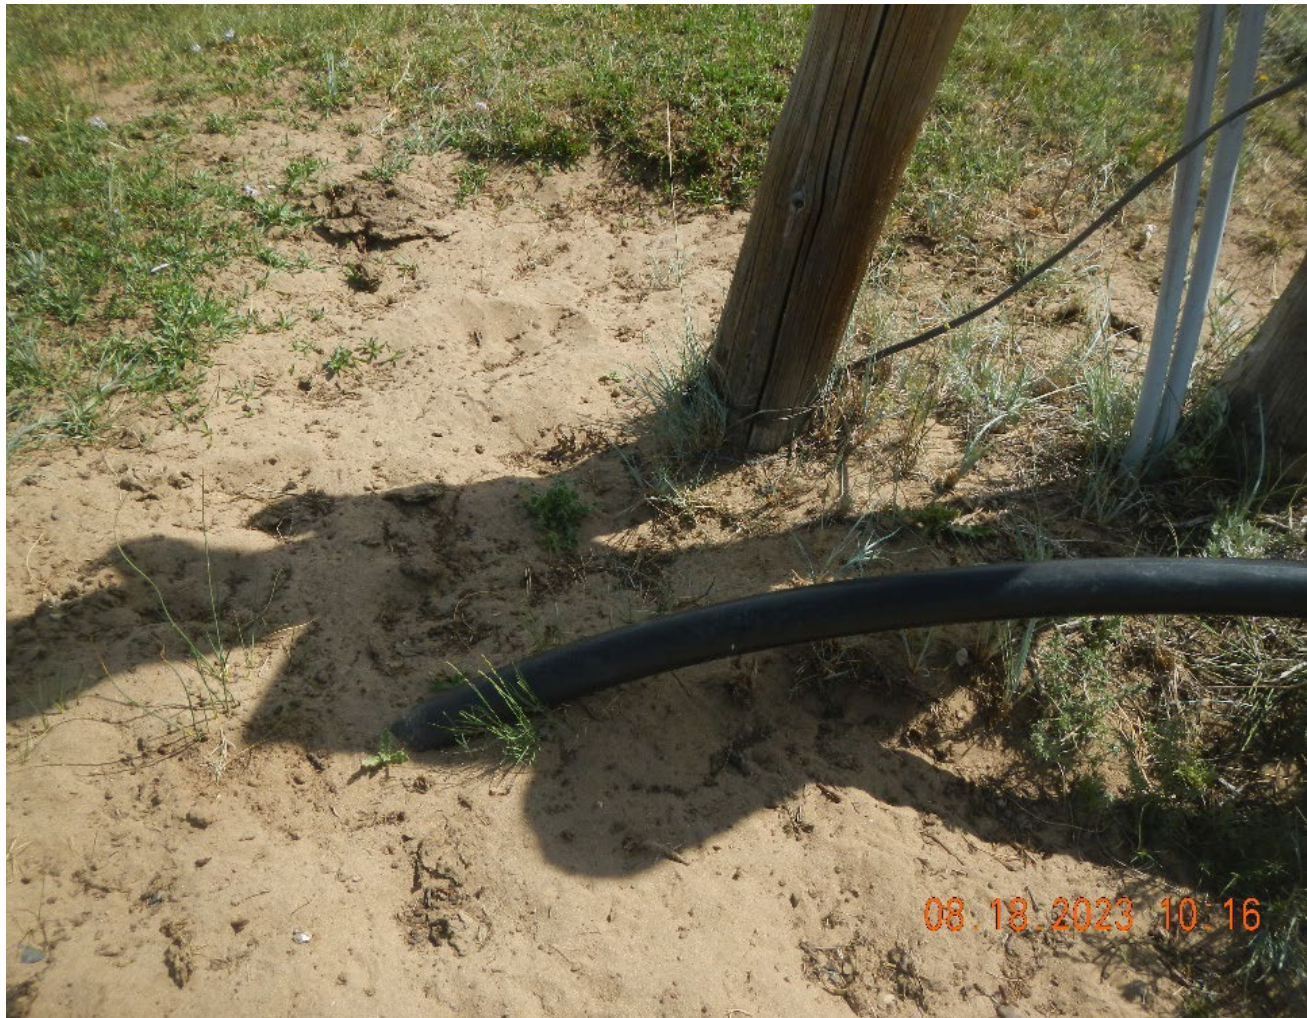
**Photo #12** Appears that this is the Poly flowline that is coming from the 12-1 well. There is no Sign identifying this tank as related to the 12-1 well.

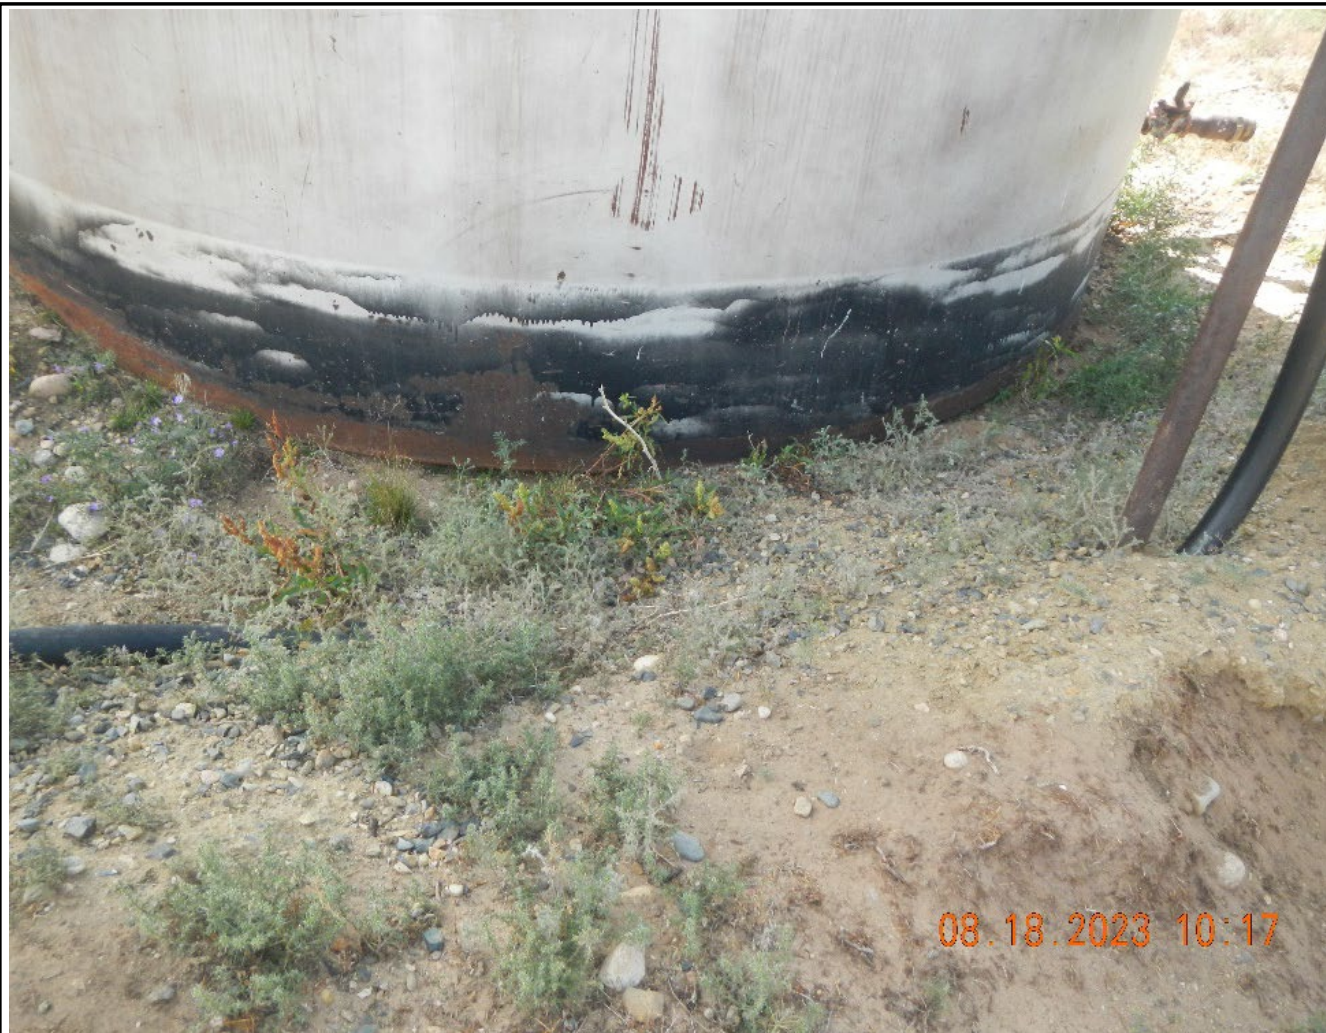
**Photo #13 Poly line is buried in the tank Berm.**

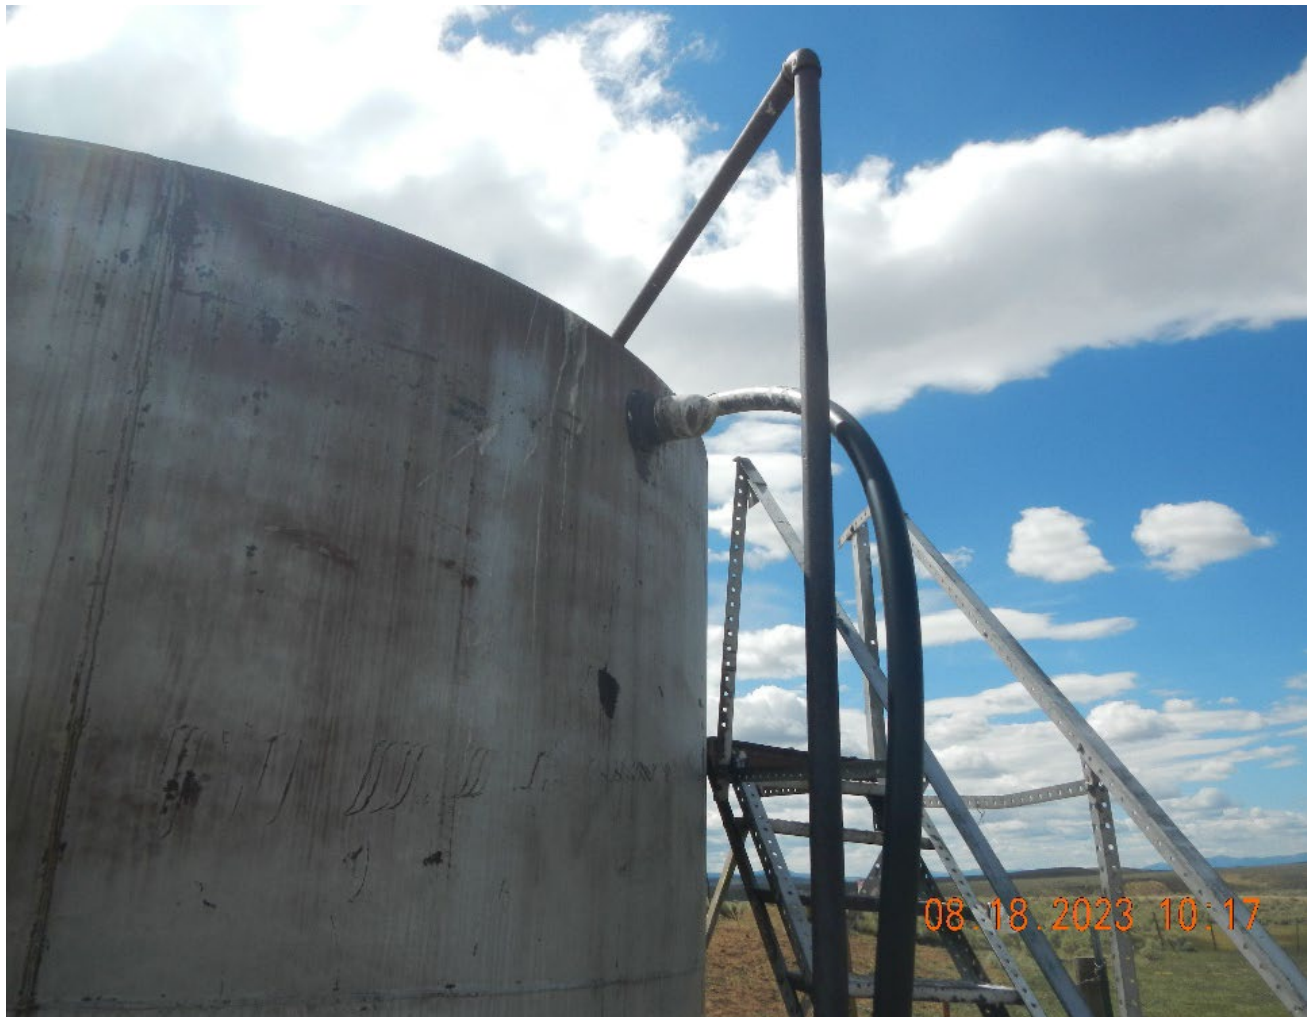
**Photo #14 Poly line entering the Production Tank.**

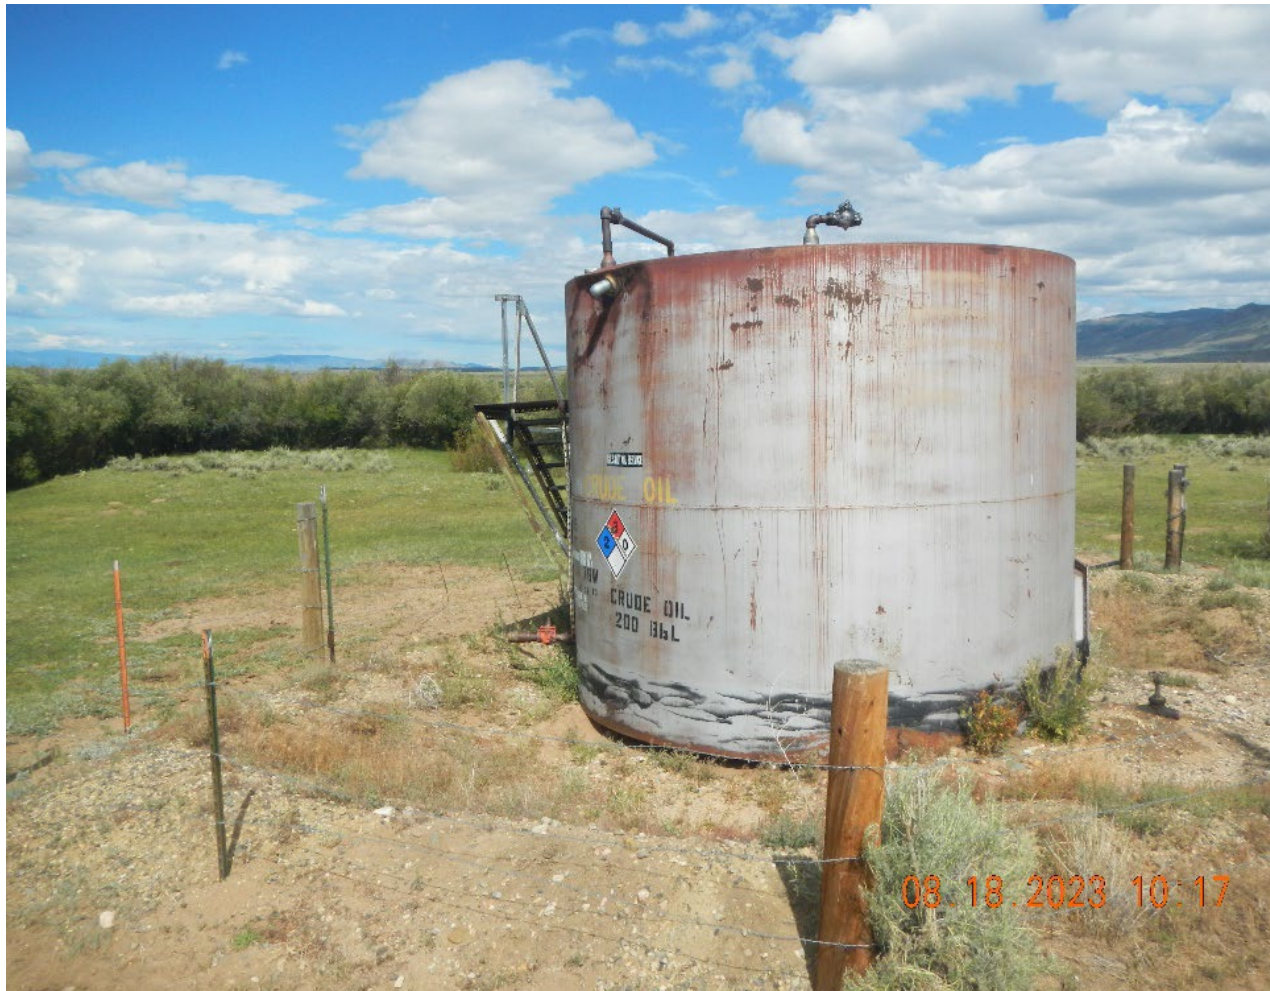
**Photo #15 Tank is fenced.**
