Inspection Photos

Location Name: CAERUS PICEANCE LLC COUEY O30NE Pad

Location #: 335358

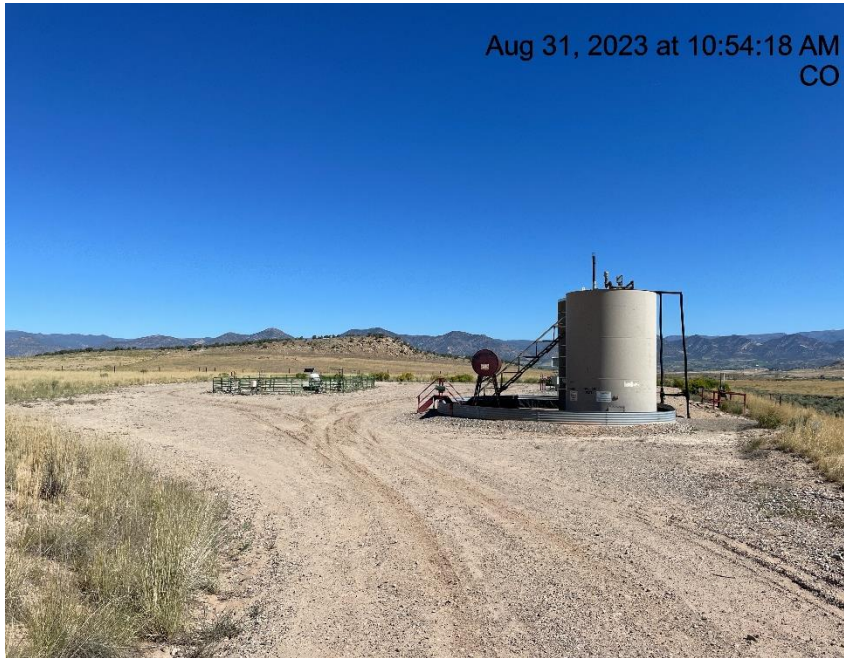
Photo # 7838 From entrance to location

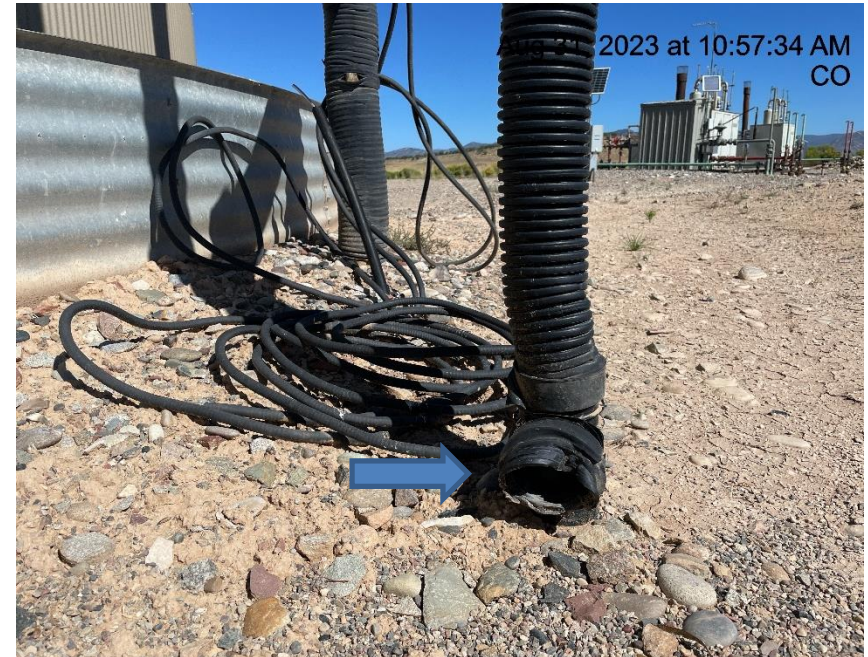
Photo # 7843 Flowline heating insulation open ended

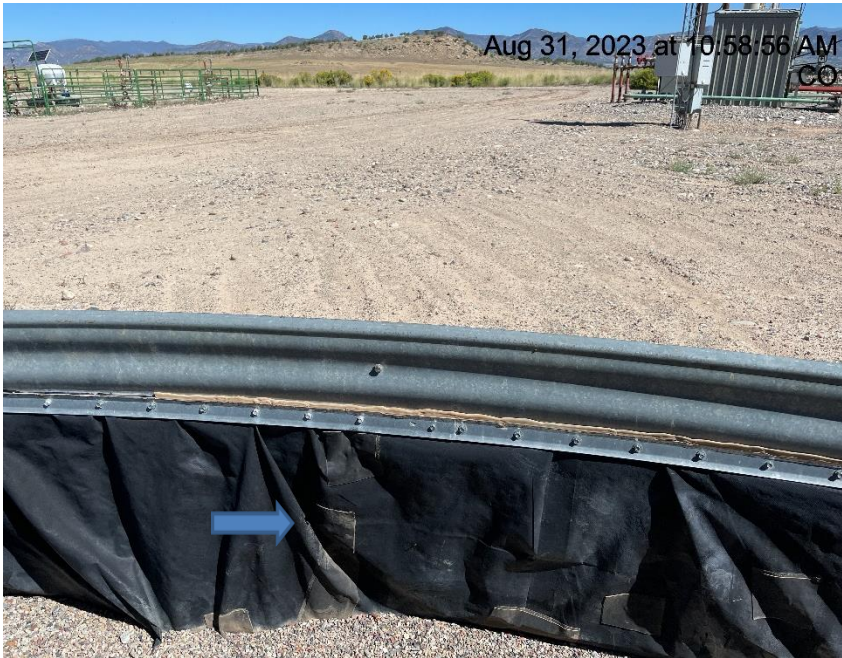
Photo # 7844 Hole in liner/liner needs maintenance

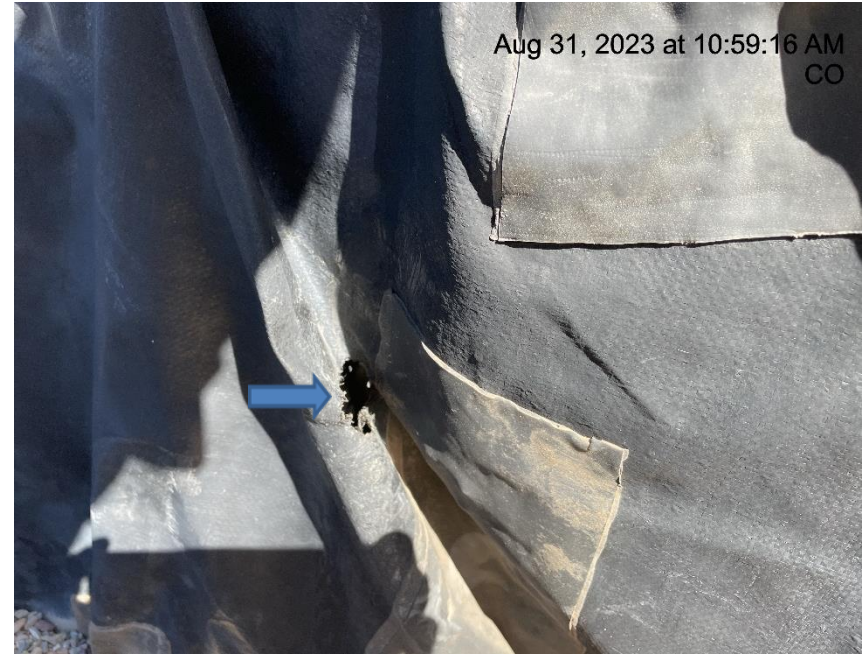
Photo # 7846 Hole in liner/liner needs maintenance

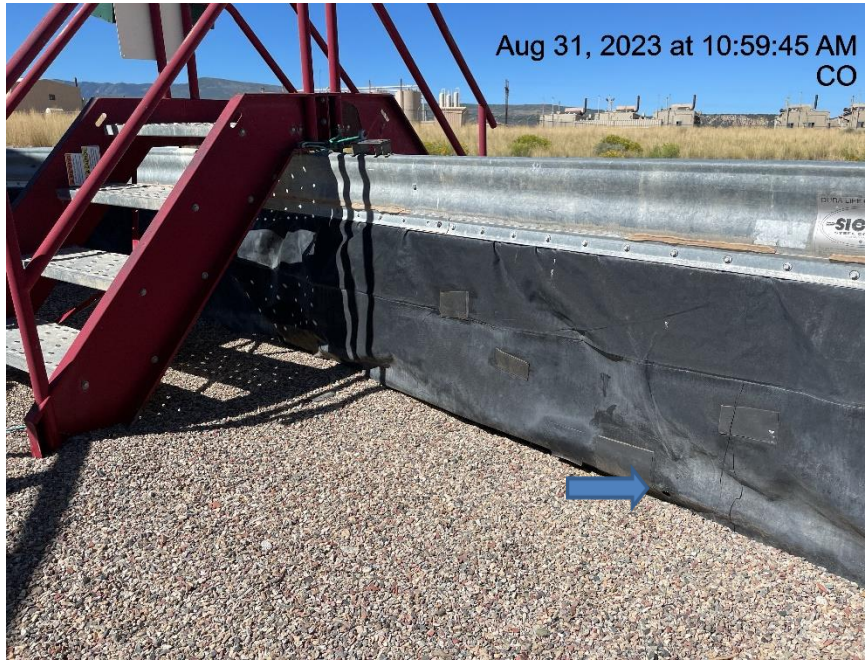
Photo # 7848 Hole in liner/liner needs maintenance

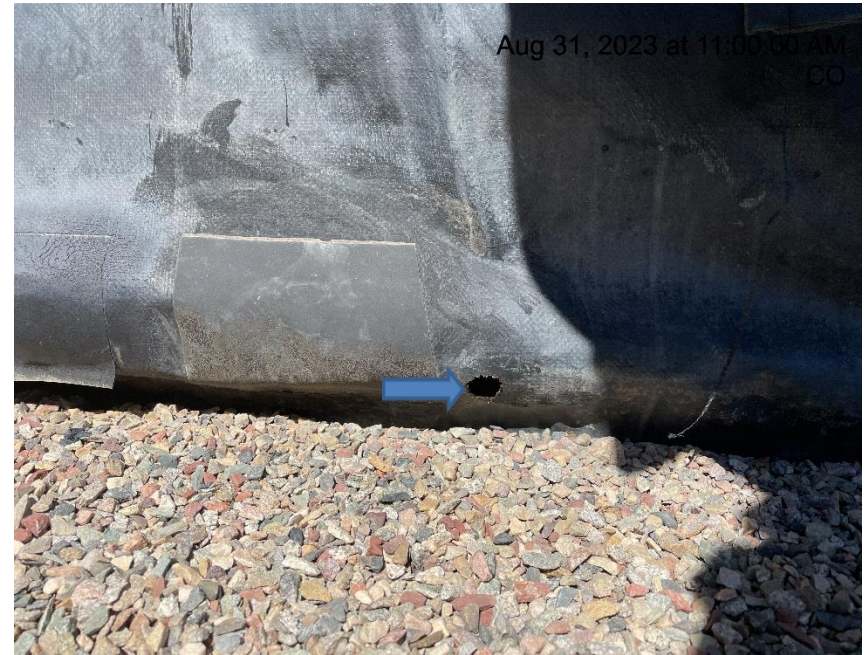
Photo # 7849 Hole in liner/liner needs maintenance

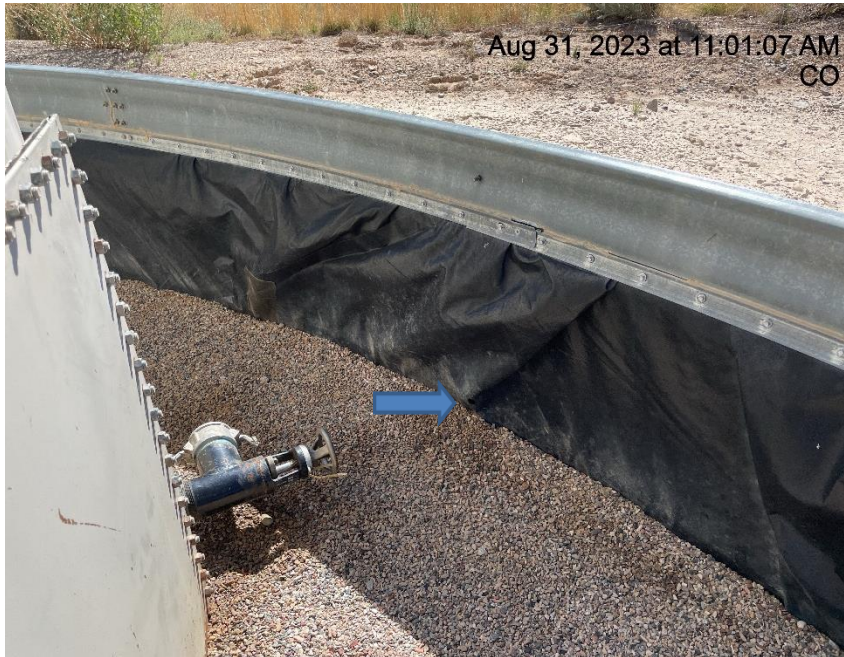
Photo # 7851 Hole in liner/liner needs maintenance

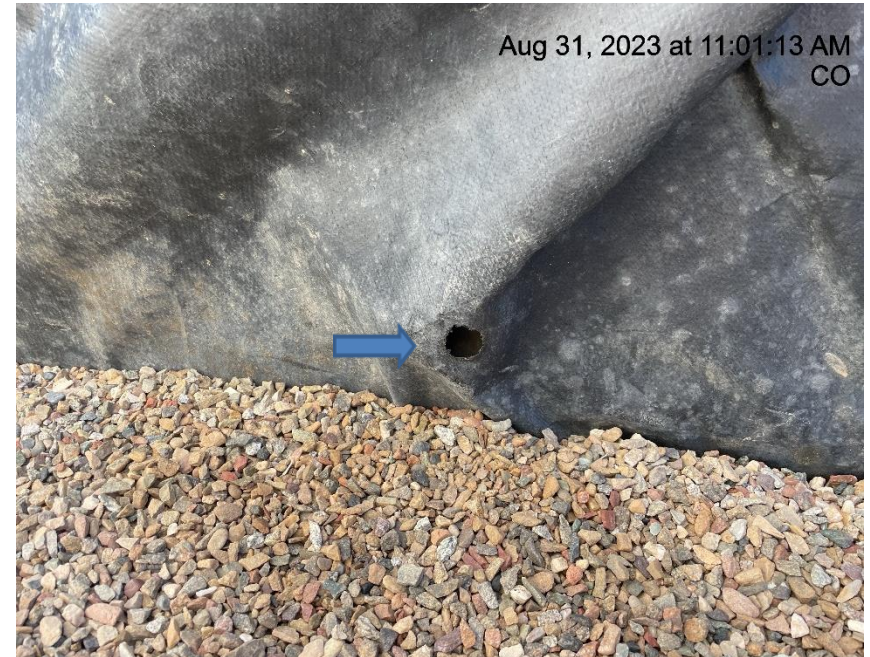
Photo # 7852 Hole in liner/liner needs maintenance

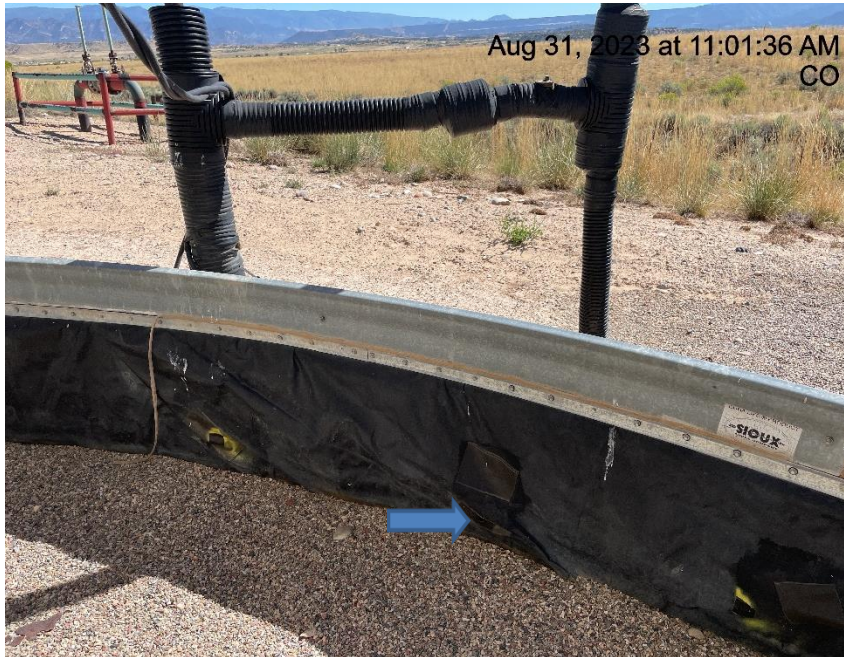
Photo # 7853 Hole in liner/liner needs maintenance

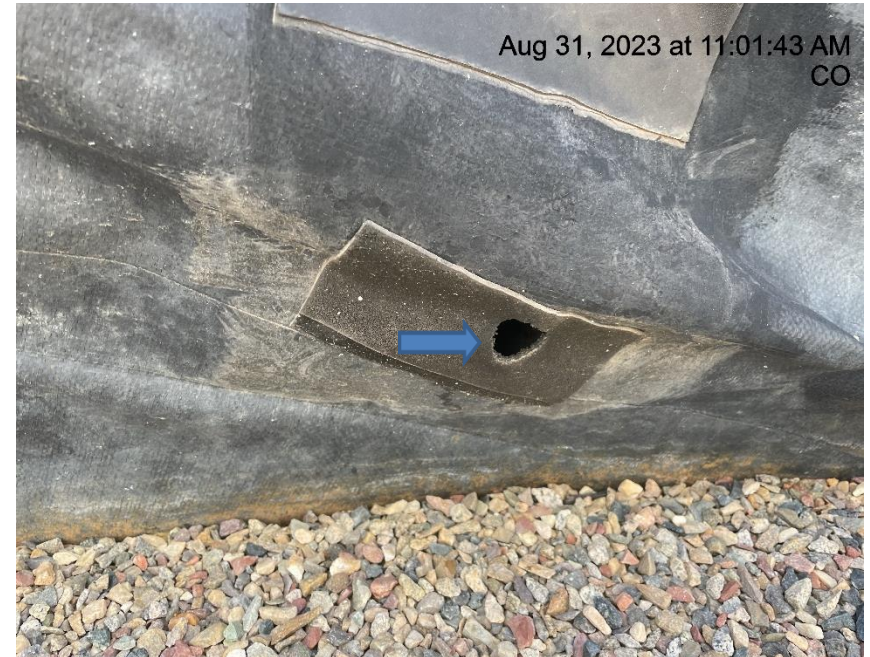
Photo # 7854 Hole in liner/liner needs maintenance

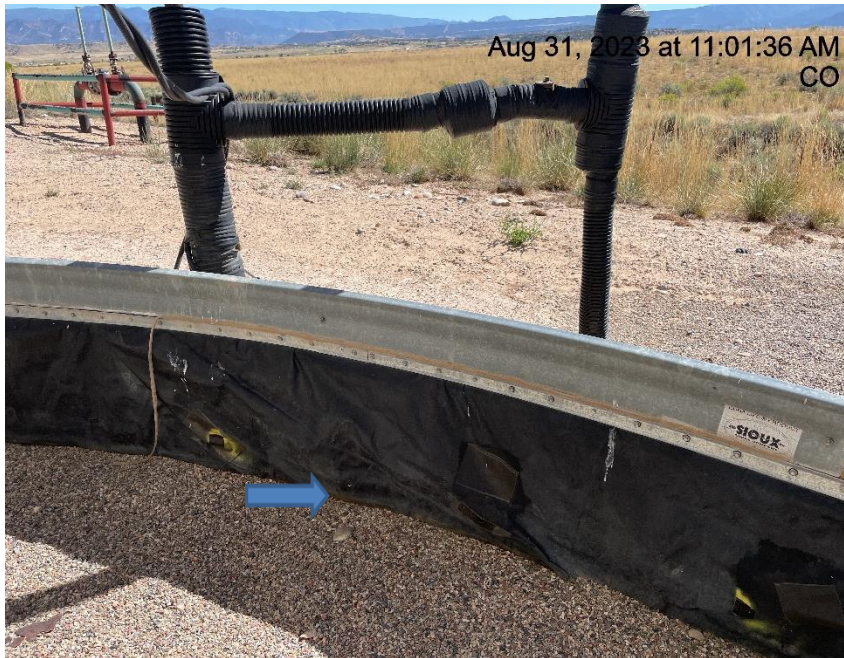
Photo # 7853 Holes in liner/liner needs maintenance

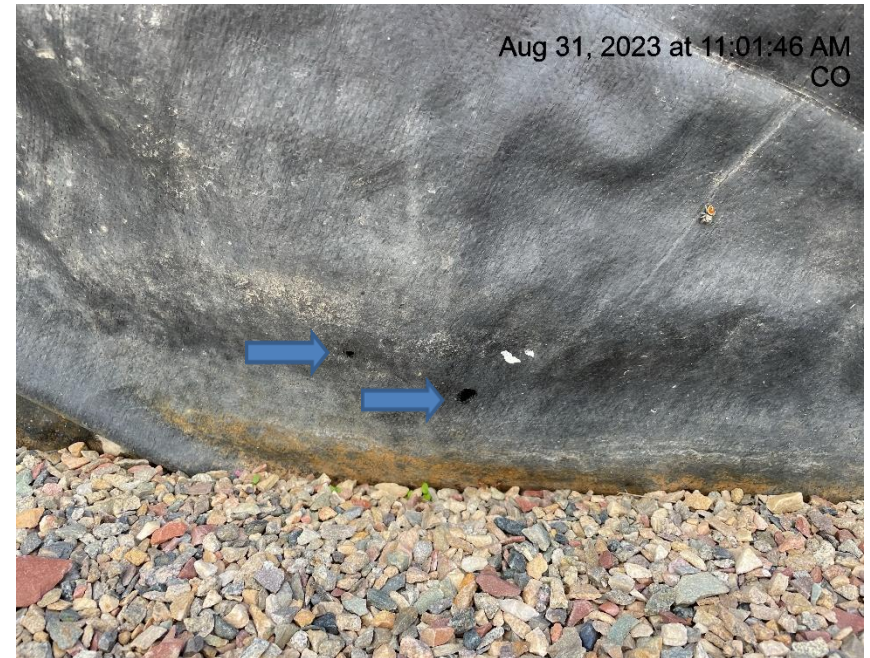
Photo # 7855 Holes in liner/liner needs maintenance

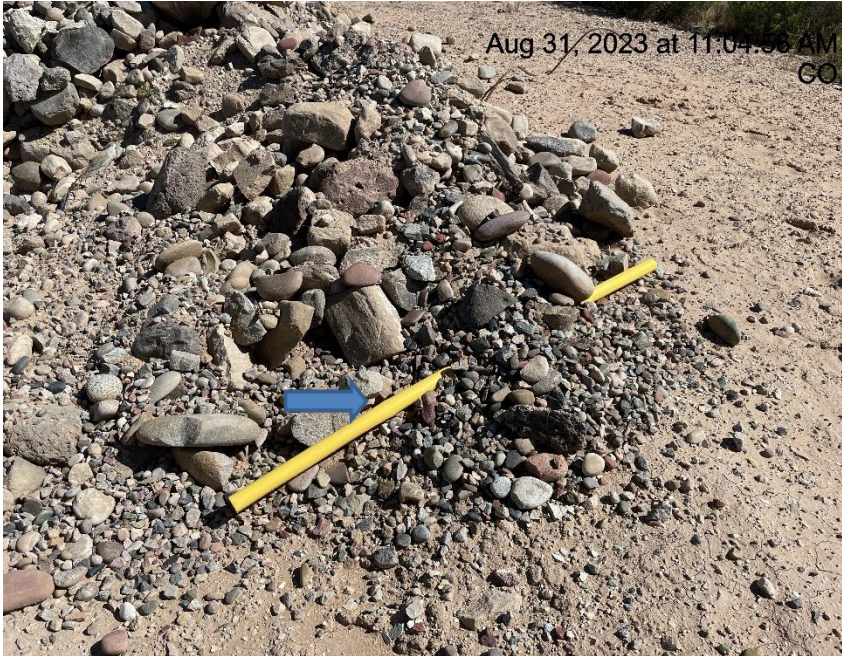
Photo # 7861 Debris

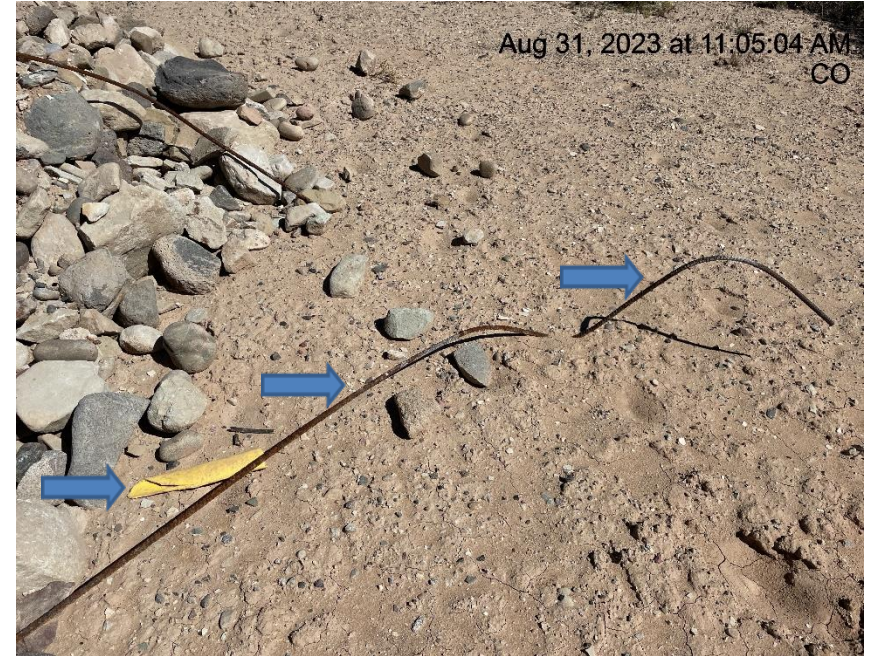
Photo # 7862 Debris

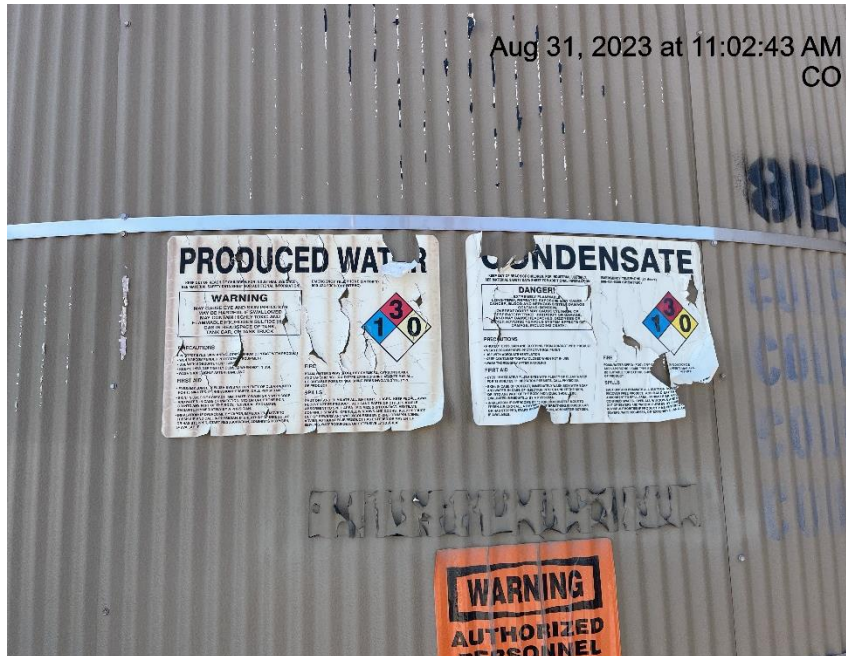
Photo # 7858 Tank labels peeling off
