Inspection Photos
Location Name: CAERUS PICEANCE LLC B31 Pad
Location #: 335307

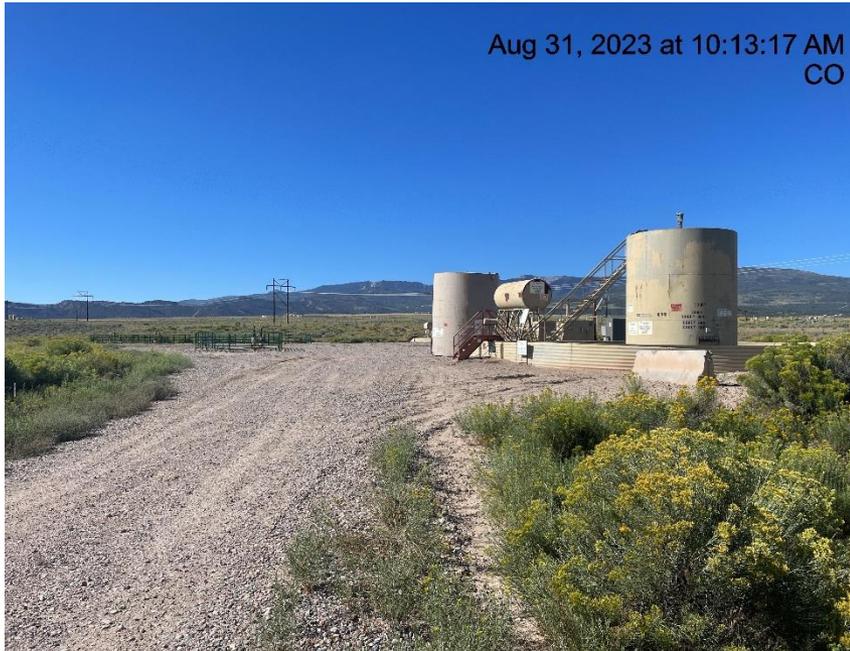
Photo # 7789 From entrance to location

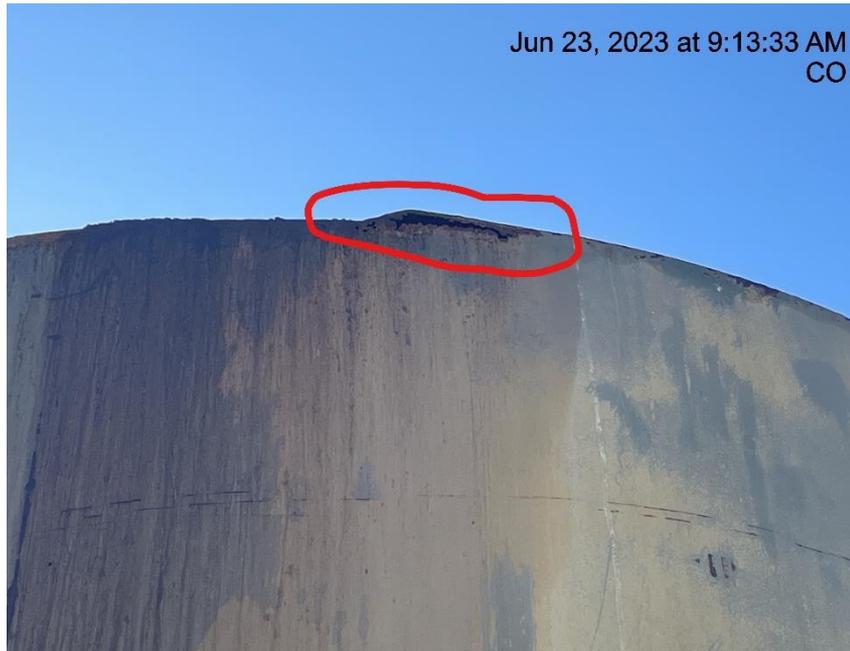
Photo # 1501 From inspection 708900837 conducted on 06/23/2023 Hole in production tank/tank corrosion

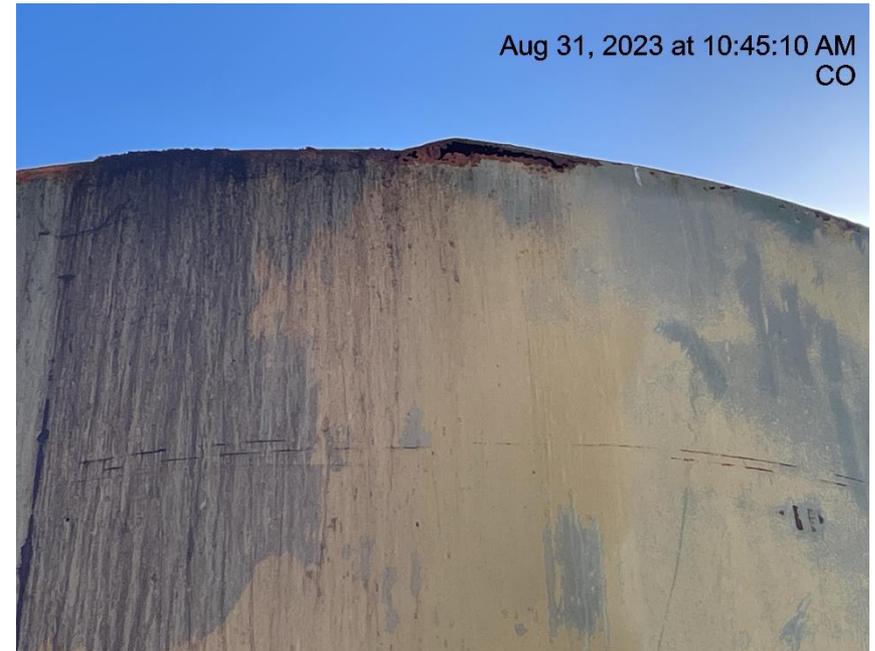
Photo # 7833 Hole in production tank/tank corrosion

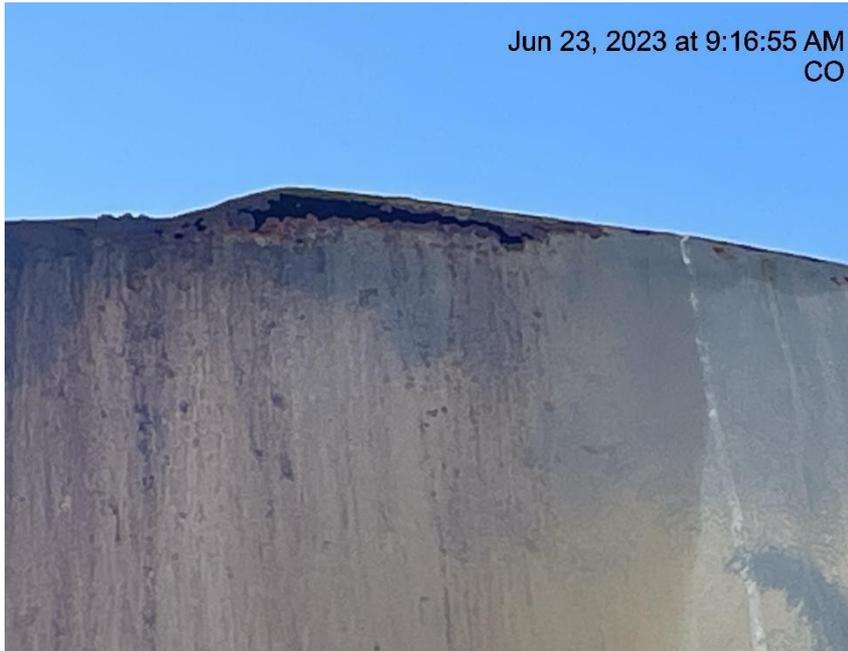
Photo # 1503 From inspection 708900837 conducted on 06/23/2023 Hole in production tank/tank corrosion

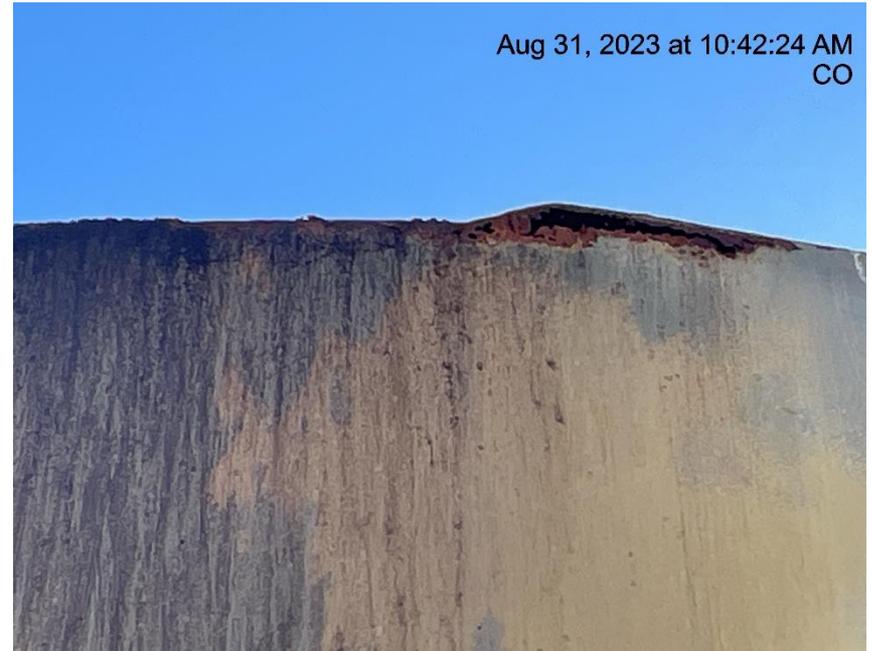
Photo # 7825 Hole in production tank/tank corrosion

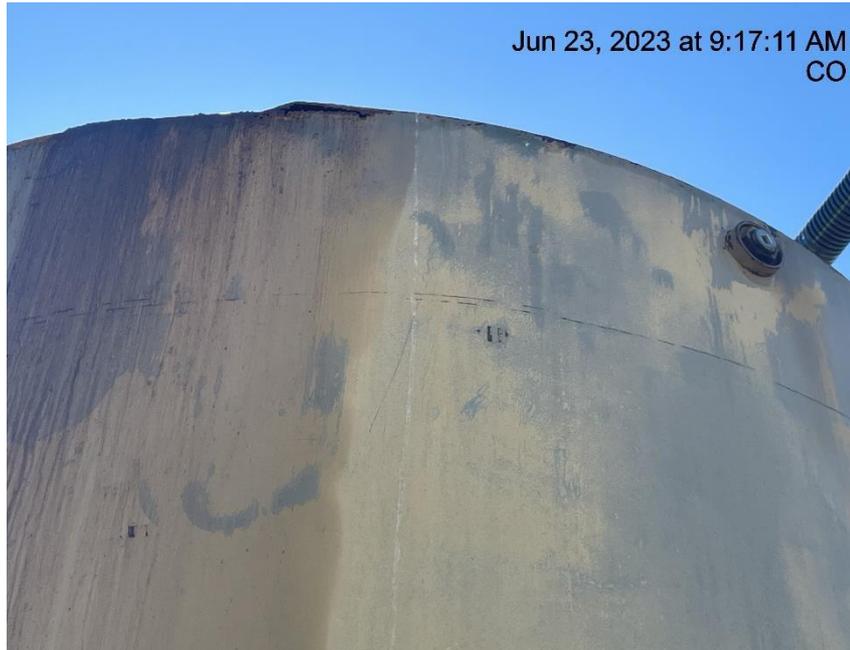
Photo # 1505 From inspection 708900837 conducted on 06/23/2023 Hole in production tank/tank corrosion

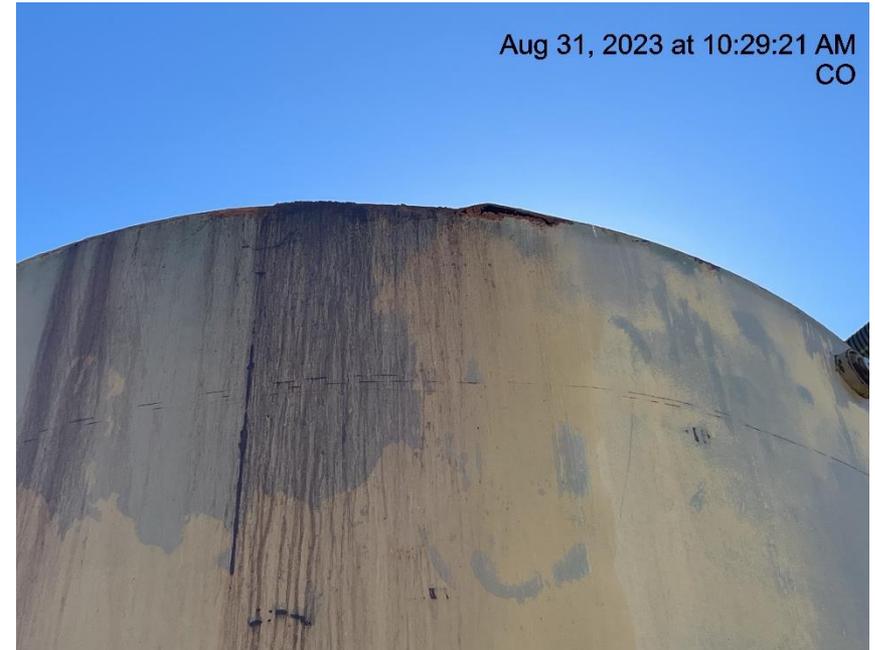
Photo # 7804 Hole in production tank/tank corrosion

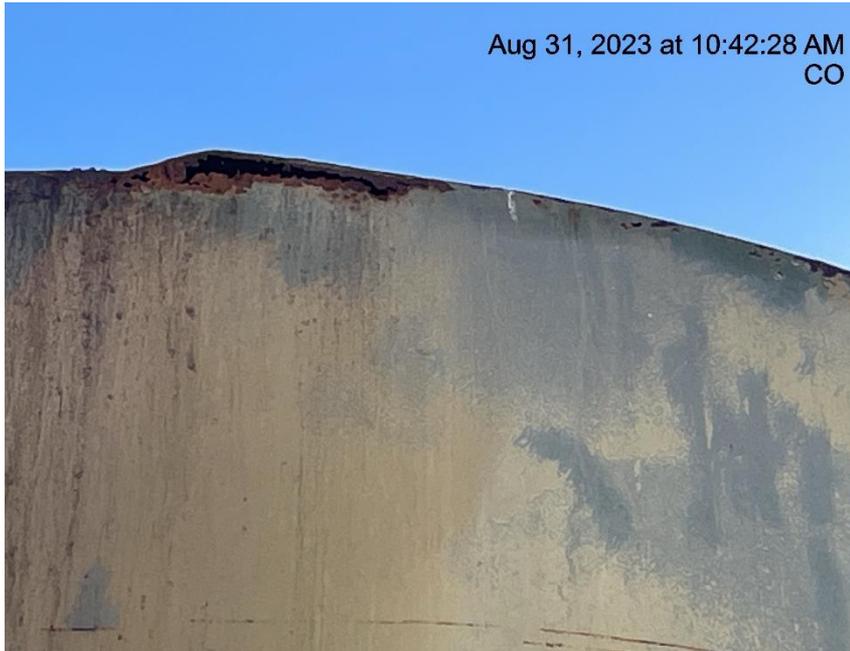
Photo # 7826 Hole in production tank/tank corrosion

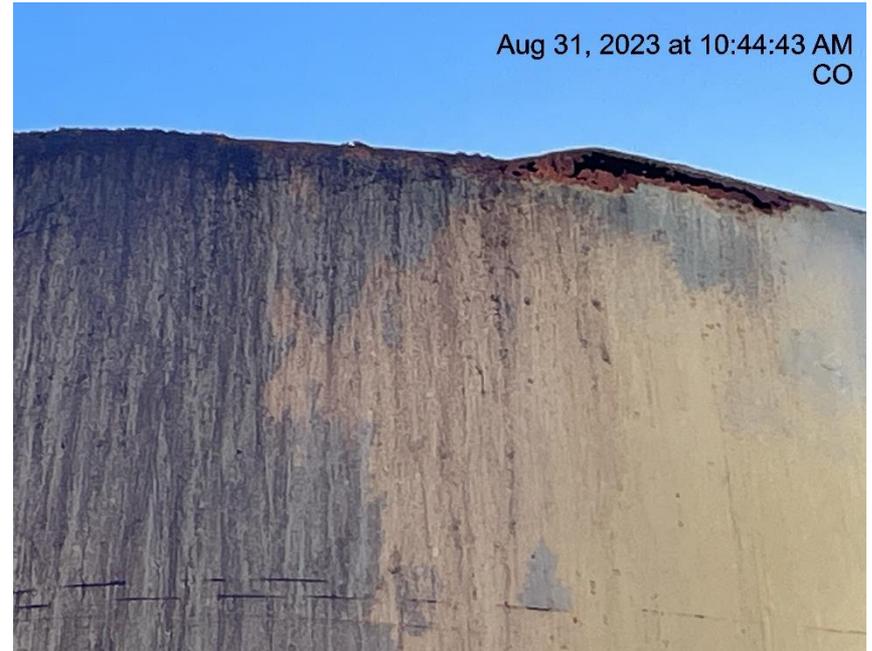
Photo # 7827 Hole in production tank/tank corrosion
