Inspection Photos

Location Name: TEP ROCKY MOUNTAIN LLC, UNOCAL-67S96W/1NWSE

Location ID: 324155

Date: 8/22/2023

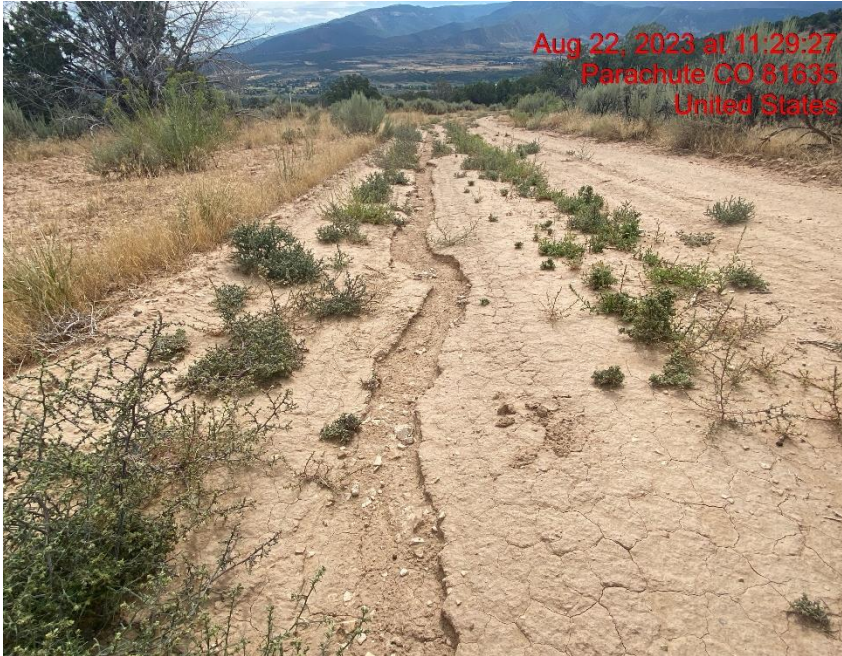
Rill Erosion Cutting Through Access Road – Photo #06041

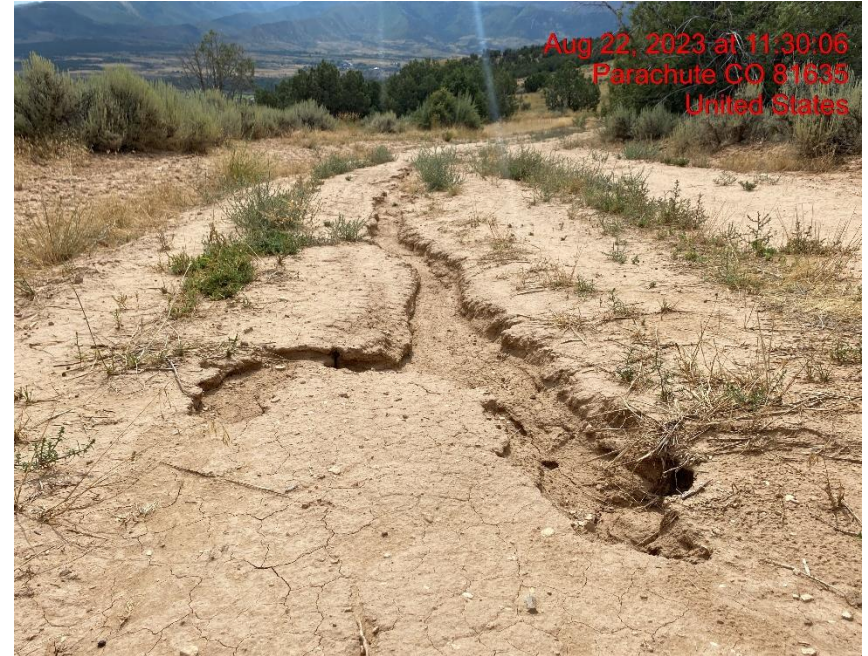
Rill Erosion Cutting Through Access Road – Photo #06042

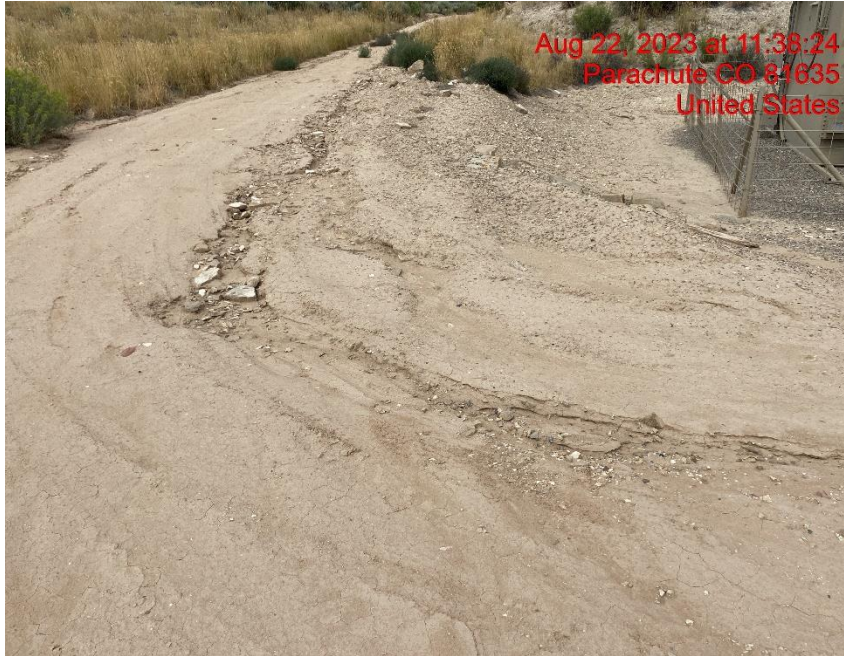
Insufficient Erosion Control – Photo #06048

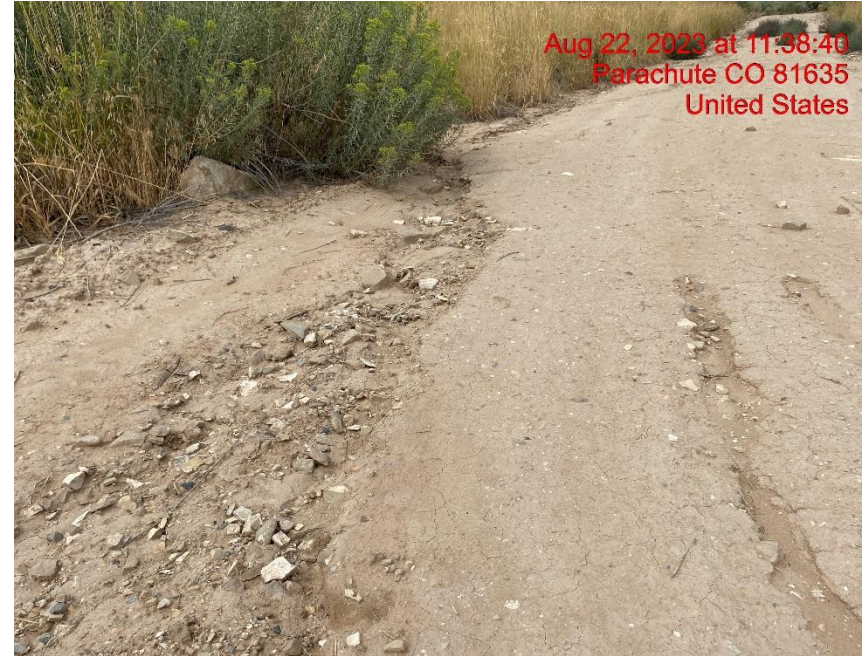
Insufficient Erosion Control – Photo #06049

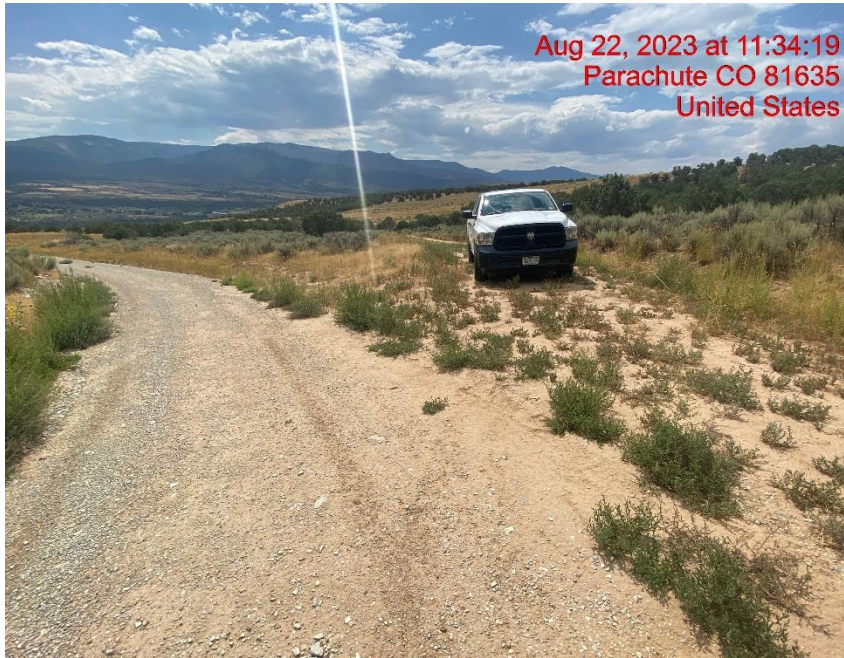
Insufficient Vehicle Tracking BMPs at Location Entrance/Exit
– Photo #06044

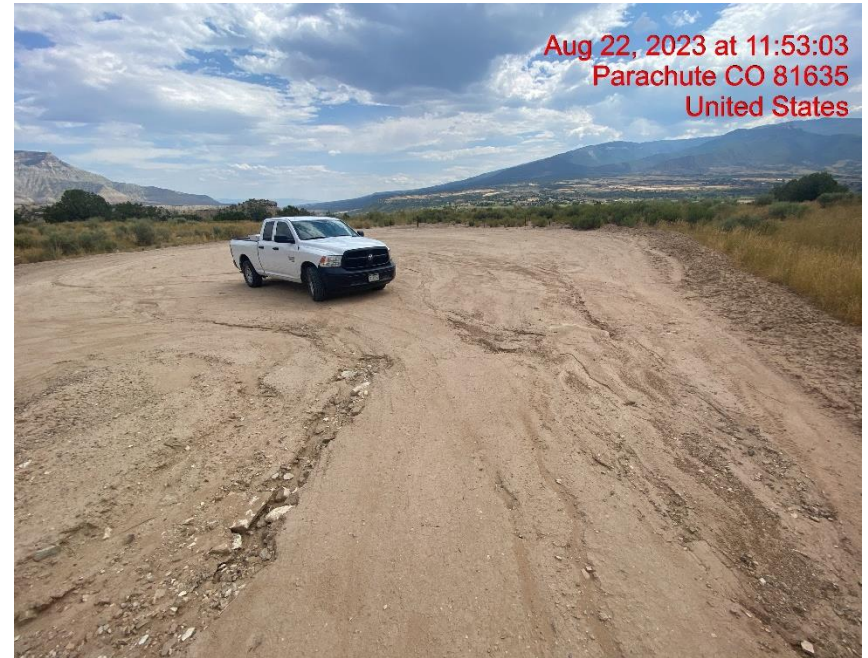
Insufficient Vehicle Tracking BMPs at Location Entrance/Exit
– Photo #06051
