Inspection Photos

API: 043-40001

Operator: JAVERNICK OIL

Inspection Date: 9/1/2023

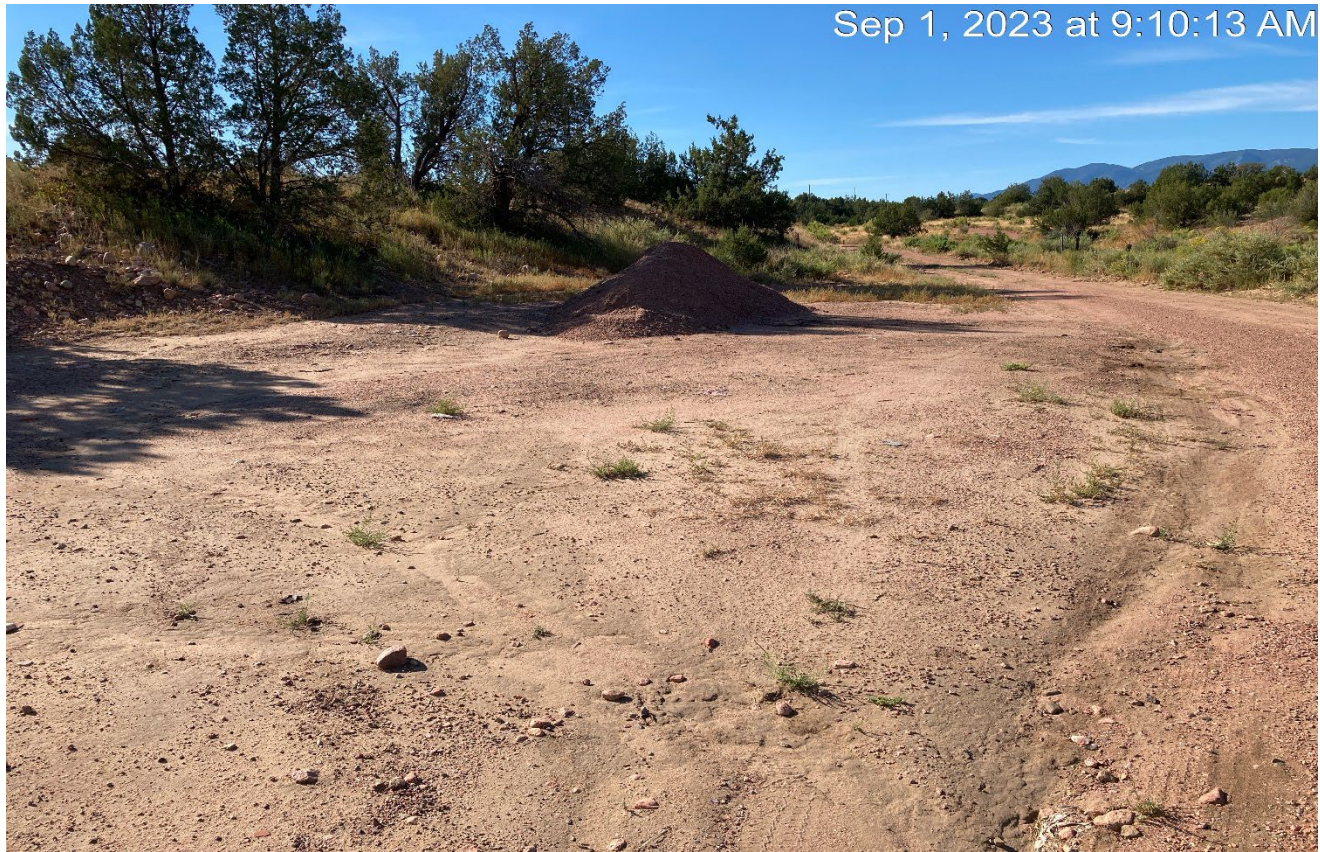
Photo 1. Facing southeast toward the abandoned wellsite which was never reclaimed. Soils remain bare of vegetation..

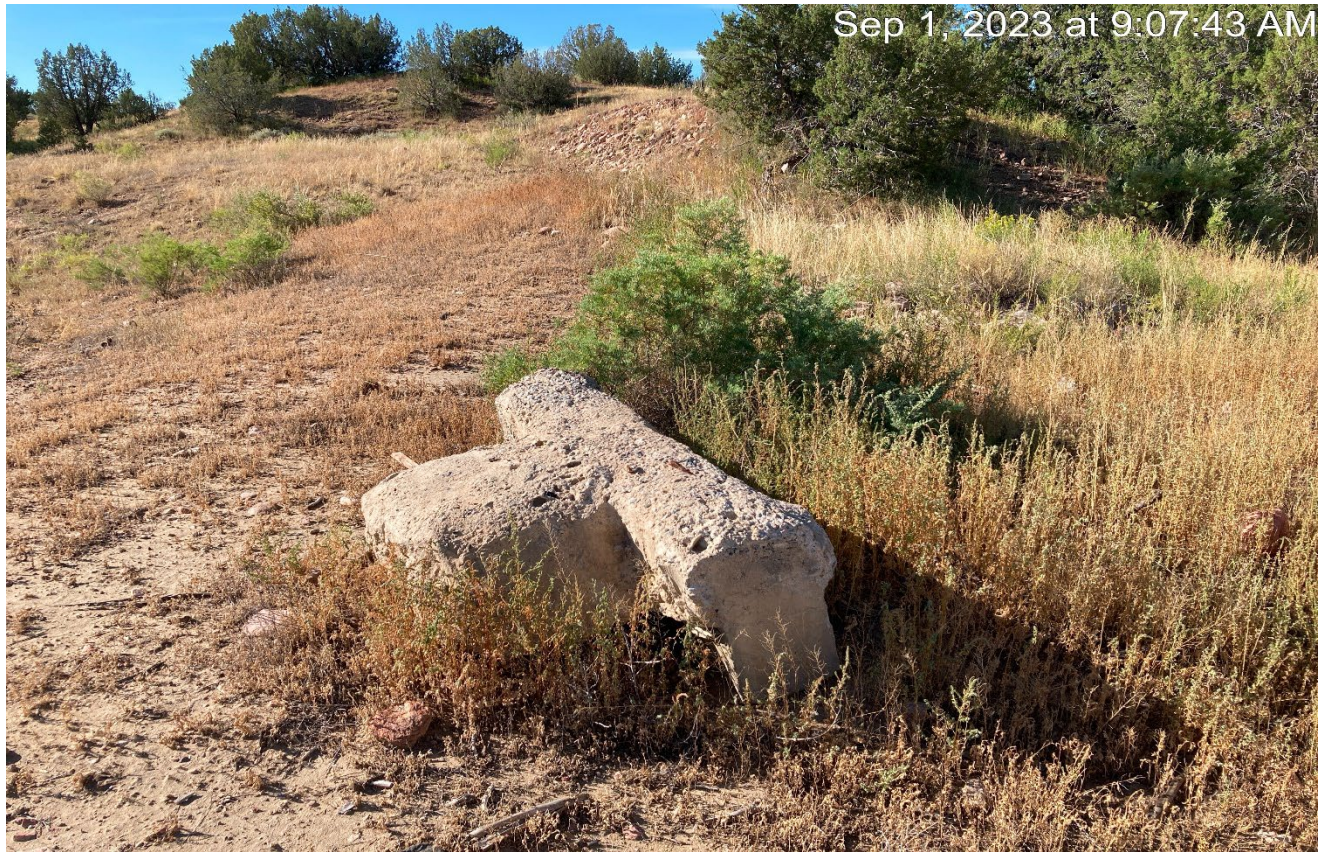
Photo 2. There is a cement block that remains at the east side of the location that needs to be removed.

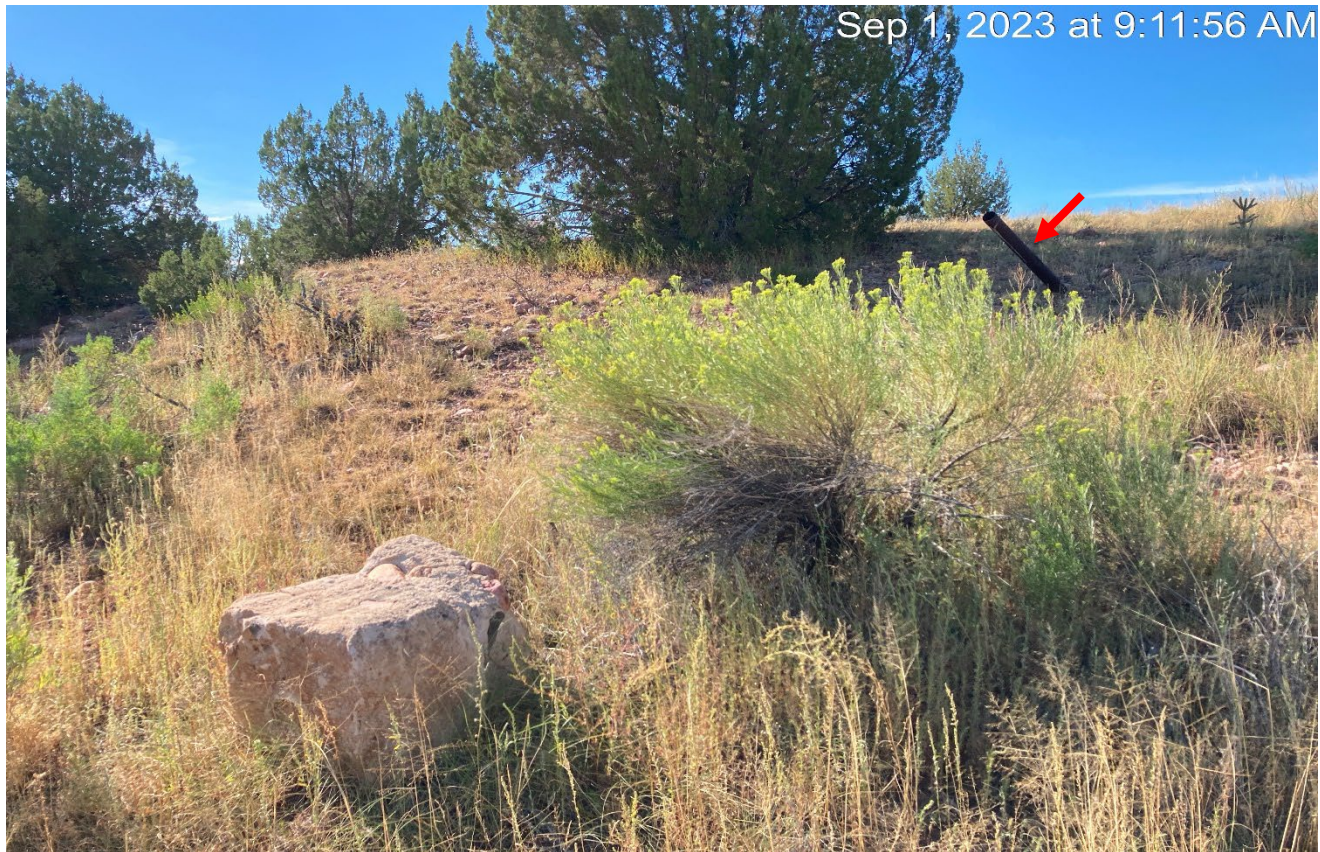
Photo 3. Facing southeast at the east side of the location. Another cement block remains and a metal pipe anchor shown at red arrow..

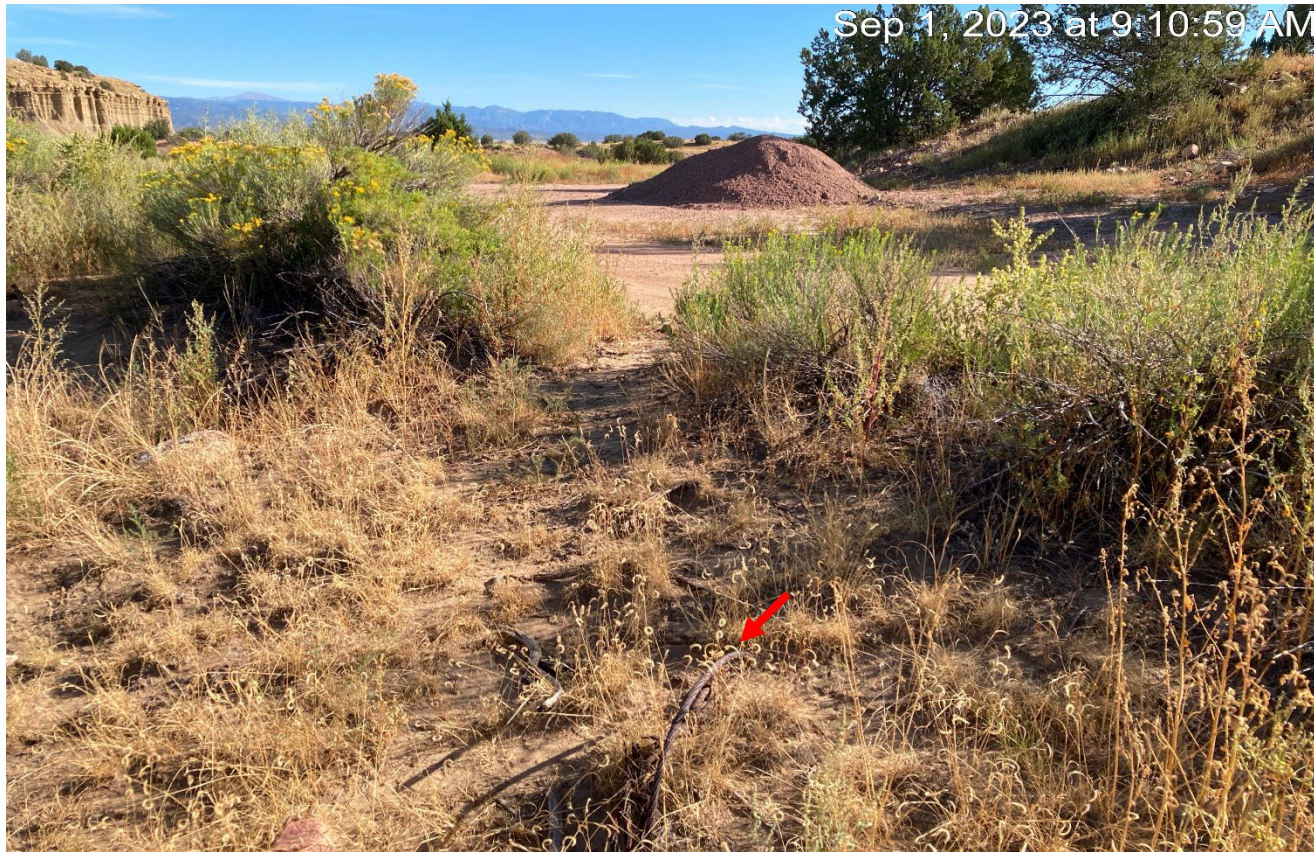
Photo 4. Facing northeast at the wellsite. There is a metal cable guyline anchor that remains at red arrow.
