Inspection Photos

API: 043-40000

Operator: JAVERNICK OIL

Inspection Date: 9/1/2023

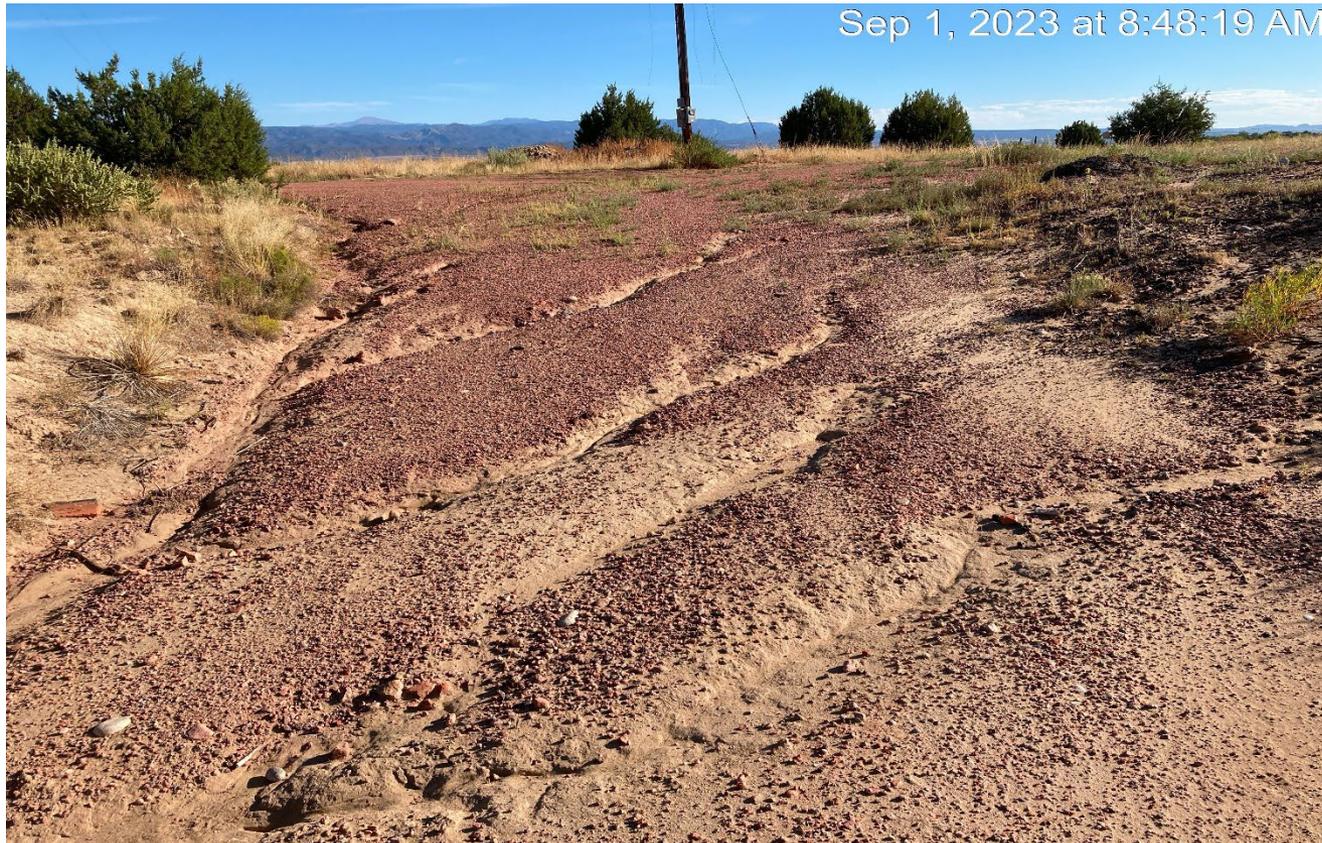
Photo 1. Facing northeast toward the abandoned wellsite which was never reclaimed. Soils remain bare of vegetation and there is erosion occurring.

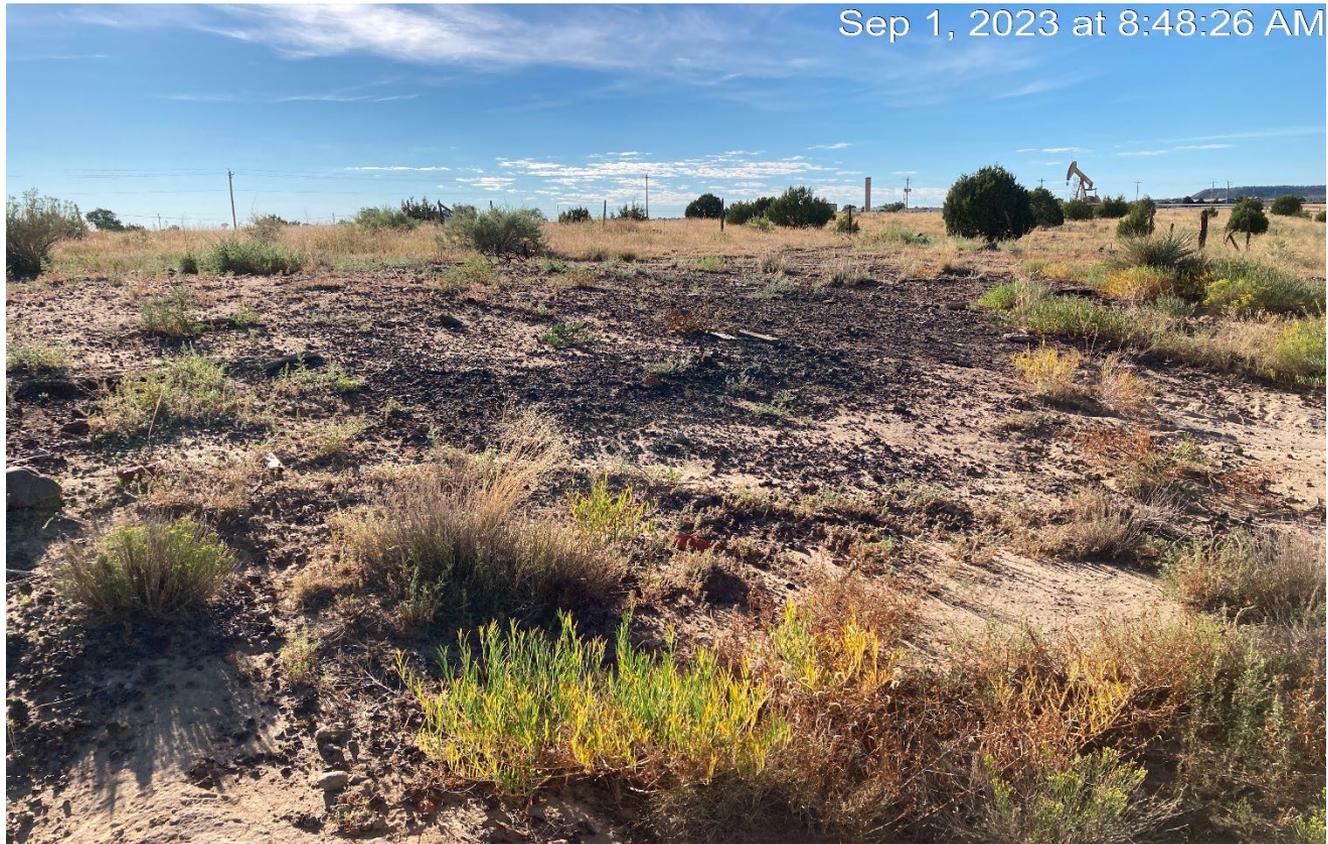
Photo 2. Facing southeast at the location. Soils remain bare of vegetation and reclamation was never performed.

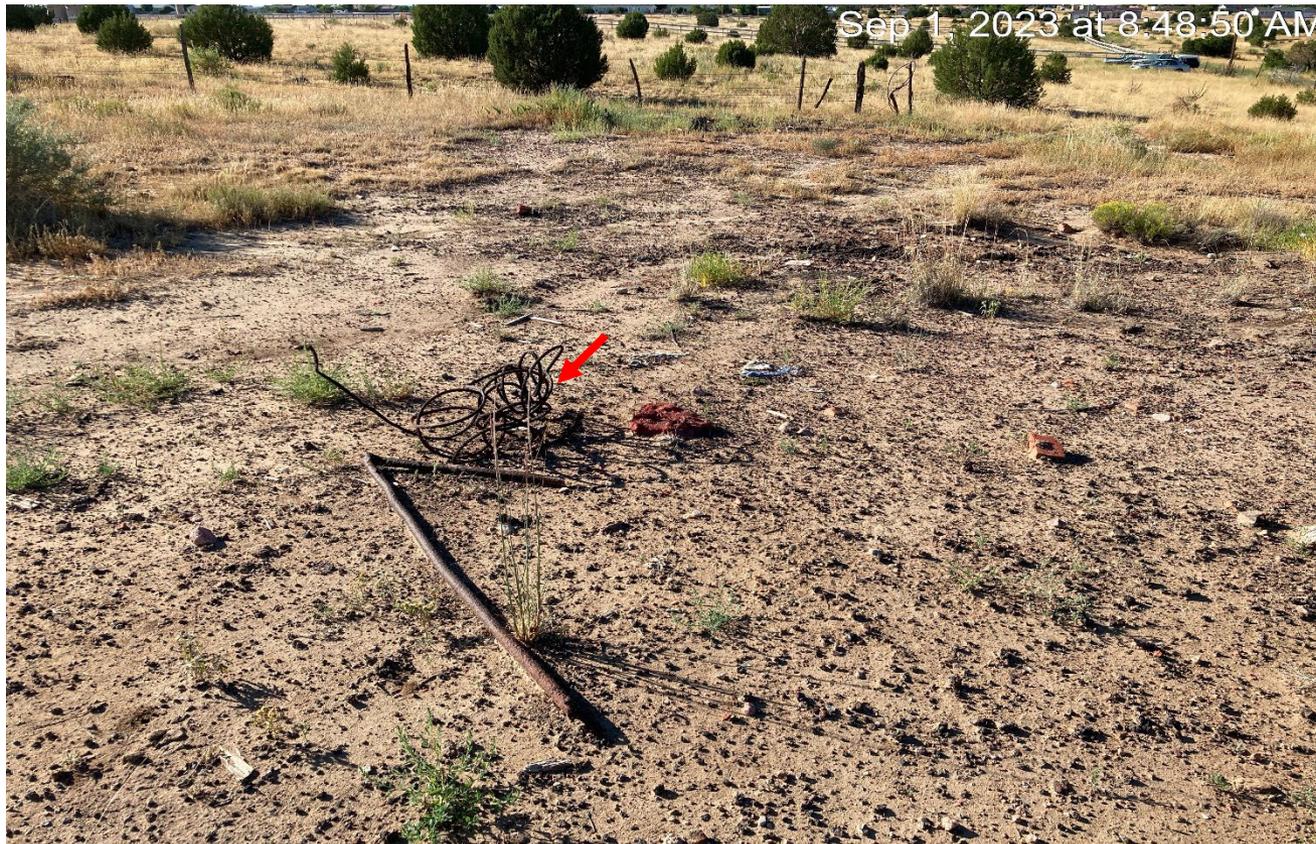
Photo 3. Facing south at the location. There is metal cable and pipe that remains along with other debris.

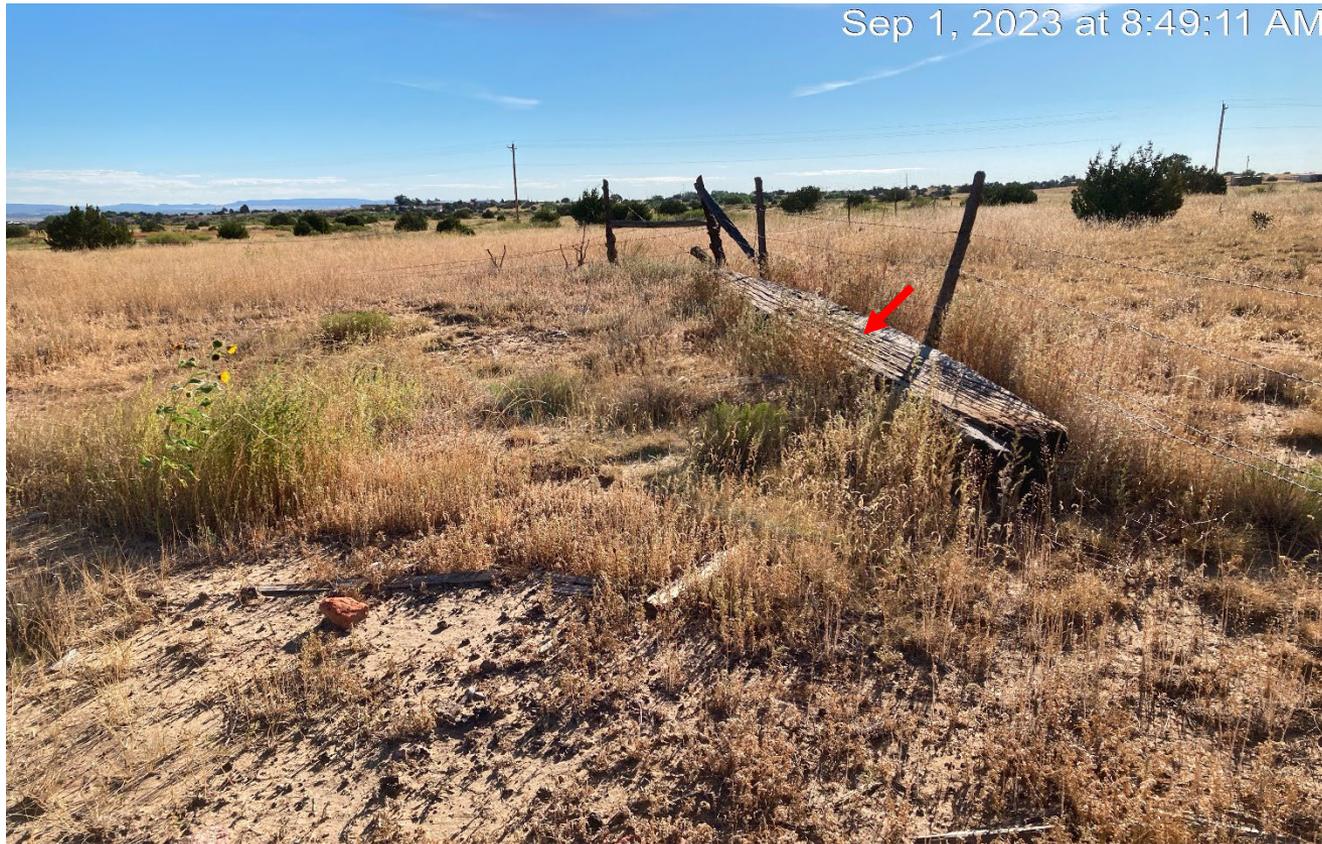
Photo 4. Facing southeast. There is a degraded perimeter fence that remains around the location. There is also an old bridge timber that remains.

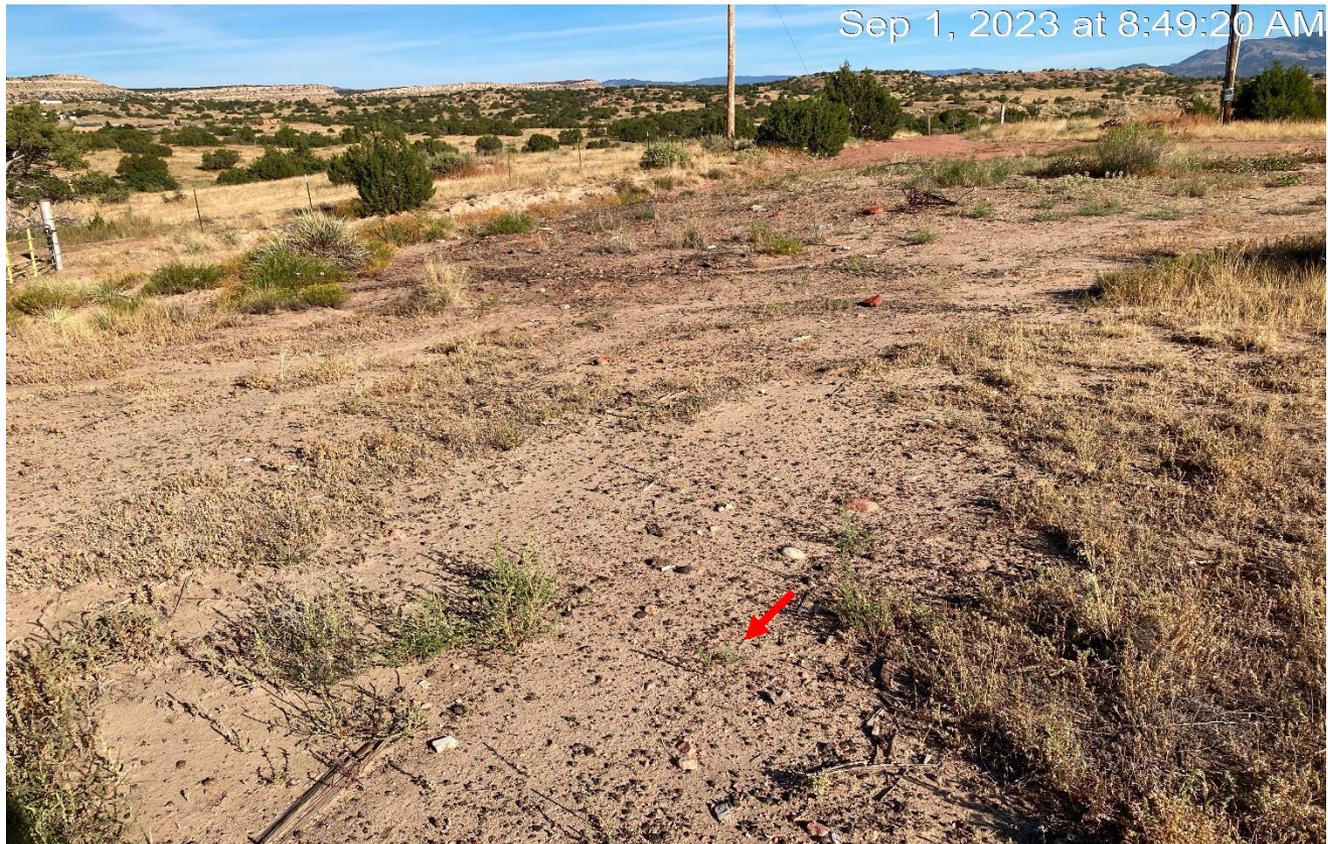
Photo 5. Facing northwest at the location. Soils remain bare of vegetation and reclamation was never performed.

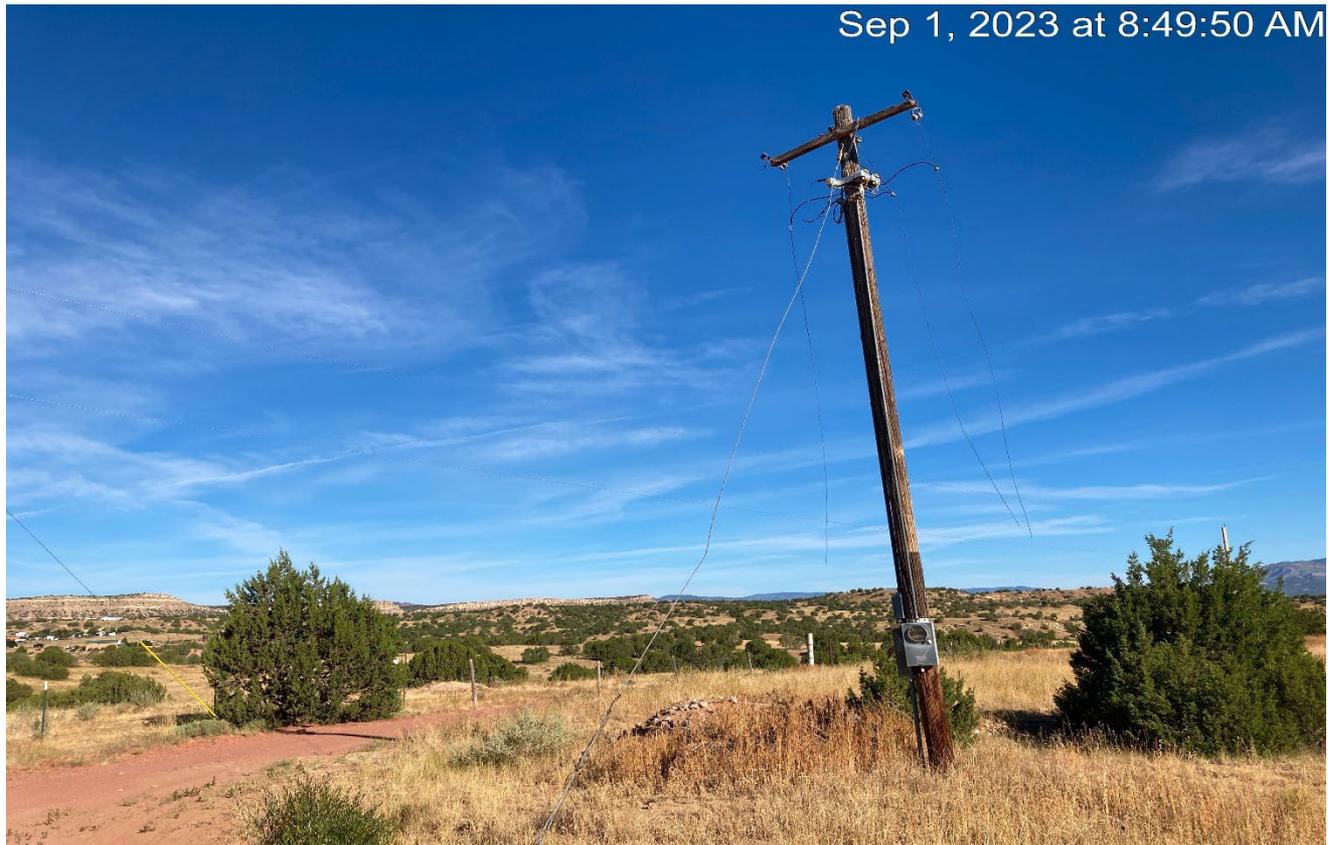
Photo 6. Facing northwest at the wellsite. There is an abandoned powerpole that has not been removed
