Inspection Photos

Location Name: TEP Rocky Mountain LLC LANGSTAFF RMV 12-16 Pad

Location # 335188

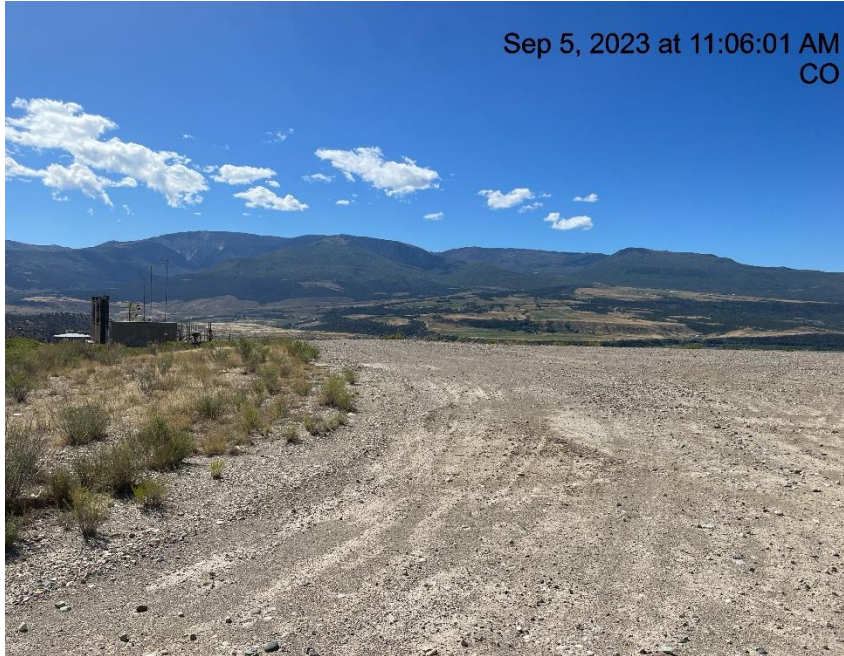
Photo # 8185 From entrance to location

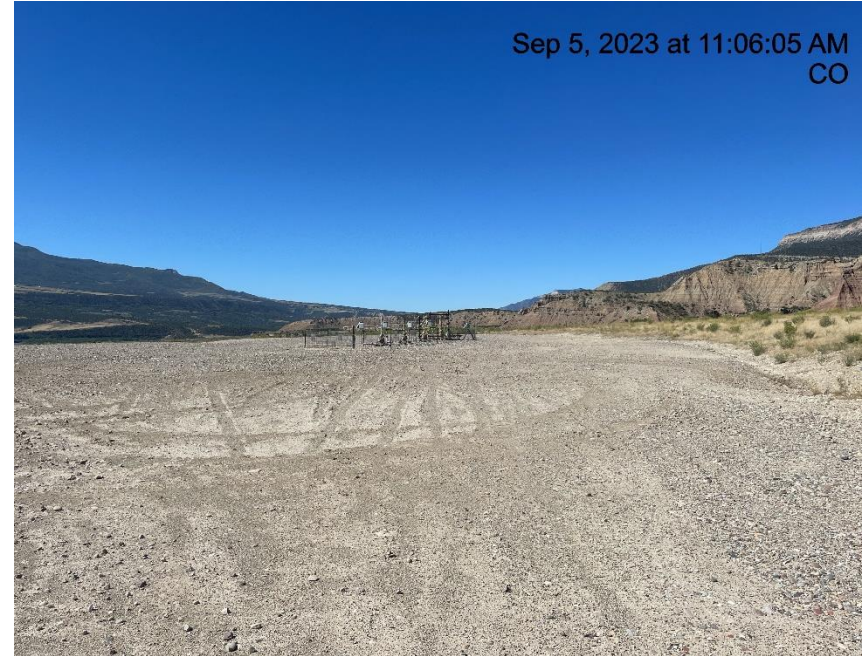
Photo # 8186 From entrance to location

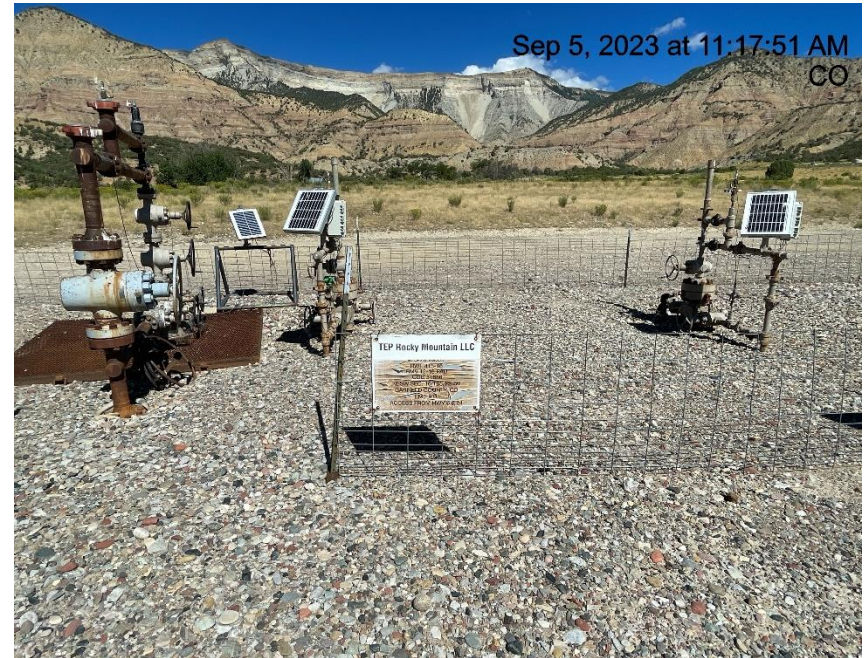
Photo # 8197 RWF 413-16 wellhead sign weathered/cracking & some info illegible

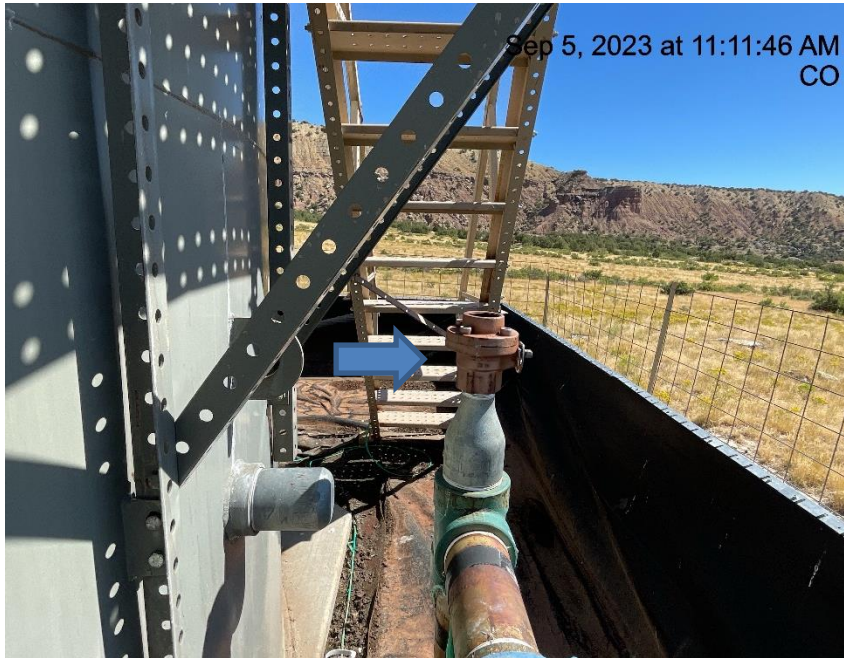
Photo # 8189 Open ended load line

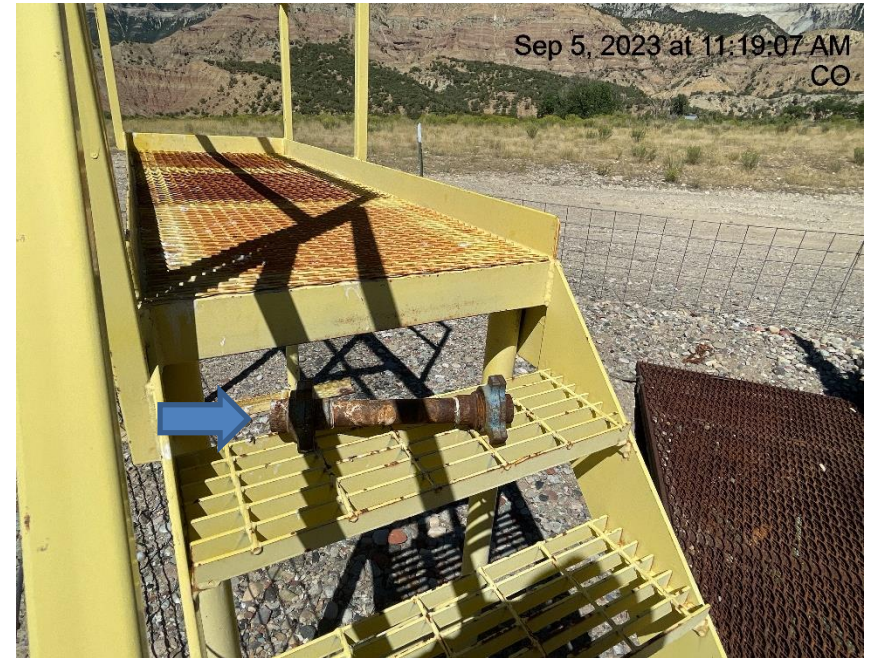
Photo # 8199 Debris

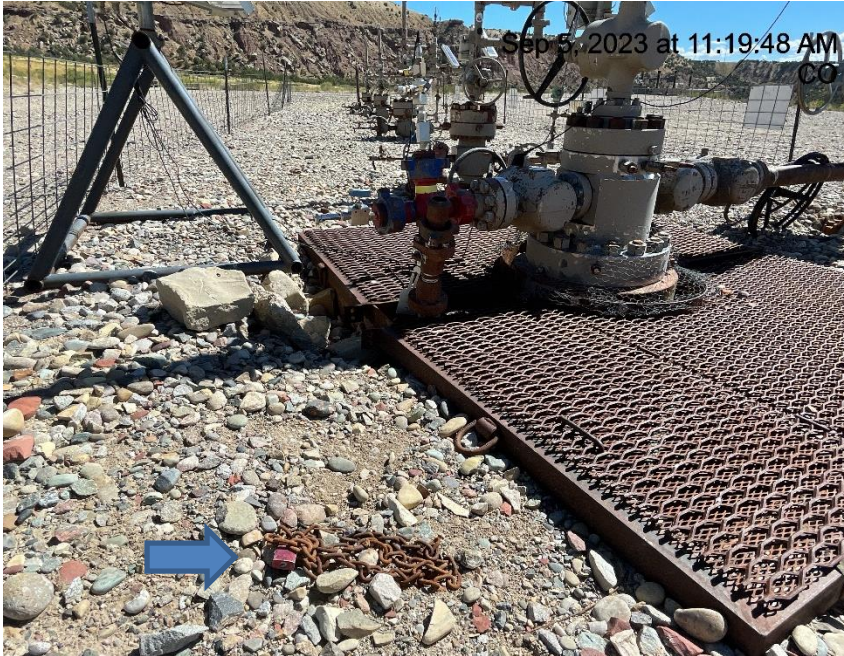
Photo # 8200 Debris

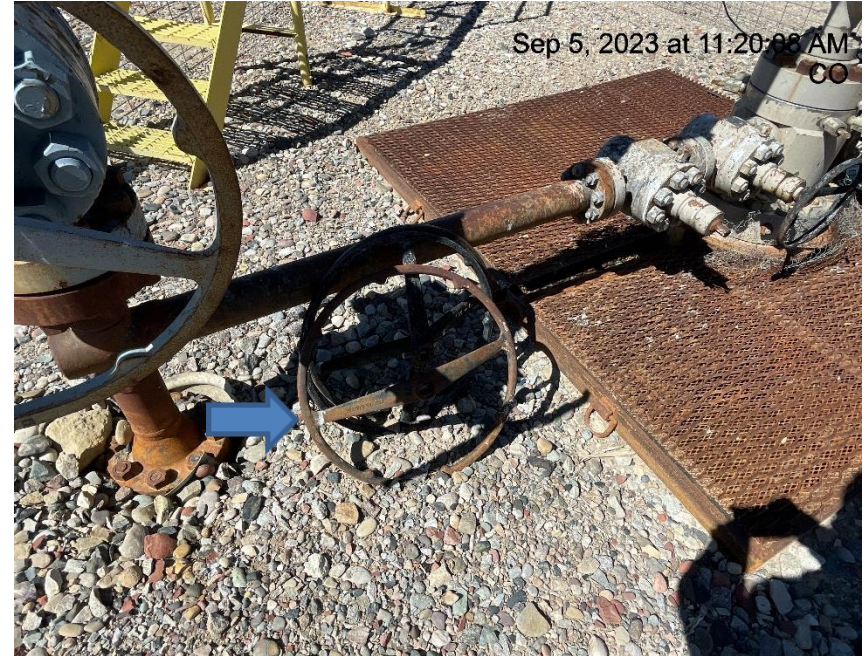
Photo # 8201 Debris

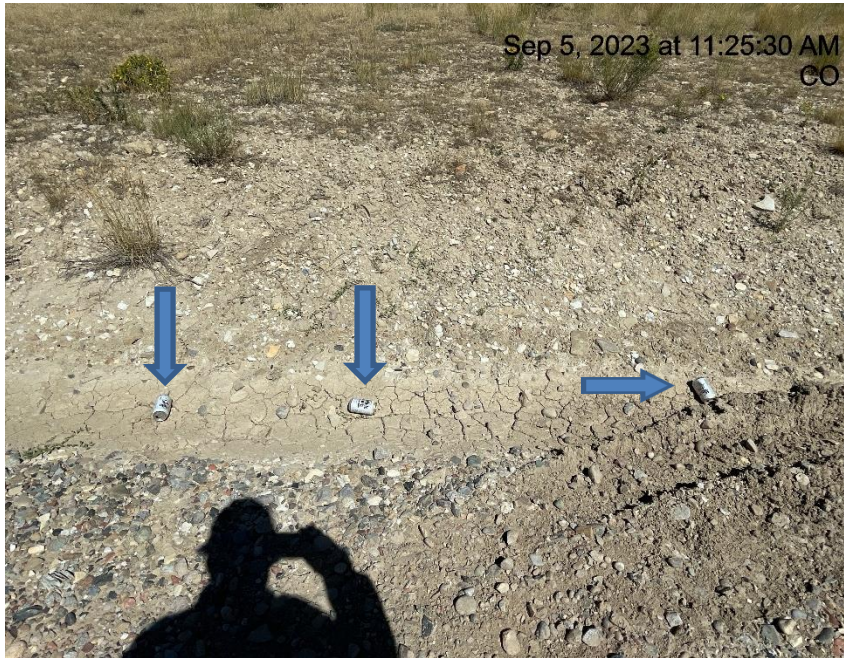
Photo # 8205 Debris

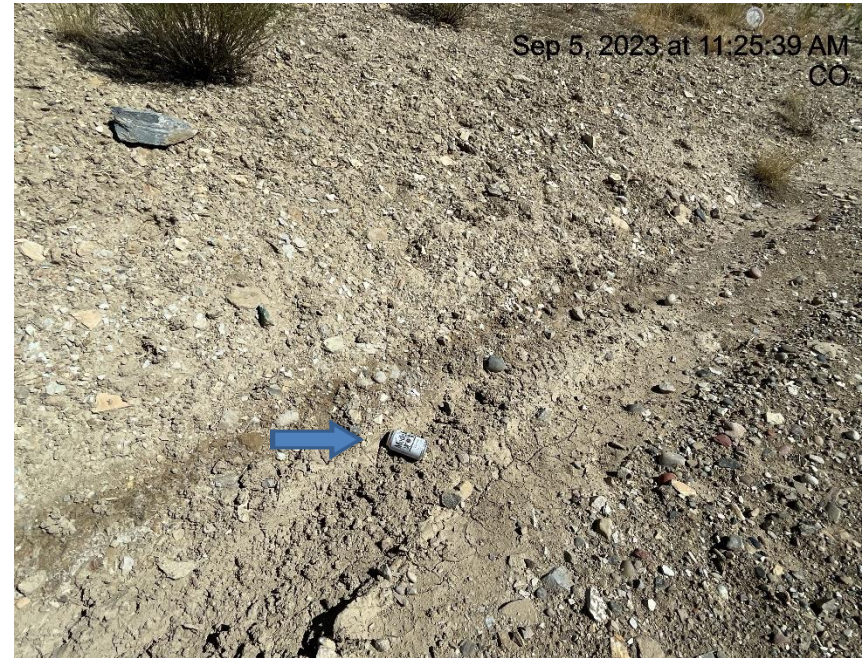
Photo # 8206 Debris
