Inspection Photos

Location Name: TEP ROCKY MOUNTAIN LLC, FEDERAL-67S96W/4NWNE

Location ID: 323960

Date: 8/24/2023

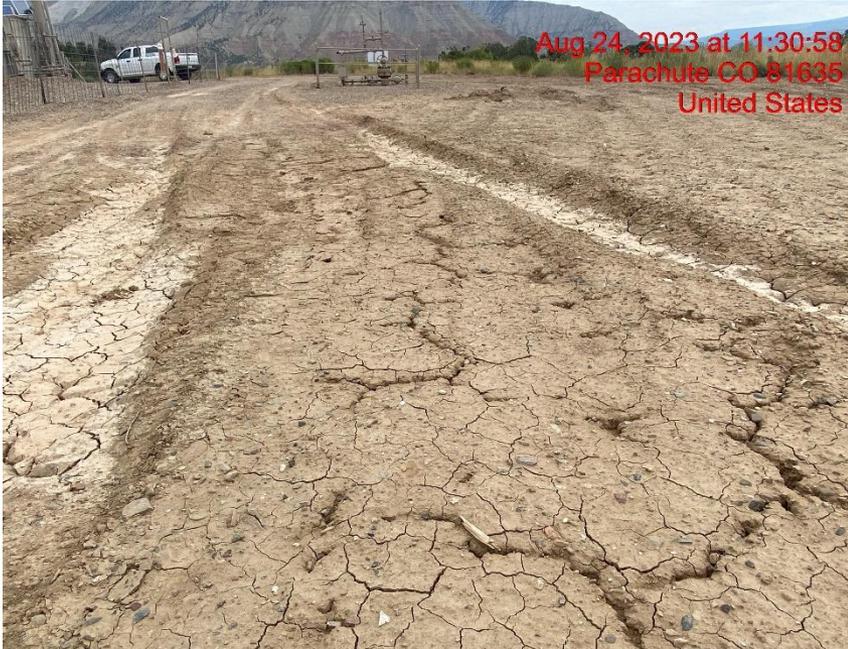
Location Lacks Stabilization – Photo #06134

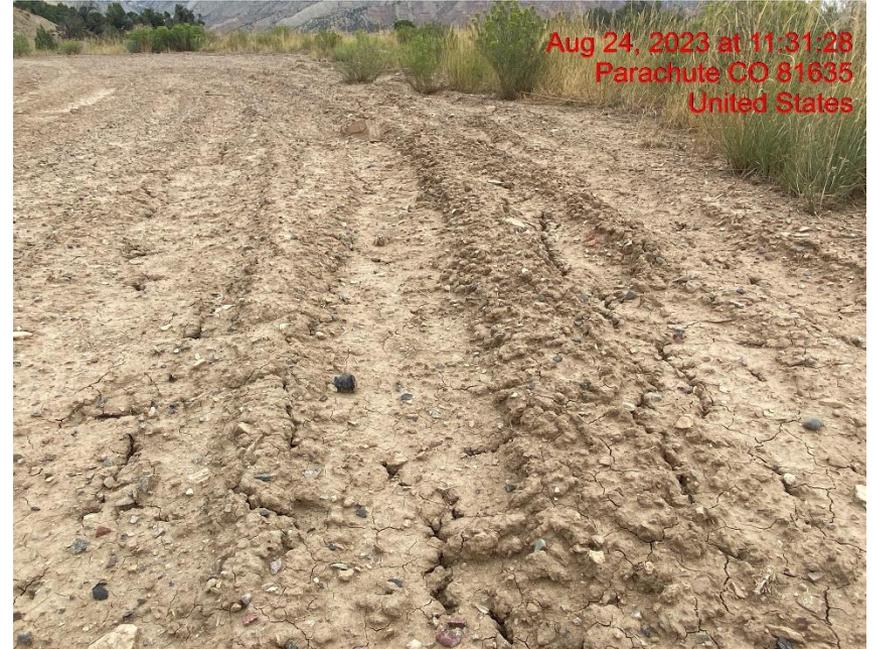
Location Lacks Stabilization – Photo #06136

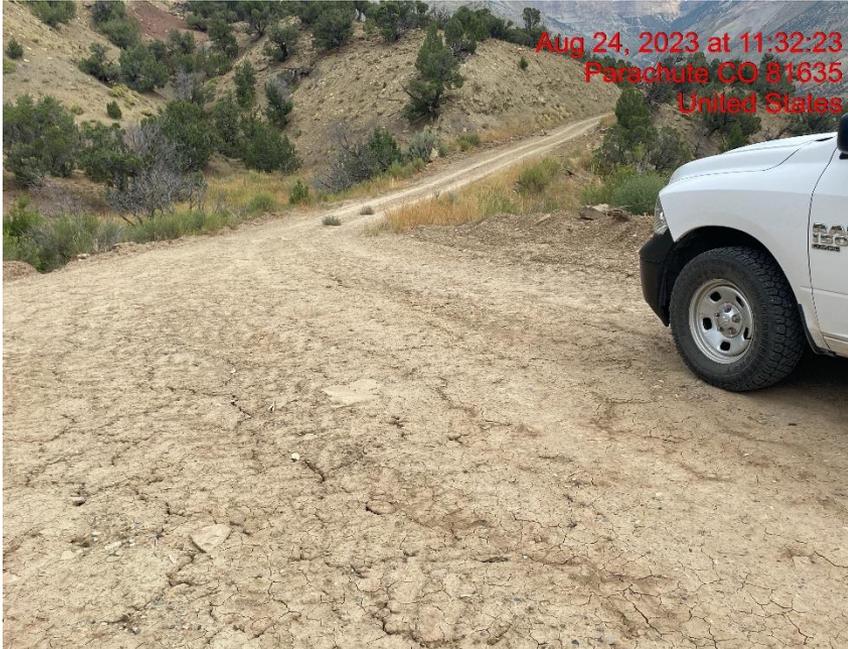
**Insufficient Vehicle Tracking BMPs at Location Entrance/Exit
– Photo #06141**

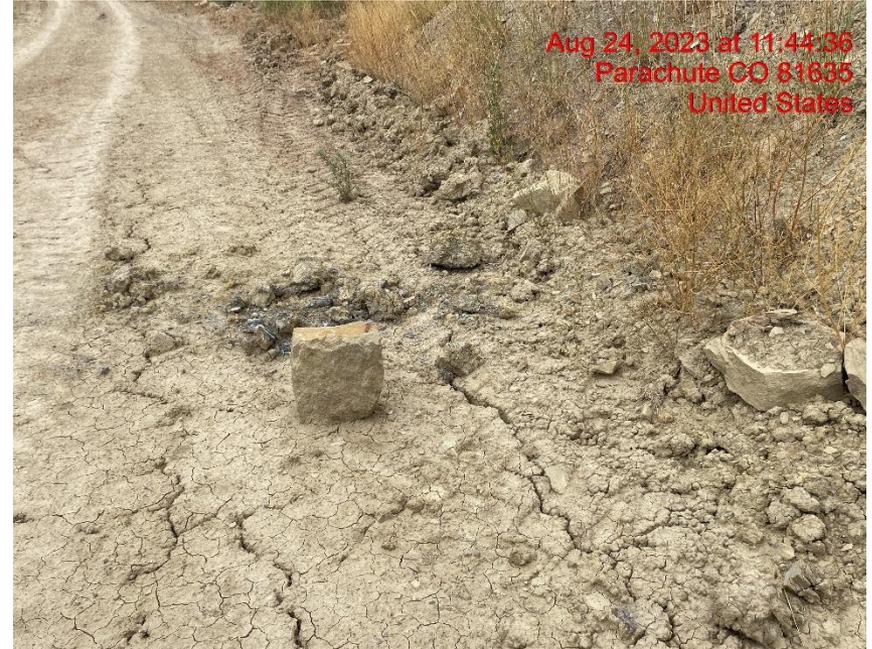
Access Road Degradation – Photo #06142

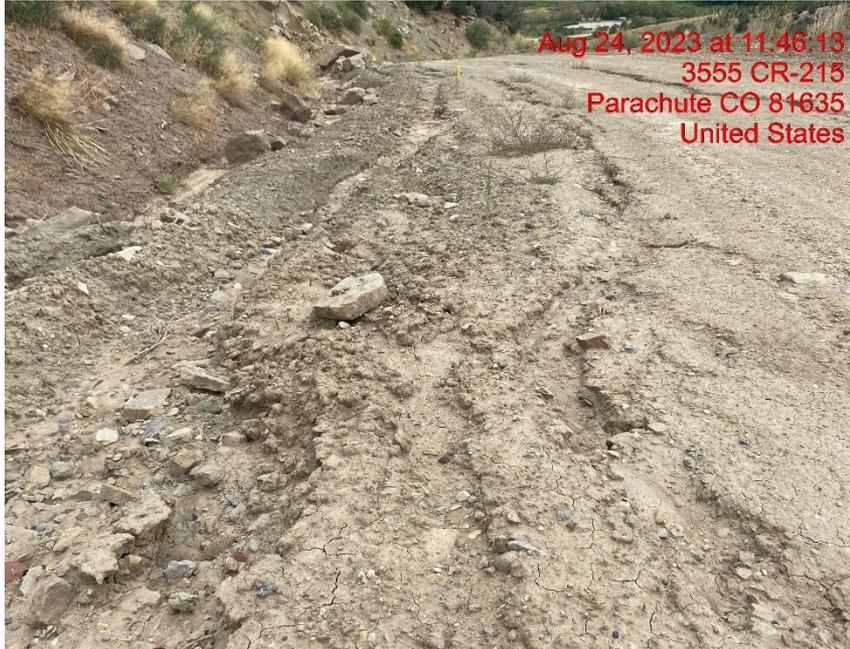
**Access Road Degradation/Insufficient Erosion Control –
Photo #06144**

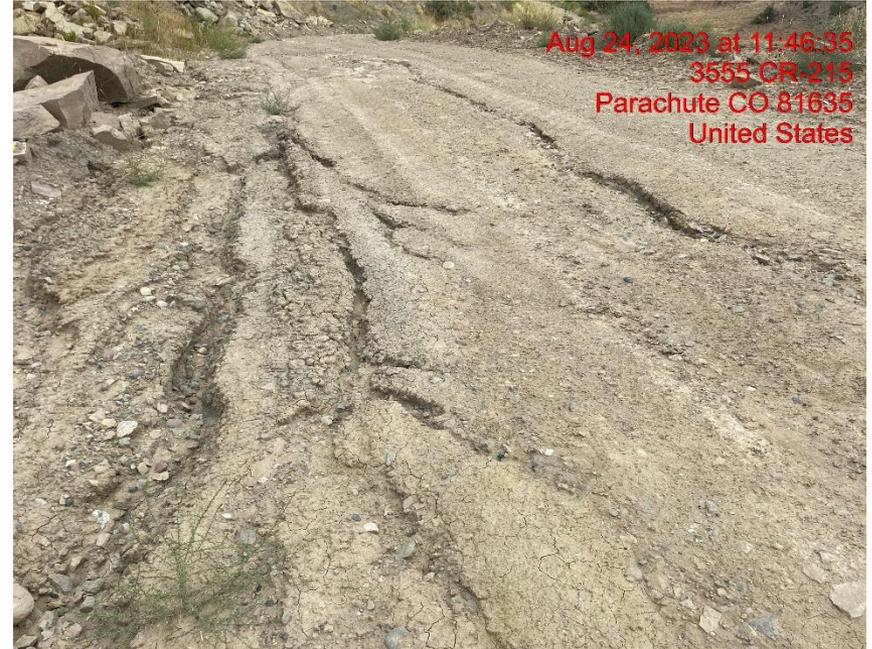
Insufficient Erosion Control/Rill Erosion – Photo #06146
