Inspection Photos

Location Name: TEP ROCKY MOUNTAIN LLC, UNOCAL-66S96W/33SWSE

Location ID: 334870

Date: 8/24/2023

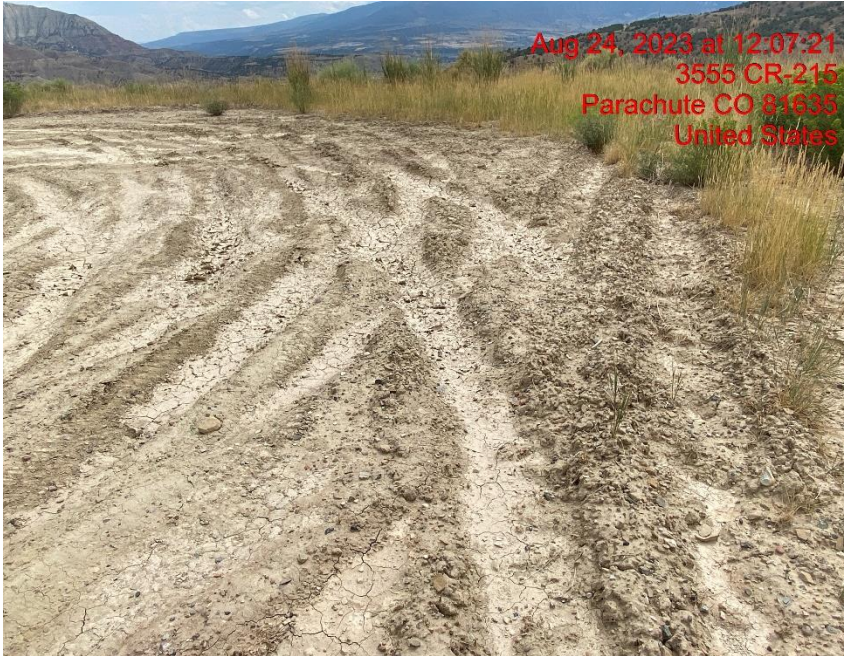
Location Lacks Stabilization – Photo #06159

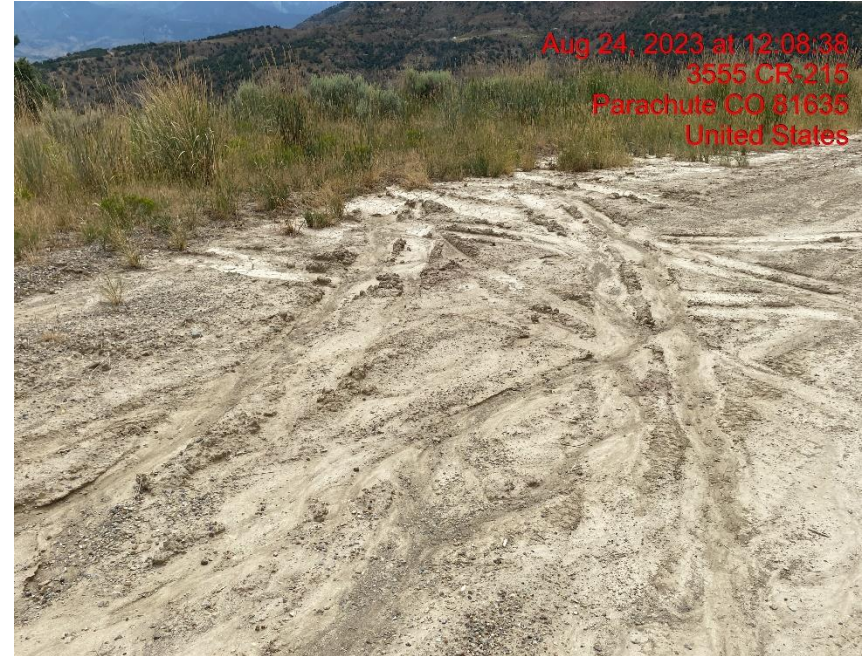
Location Lacks Stabilization – Photo #06161

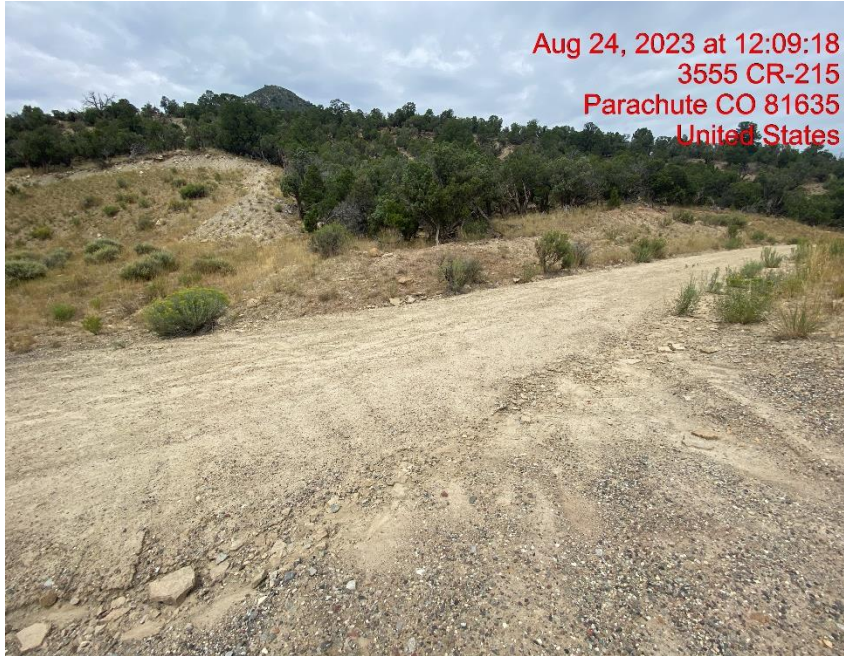
**Insufficient Vehicle Tracking BMPs at Location Entrance/Exit
– Photo #06163**

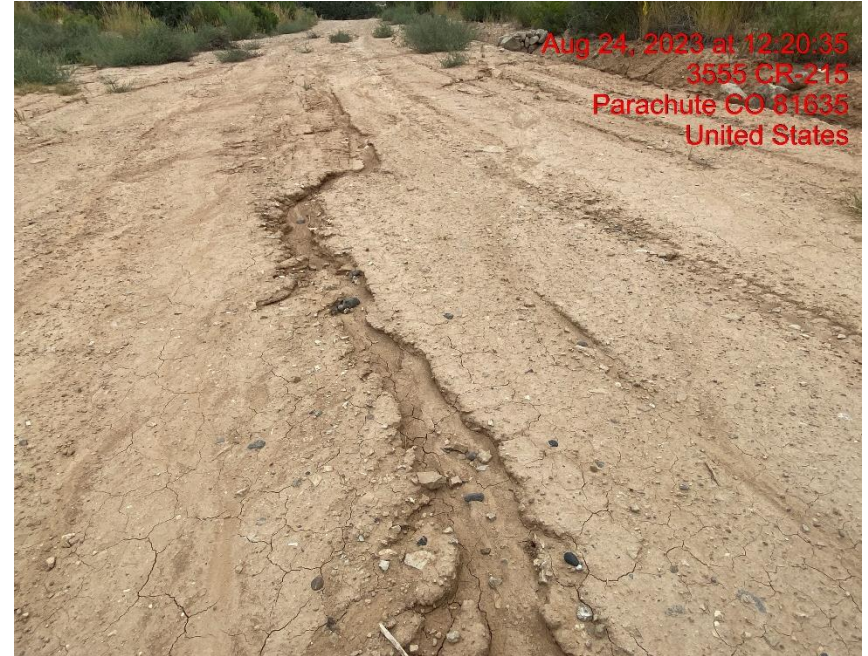
**Insufficient Erosion Control/Rill Erosion on Access Road –
Photo #06166**

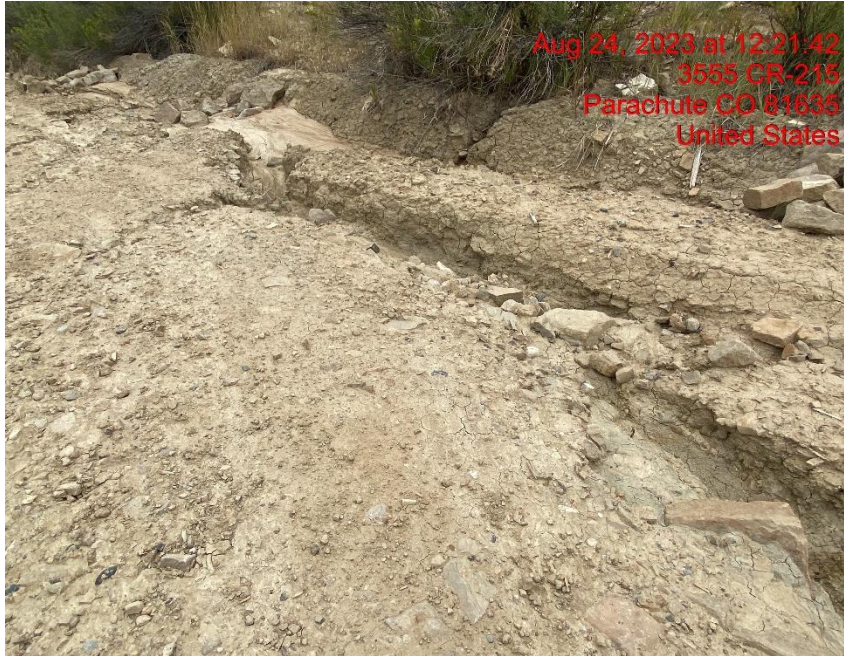
**Insufficient Erosion Control/Rill Erosion on Access Road –
Photo #06168**

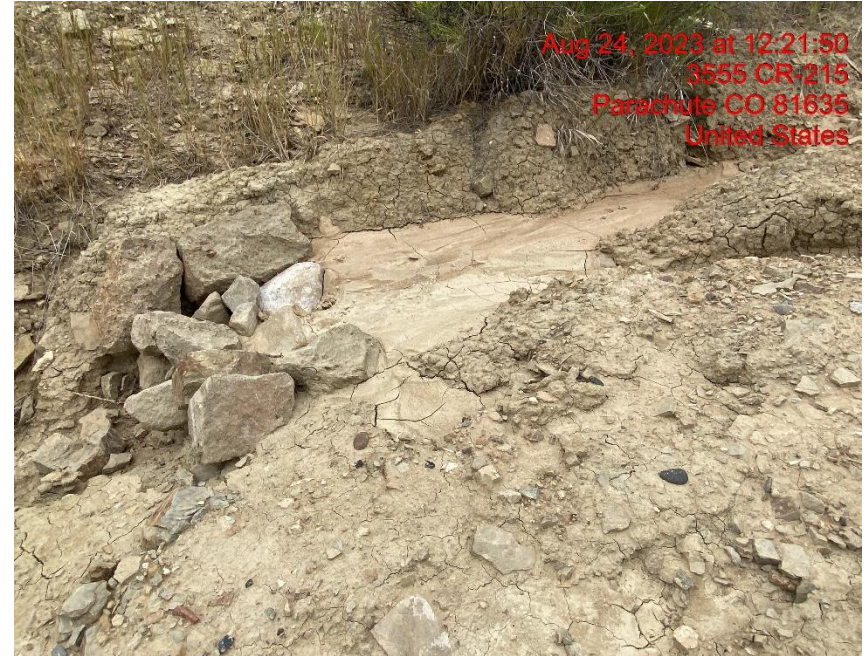
Check Dam BMP Needs Maintenance – Photo #06169
