Inspection Photos

Location Name: TEP ROCKY MOUNTAIN LLC, CHEVRON-66S96W/20NESW

Location ID: 335420

Date: 8/28/2023

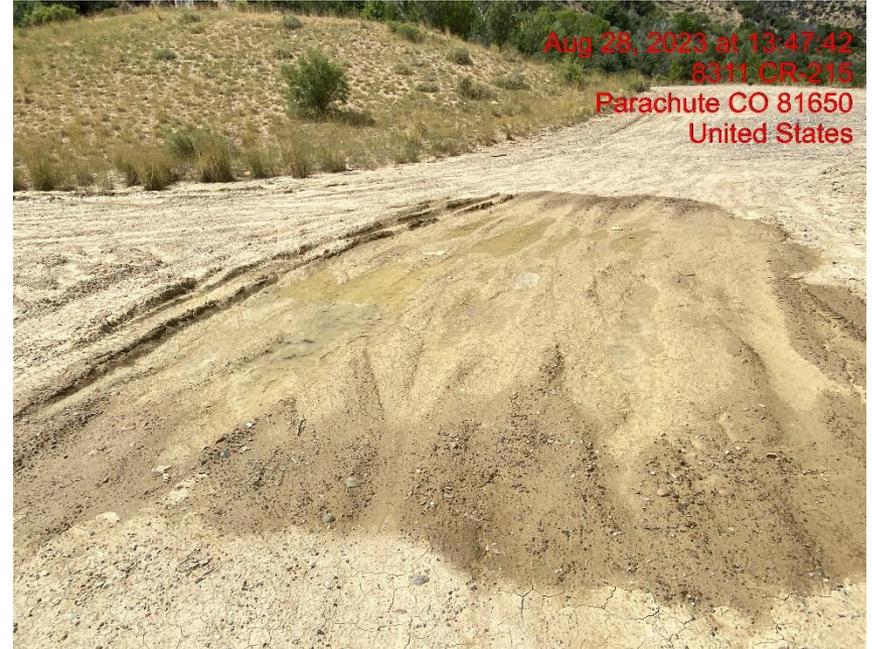
Location Lacks Stabilization – Photo #06213

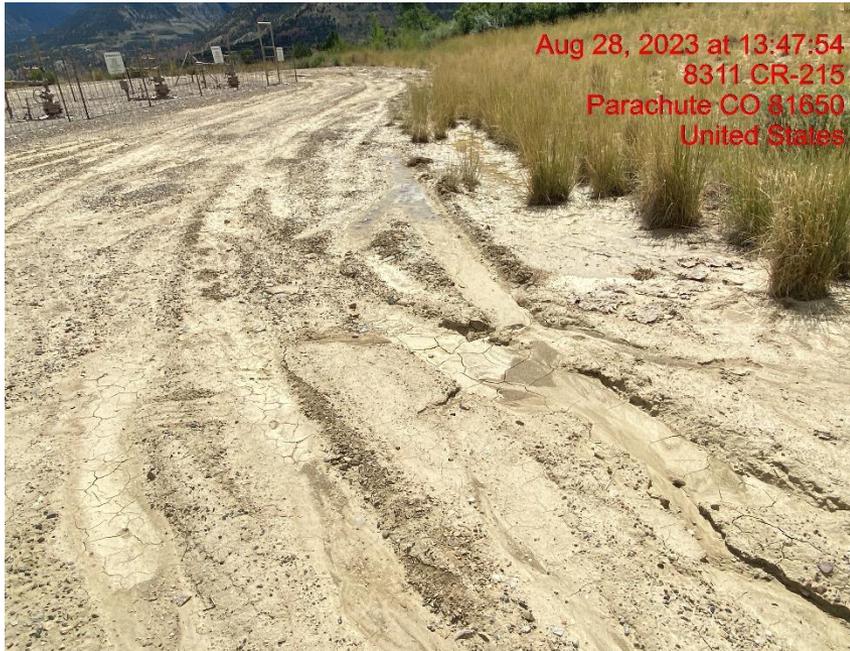
Location Lacks Stabilization – Photo #06215

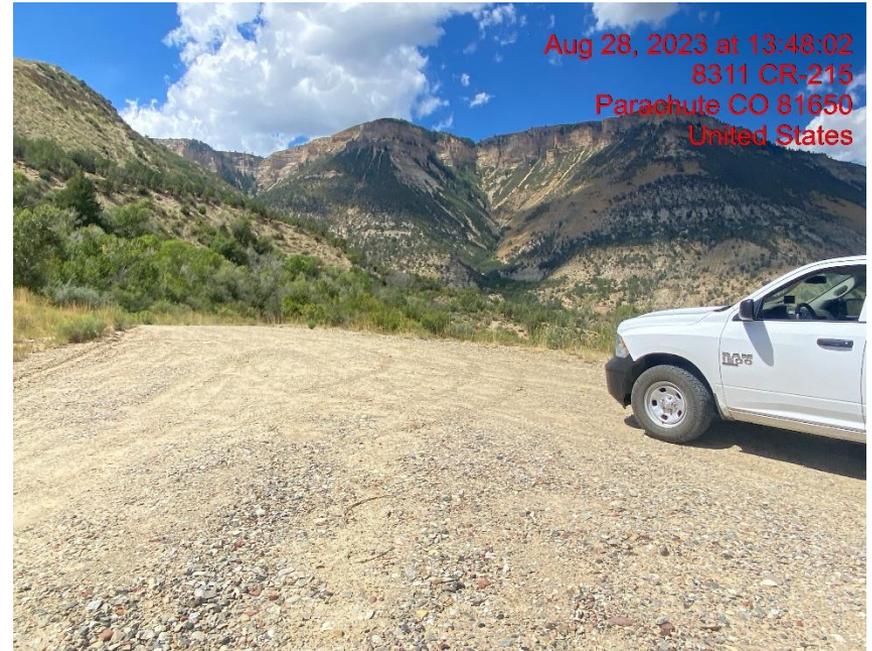
Insufficient Vehicle Tracking BMPs at Location Entrance/Exit
– Photo #06216
