**Inspection Photos**  
**Location Name: Turner #1**  
**API: 05-067-05316**

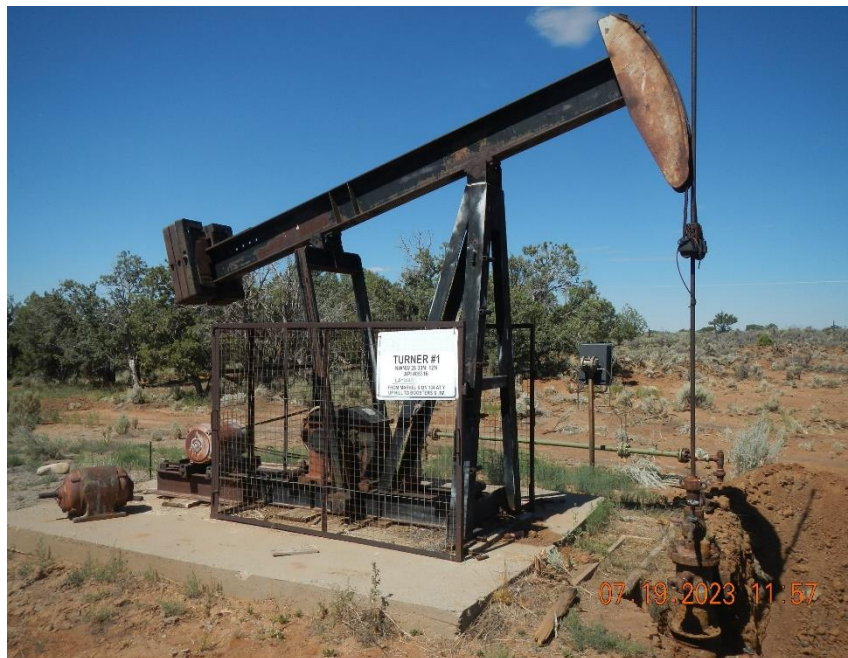
**Turner #1 pumping unit.**

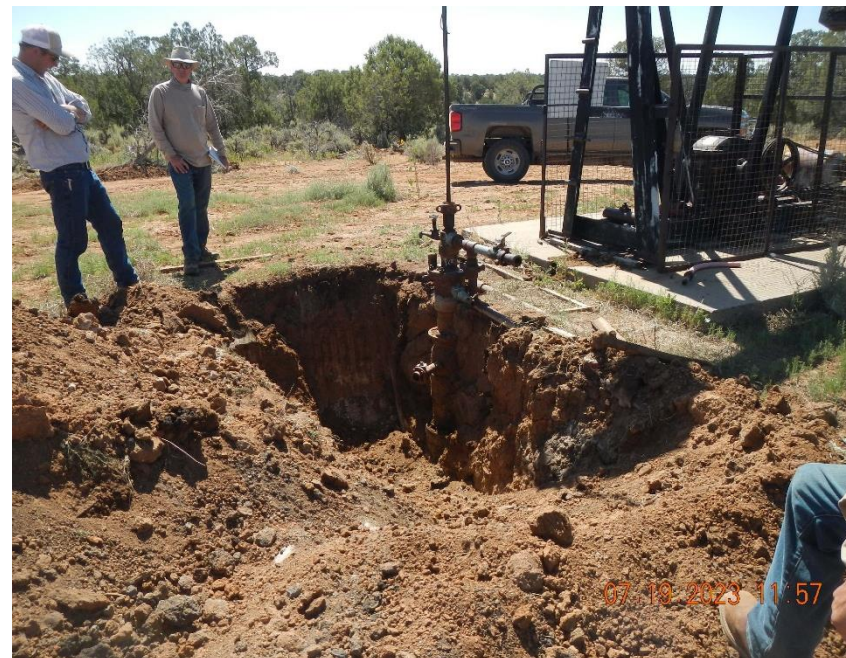
**Open excavation around well head.**

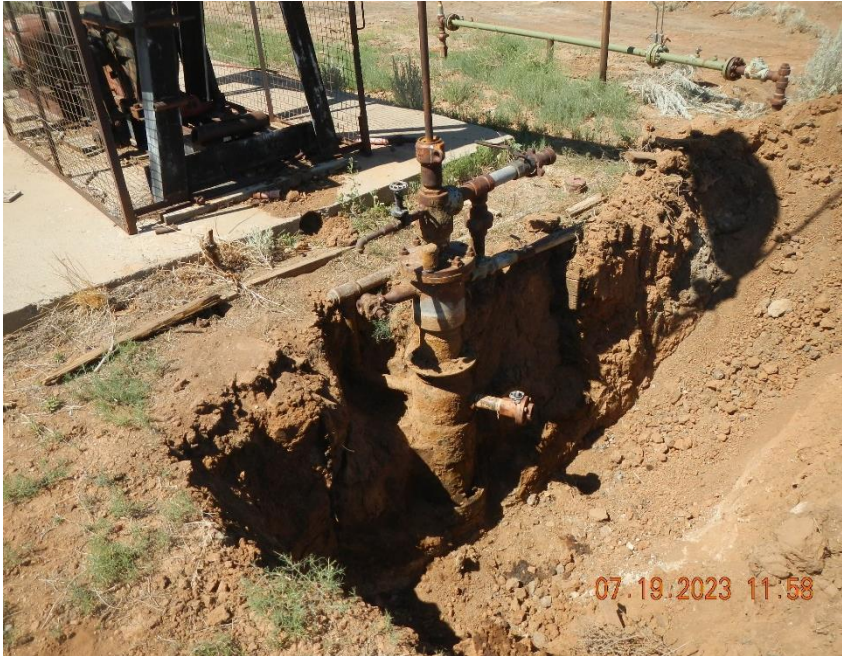
**Open excavation around well head.**

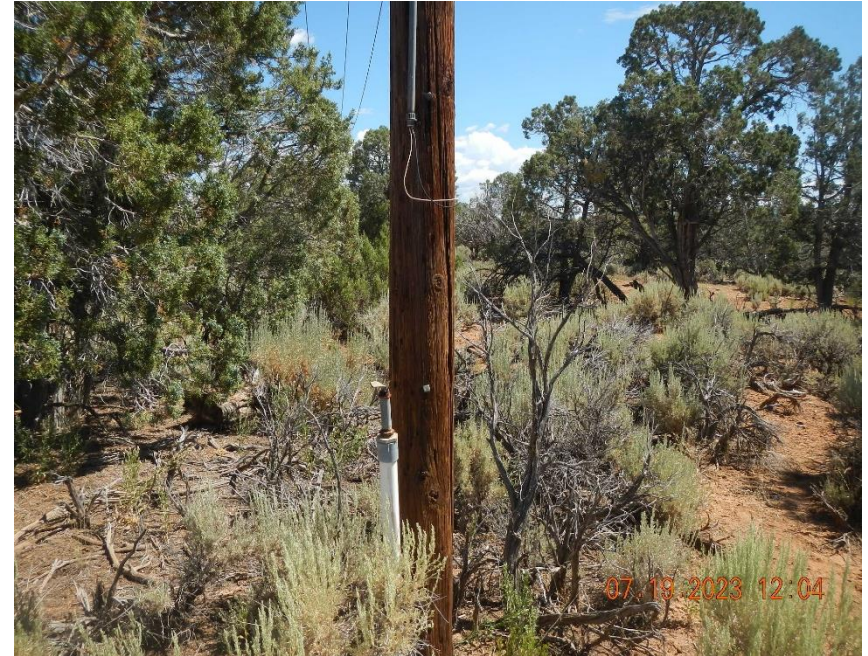
**Electrical wires have been severed at the power pole.**
