# Inspection Photos

API: 011-06024

Operator: OXY USA INC

Inspection Date: 9/6/2023

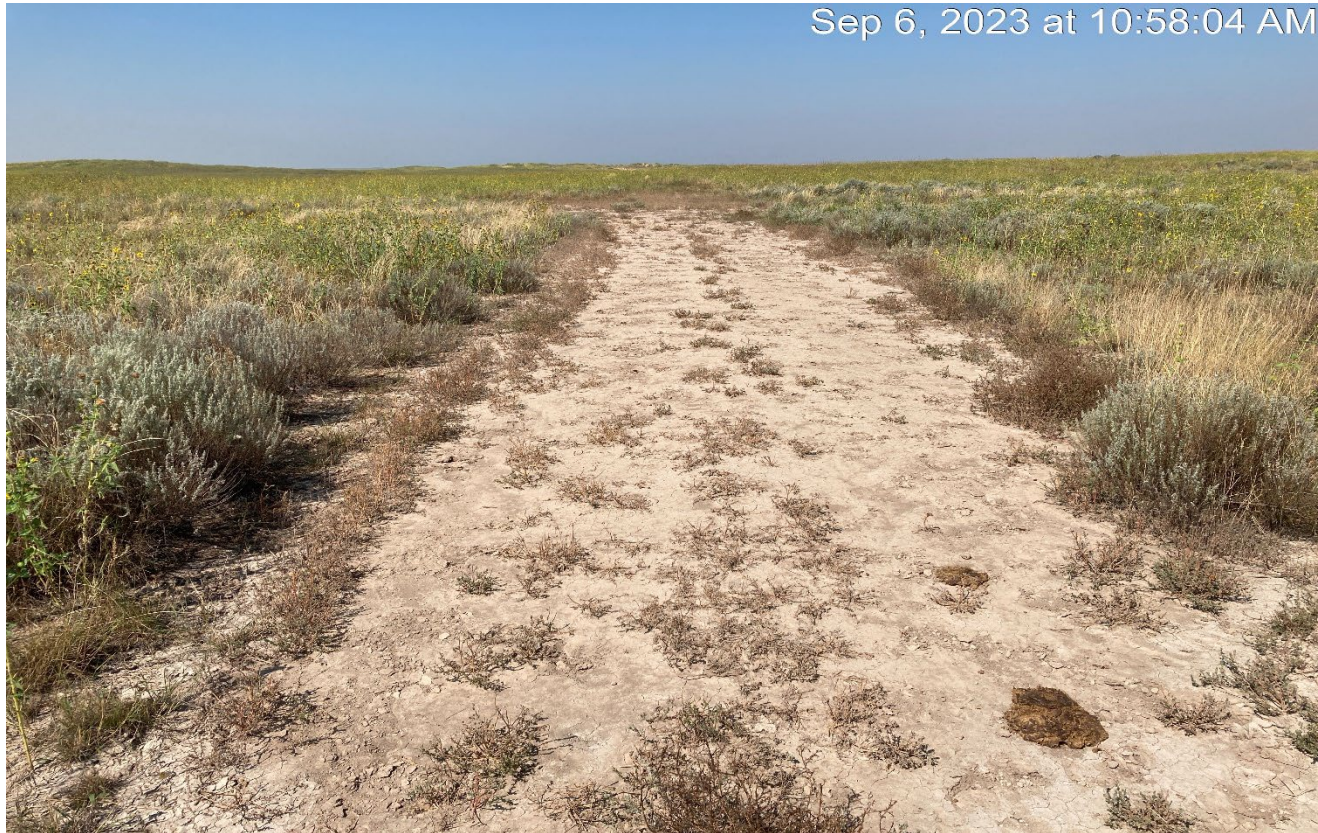
**Photo 1.** Facing west at the location. This area approx. 200'x30' has not re-established perennial vegetation.

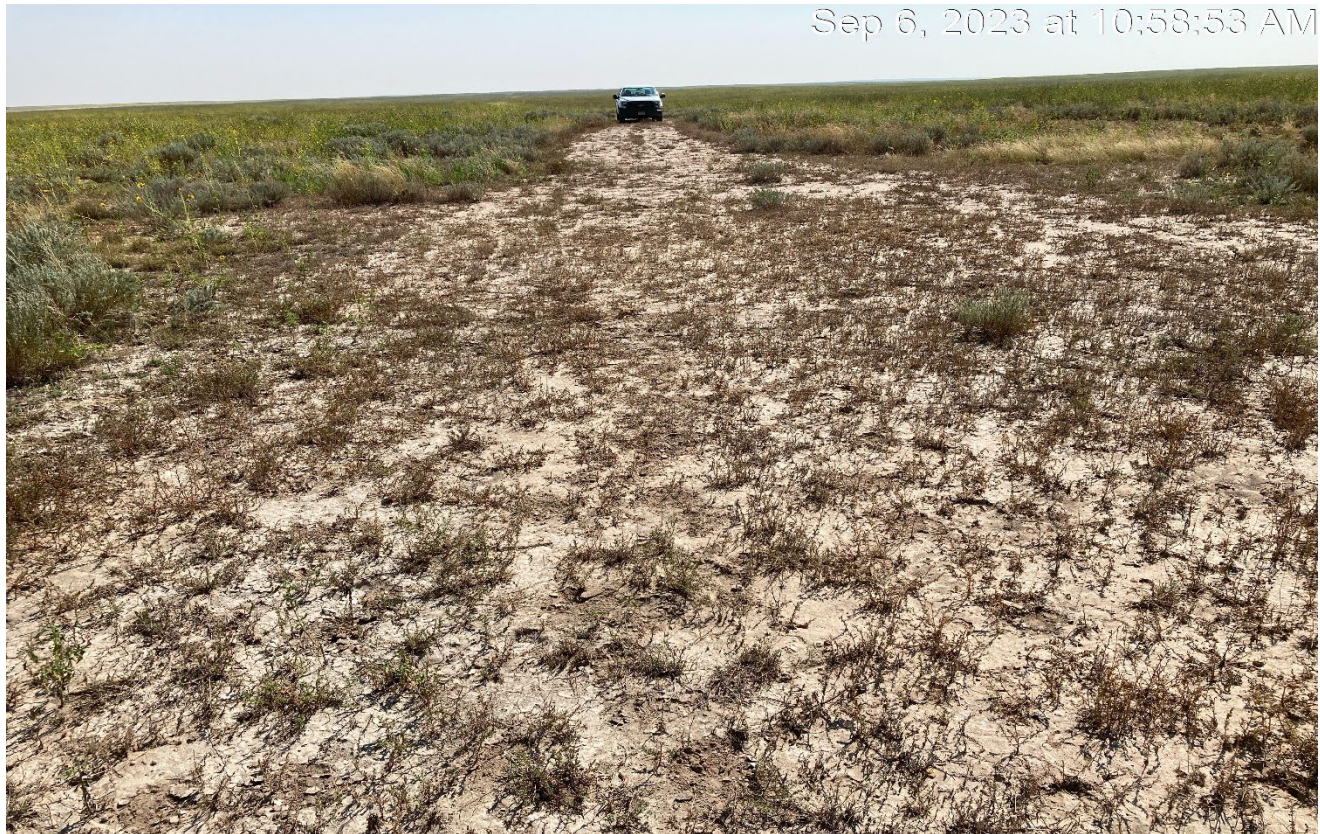
**Photo 2.** Facing east at the location. This area approx. 200'x30' has not re-established perennial vegetation.

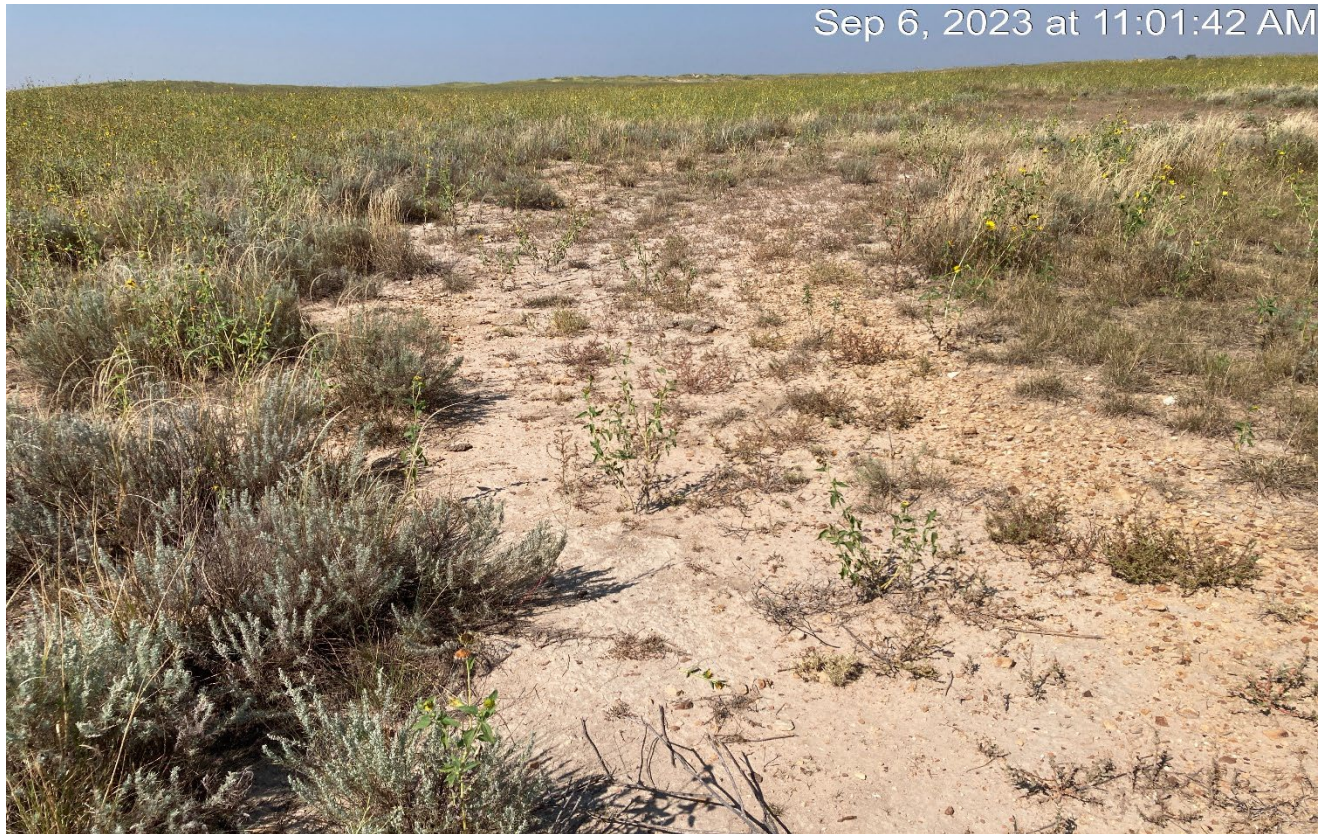
**Photo 3.** South side of the location facing. The turn around area of the road has not re-established perennial vegetation.

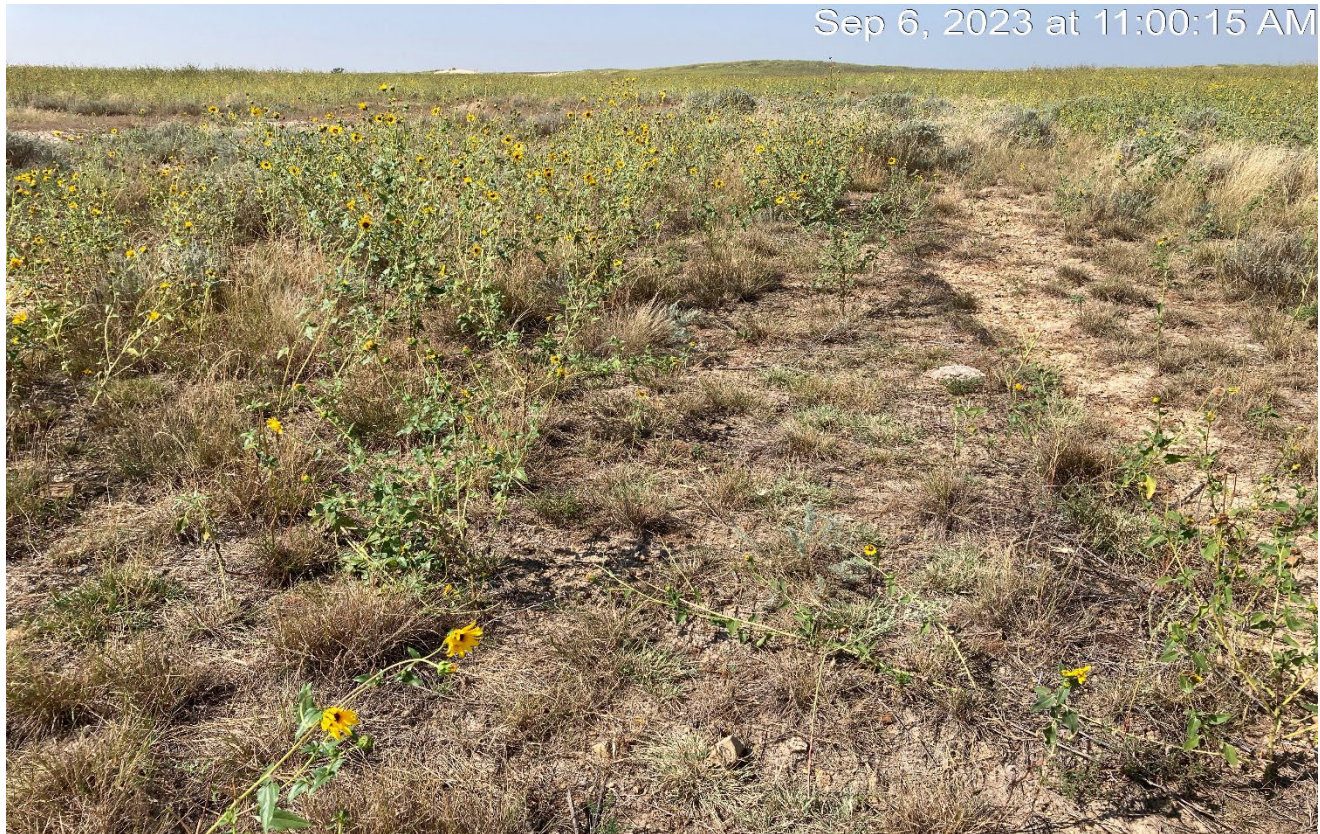
**Photo 4.** North side o the location facing southwest. This area that was reclaimed and stabilized with straw blanket has re-established perennial vegetation..
