Storm Water Management and Erosion control
Location Name: TEP Rocky Mountain LLC CLOUGH RWF 341-15 Pad
Location # 335572

Section/Township/Range: 15 6S94W

COLORADO
Energy & Carbon Management
Commission
Department of Natural Resources

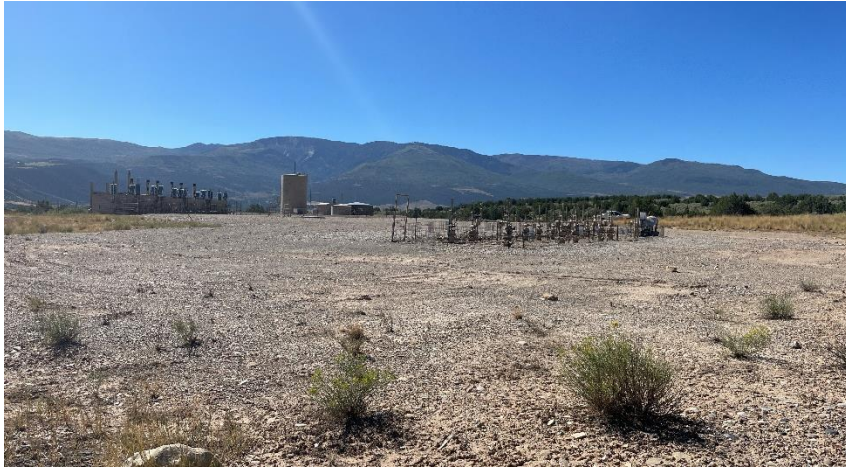
North West corner of location.

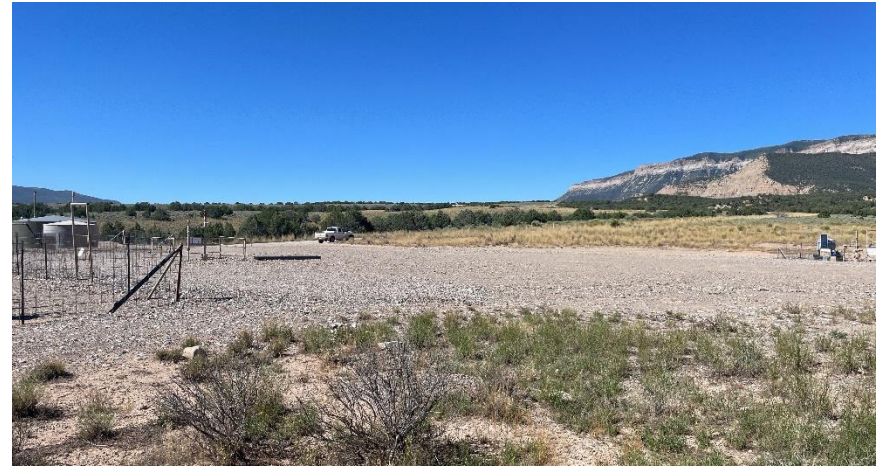
North East corner of location.

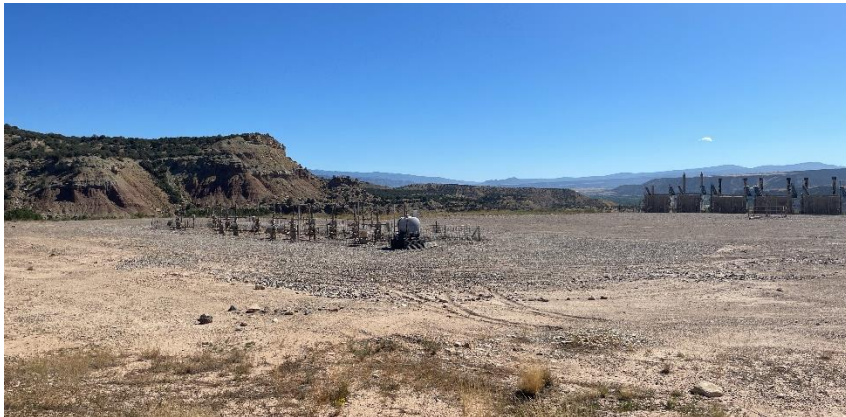
South West corner of location.

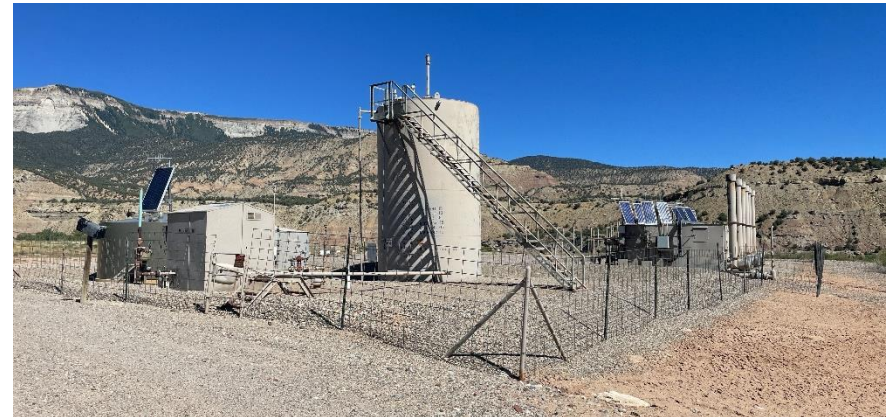
South East corner of location.

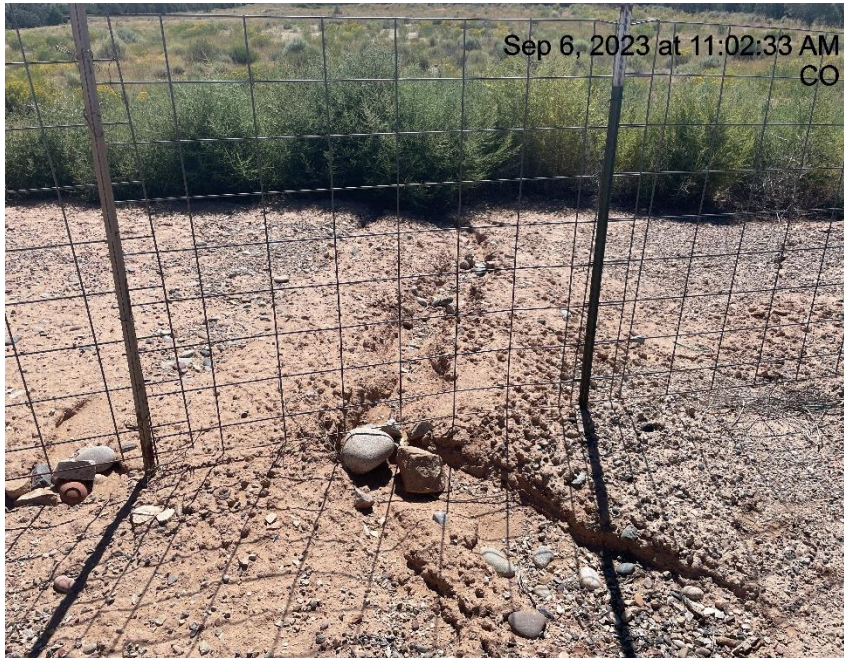
Photo # 8331 Erosion & transport of sediment off location & into a vegetated area/BMP's need maintenance

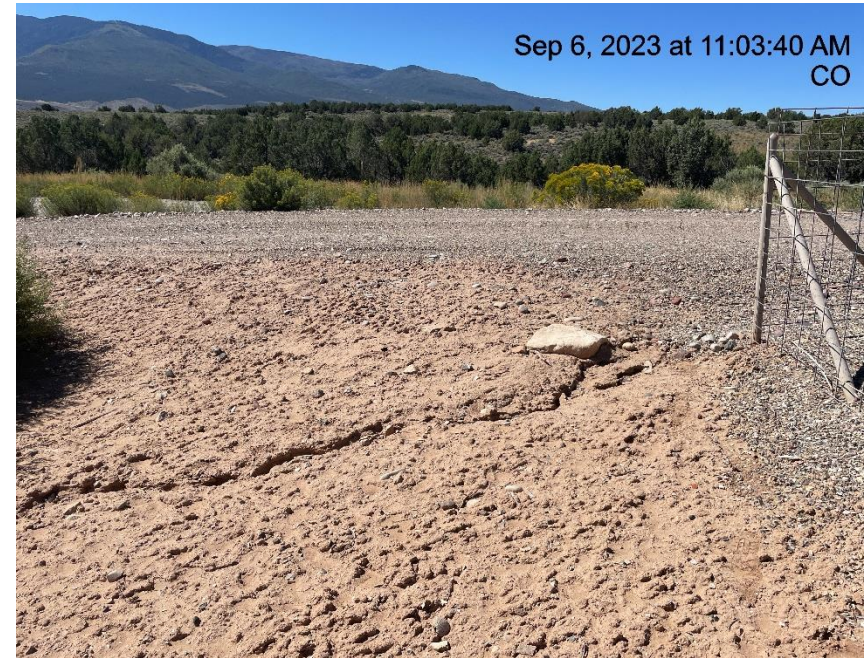
Photo # 8335 Erosion & transport of sediment off location & into a vegetated area

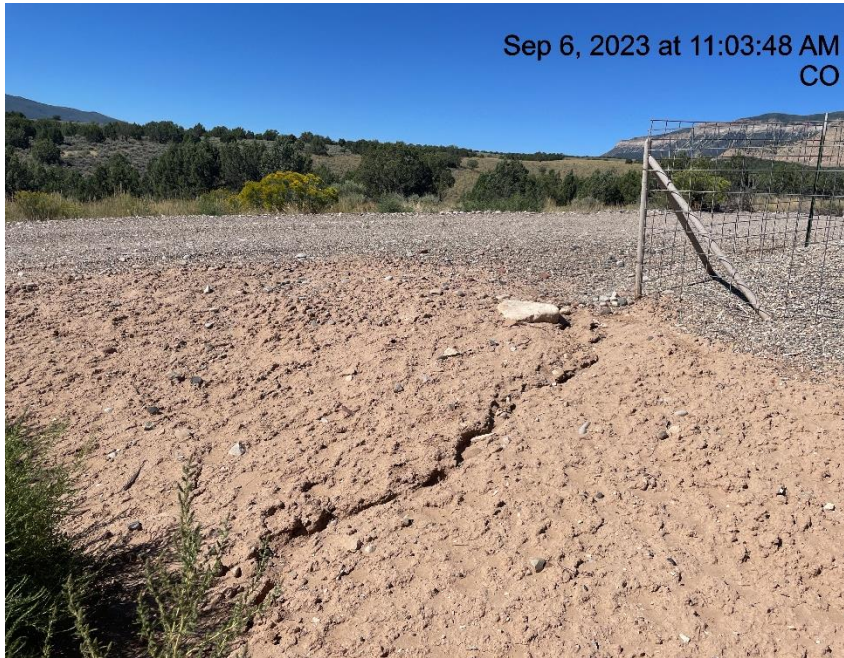
Photo # 8336 Erosion & transport of sediment off location & into a vegetated area

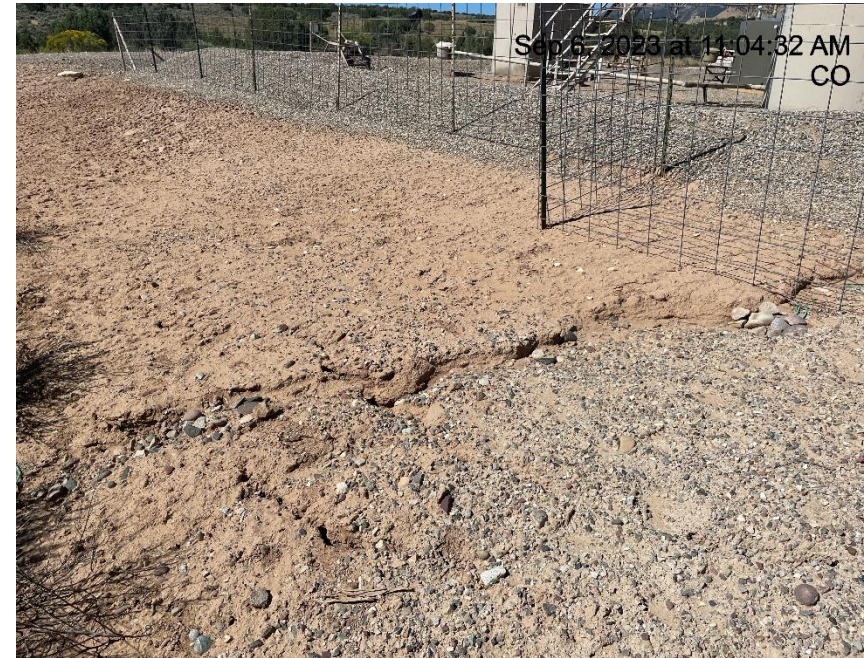
Photo # 8340 Erosion & transport of sediment off location & into a vegetated area/BMP's need maintenance

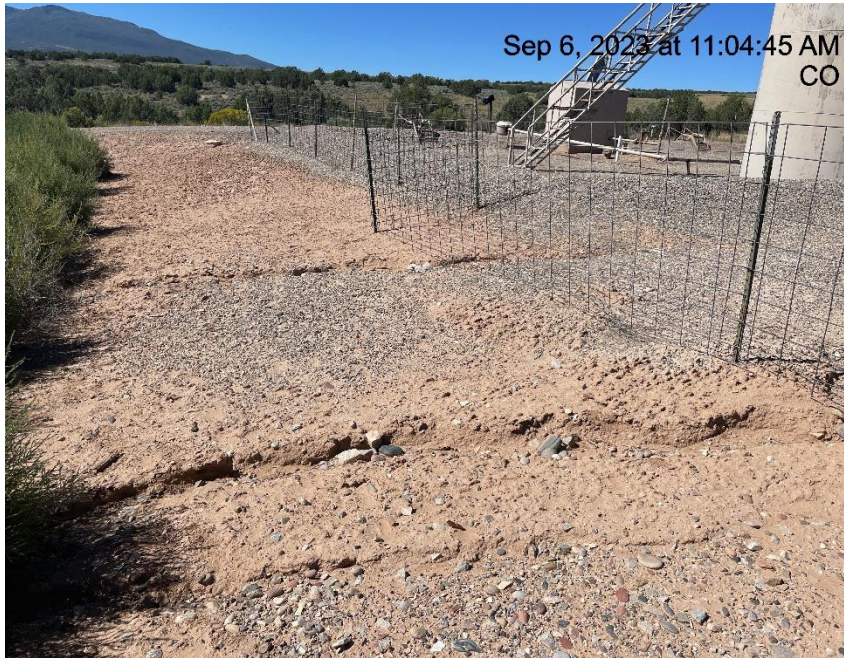
Photo # 8341 Erosion & transport of sediment off location & into a vegetated area/BMP's need maintenance

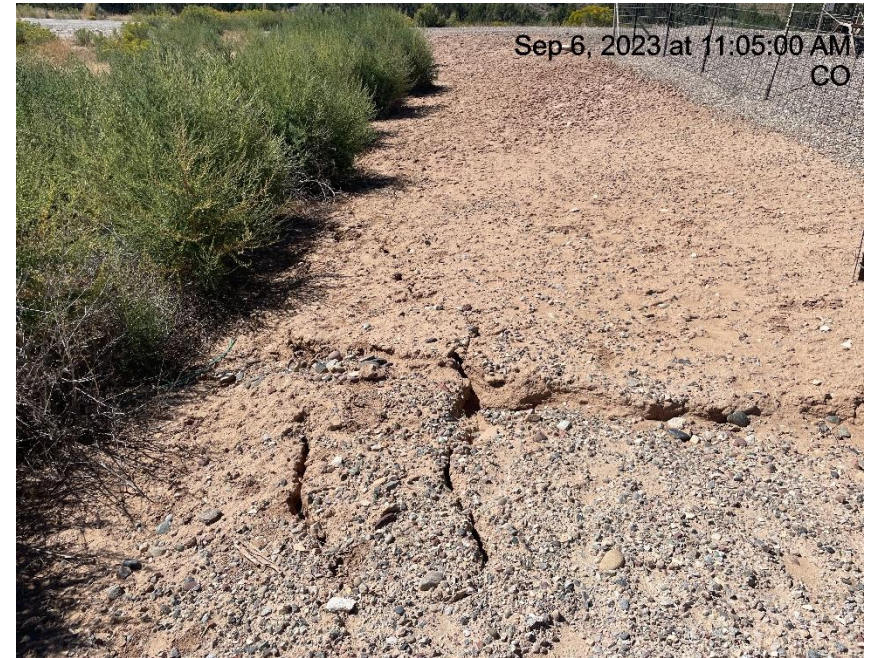
Photo # 8342 Erosion & transport of sediment off location & into a vegetated area

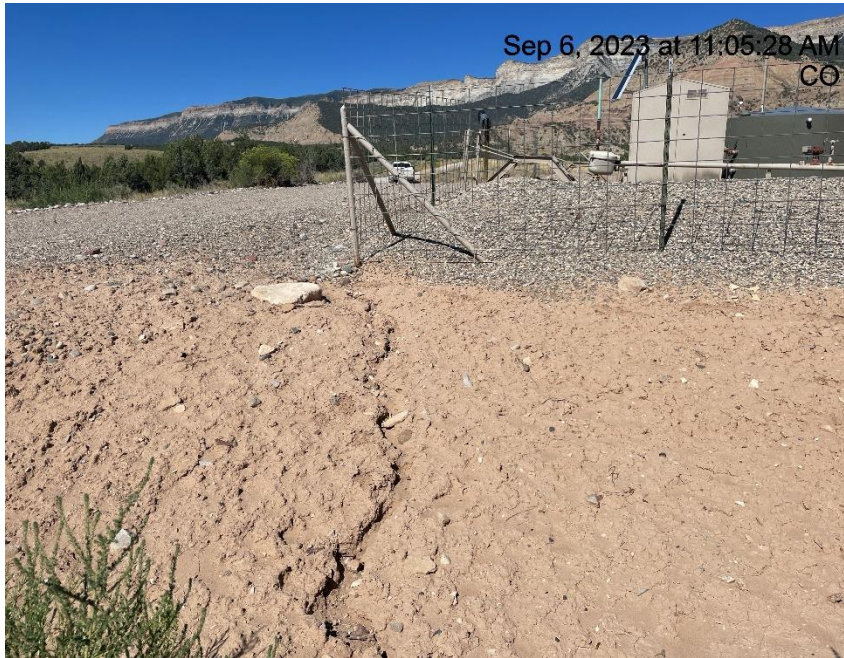
Photo # 8344 Erosion & transport of sediment off location & into a vegetated area

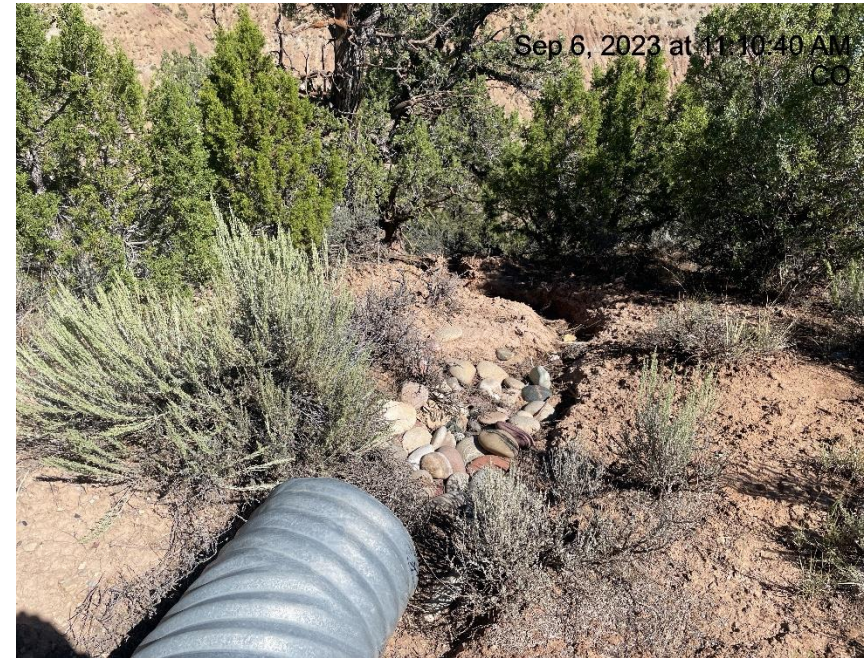
Photo # 8362 Rip Rap/BMP's need maintenance/erosion & transport of sediment/insufficient runoff controls/BMP's (NW corner of location after sediment trap)

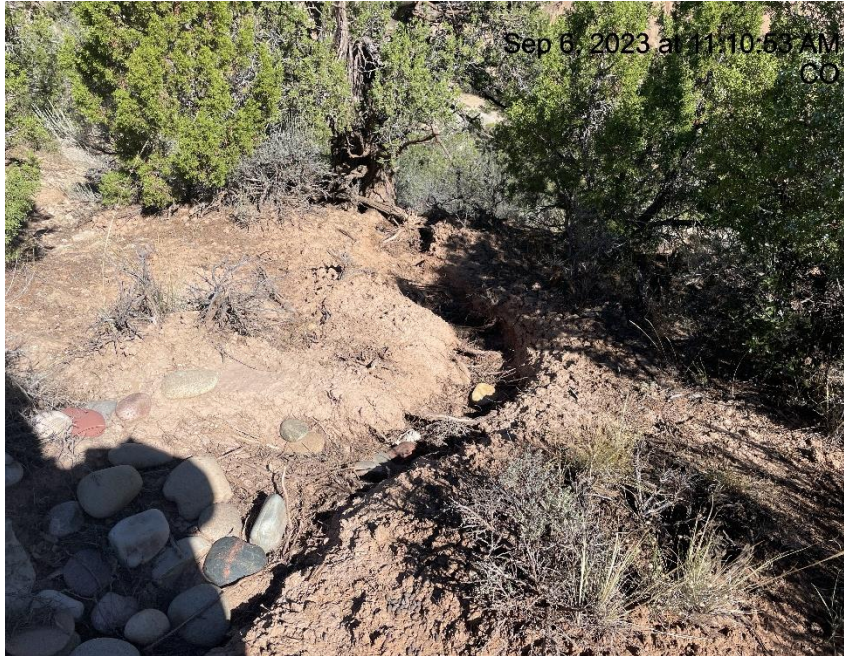
Photo # 8363 Rip Rap/BMP's need maintenance/erosion & transport of sediment/insufficient runoff controls/BMP's (NW corner of location after sediment trap)

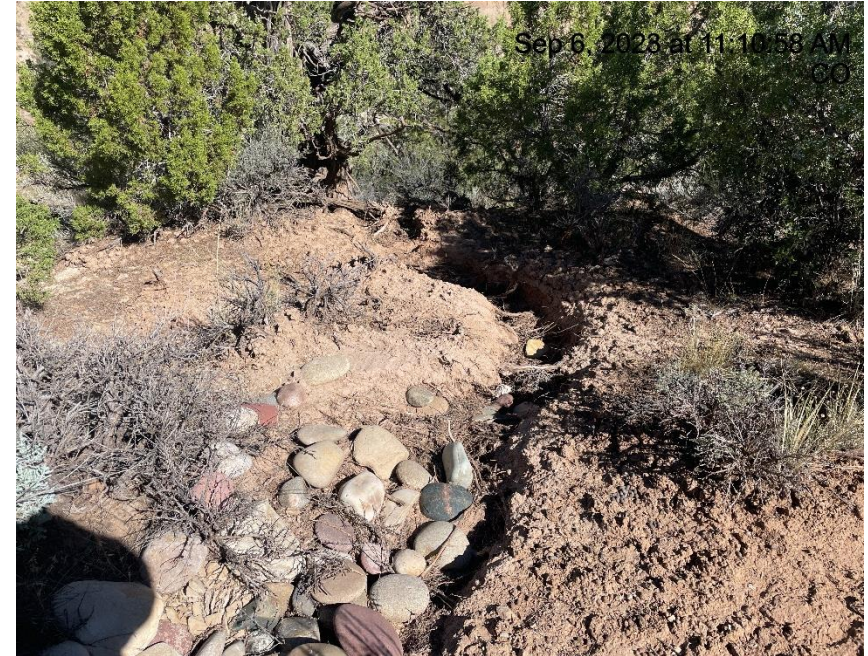
Photo # 8364 Rip Rap/BMP's need maintenance/erosion & transport of sediment/insufficient runoff controls/BMP's (NW corner of location after sediment trap)

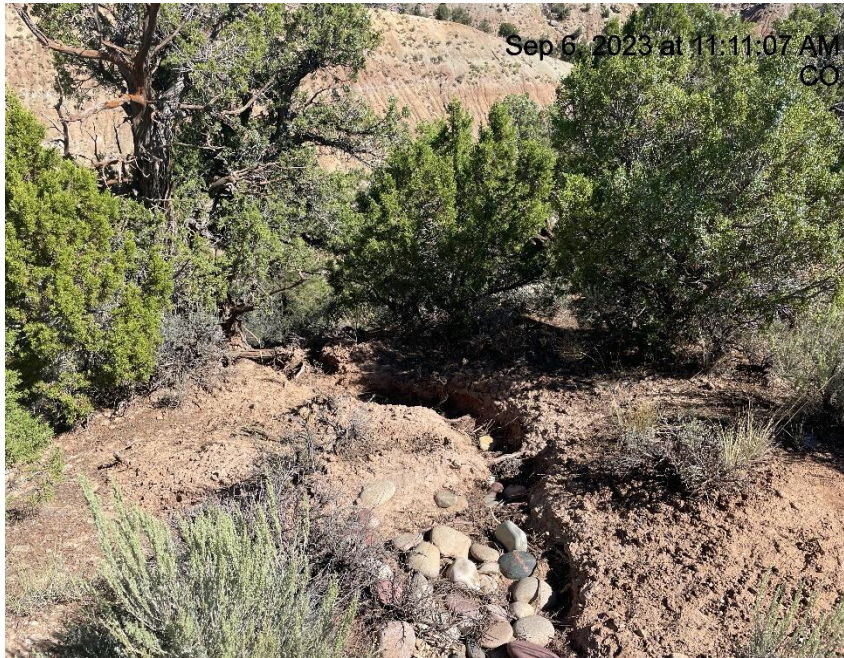
Photo # 8365 Rip Rap/BMP's need maintenance/erosion & transport of sediment/insufficient runoff controls/BMP's (NW corner of location after sediment trap)

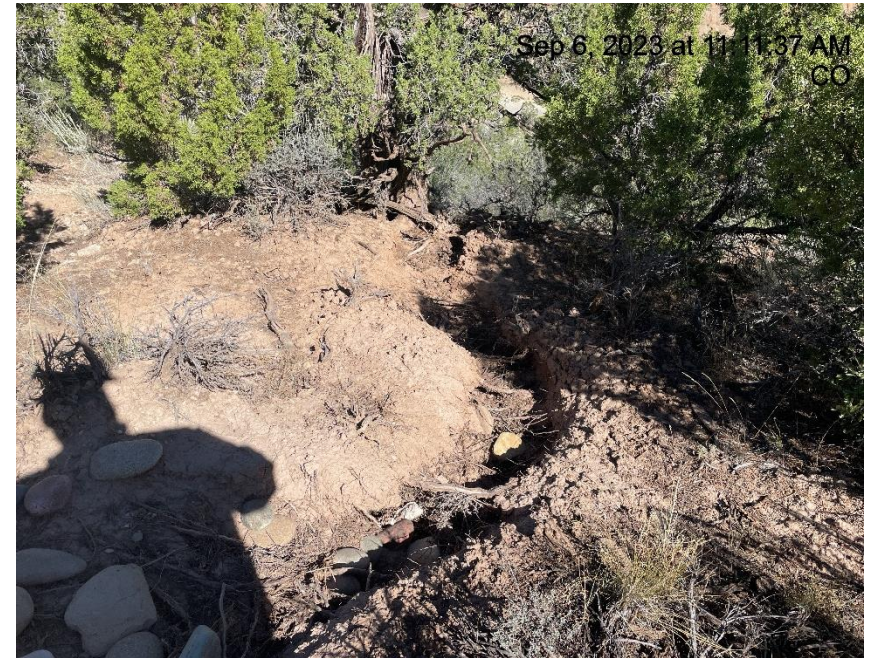
Photo # 8368 Rip Rap/BMP's need maintenance/erosion & transport of sediment/insufficient runoff controls/BMP's (NW corner of location after sediment trap)
