# Interim Reclamation and Stormwater Inspection

Operator: KERR MCGEE OIL & GAS ONSHORE LP - #47120

Location ID: 481939

Location Name: PAUL NELSON/25-29HZ & CHARLENE NELSON 12-34HZ

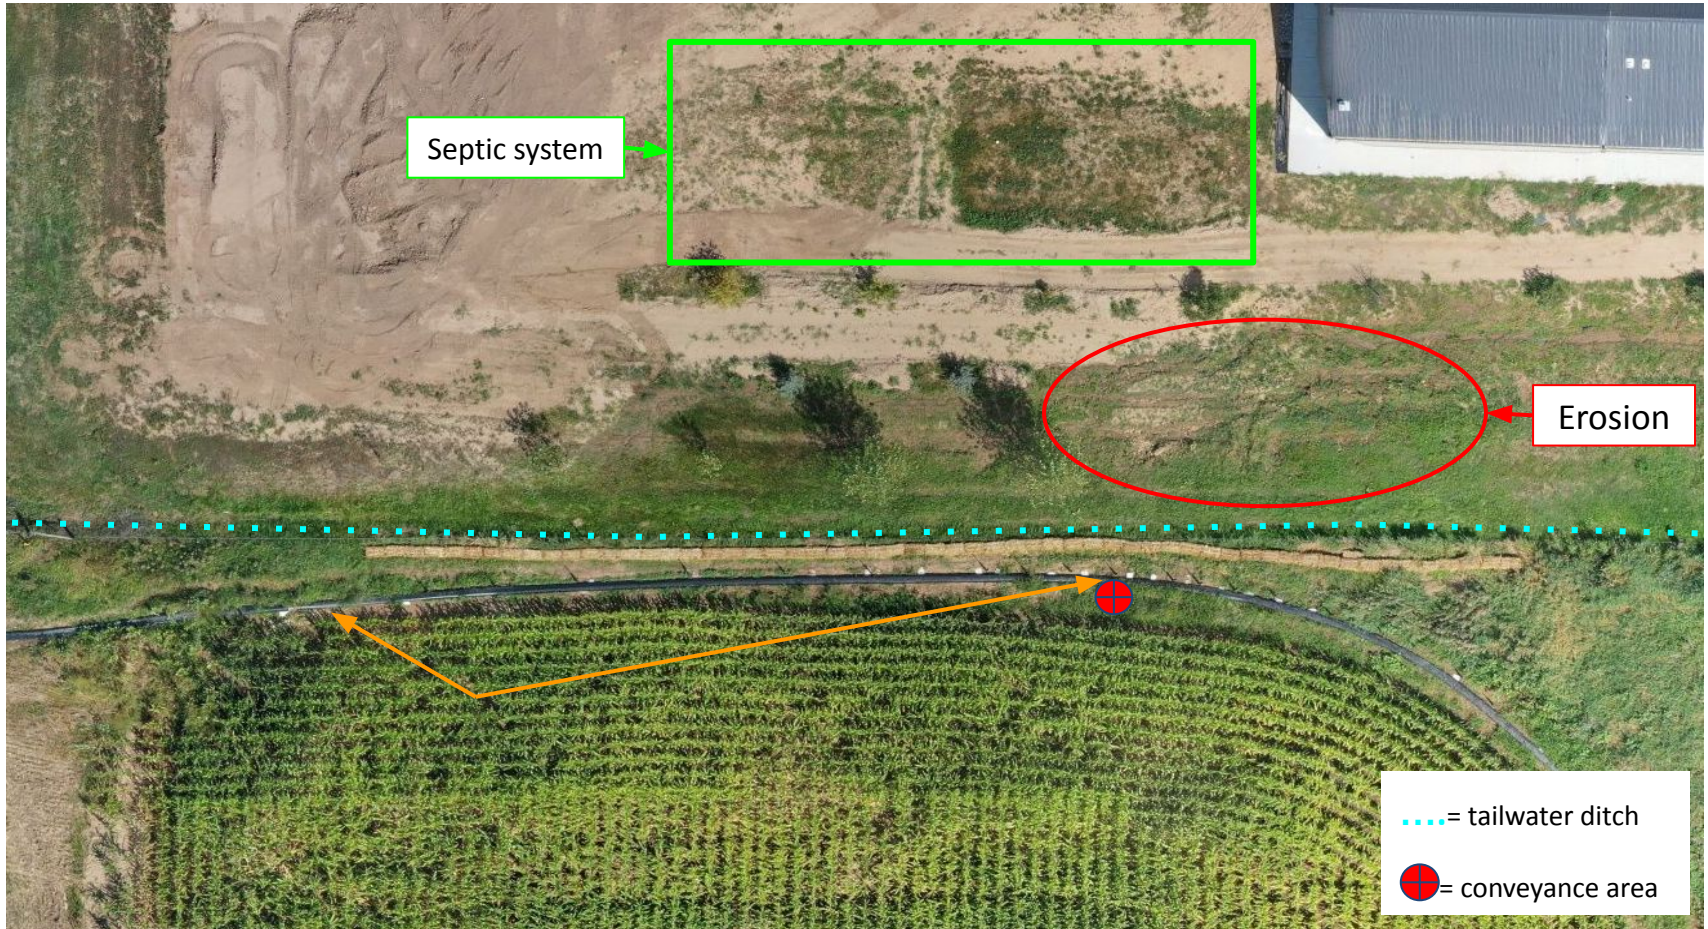
**Photo 1.** ECMC follow up drone aerial imagery illustrates the Operator surface waterline. Based on the most recent flood irrigation event (8/20-8/22), the orange arrows illustrate an approximate 100' section of waterline that is preventing irrigation tailwater to flow into the tailwater ditch. Tailwater instead backs up and is conveyed further east, then undermined the waterline causing erosion on the complainant's property. The waterline is ultimately causing concentrated tailwater flows, which was not historically observed. This confirms the complainant's waterline erosion issues.

Note- straw bales were installed by the Operator as a mitigation effort and in response to the previous ECMC corrective action.

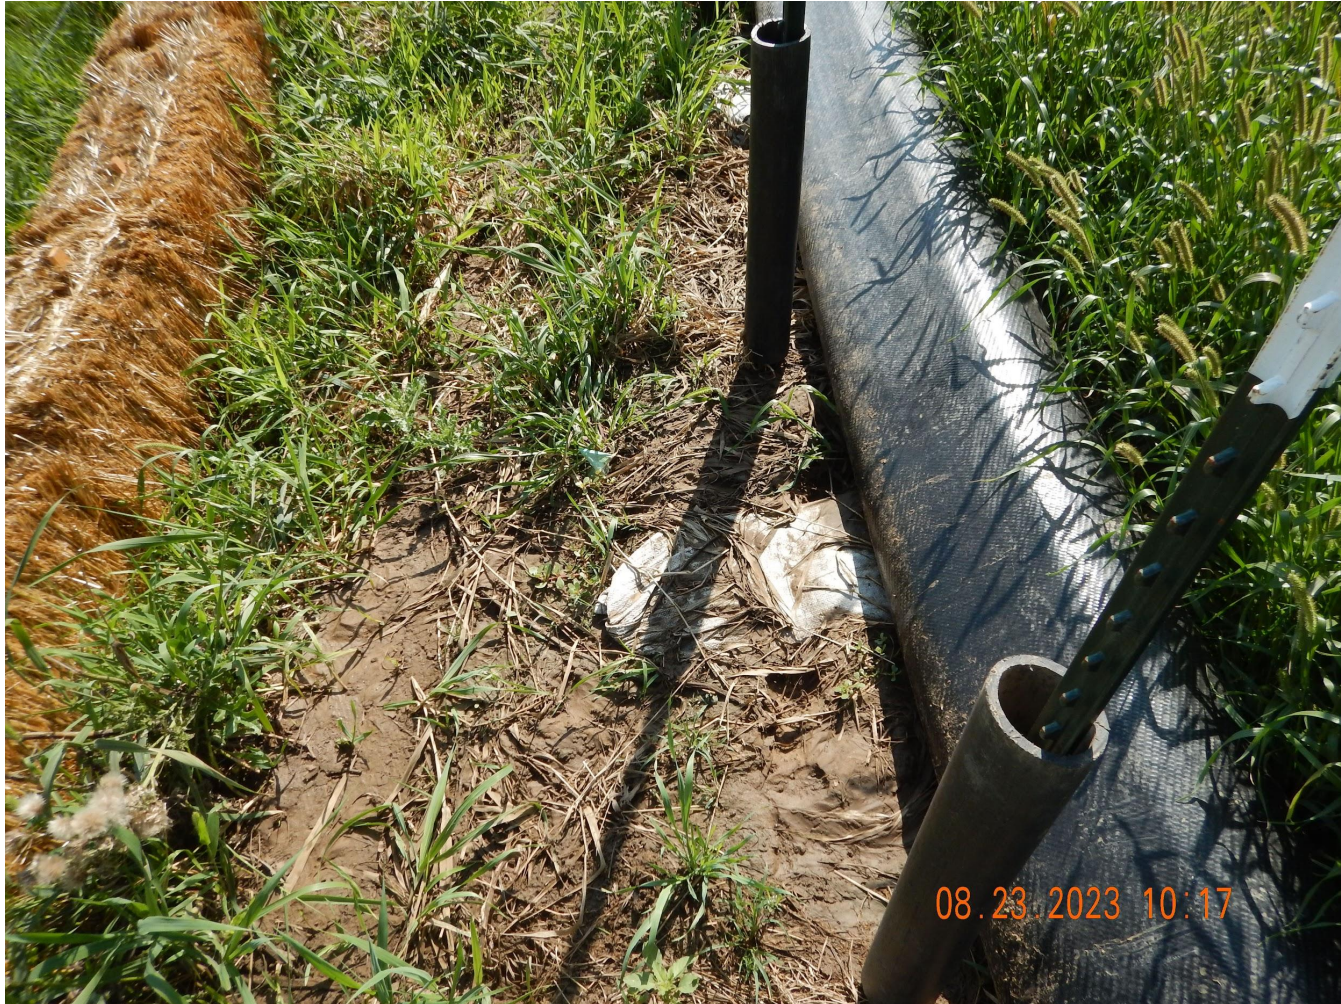
**Photo 2.** Photo taken from the conveyance area where irrigation tailwater undermined the waterline causing erosion on the complainants property. It appears the Operator also placed the waterline back onto the sand bags.

Note- waterline was not pressurized at the time of this inspection and does not appear to be in use.

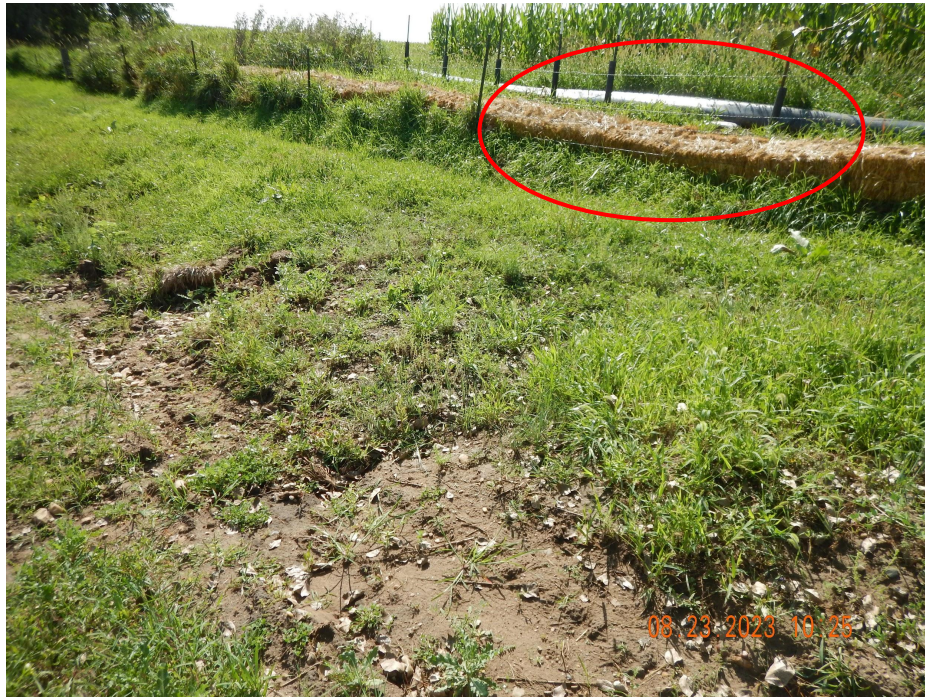
**Photo 3.** Photo illustrates the conveyance area where irrigation tailwater undermined the waterline causing erosion on the complainants property and threatening their septic system.

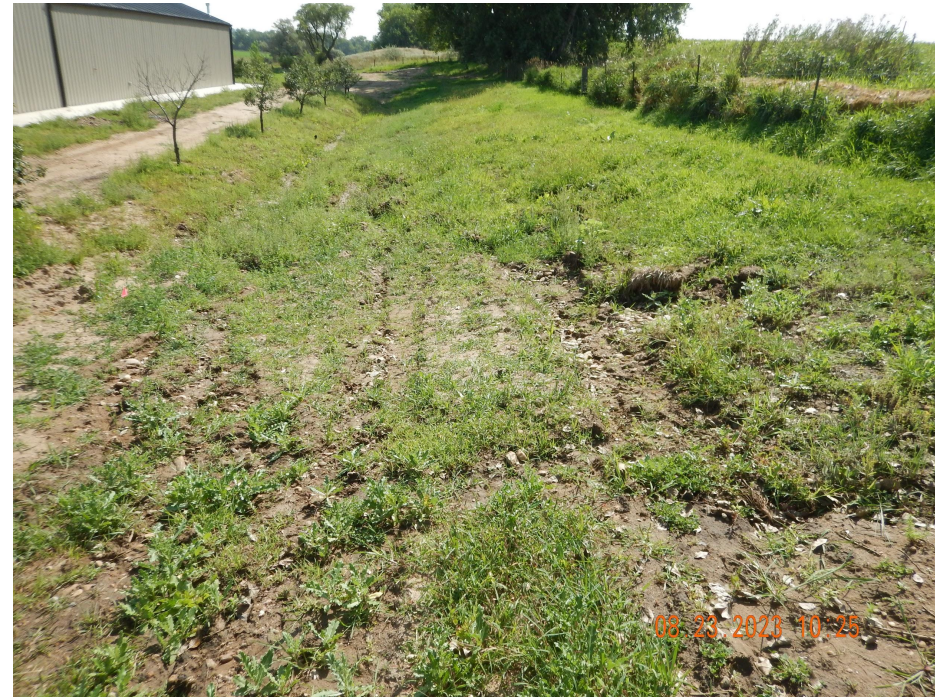
**Photo 4.** Photo illustrates some of erosion on the complainants property.
