Inspection Photos
Location Name: Doris Ackerson Unit 4
Location ID: 318638

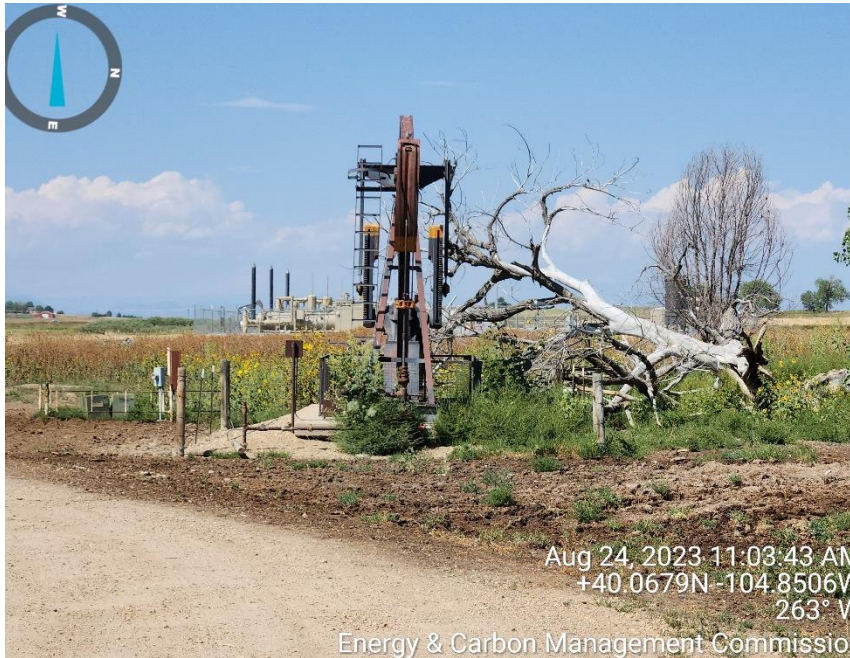
Photo 1 well head and equipment

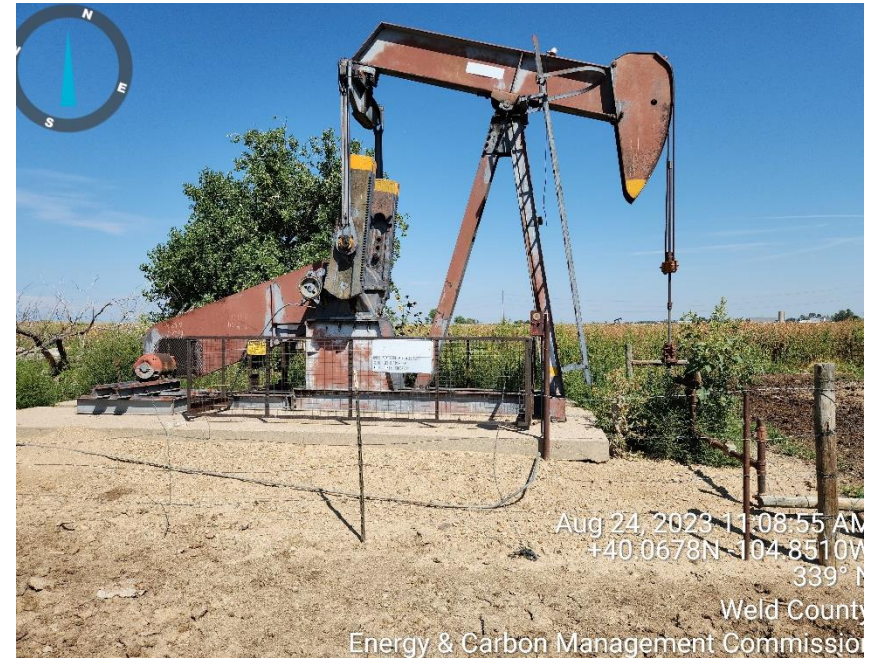
Photo 2 well sign

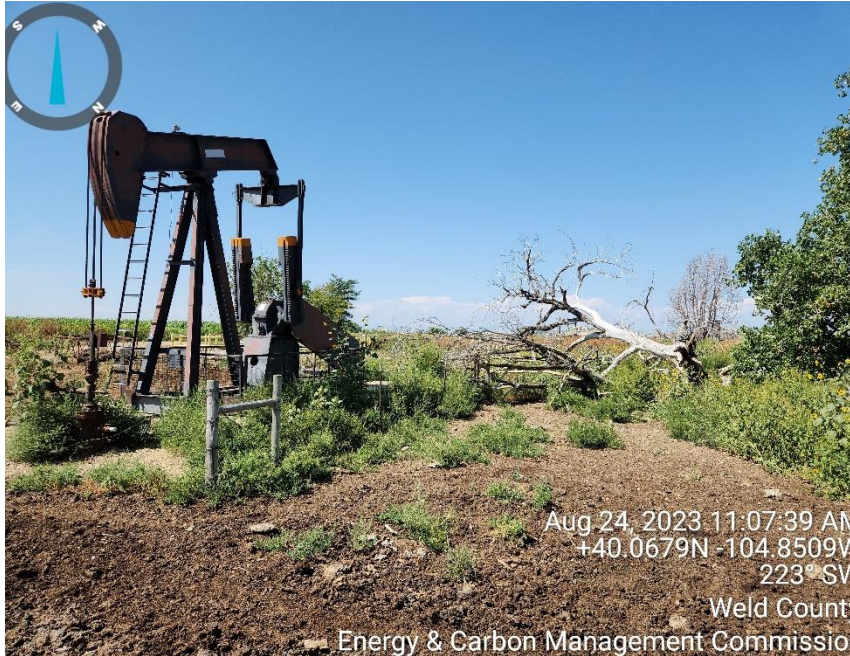
Photo 3 debris on site

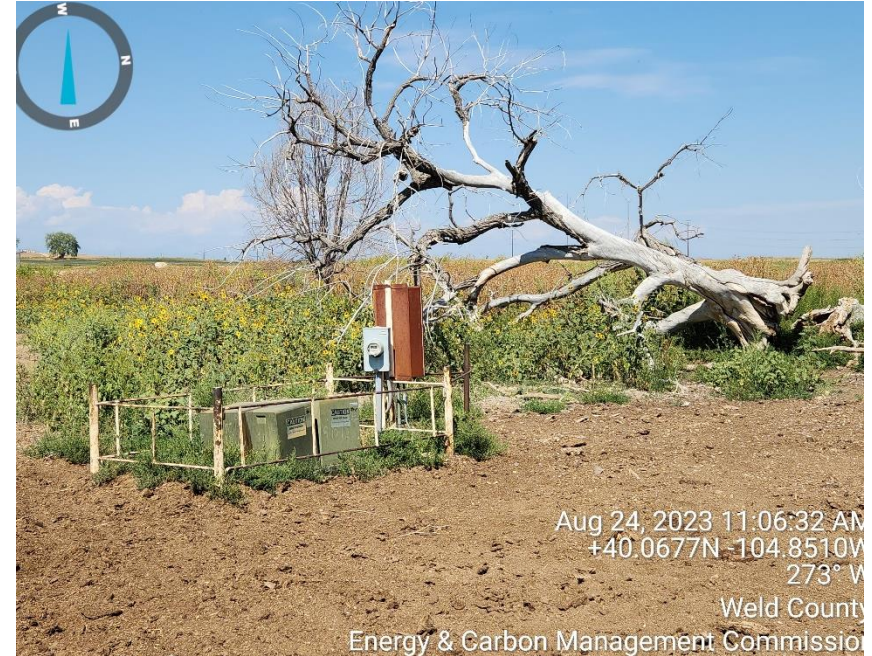
Photo 4 electrical panel and debris

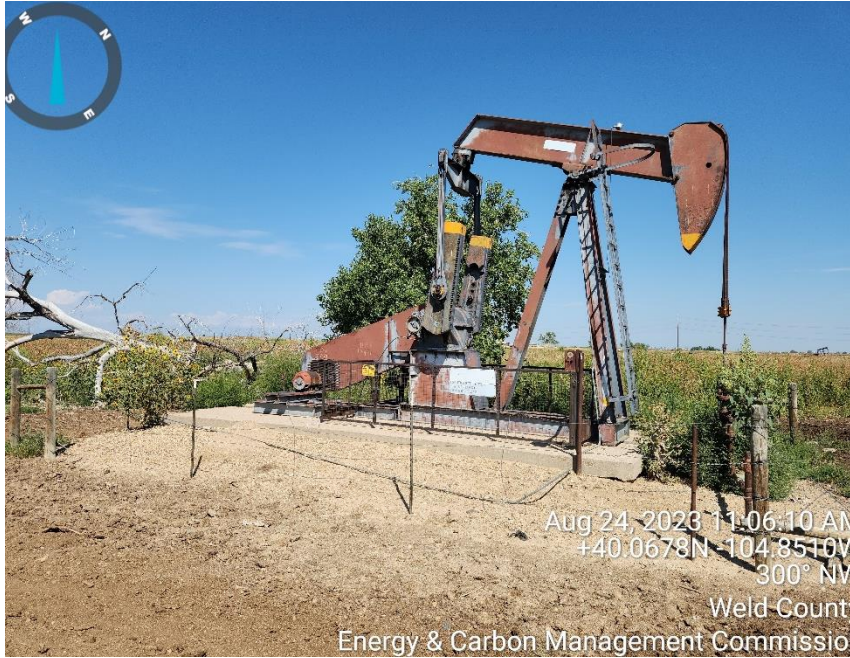
Photo 5 equipment and debris
