Inspection Photos

Location Name: VISION ENERGY LLC, SOUTH SHALE RIDGE-68S98W/14NENE

Location ID: 324270

Date: 9/6/2023

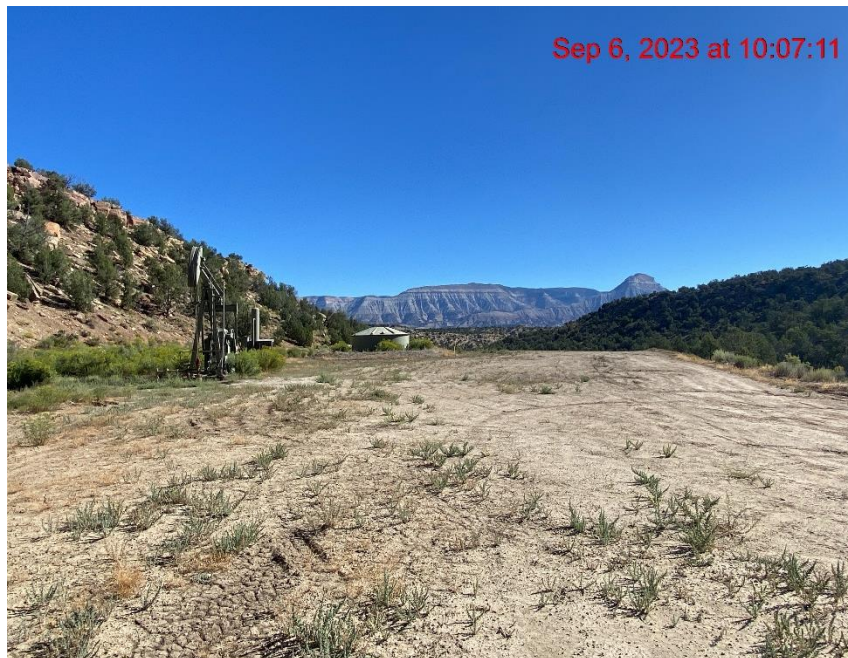
West End of Location – Photo #06252

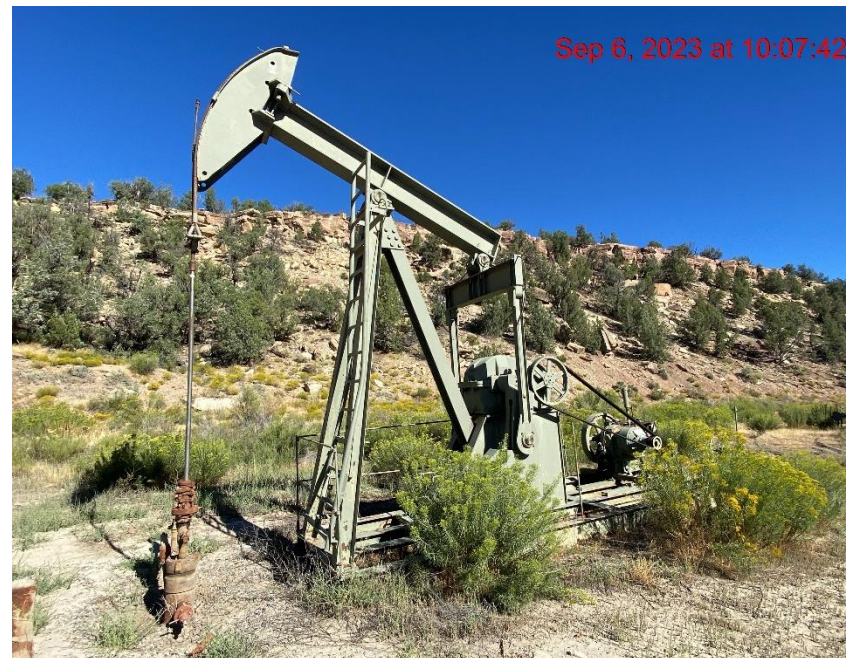
Wellhead – Photo #06253

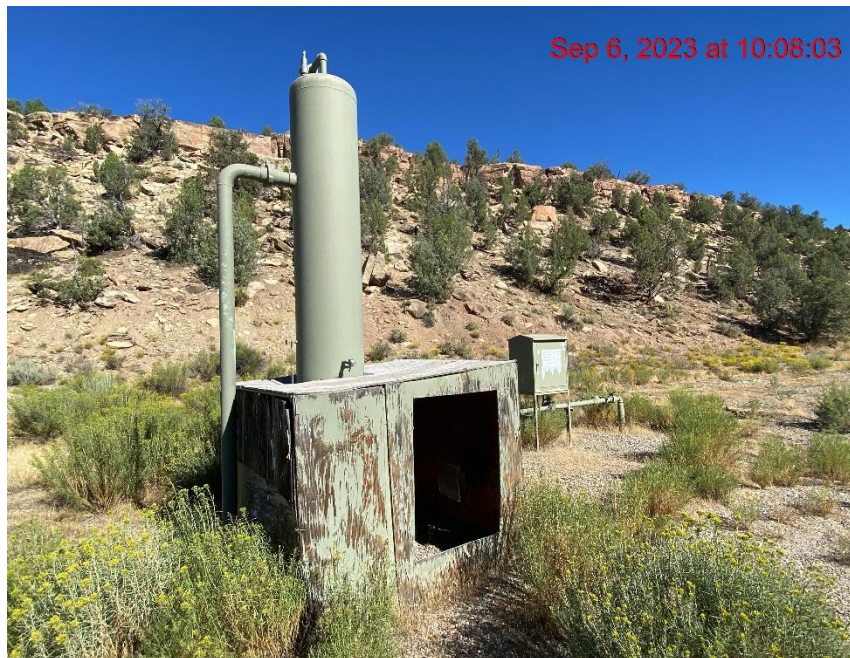
Separator/Gas Meter Run – Photo #06255

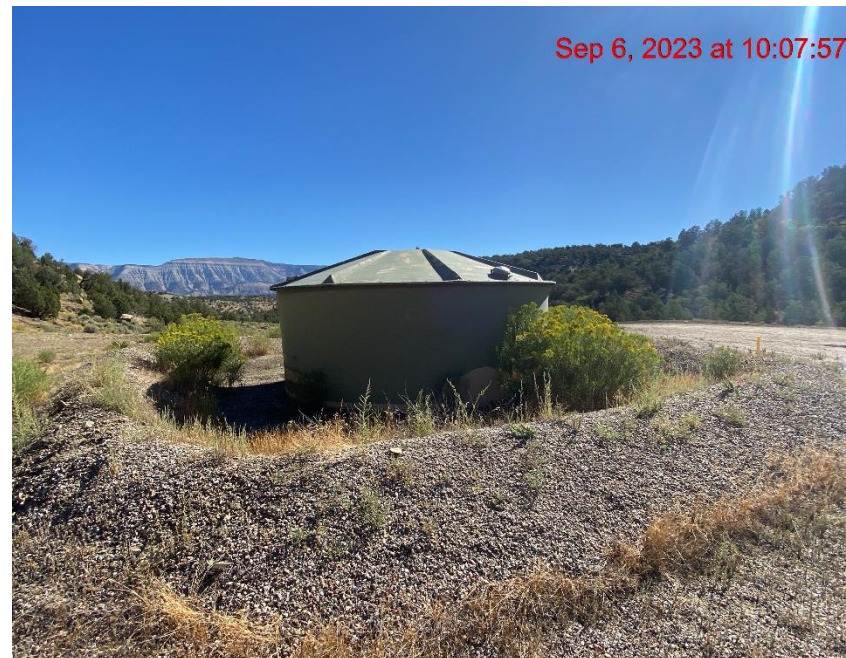
Tank Battery – Photo #06254

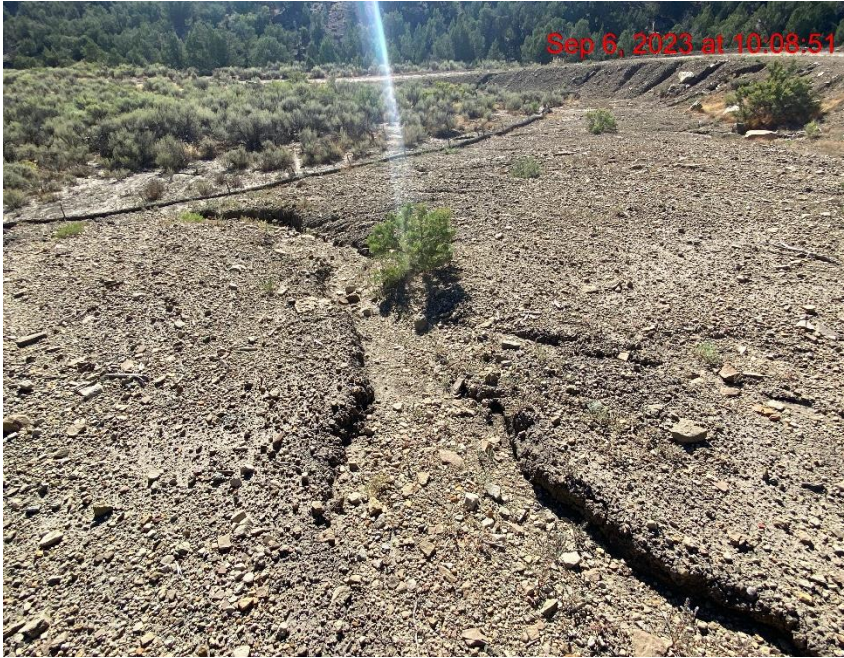
Rill Erosion Transporting Sediment Off-Location – Photo #06258

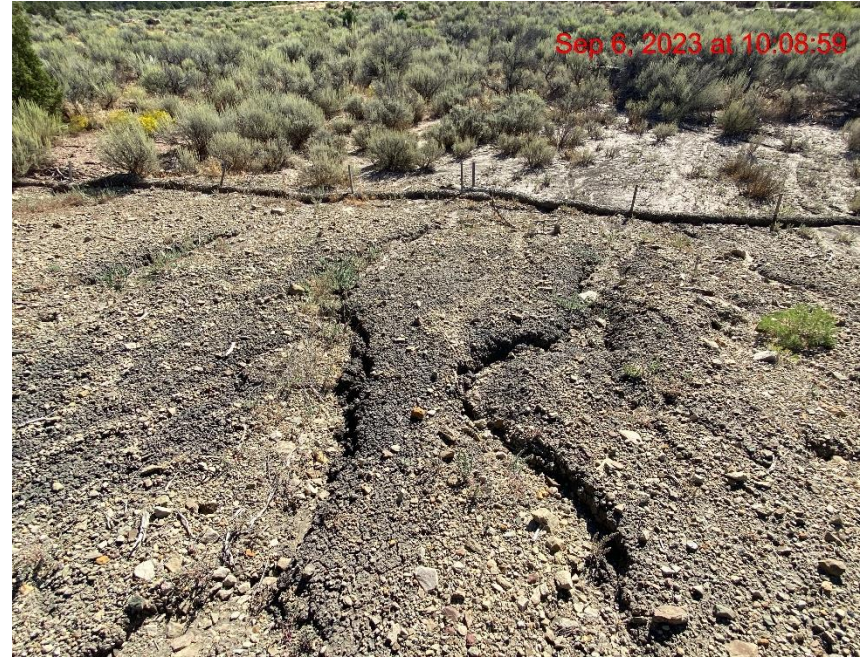
Rill Erosion Transporting Sediment Off-Location – Photo #06259

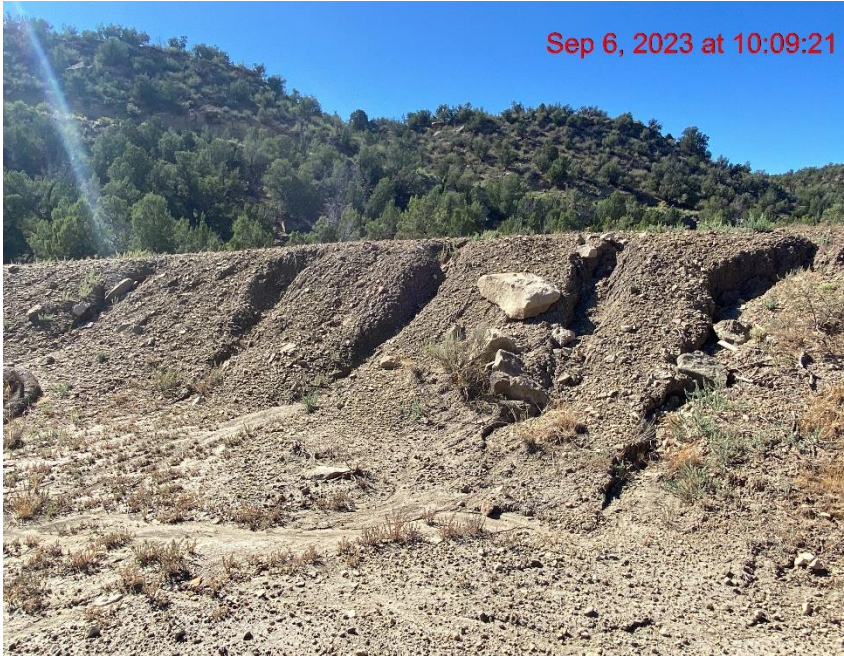
Gulley Erosion Transporting Sediment Off-Location – Photo #06261

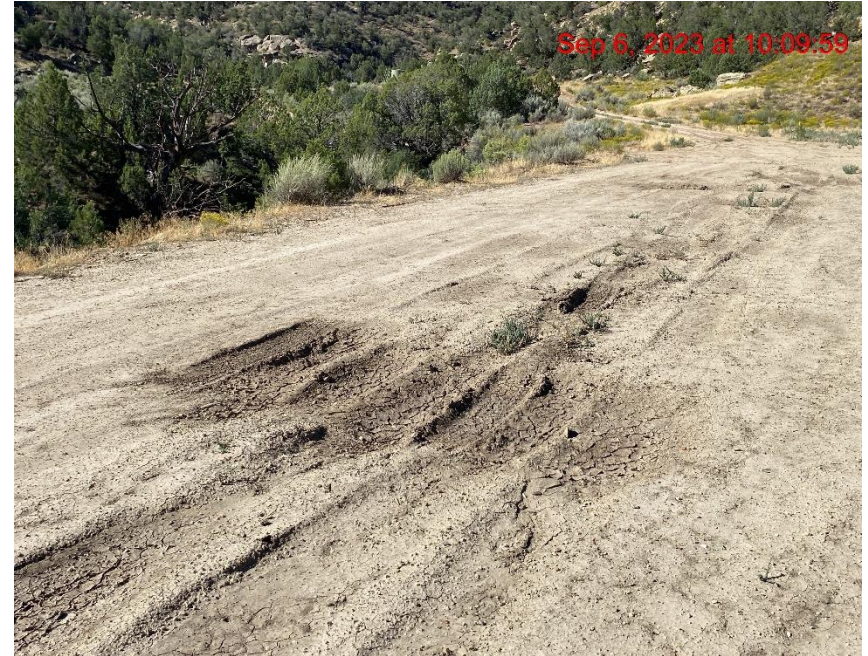
Location Lacks Stabilization – Photo #06263

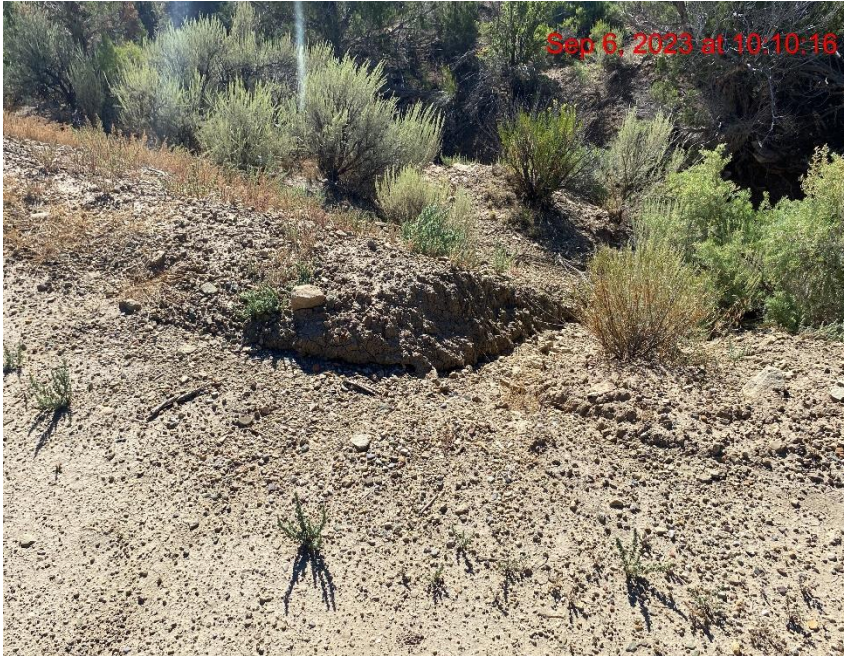
**Rill Erosion Transporting Sediment from Access
Road to Drainage Ditch – Photo #06265**

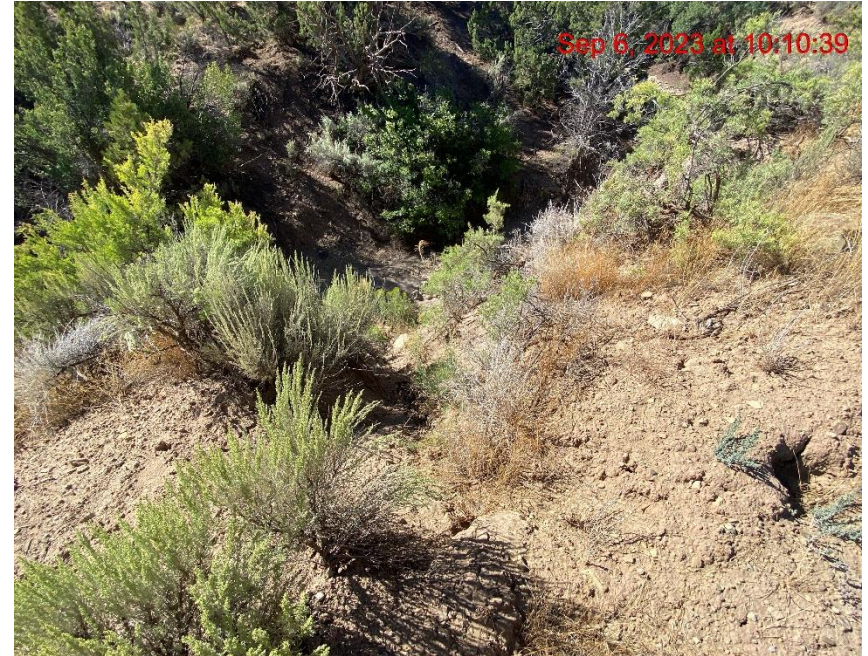
**Rill Erosion Transporting Sediment from Access
Road to Drainage Ditch – Photo #06267**

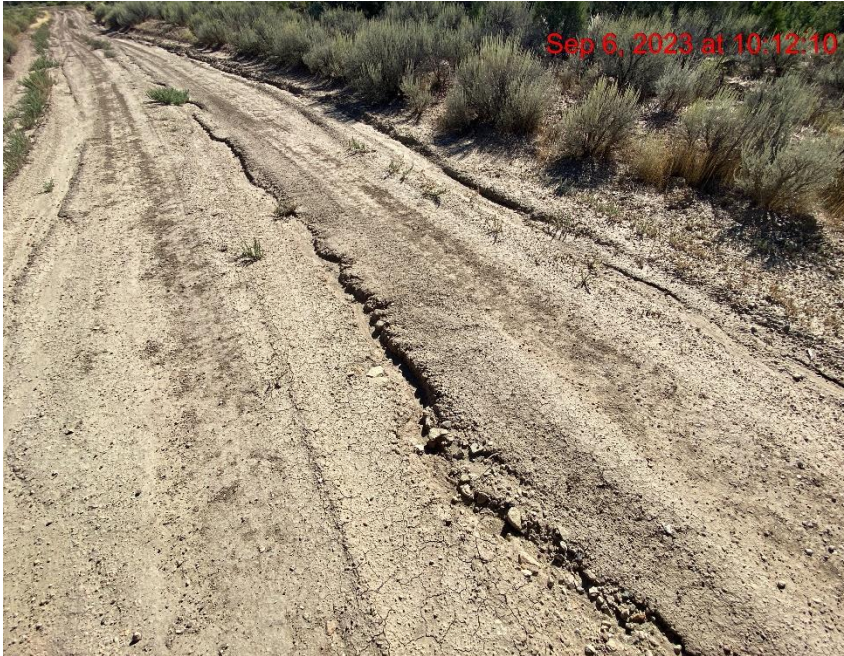
Access Road Lacks Stabilization – Photo #06269

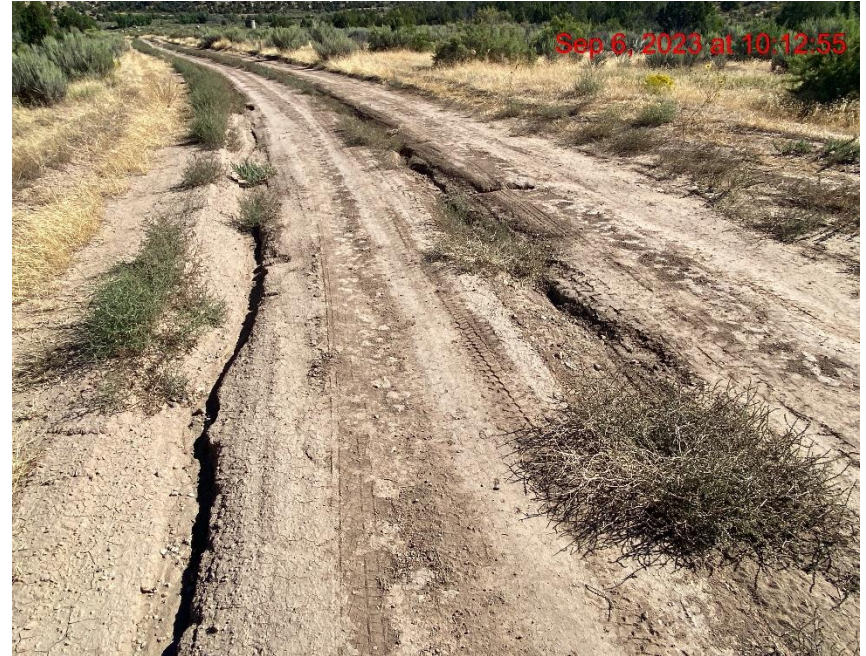
Access Road Lacks Stabilization – Photo #06270

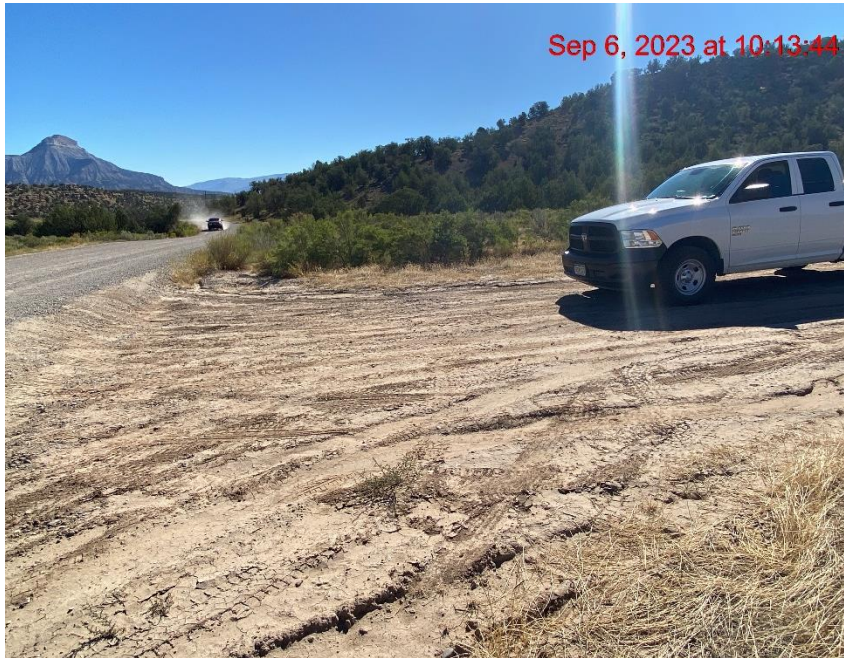
Insufficient Vehicle Tracking BMPs at Location

Entrance/Exit – Photo #06271
