Inspection Photos

API: 011-06046

Operator: STRACHAN EXPLORATION INC

Inspection Date: 9/6/2023

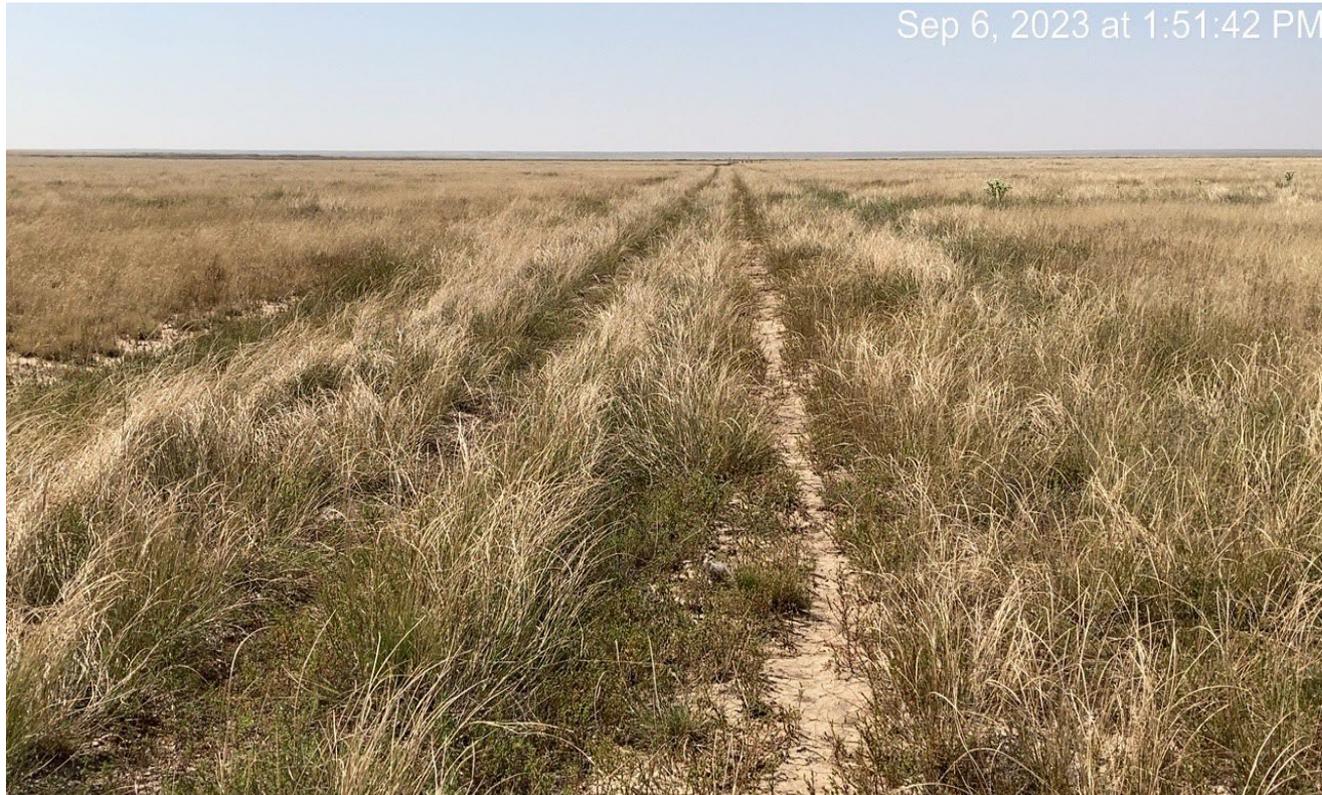
Photo 1. Facing west along the former access road. There are areas of the road that have not established vegetation.

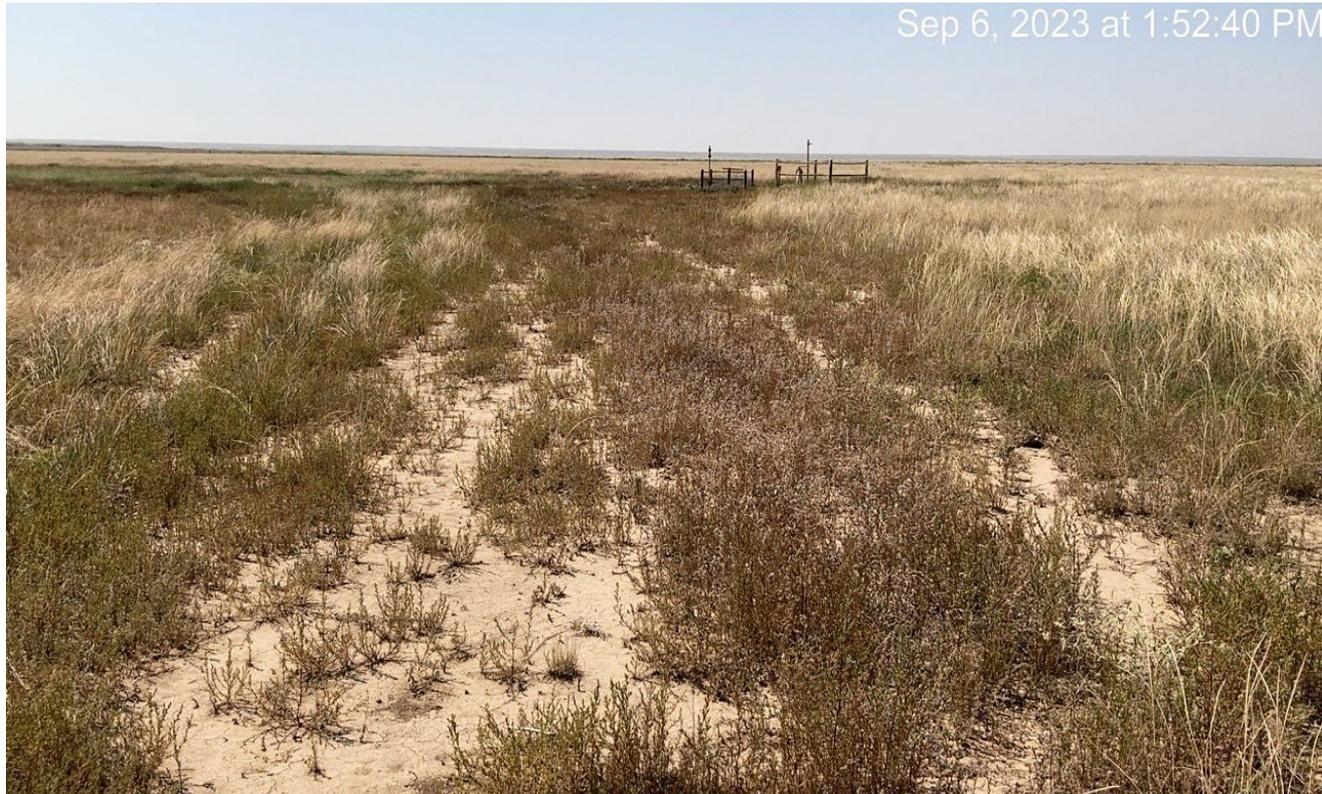
Photo 2. Facing west toward the location which has not been reclaimed. There are undesirable weeds throughout the location and areas bare vegetation. There is equipment that remains at the north side of the location. Previous corrective action was not completed..

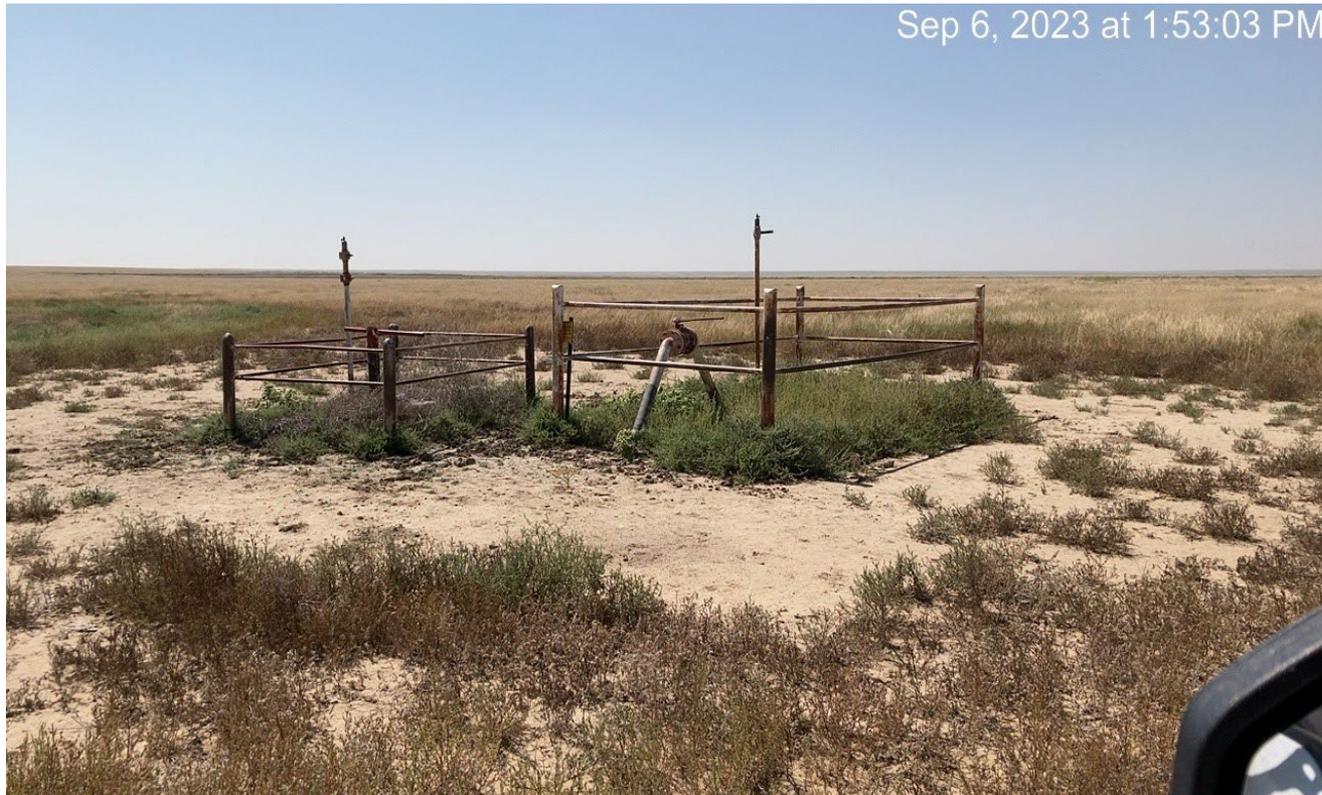
Photo 3. There are pipe risers associated with the former well site that have not been removed. Previous corrective action was not completed.

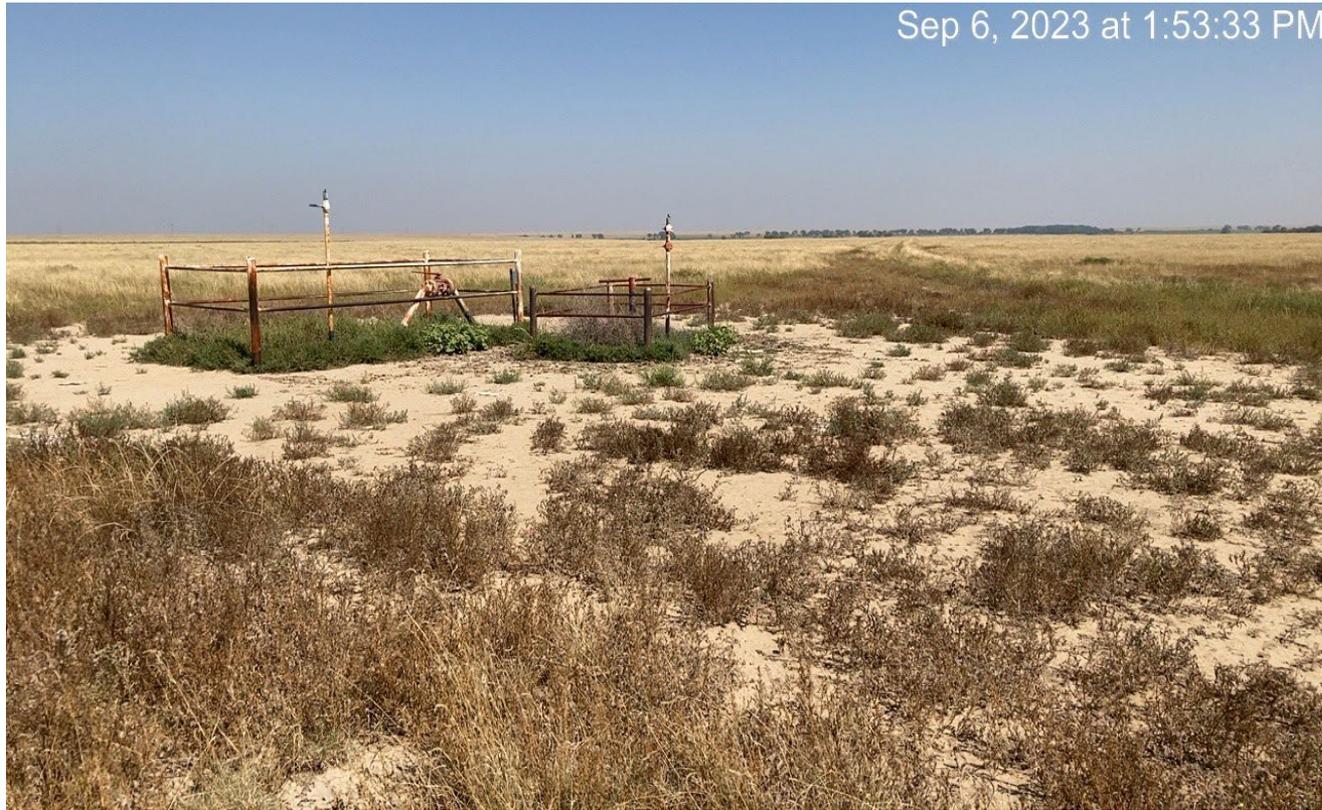
Photo 4. North side o the location facing east. There are areas of the location that are bare of vegetation or consist of undesirable weeds.

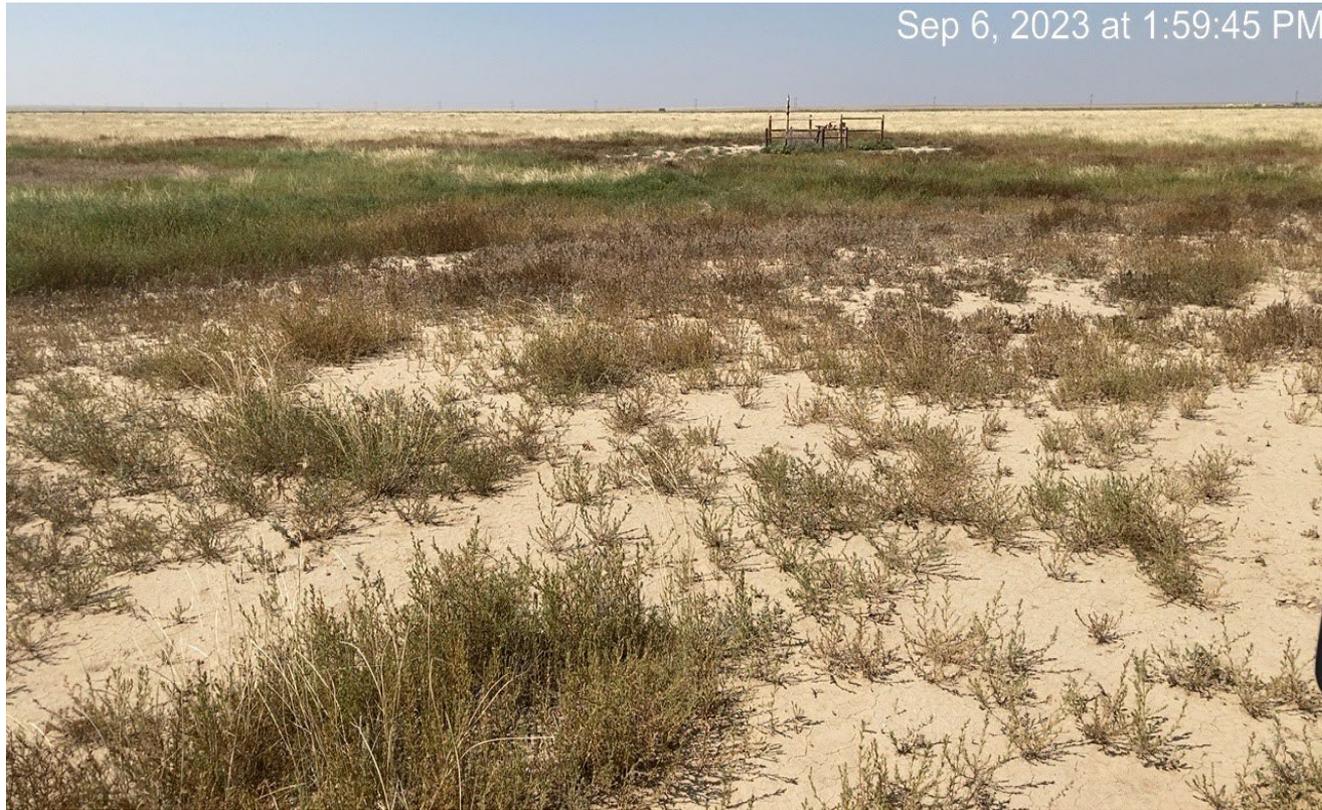
Photo 5. South side of the location facing north. There are undesirable weeds throughout the location and areas bare vegetation. Reclamation has not been completed.

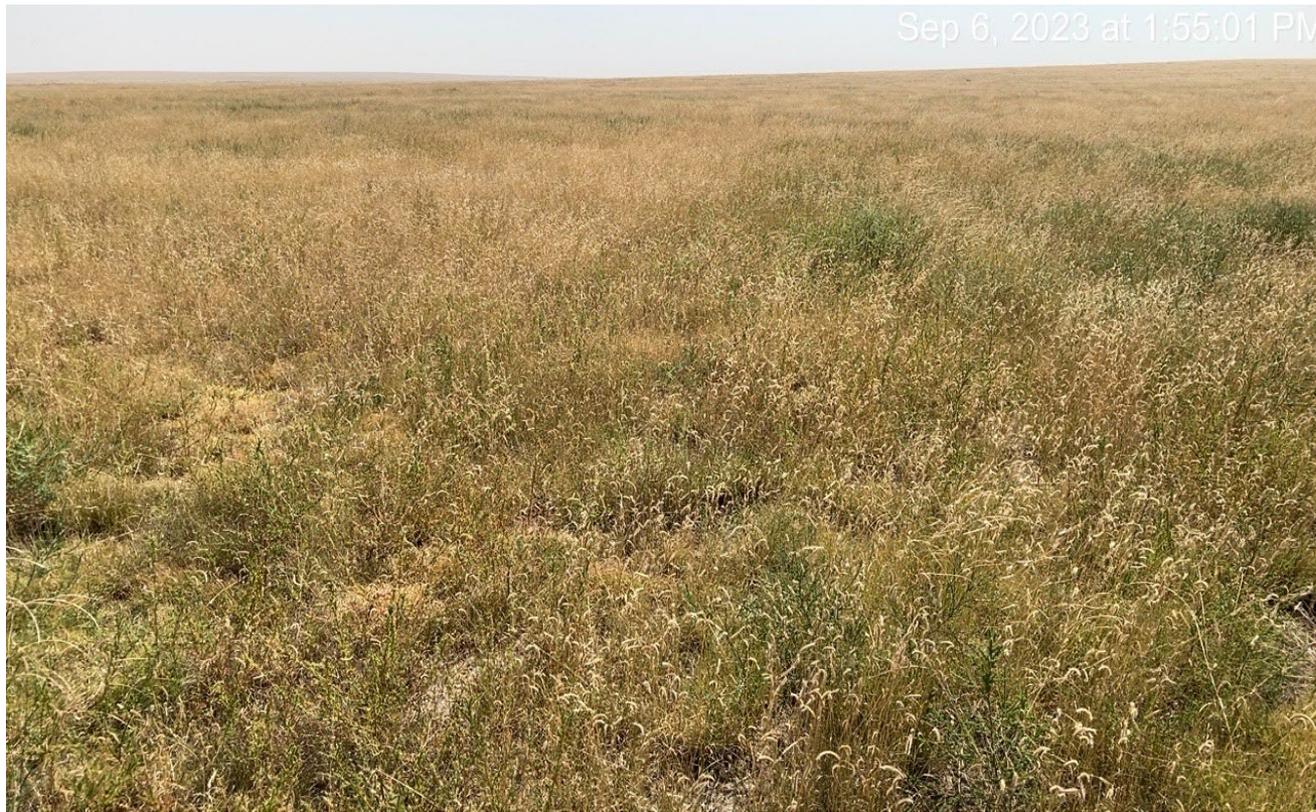
Photo 6. Facing south at the surrounding undisturbed reference area which shows a uniform vegetation cover consisting of Blue grama, Sand dropseed, Prairie threeawn among other species.
