Inspection Photos

API: 011-06108

Operator: THOMAS L SPRING LLC

Inspection Date: 9/6/2023

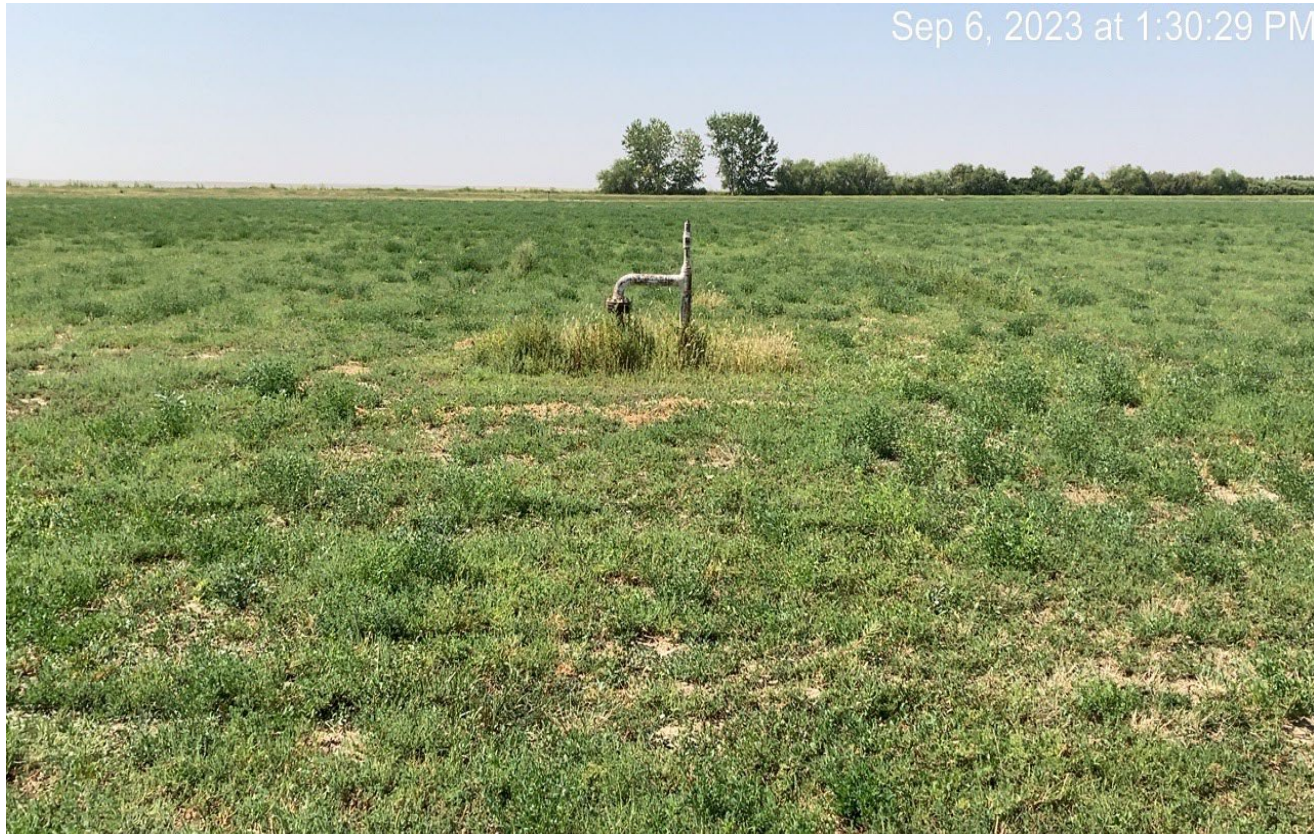
Photo 1. Facing west toward the abandoned wellsite. There is an abandoned pipe riser that still remains at the location. .
